**San Luis Obispo County
Flood Control and Water Conservation District**

**2005/2006 Annual On-Site Inspection of the
Arroyo Grande Creek Channel and
Los Berros Creek Diversion Channel**

December 15, 2006

Report prepared by:
Nola Engelskirger
San Luis Obispo County Public Works Department

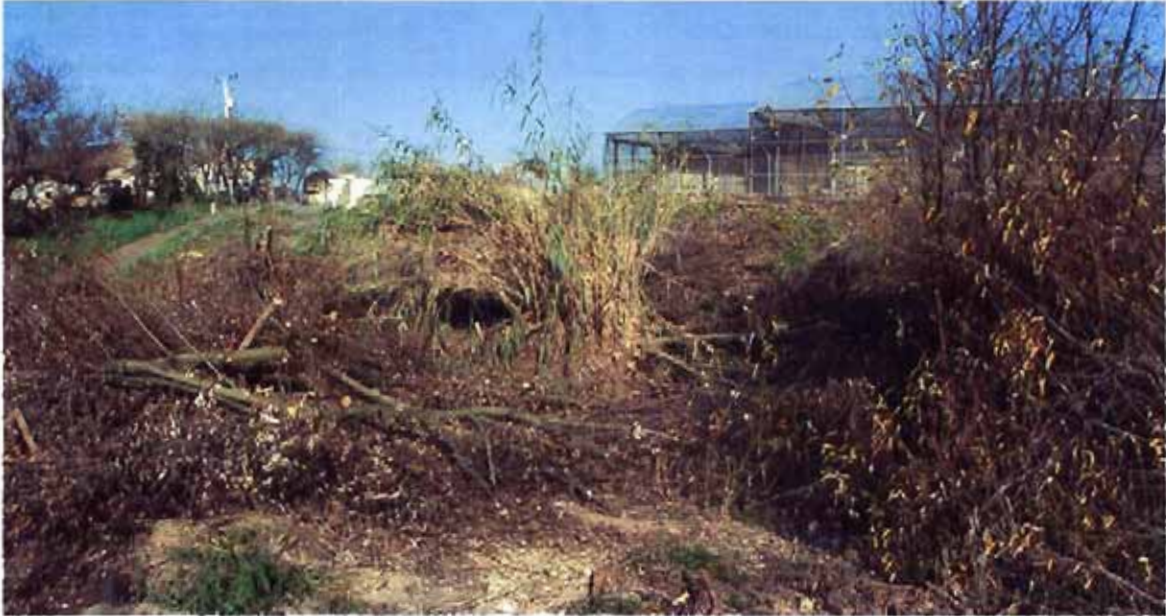
The debris jams appeared to be caused by trees that had been chopped down on the banks of the channel, but had not been removed from the channel. The trees were not chopped down during the vegetation maintenance coordinated by the CSLRCD or the SLCFC&WCD, but had apparently been chopped down and left by a resident who probably thought that they were helping by cutting down the trees, not knowing that the cut limbs would cause jams if left on the bank.

Photo 1:
All the debris

The debris jams were removed a week after they were reported. The CSLRCD obtained the required permits and coordinated the required red-legged frog monitoring. The SLCFC&WCD contracted with the California Conservation Corps to remove the debris jam and provided necessary equipment such as chipper and dump truck. Work to remove the debris jams commenced February 2, 2006 and was completed February 8, 2006.

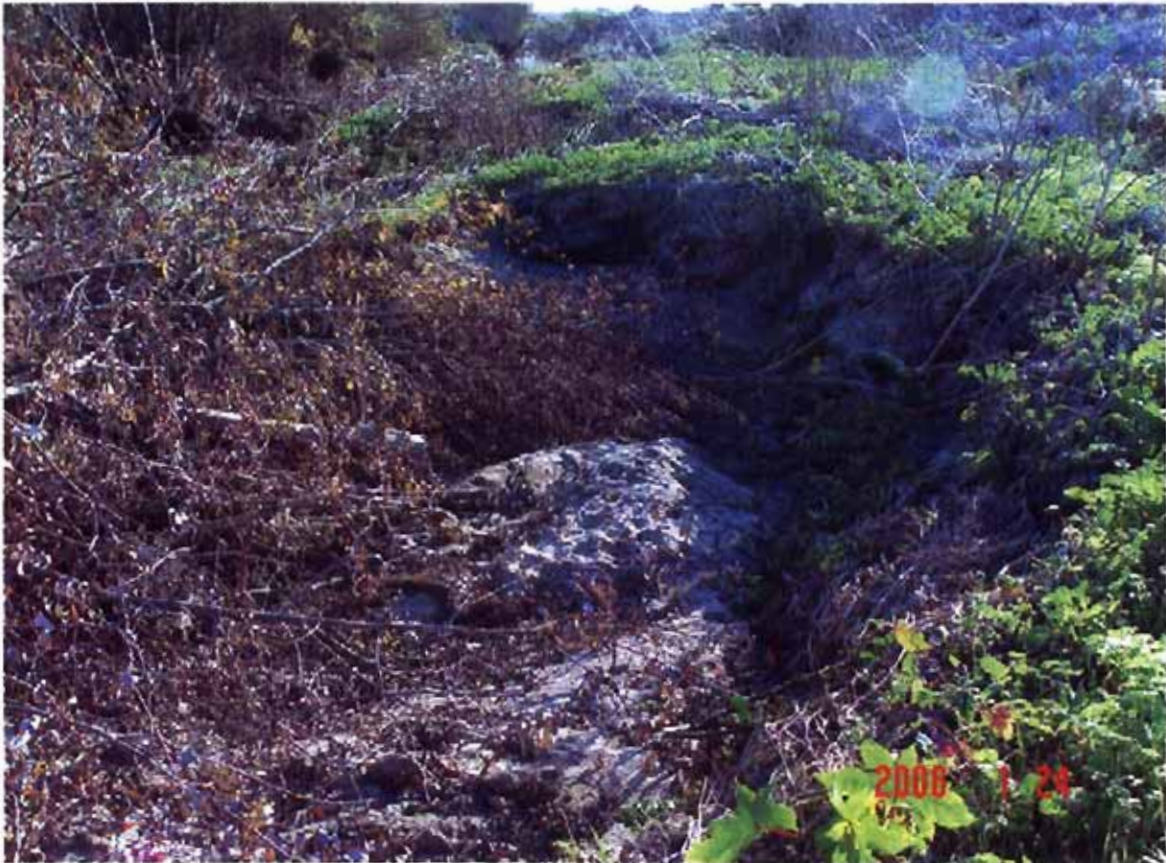
Photo 2:
Scour around debris

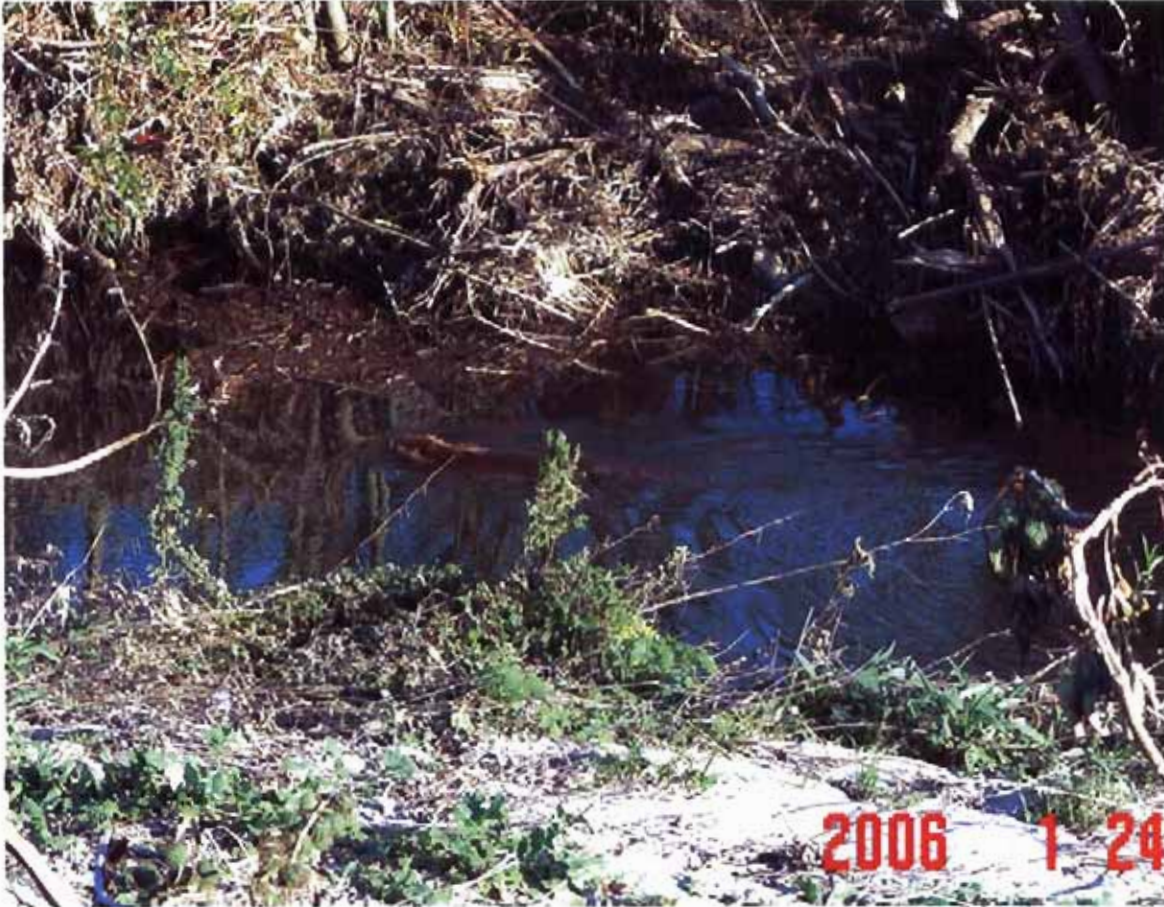
Photo 3:
Beaver swimming away from debris

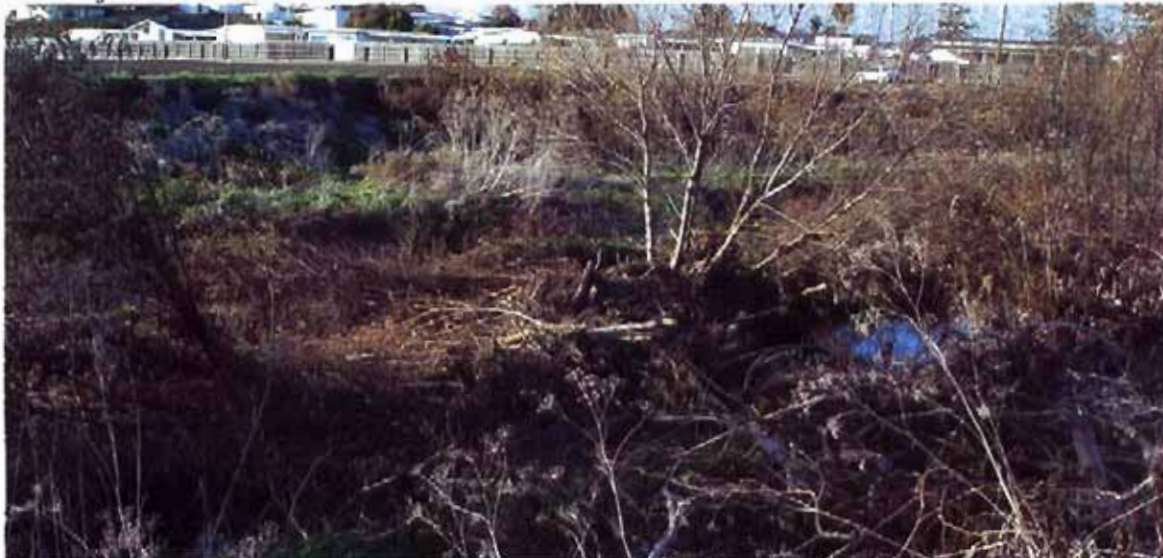
Photo 4:
Debris jam from east

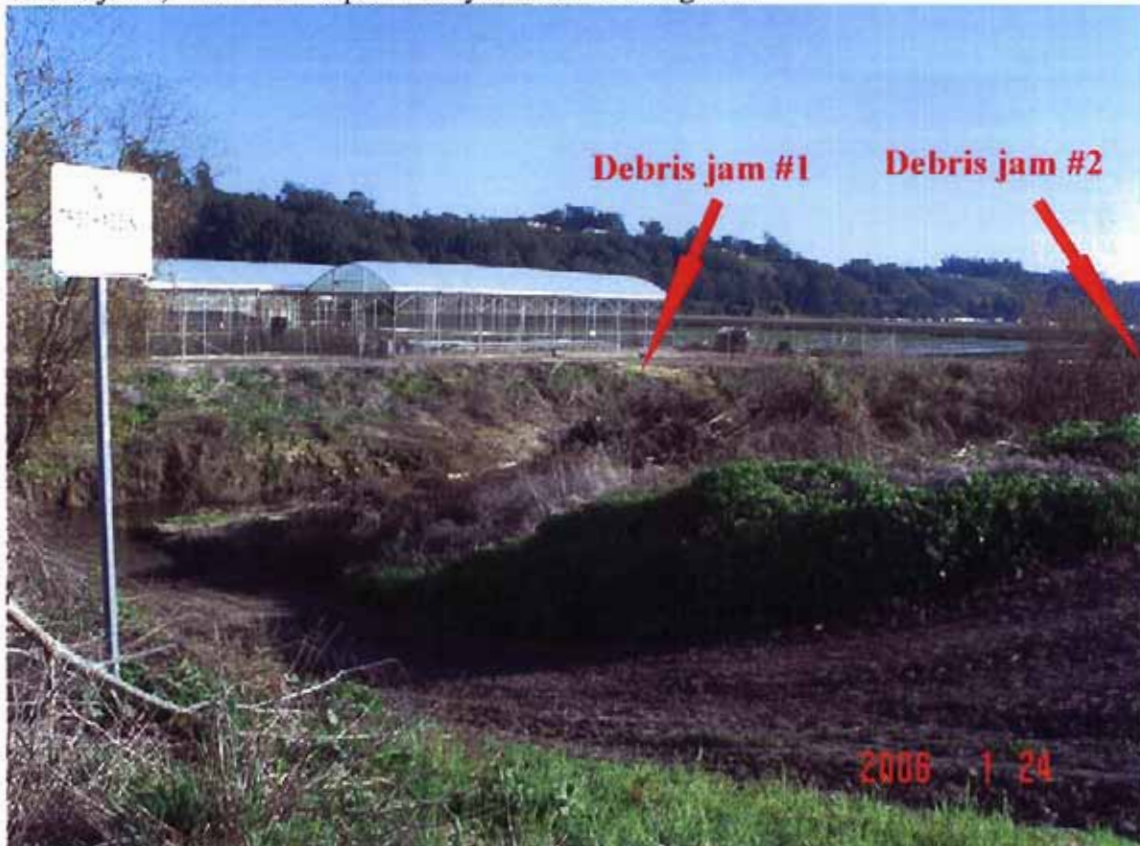
Photo 5:
Debris jams, view from top of Haleyon Road looking east

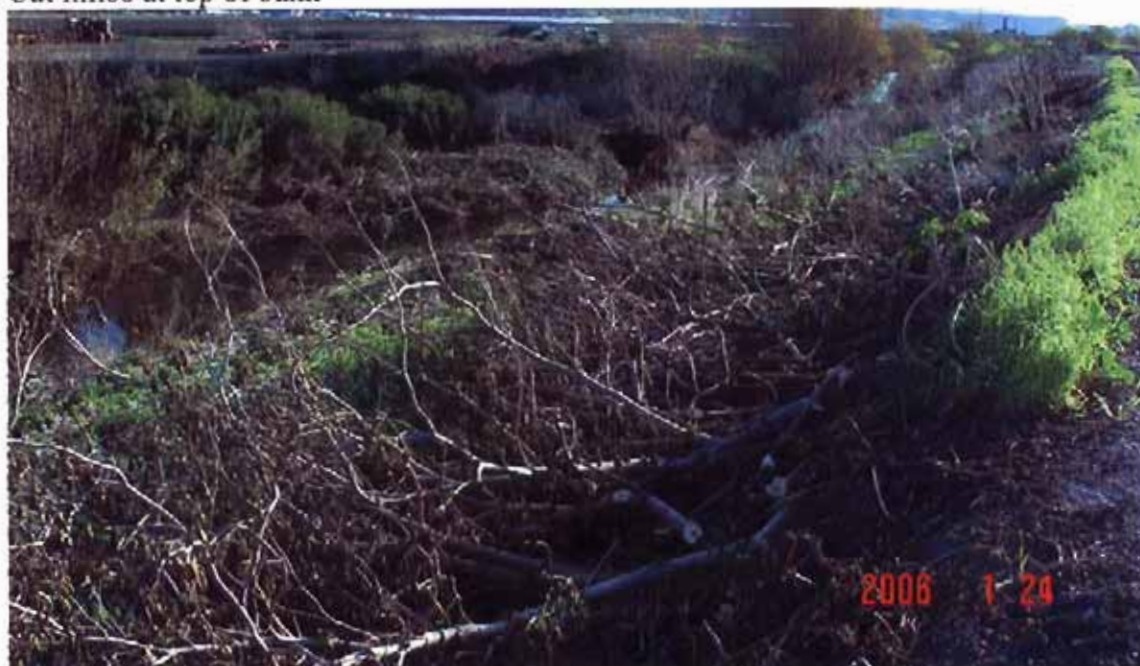
Photo 6:
Cut limbs at top of bank

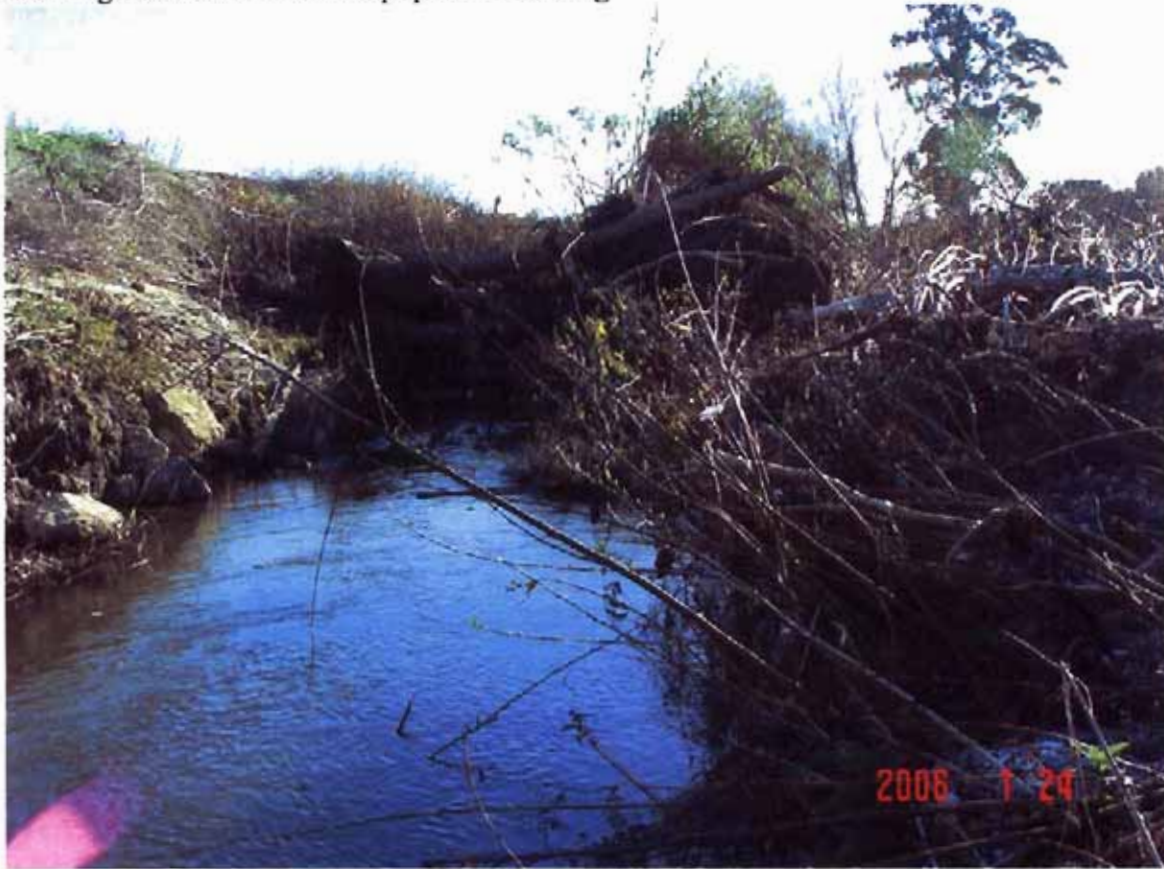
Photo 7:
Looking downstream from equipment crossing

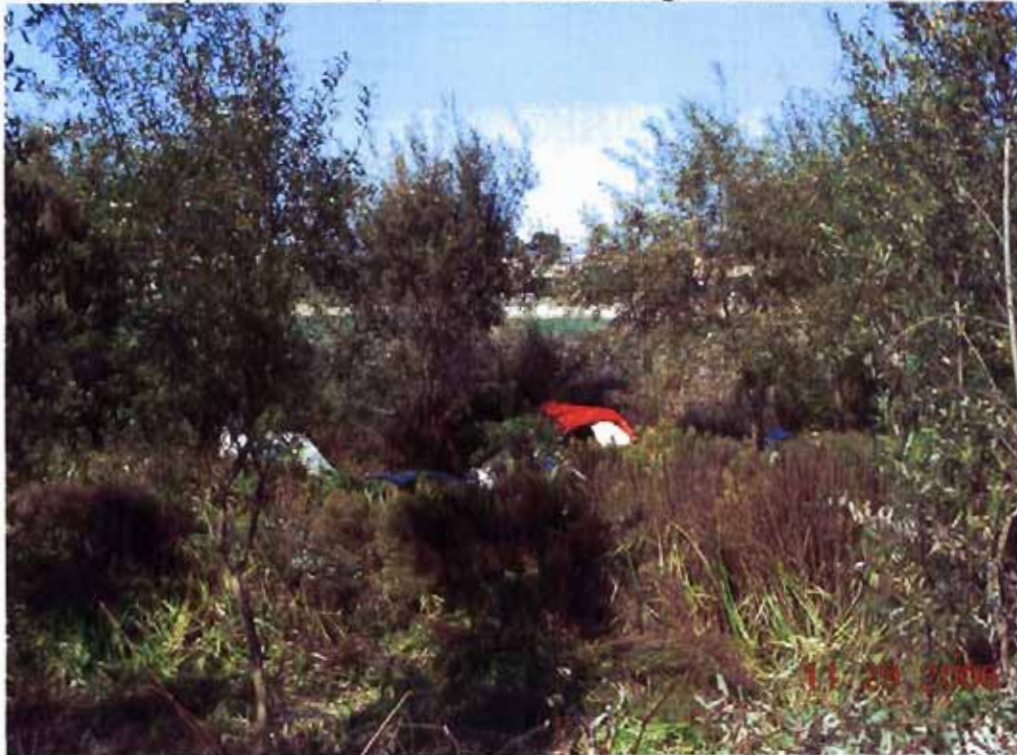
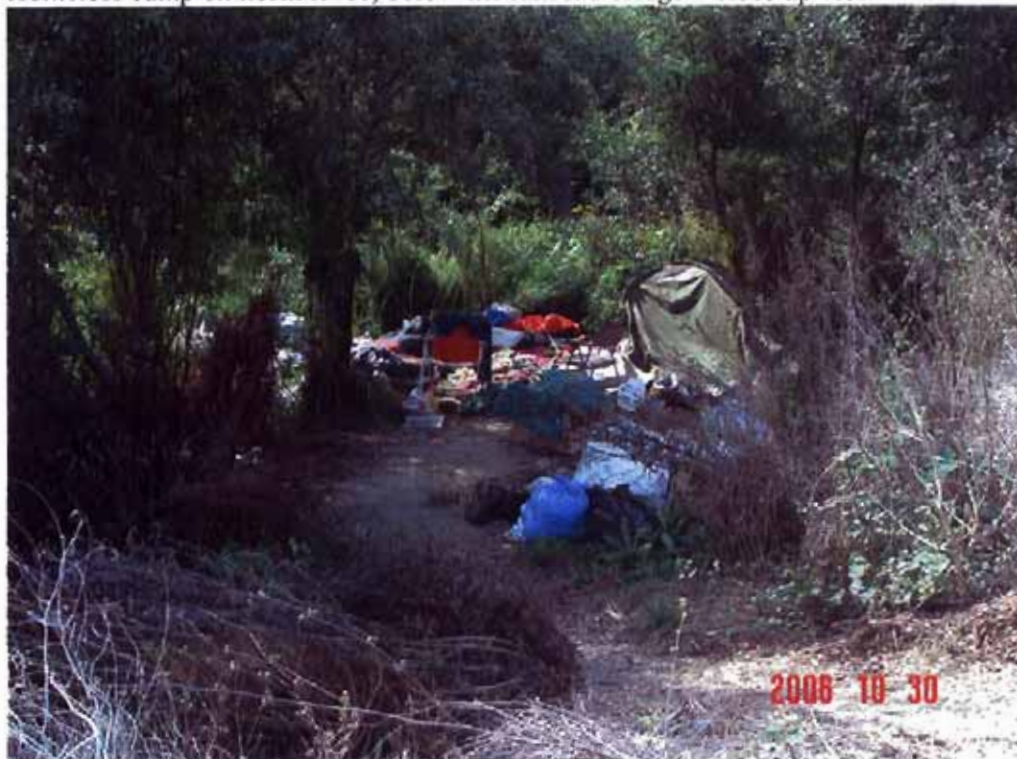
- c. In vicinity of Station 55+00 on north levee, a homeless camp was observed. See Attachment 5, photos 1 and 2.
 - d. Along the north levee, east of the 22nd Street bridge, several bags of garbage and a truck liner filled with garbage were dumped. See Attachment 5, photo 3.

Photo 1:
Homeless Camp on north levee, below the railroad bridge – view from south levee

Photo 2:
Homeless camp on north levee, below the railroad bridge – close up view

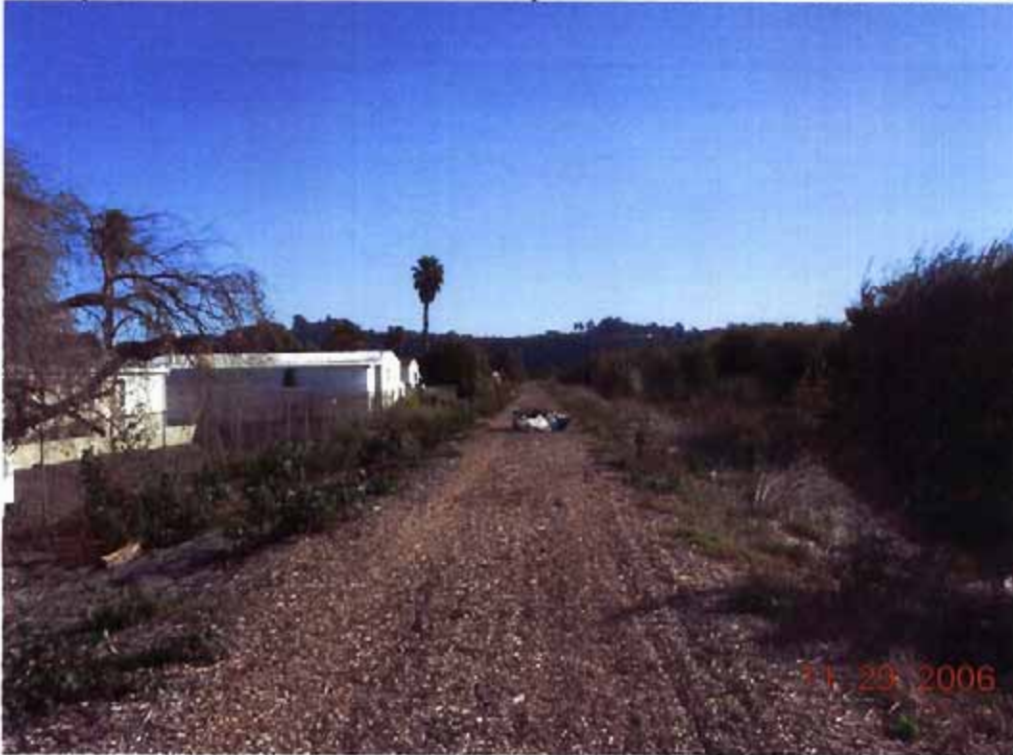
Photo 3:
Pick-up truck bed liner filled with trash dumped on north levee above 22nd Street bridge -

1. High Priority Maintenance:
- a. Remove debris from levee tops between 22nd Street and Highway 1 Bridge (pick-up truck bed liner, mattress, dresser, garbage, etc.)
 - b. Remove cut vegetation from along north levee west of 22nd Street Bridge and from within channel north of Highway 1 Bridge.
 - c. Remove or cut up large log on south levee near Station 85+00, opposite horse ranch.
 - d. Fill/raise low spot near approximate Station 103+50 caused by farm equipment and other vehicle traffic accessing the nearby equipment crossing.
 - e. Repair flap gates and clear culverts along the north levee between 22nd Street bridge and Highway 1 bridge.

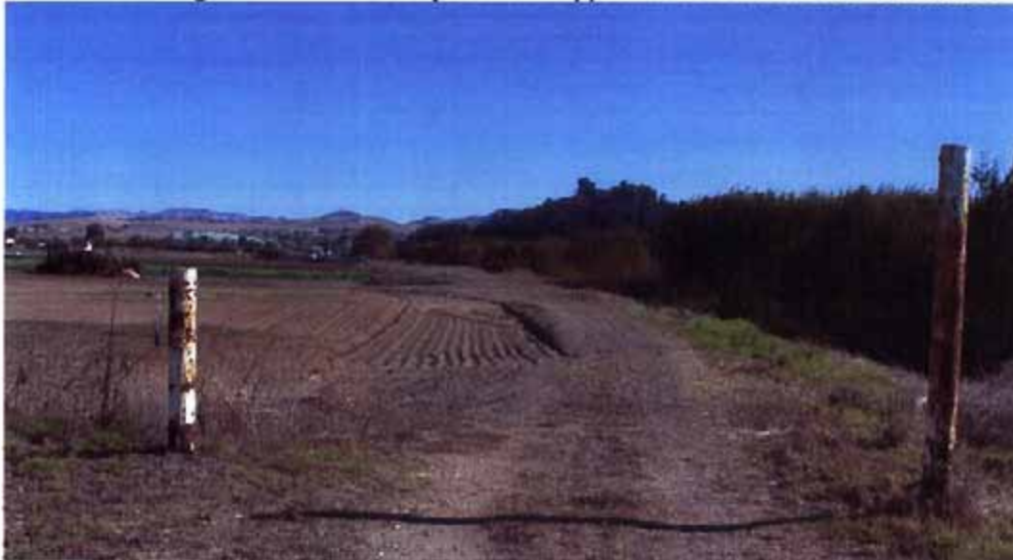
- j. Station 93+30, near east gate on north levee, flap gate is buried.
 - k. Between approximate Station 103+00 and 103+50 there appears to be farmland encroaching on the north levee. See Attachment 5, photo 4.

Photo 4:
Farmland cutting into north levee top between approximate Stations 103+00 and 103+50 -

- i. Los Berros Outlet Structure - \$30,000
 - ii. Sand Canyon Outlet Structure - \$40,000
- c. Work with property owner at 2750 Cienaga Street (APN: 075-032-011) to make repairs to north levee where farmland appears to be encroaching on levee top between approximate stations 103+00 and 103+50.

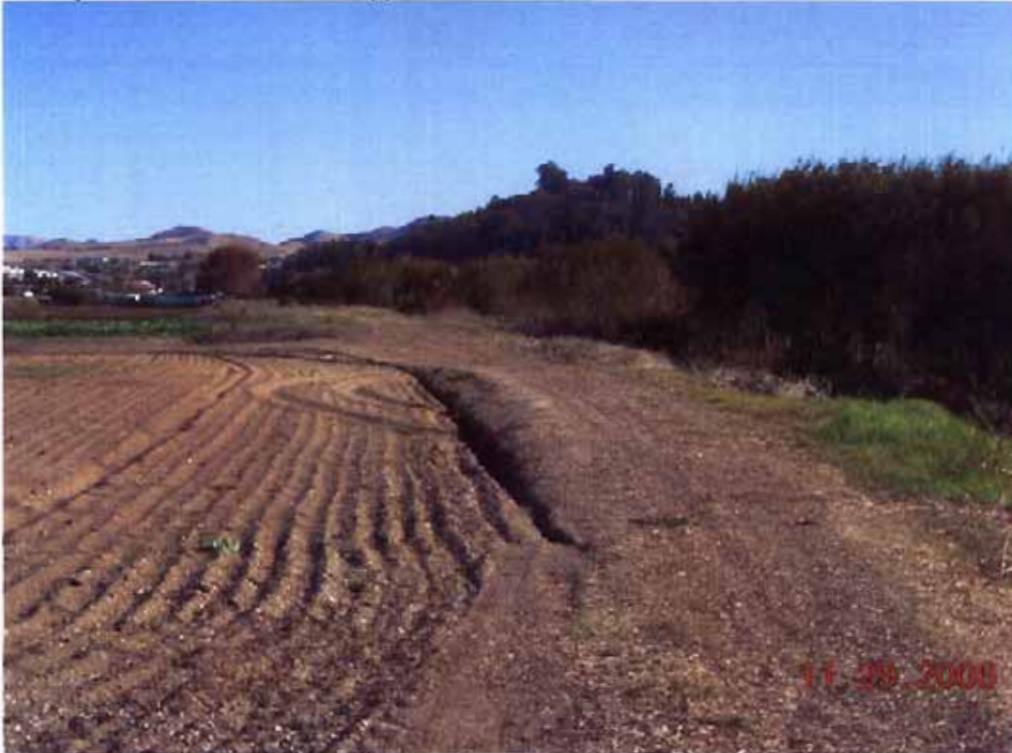
- l. Approximate Station 103+50, at equipment crossing, observed significant low spot on north levee due to erosion from vehicle traffic. See Attachment 5, photo 5.

Photo 5:
Low spot on north levee near approximate Station 103+50 –

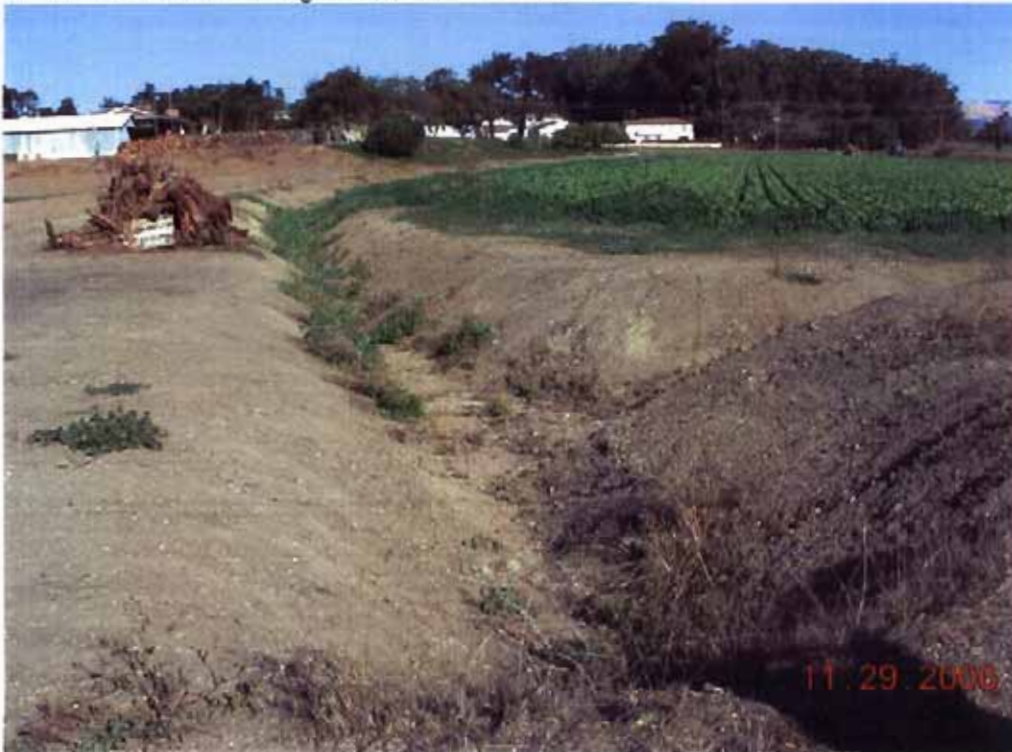
- m. Approximate Station 103+50, flap gate is buried. Earth ditch and culvert leading to flap gate appears to be adding sediment to creek. See Attachment 5, photo 6.

Photo 6:
Earthen ditch contributing sediments to AG Creek –

- d. Reduce sedimentation to channel by requesting CSLRCD and NRCS work with property owners immediately adjacent to the creek channels to improve erosion control. (Could start with owner of property where earth swale was observed to be adding sediment to Arroyo Grande Creek, just south of the Highway 1 bridge near approximate station 103+50. This is the same property that appears to be encroaching on north levee, see item c immediately above.)

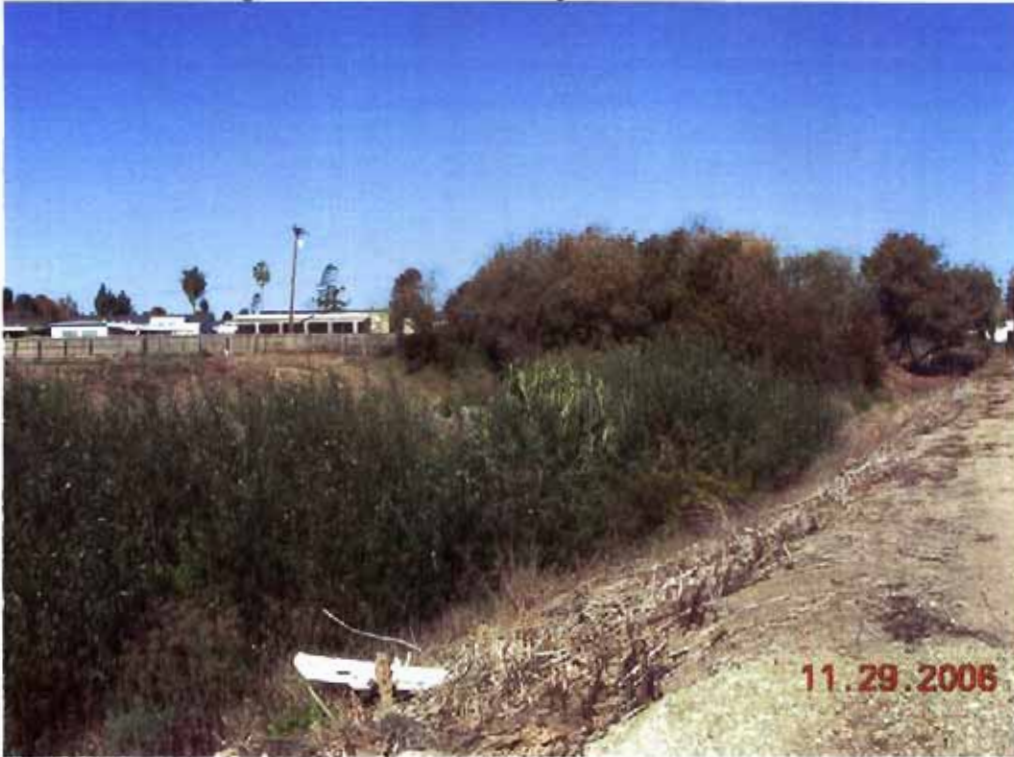
- q. Areas north of Highway 1 bridge appear to have obvious re-growth of castor bean; several large patches were observed.
 - r. North end of Zone 1/1A, near Arroyo Grande City Limits where un-permitted willow removal occurred previous year by resident, observed abundant willow re-growth. See Attachment 5, photo 7.

Photo 7:
Abundant willow regrowth near north boundary of Zone 1/1A –

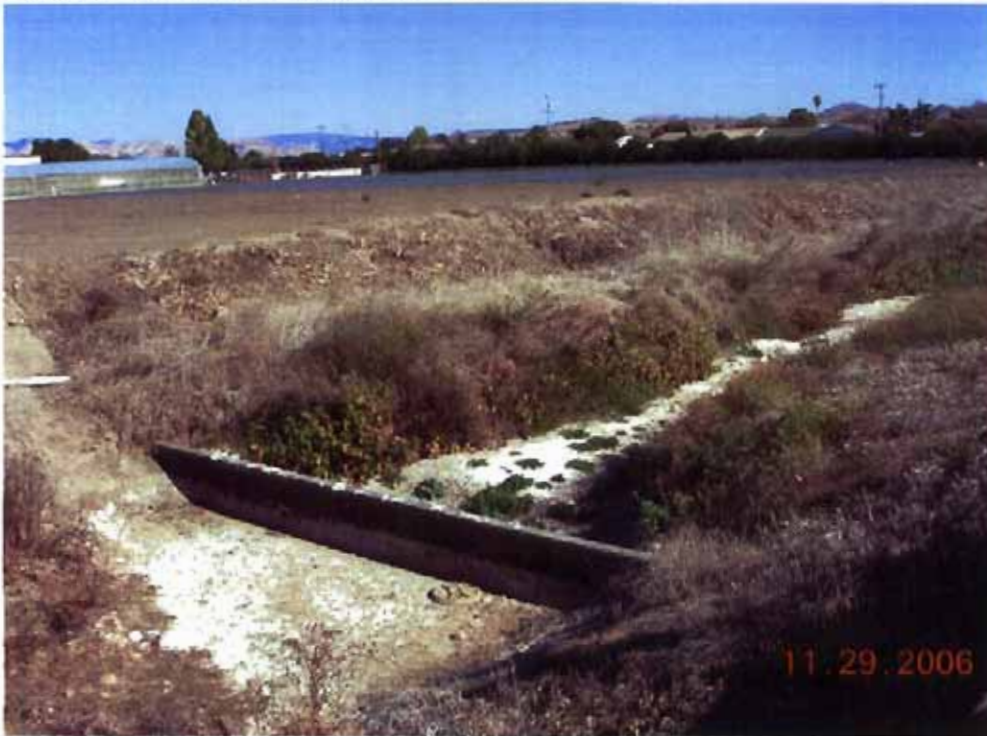
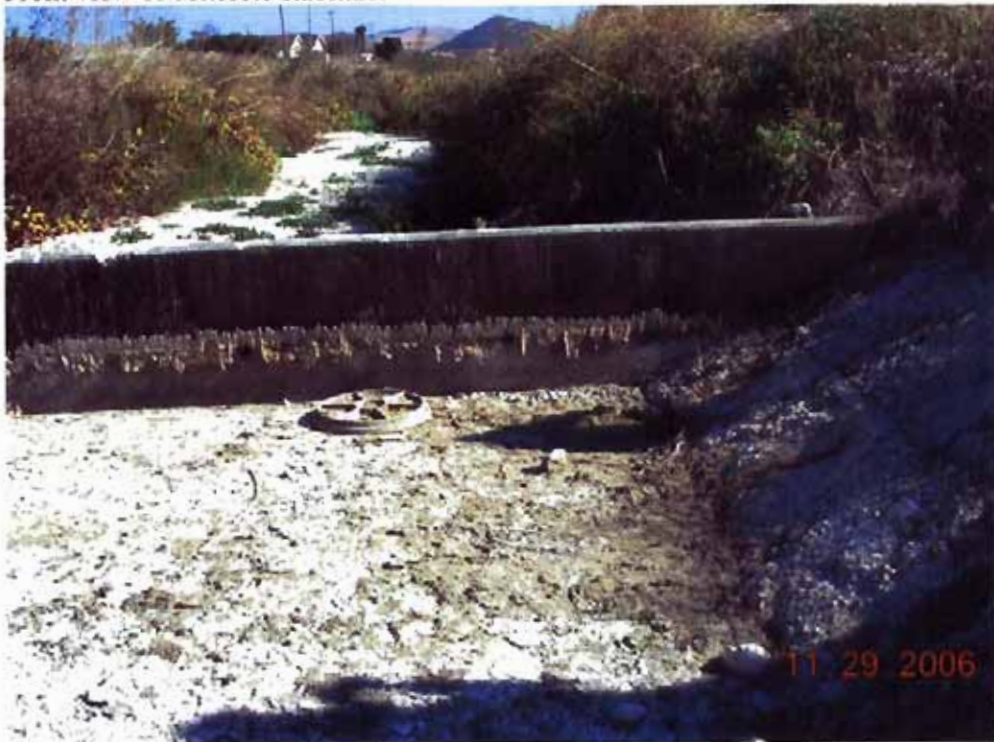
2. Los Berros Channel – downstream to upstream
- a. Station 13+25, concrete stabilizer is eroded on both upstream and downstream sides so that original concrete rip rap on channel bottom and sides are exposed. See Attachment 5, photos 8 and 9.

Photo 8:
Concrete stabilizer with erosion on both sides of concrete barrier –

Front view of concrete stabilizer –

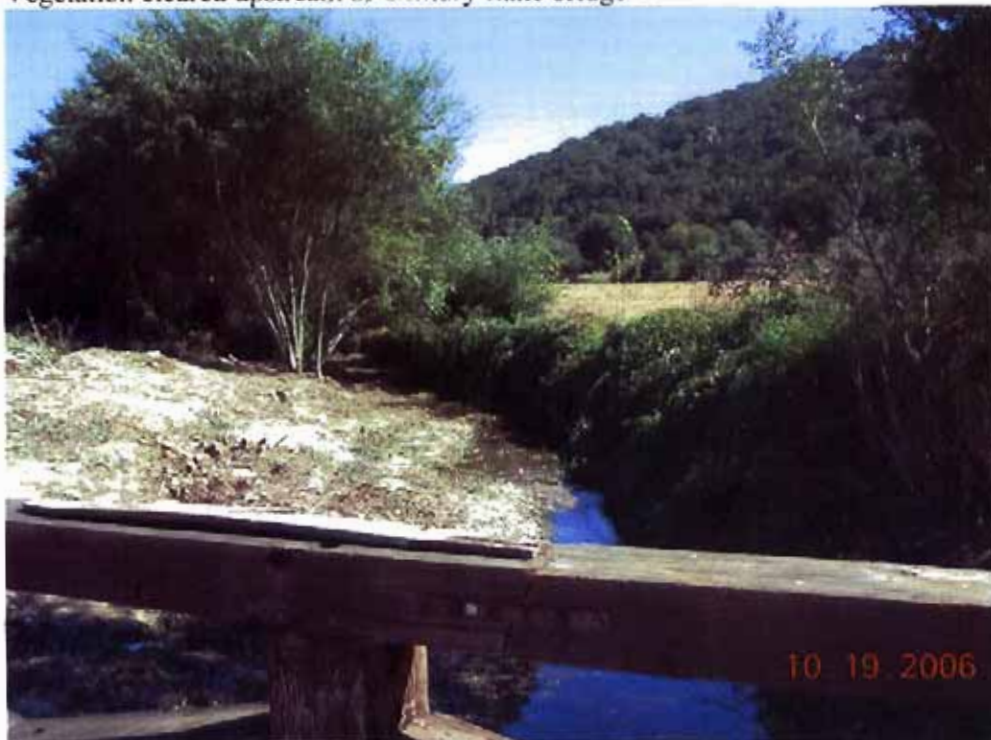
- e. North of Century Lane Bridge was clear of willows for 50 feet upstream of the bridge for the first time in several years. See Attachment 5, photo 10.

Photo 10:
Vegetation cleared upstream of Century Lane bridge –
