**Stenner Creek Erosion Control and  
Sediment Reduction Plan,  
California Polytechnic State University,  
San Luis Obispo County, California**

**PWA Report No. 231039902  
April 2023**

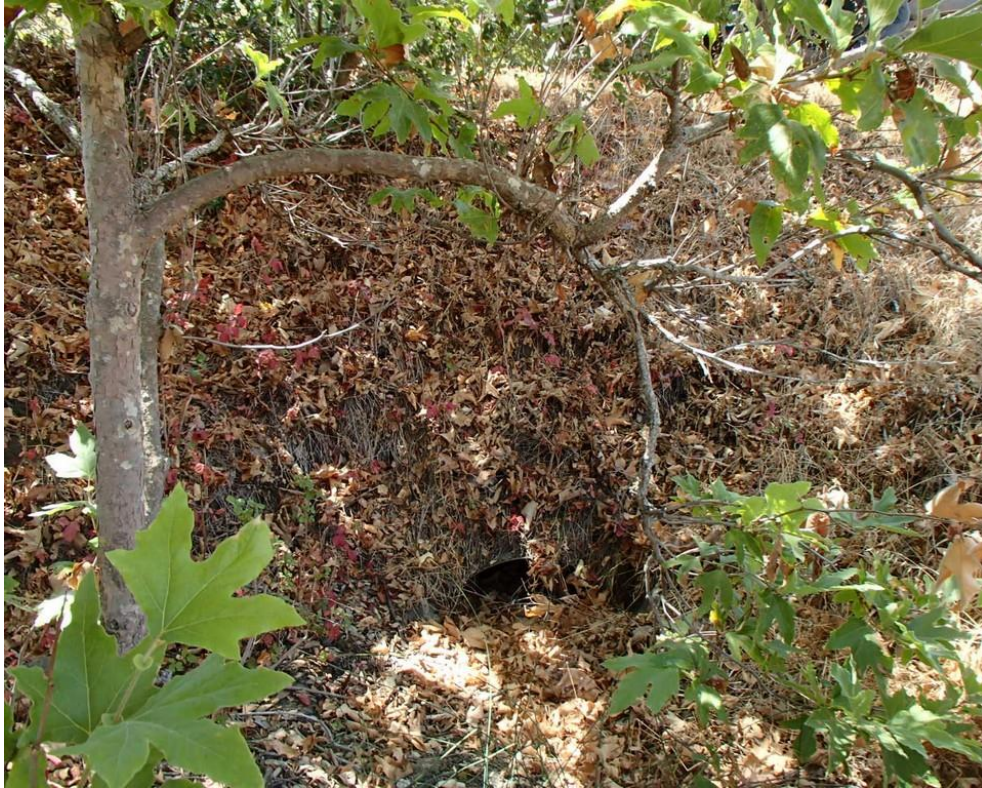
**Photo 1.** Site 193 (Architectural Canyon Complex Rd.): View of Site 193 looking downstream. This plugged and undersized culvert inlet is visible in the center and the road crossing is in the top of the frame.

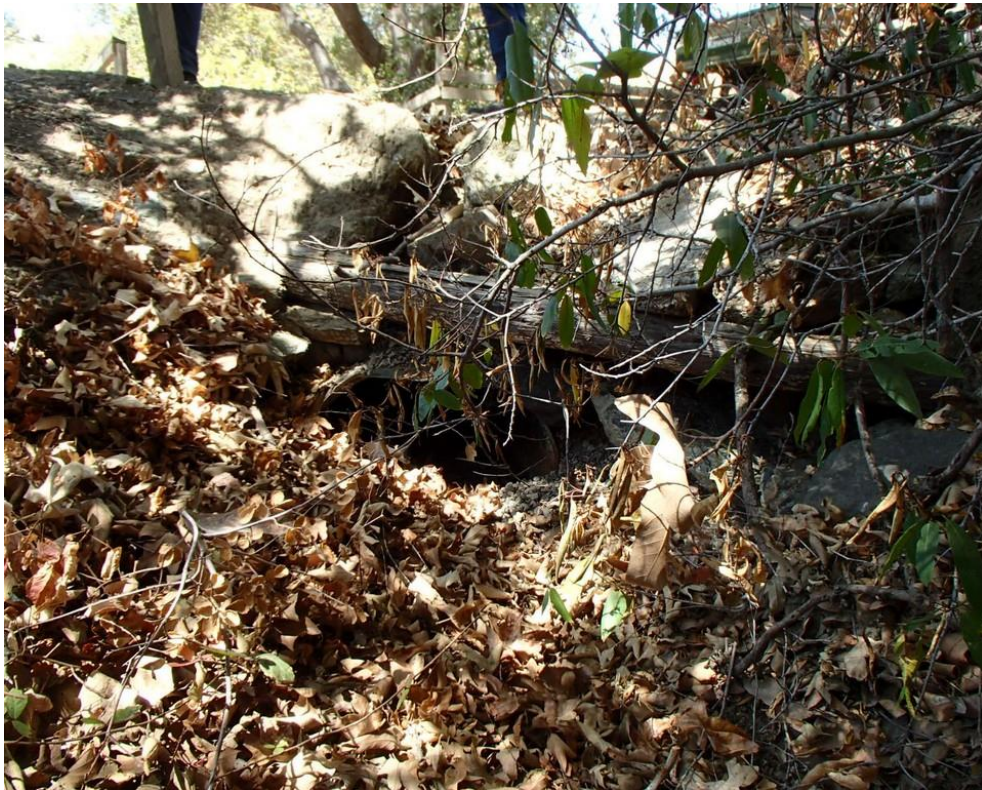
**Photo 2.** Site 193 (Architectural Canyon Complex Rd.): View of Site 193 looking upstream. The plugged culvert outlet is visible in the center, the road crossing, and road gravel discharge load are in top of the frame.

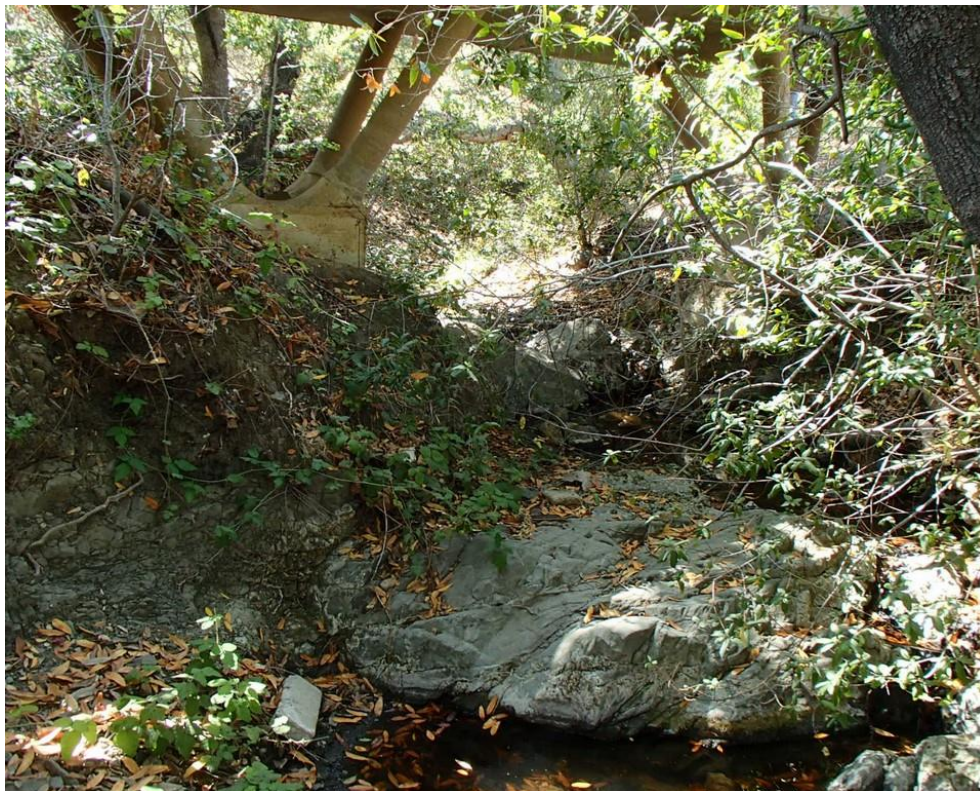
**Photo 4.** Site 194 Architectural Canyon Complex Rd.): View of Site 194 looking upstream where road surface drainage delivers directly to this location. No proposed work at bridge, trail only.

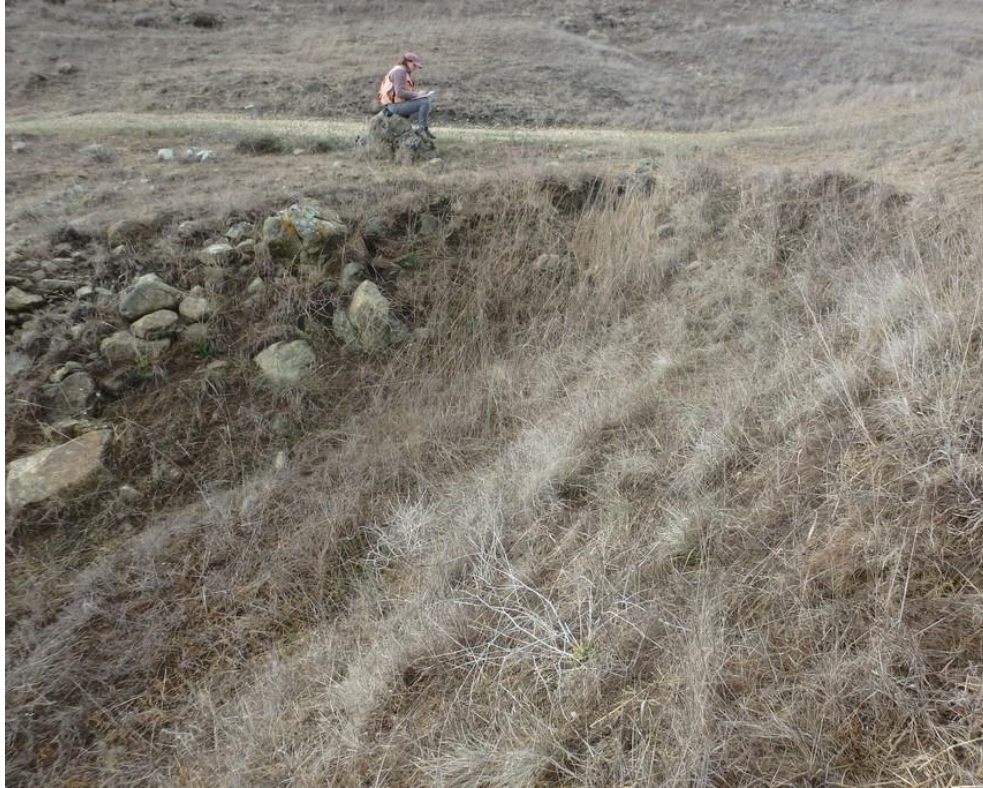
**Photo 7.** Site 195.1 (Powerline Rd.): View of Site 195.1 looking upstream at the armored fill crossing. Visible in the center of the frame is a headcut that is migrating up towards the outboard road edge.

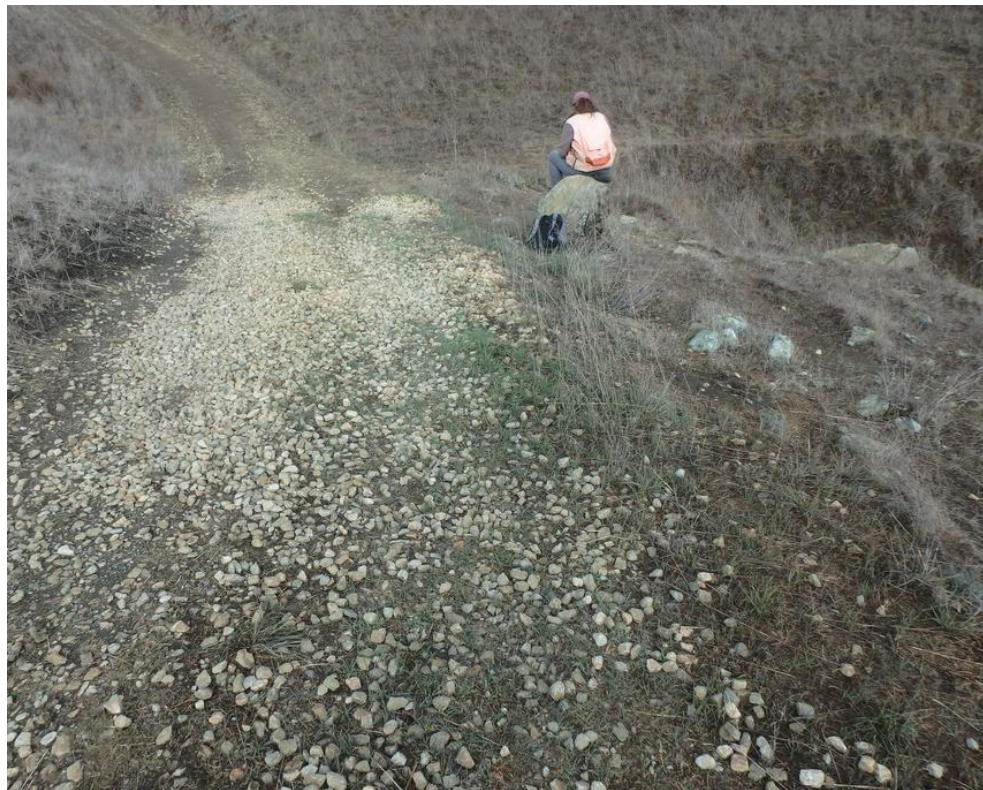
**Photo 8.** Site 195.1 (Powerline Rd.): View of Site 195.1 looking down the right road approach towards the stream crossing. The proximity of the headcut to the road is visible in the upper right frame. The left road approach is visible in the upper left corner of the photo.

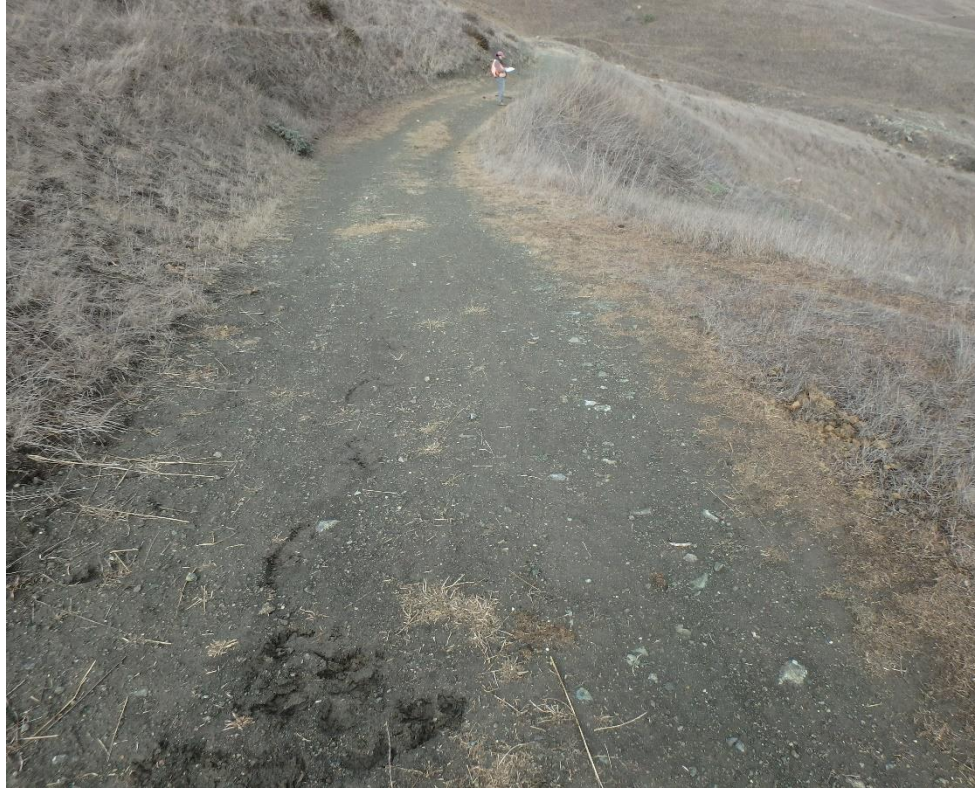
**Photo 9.** Site 195.2 (Powerline Rd.): View of Site 195.2 looking up the road at an unstable road fillslope. This section of road is located at the headwaters of a Class III stream. The steep fillslope is saturated and has the potential for failure.

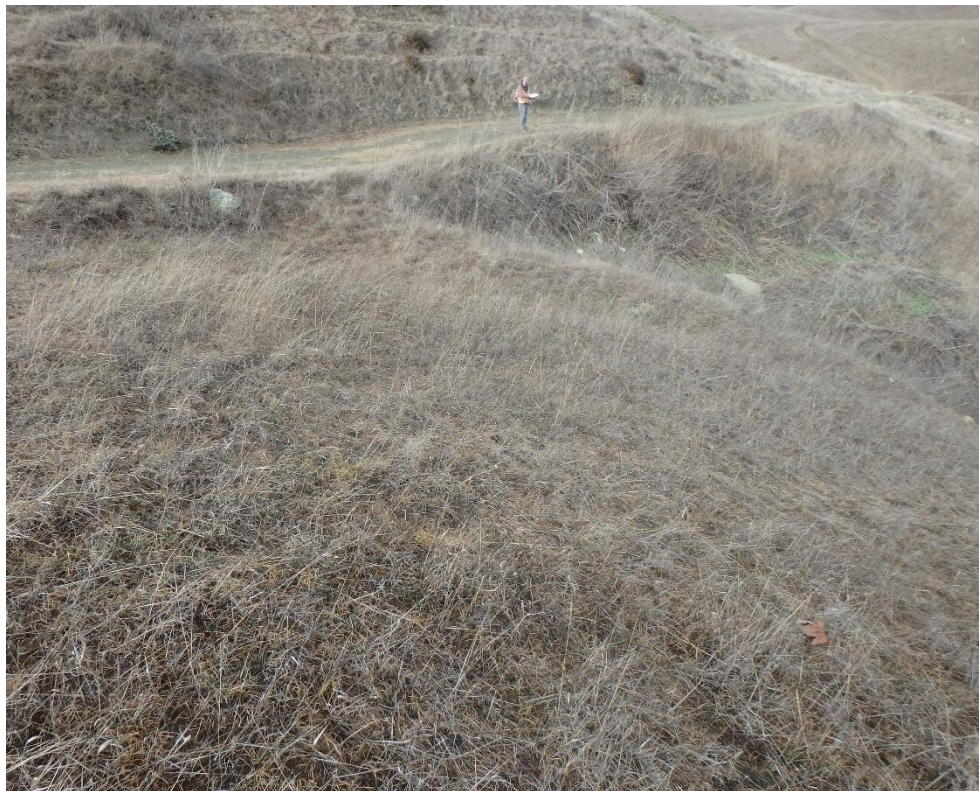
**Photo 10.** Site 195.2 (Powerline Rd.): View of Site 195.2 looking at the outboard edge of the fillslope. This area has erodible soils and is saturated from emergent springs. The steep fillslope should be monitored for potential failure.

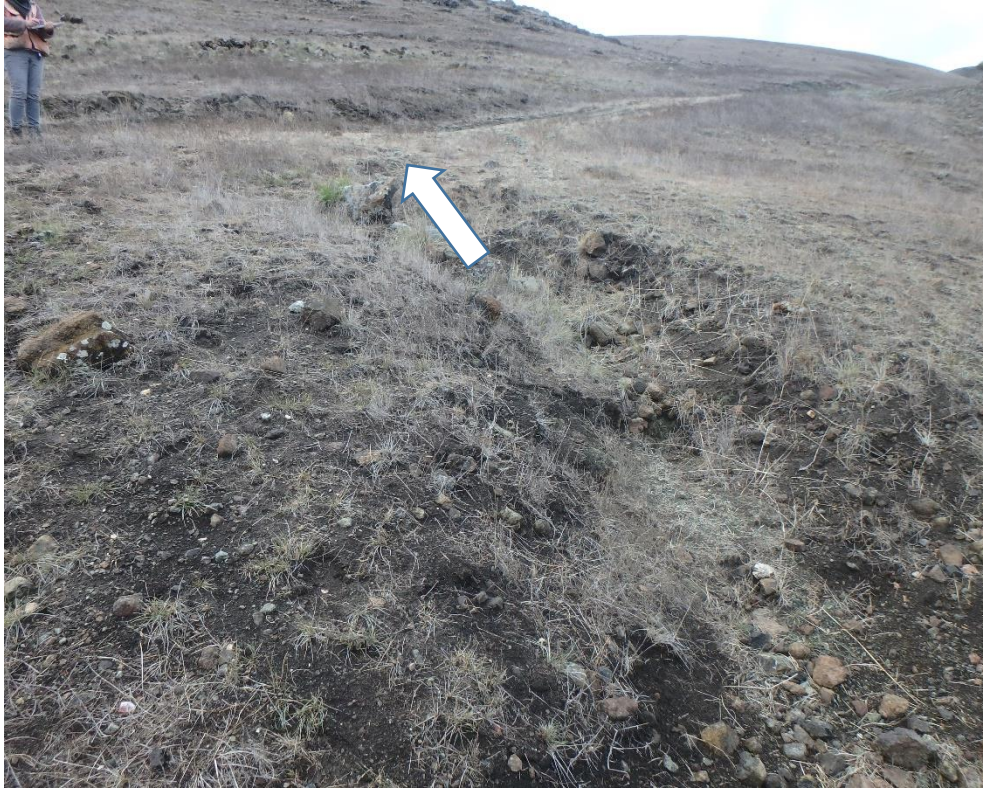
**Photo 11.** Site 195.3 (Powerline Rd.): View of Site 195.3 looking up at the road surface discharge point and subsequent gully (see arrow). Nearly 450' of road and hillslope runoff exit the road at this location.

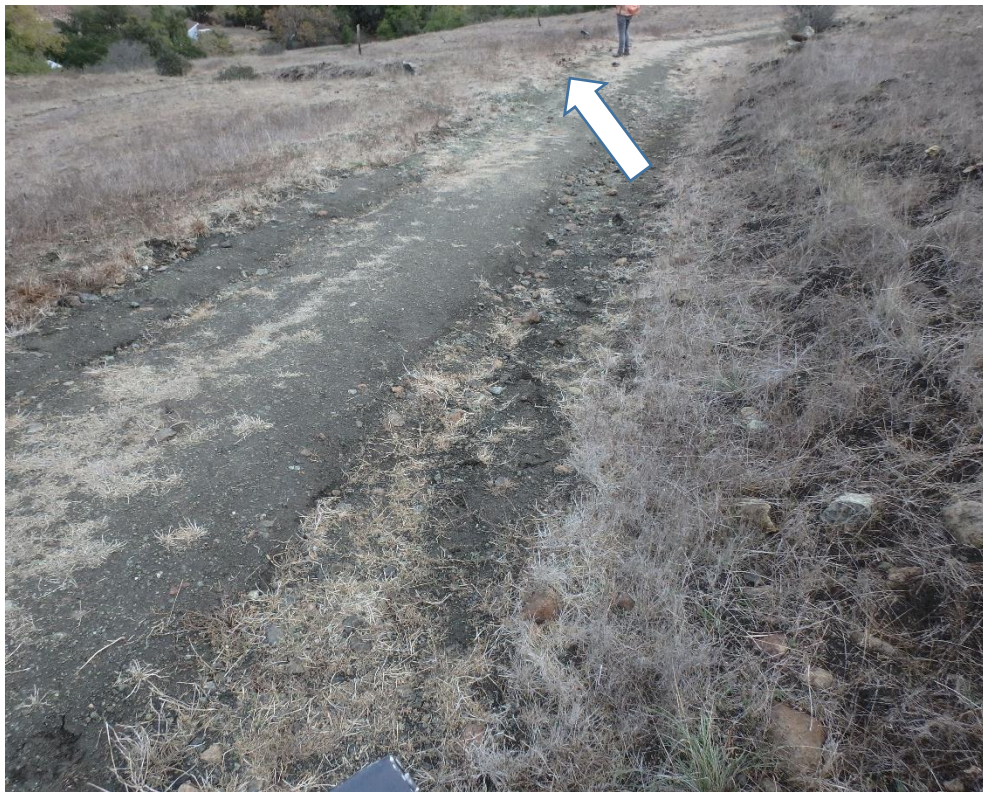
**Photo 12.** Site 195.3 (Powerline Rd.): View of Site 195.3 looking down the left road towards the road surface discharge point. The discharge point and subsequent gully are visible in the upper left corner of the frame (see arrow).

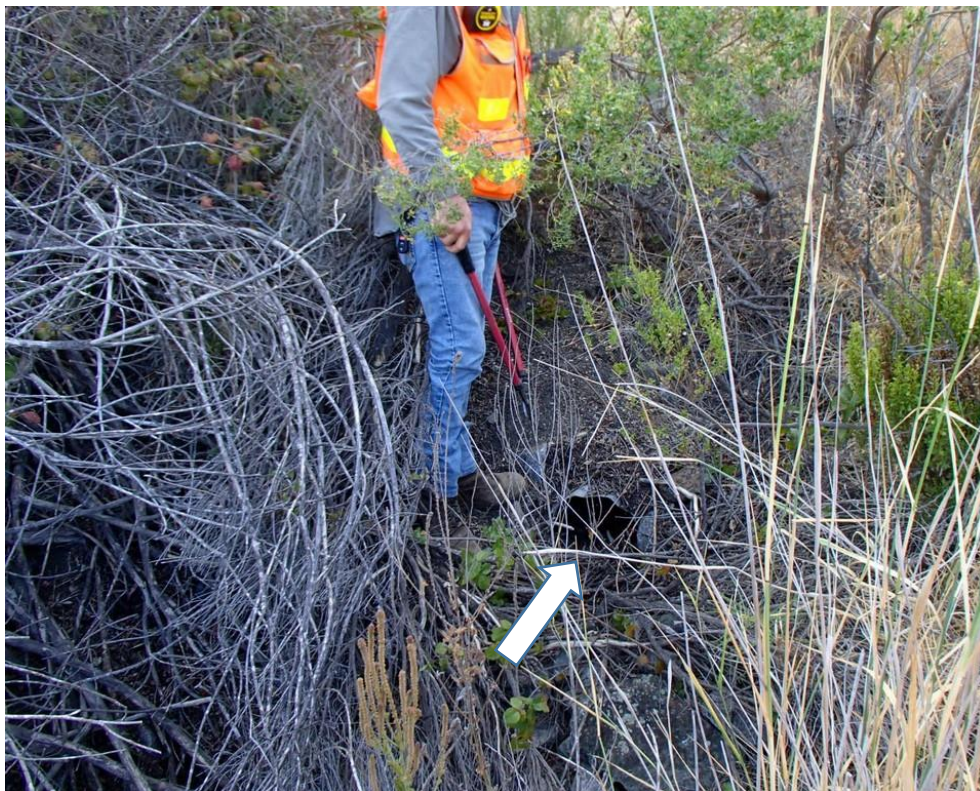
**Photo 16.** Site 197 (Barn Rd.): View of Site 197 standing upslope of the ditch relief culvert inlet area. The culvert inlet is visible to the right of the worker's feet and is approximately 25% plugged (see arrow).

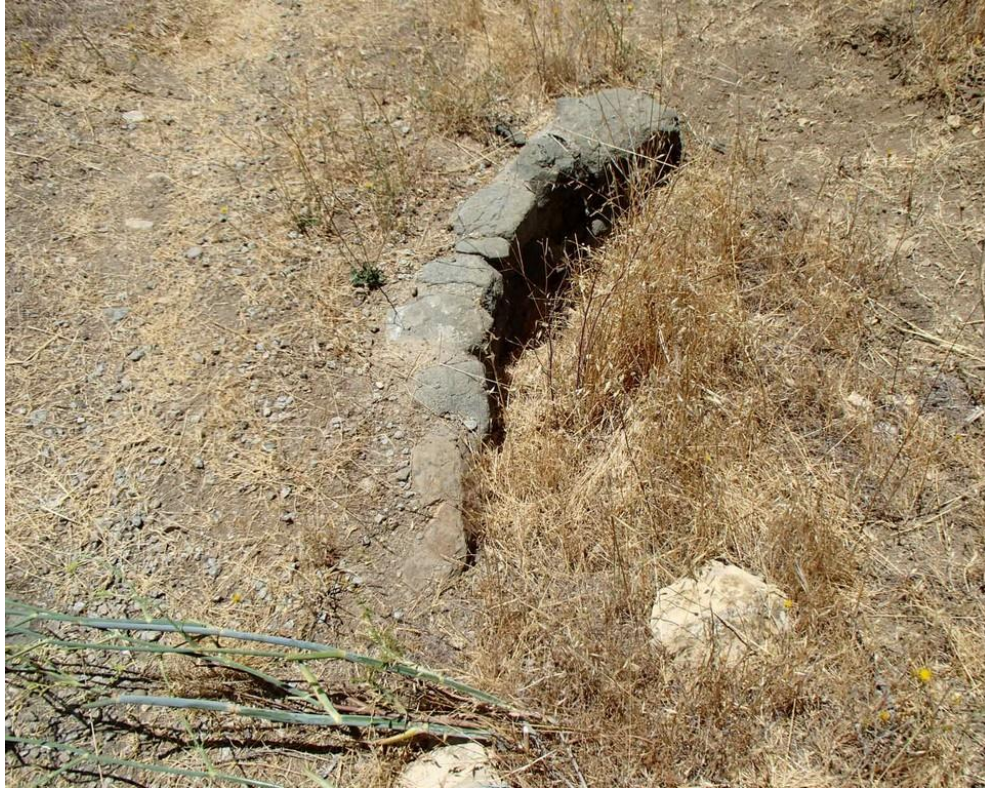
**Photo 19.** Site 198 (Barn Rd.): View of the ditch relief culvert inlet area at Site 198. A short rock wall encases the culvert in this location. The culvert inlet is mostly plugged with sediment.

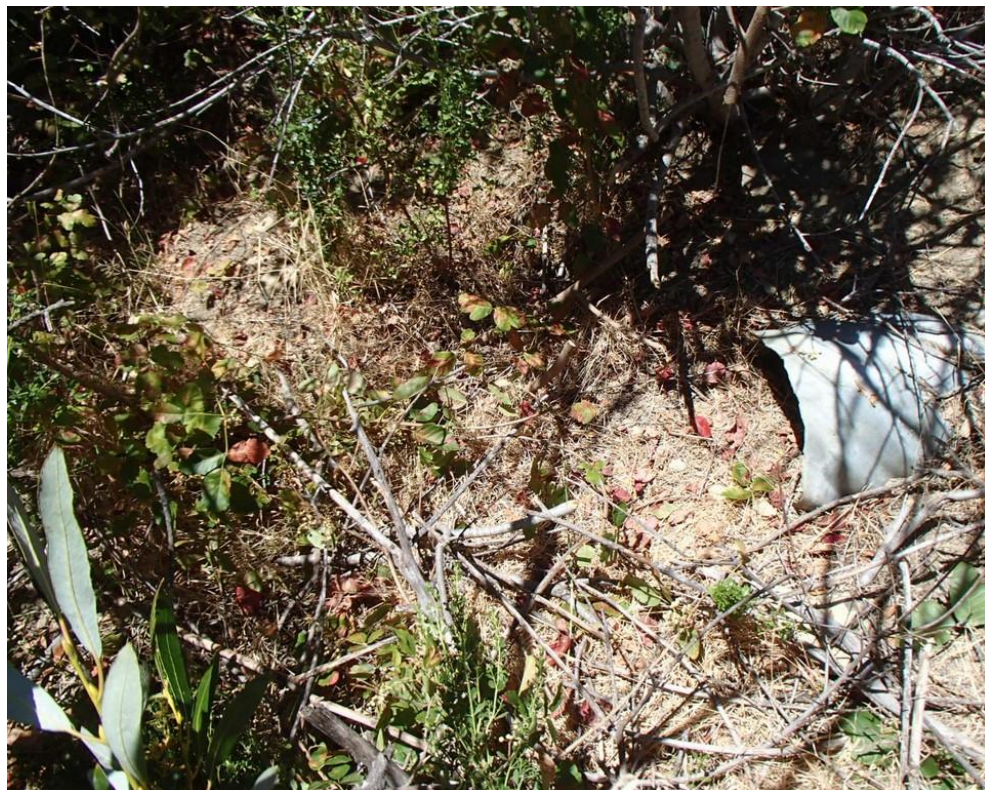
**Photo 20.** Site 198 (Barn Rd.): View of the ditch relief culvert outlet area at Site 198. The culvert outlet is approximately 50% plugged with sediment.

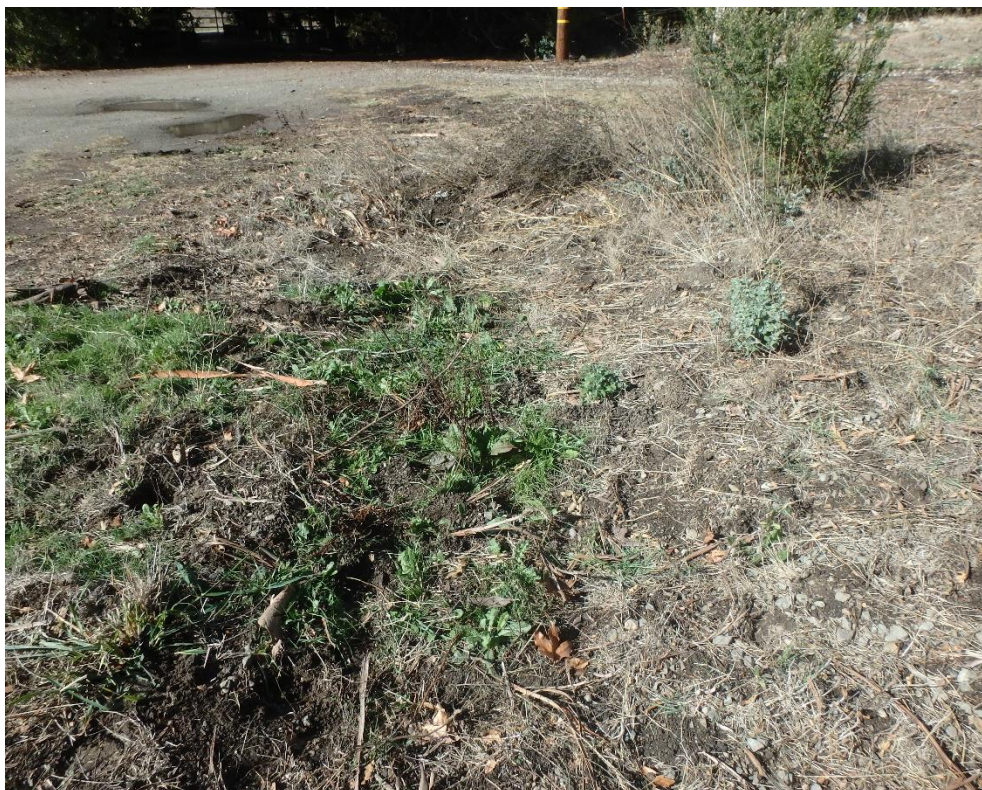
**Photo 28.** Site 201 (Peterson Ranch Rd.): View of Site 201 looking towards mainstem Stenner Creek. The plugged and undersized ditch relief culvert inlet is in the upper center frame.

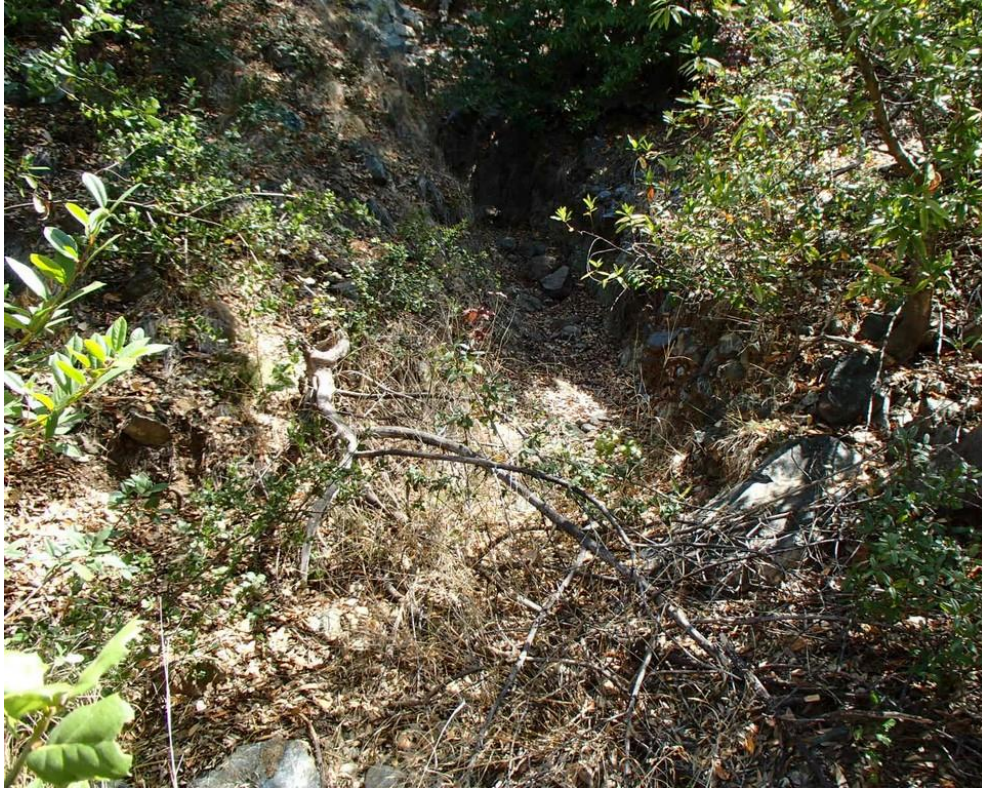
**Photo 31.** Site 203 (Upper Stenner Spur): View of Site 203 looking downstream. This crossing is mostly washed out and would need major improvements to be made usable again.

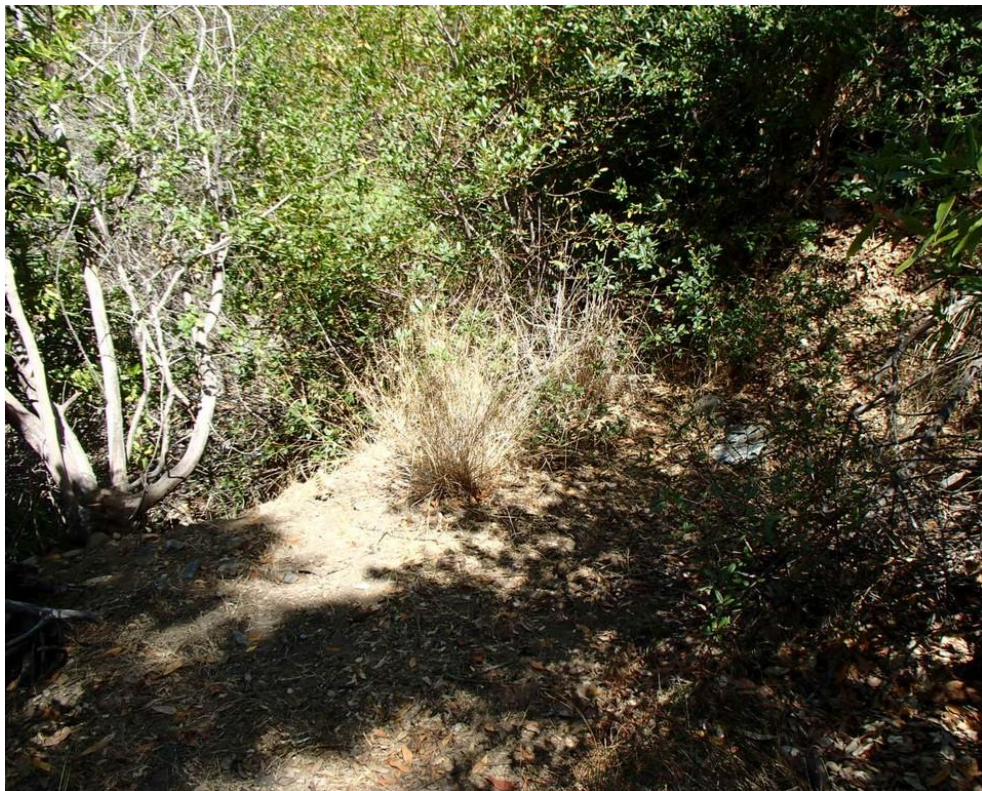
**Photo 32.** Site 203 (Upper Stenner Spur): View of Site 203 looking obliquely at stream crossing. This portion of the trail is heavily overgrown and not currently usable.

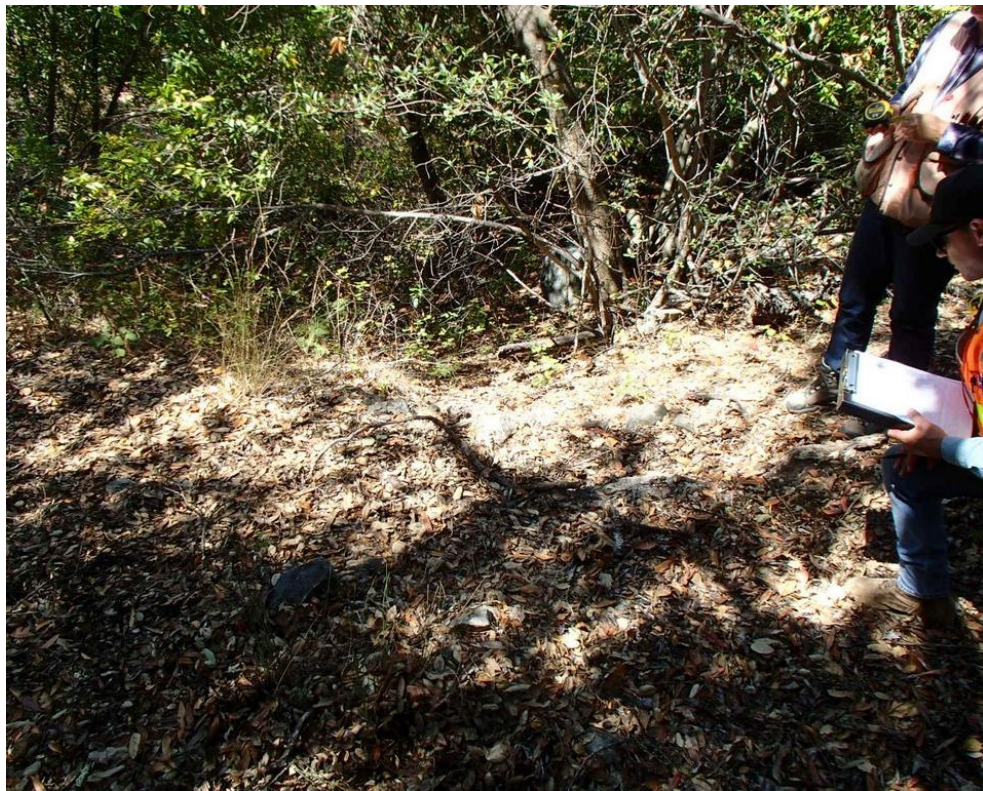
**Photo 34.** Site 204 (Upper Stenner Spur): View of Site 203 looking downstream. This area has been neglected for some time and needs major improvements to be made usable.

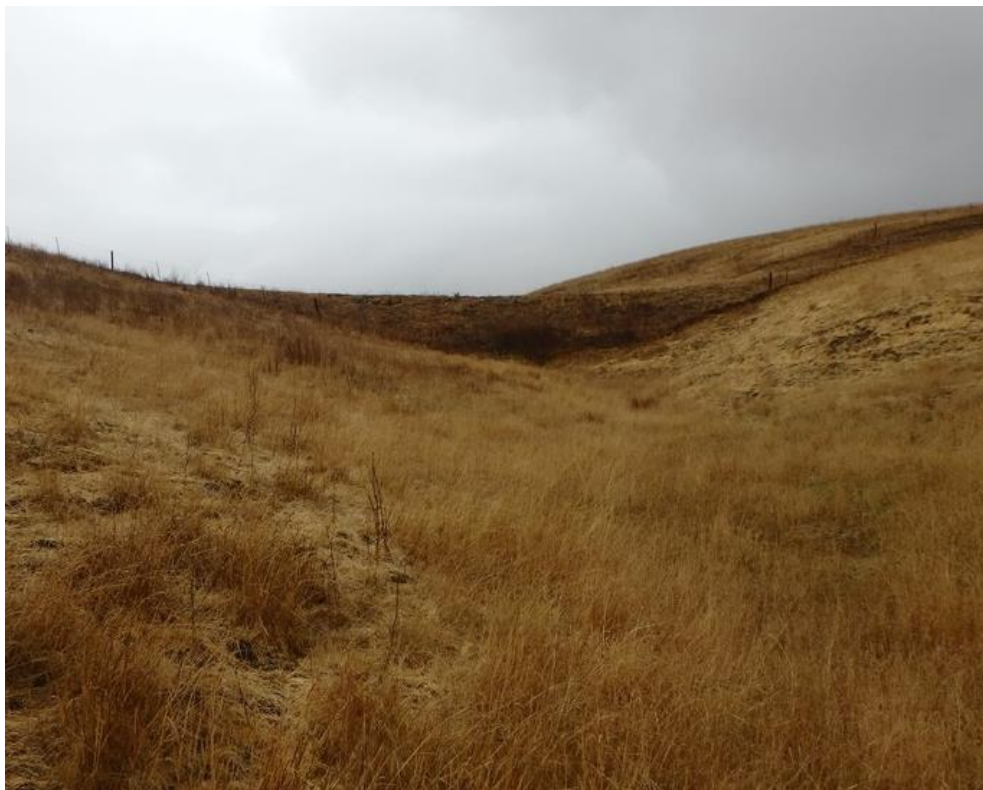
**Photo 36.** Site 205 (Peterson Ranch Rd.): View of Site 205 looking upstream. The culvert outlet is plugged with silt and is overgrown with vegetation. The outboard edge of the road fill is visible in center of the frame.

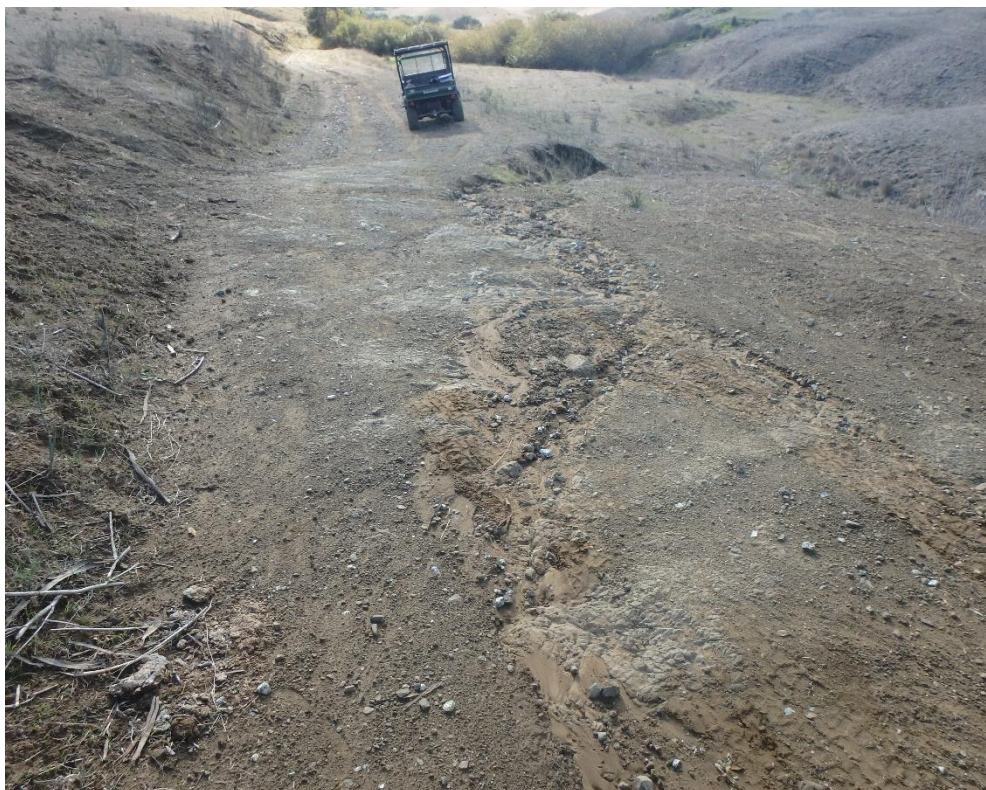
**Photo 40.** Site 207 (Peterson Ranch Rd.): View of Site 207 looking down the right road towards the road surface discharge point and subsequent gully. Note that fine sediment generated from road surface erosion is being transported down road via a gully in the roadbed.

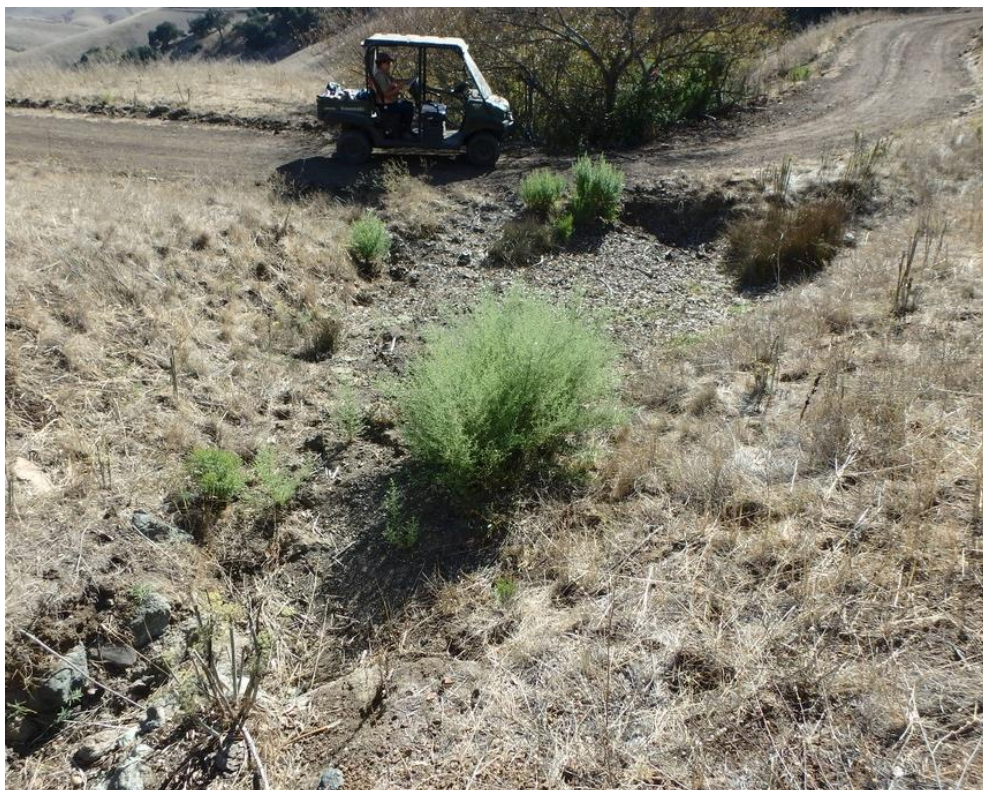
**Photo 52.** Site 213 (Peterson Ranch Rd.): View of Site 213 looking downstream. The culvert inlet area and aggraded sediment is visible in the middle frame. Both road approaches contribute fine sediment runoff directly to site.

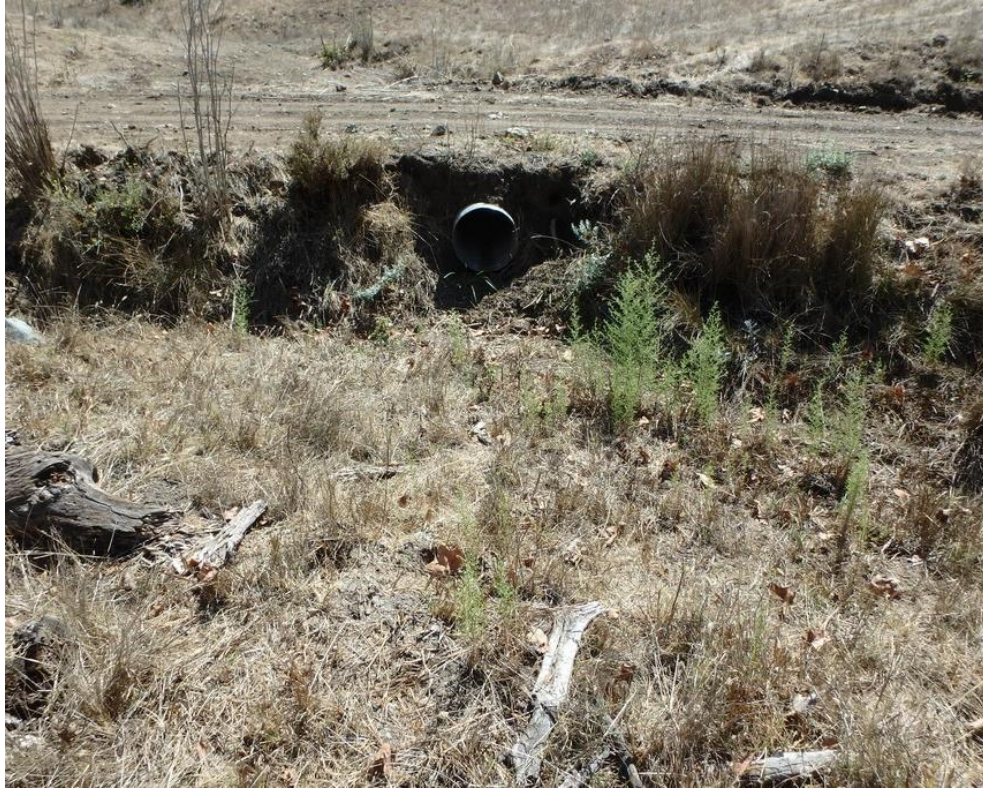
**Photo 59.** Site 217 (Peterson Ranch Rd.): View of Site 217 looking upstream at the culvert outlet. The upper stream channel is visible in the top of the frame.

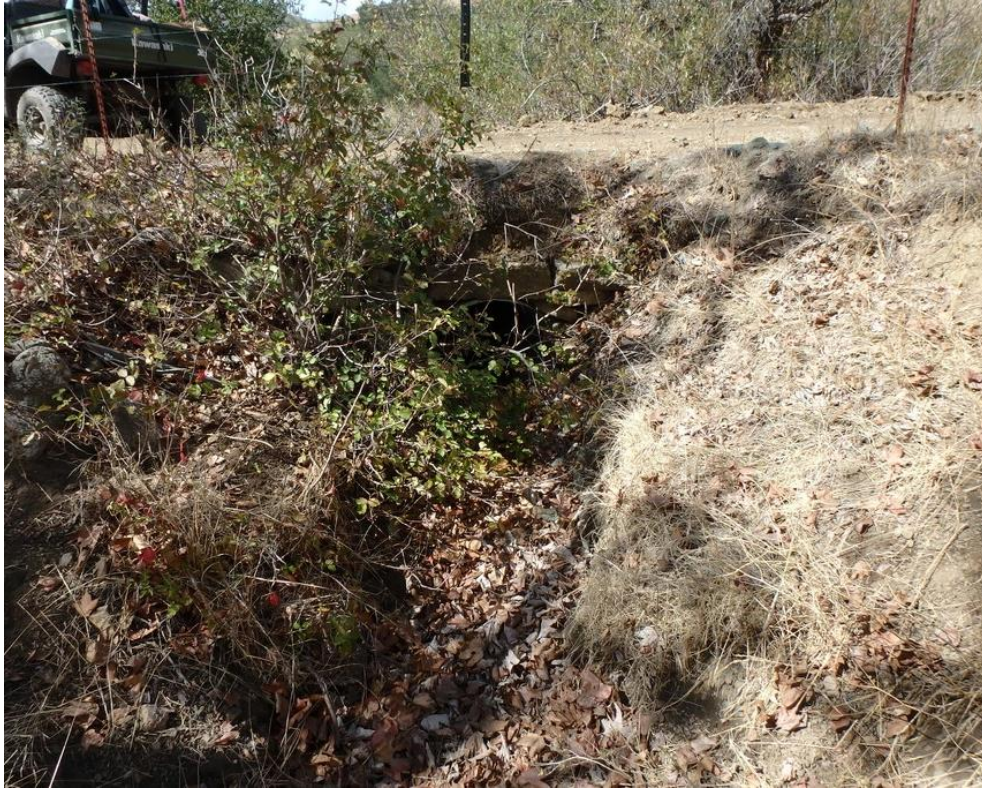
**Photo 63.** Site 218 (Peterson Ranch Rd.): View of Site 218 looking downstream at the culvert inlet. The road crossing is visible in the top of the frame.

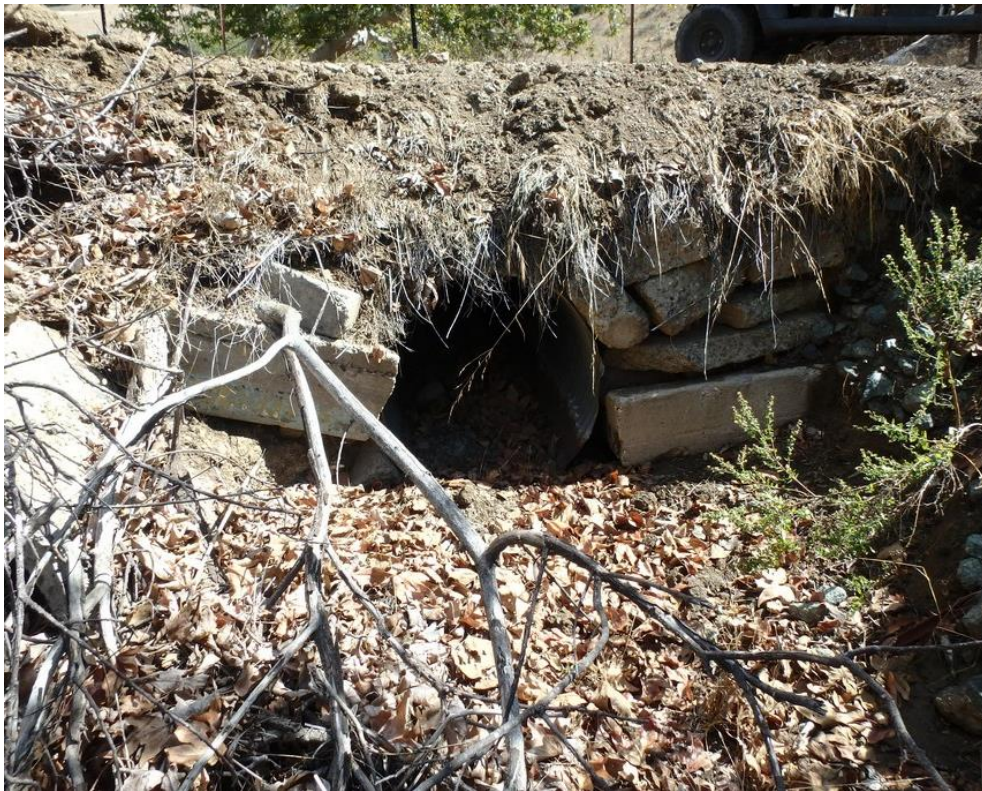
**Photo 64.** Site 218 (Peterson Ranch Rd.): View of Site 218 looking upstream at the culvert outlet. Some concrete block fill is visible in the center of the frame.

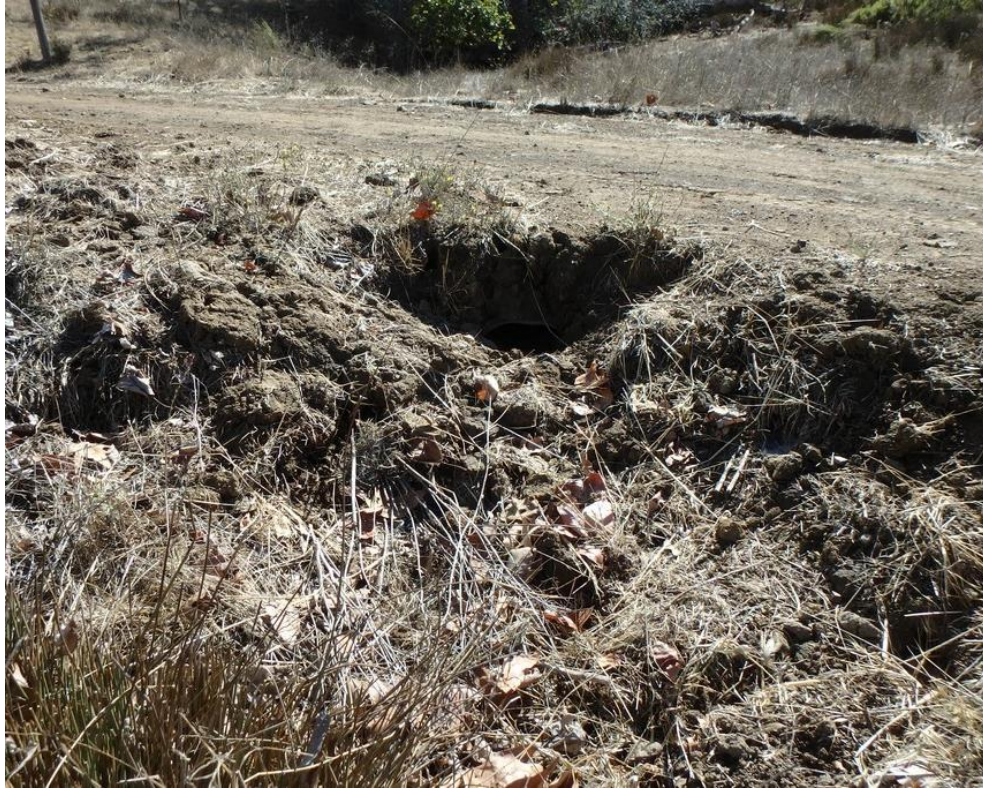
**Photo 65.** Site 219 (Peterson Ranch Rd.): View of Site 219 looking upstream at culvert outlet area. The plugged culvert is visible in the center of the frame.

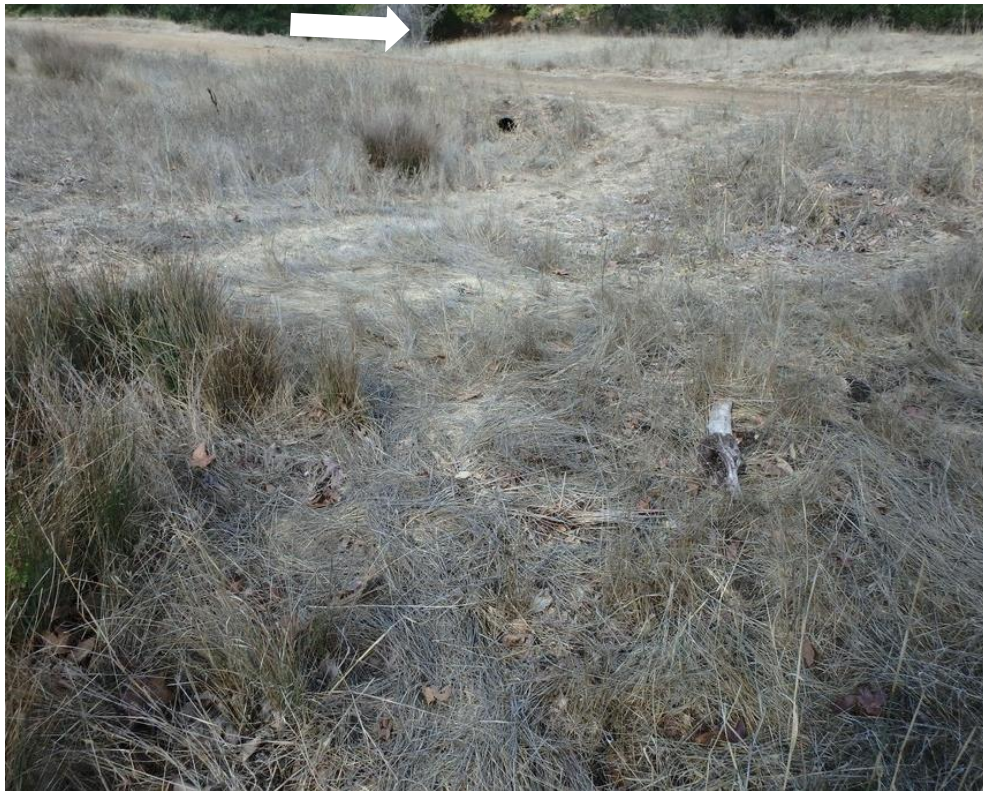
**Photo 66.** Site 219 (Peterson Ranch Rd.): View of Site 219 looking downstream at the culvert inlet. The road crossing and mainstem Brizzolari Creek are visible at the top of the frame (see arrow).

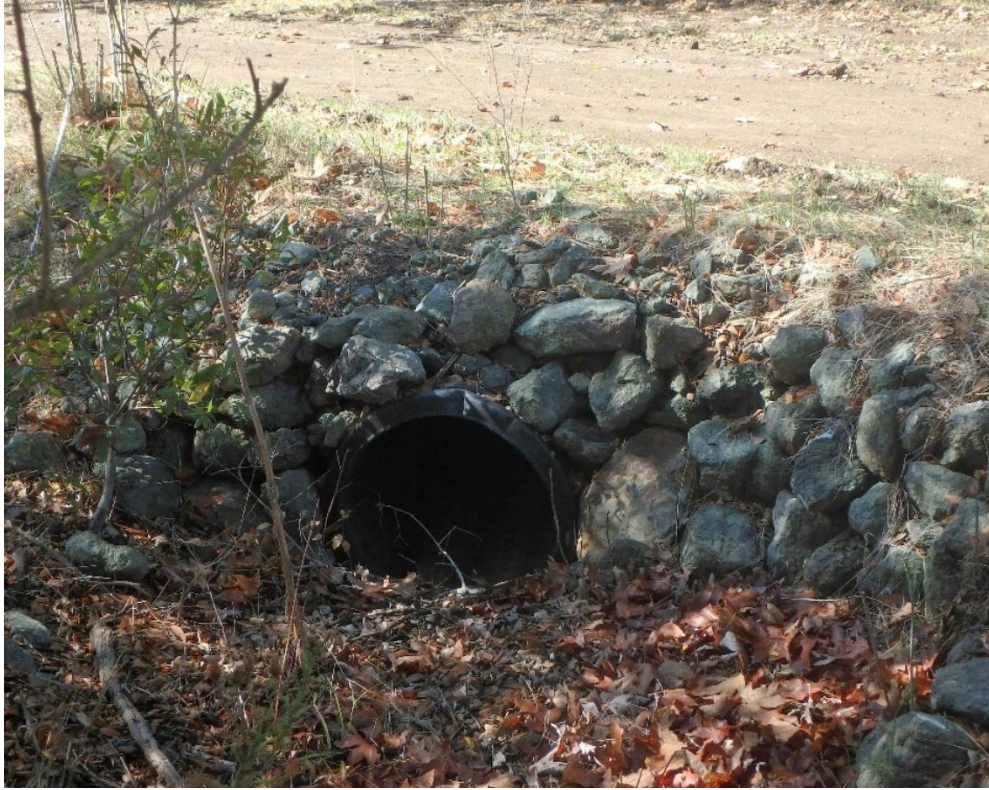
**Photo 67.** Site 220 (Peterson Ranch Rd.): View of Site 220 looking downstream towards culvert inlet. This undersized culvert is prone to plugging during storm events and discharges directly in Brizziolari Creek.

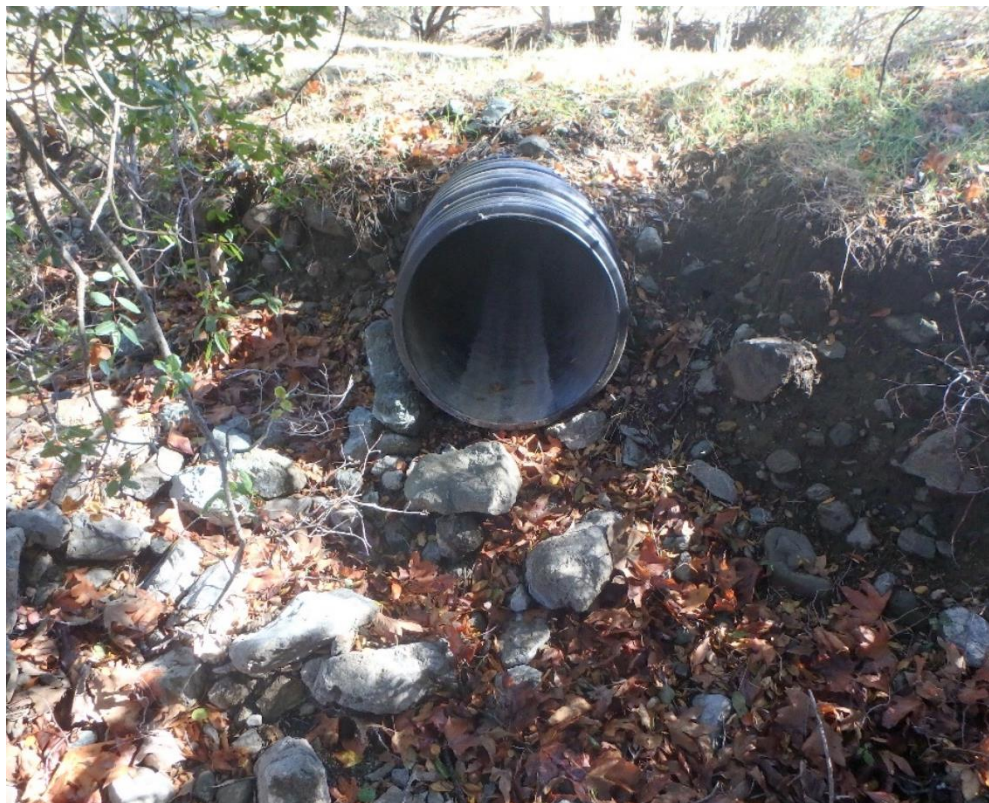
**Photo 68.** Site 220 (Peterson Ranch Rd.): View of Site 220 looking upstream at the culvert outlet area. Fine sediment from a recent storm is visible on the bottom of the corrugated plastic pipe.

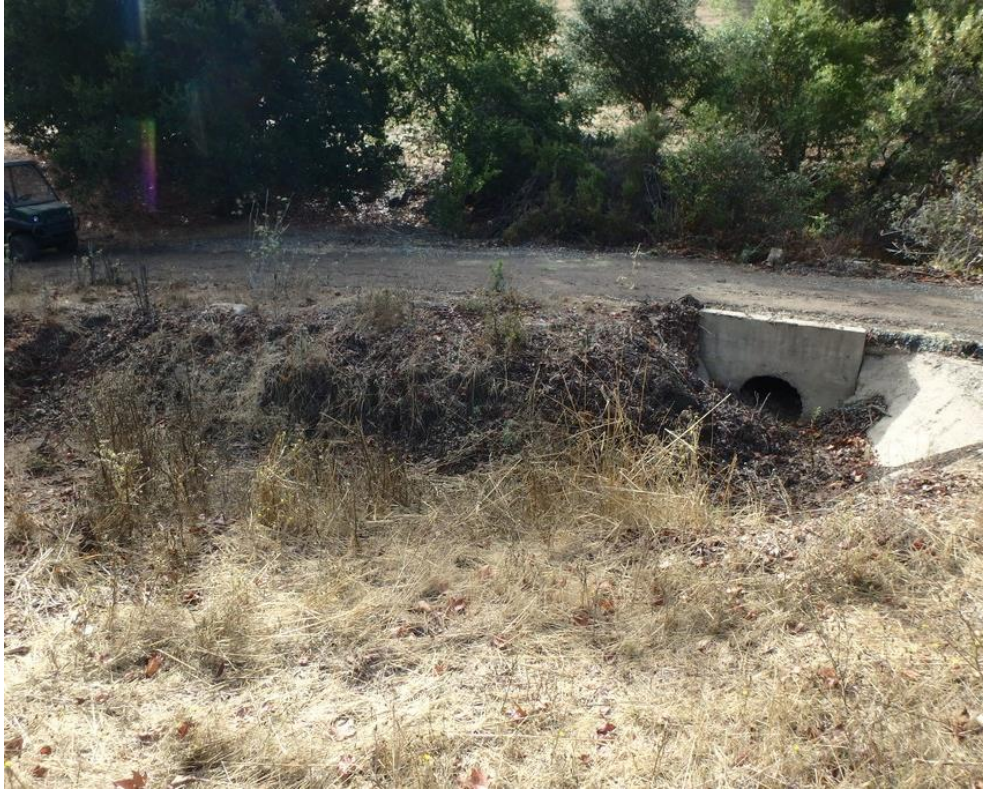
**Photo 71.** Site 222 (Peterson Ranch Rd.): View of Site 222 looking downstream. Mainstem Brizzolari Creek makes a 90 degree turn at this location, and concrete has been poured on the right bank in an attempt to buttress the slope from erosion.
