**Stenner Creek Erosion Control and  
Sediment Reduction Plan,  
California Polytechnic State University,  
San Luis Obispo County, California**

**PWA Report No. 231039902  
April 2023**

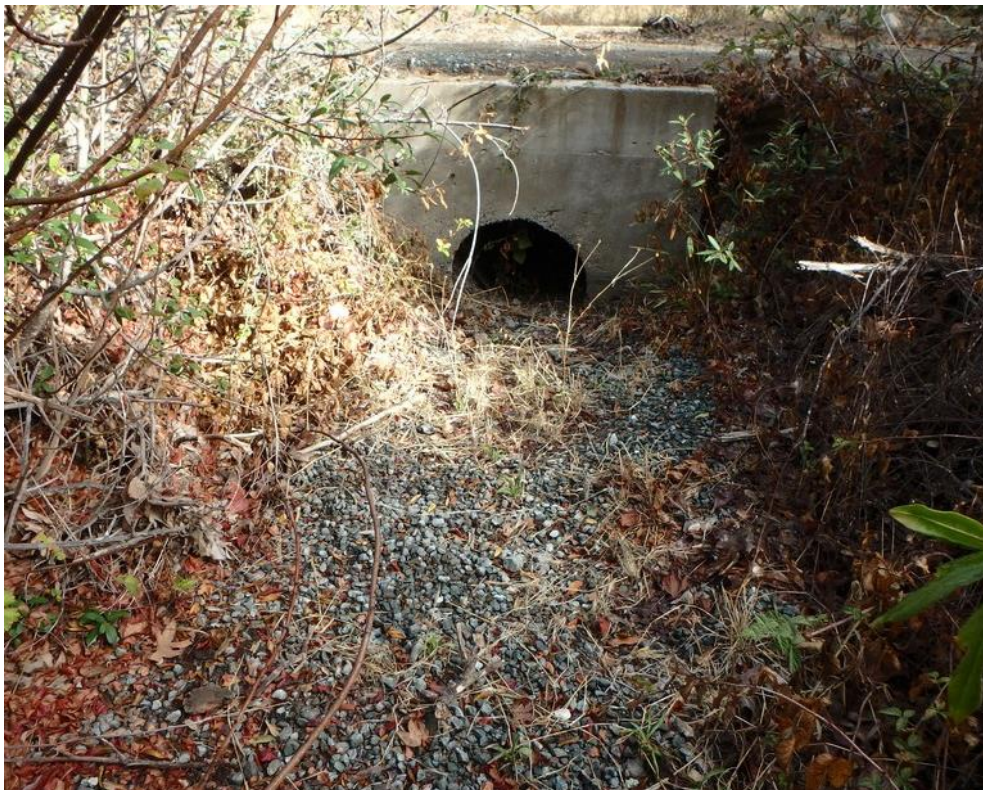
**Photo 72.** Site 222 (Peterson Ranch Rd.): View of Site 222 looking upstream at the drastically undersized culvert outlet. The road crossing is visible in the top of the frame. Gravel washed into stream can be seen in the center of the frame.

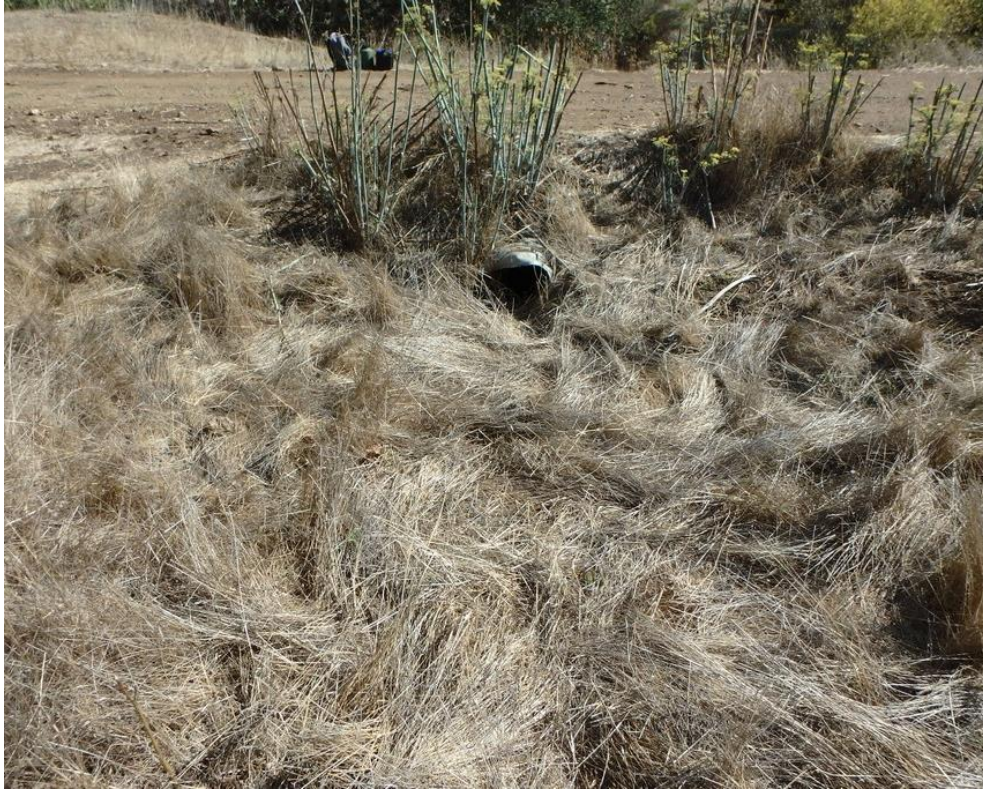
**Photo 73.** Site 223 (Peterson Ranch Rd.): View of Site 223 looking downstream at the culvert inlet. Mainstem Brizziolari Creek is located parallel to the road crossing at the top of the frame.

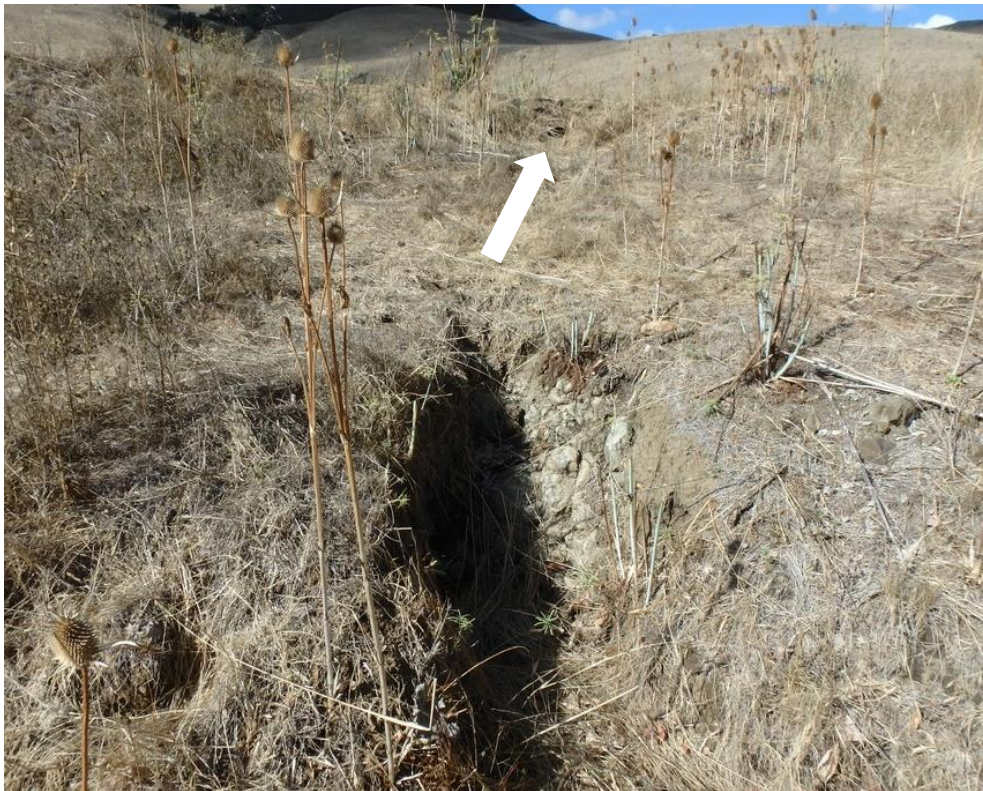
**Photo 74.** Site 223 (Peterson Ranch Rd.): View of Site 223 looking upstream at the culvert outlet. The outlet and the road crossing are visible in the top of the frame (see arrow) while erosion is visible in the center of the frame.

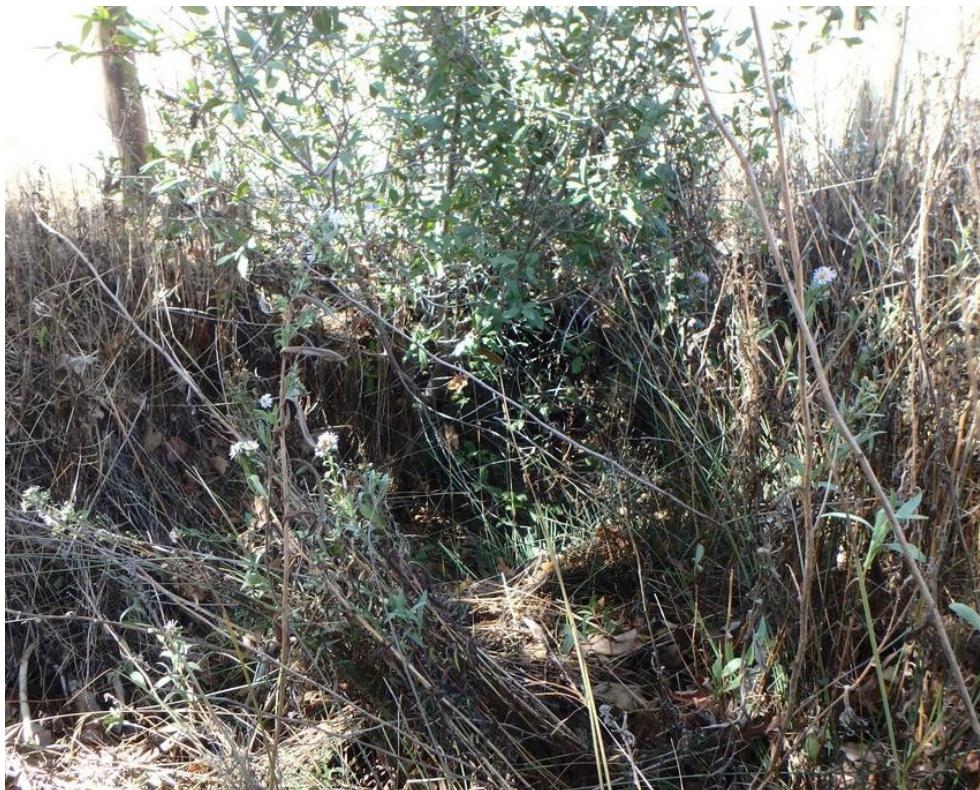
**Photo 76.** Site 224 (Peterson Ranch Rd.): View of Site 224 looking upstream at the culvert outlet area. This 18" culvert is undersized for this location and is recommended to be upgraded to a 36" culvert.

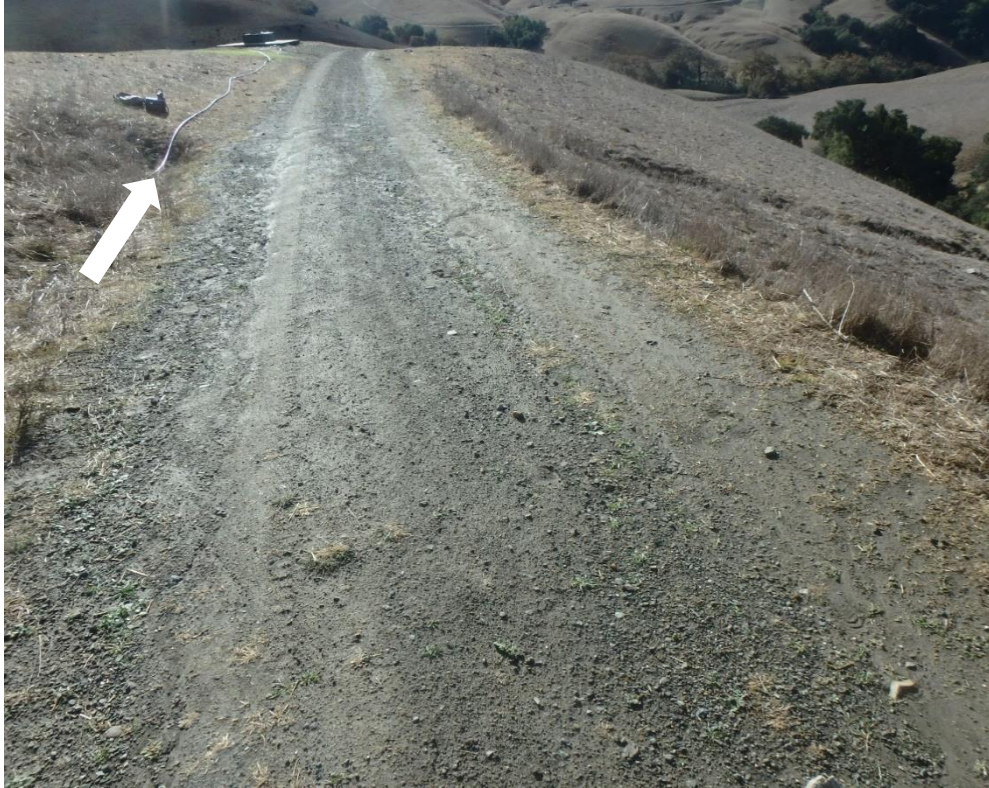
**Photo 77.** Site 225 (Peterson Ranch Rd.): View of Site 225 looking down road towards mainstem Brizziolari Creek. A plugged ditch relief culvert inlet is visible in the upper lefthand side of the frame (see arrow).

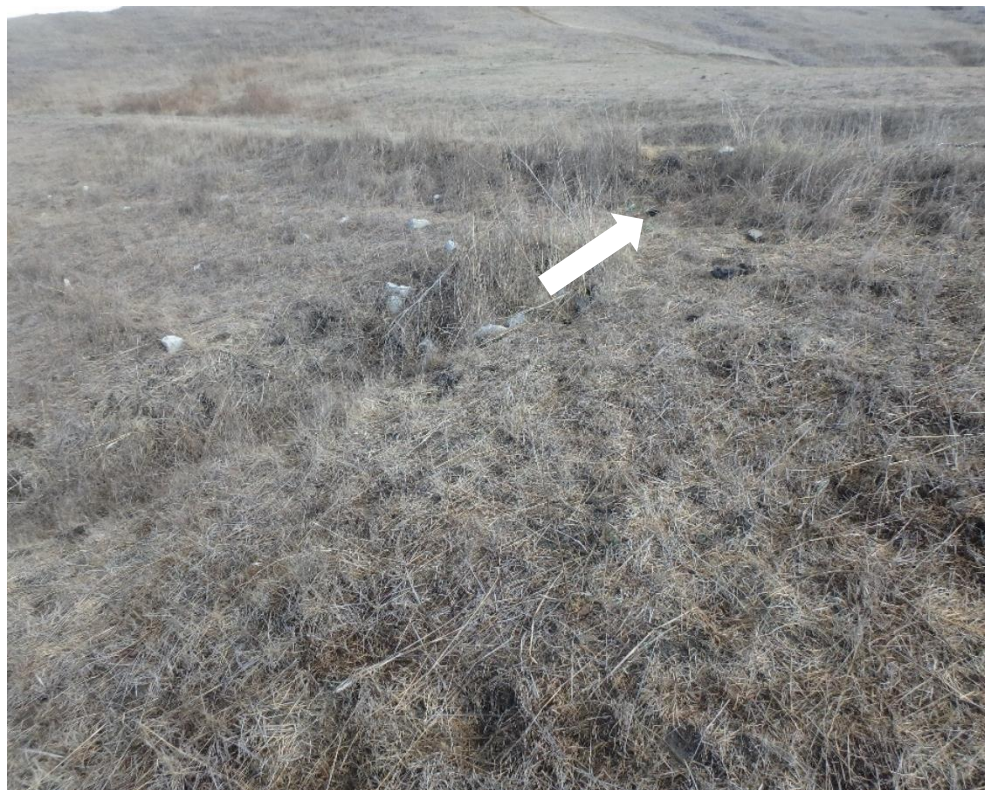
**Photo 78.** Site 225 (Peterson Ranch Rd.): View of Site 225 looking upslope towards the culvert outlet area (see arrow). The gully that has formed as a result of the culvert discharge is visible in the center left of the frame.

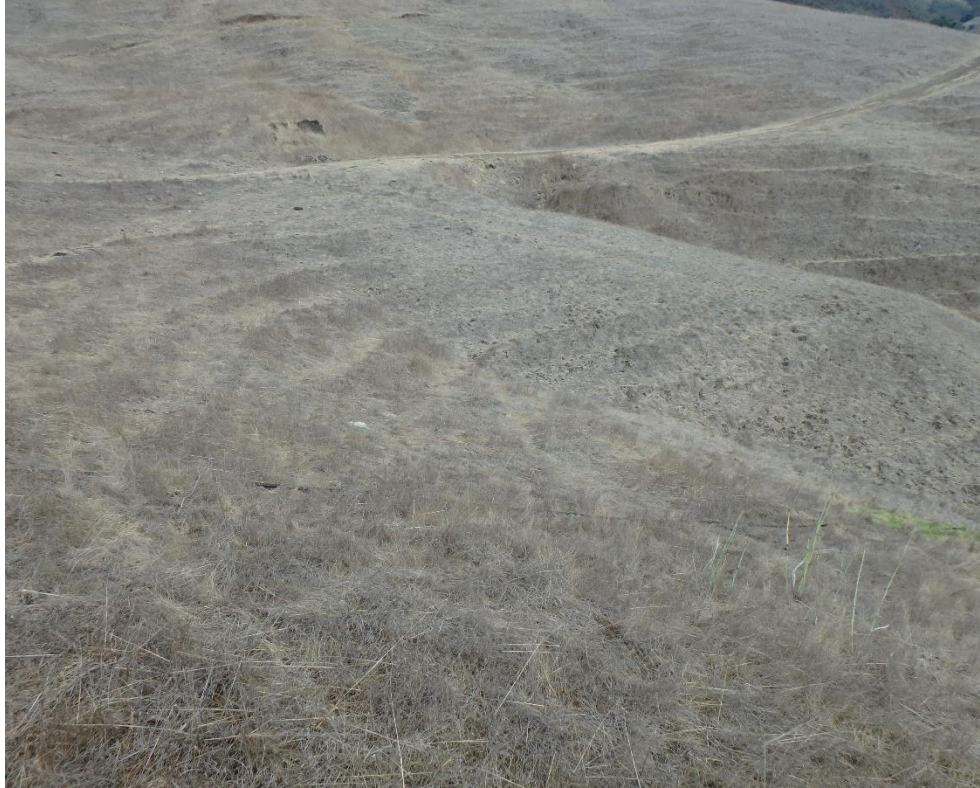
**Photo 79.** Site 226 (Peterson loop Spur) View of Site 226 looking towards outboard edge of fill. The fill in this location is failing and collapsing into the headwall of the succeeding swale.

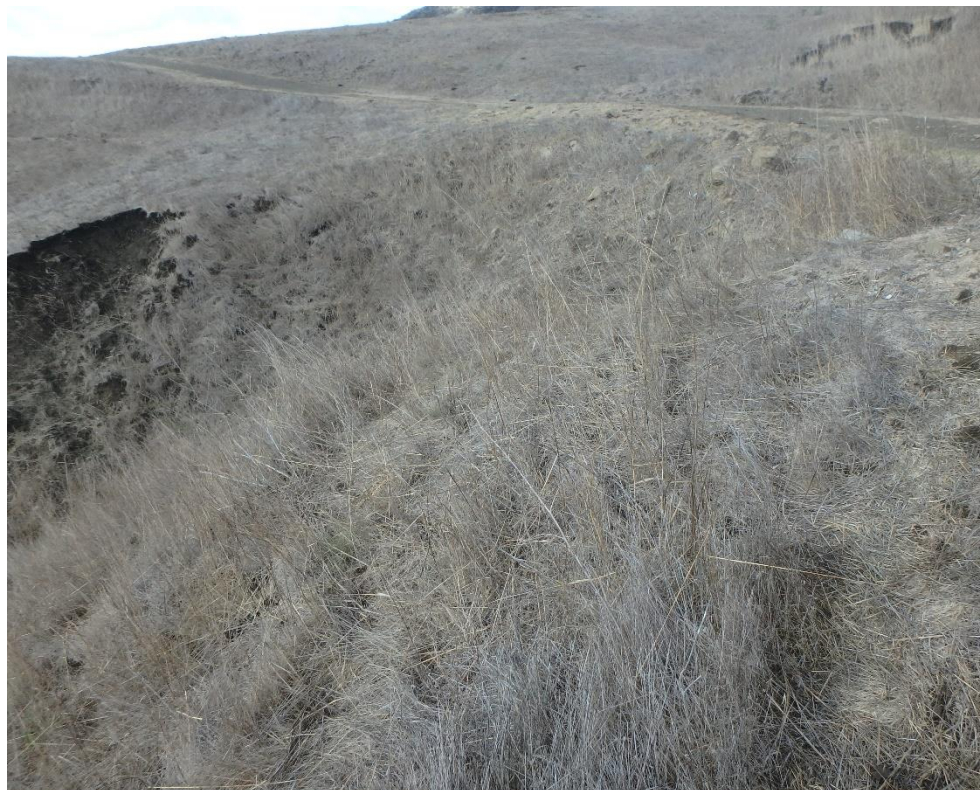
**Photo 80.** Site 226 (Peterson Loop Spur): View of Site 226 looking up the right road and outboard fill edge. The failing fill edge is visible in the upper half of the frame.

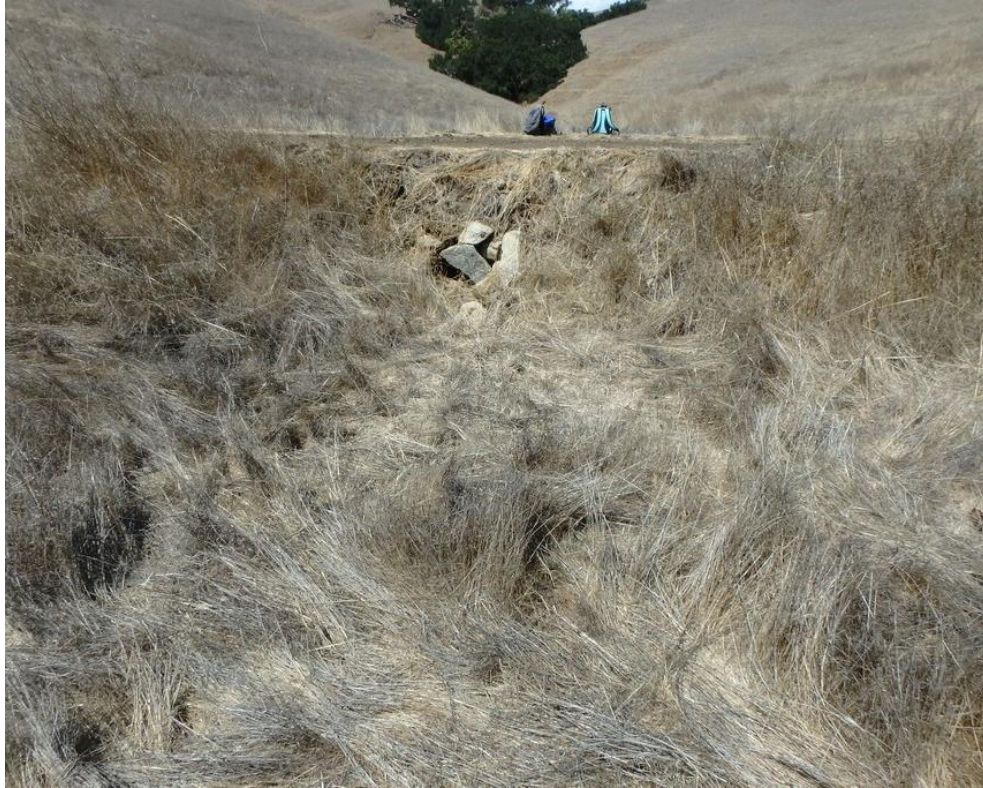
**Photo 81.** Site 227 (Peterson Ranch Rd.): View of Site 227 looking upstream at the culvert outlet. The outboard fill area is visible at the top of the frame and the upper stream channel is visible in the uppermost portion of the frame.

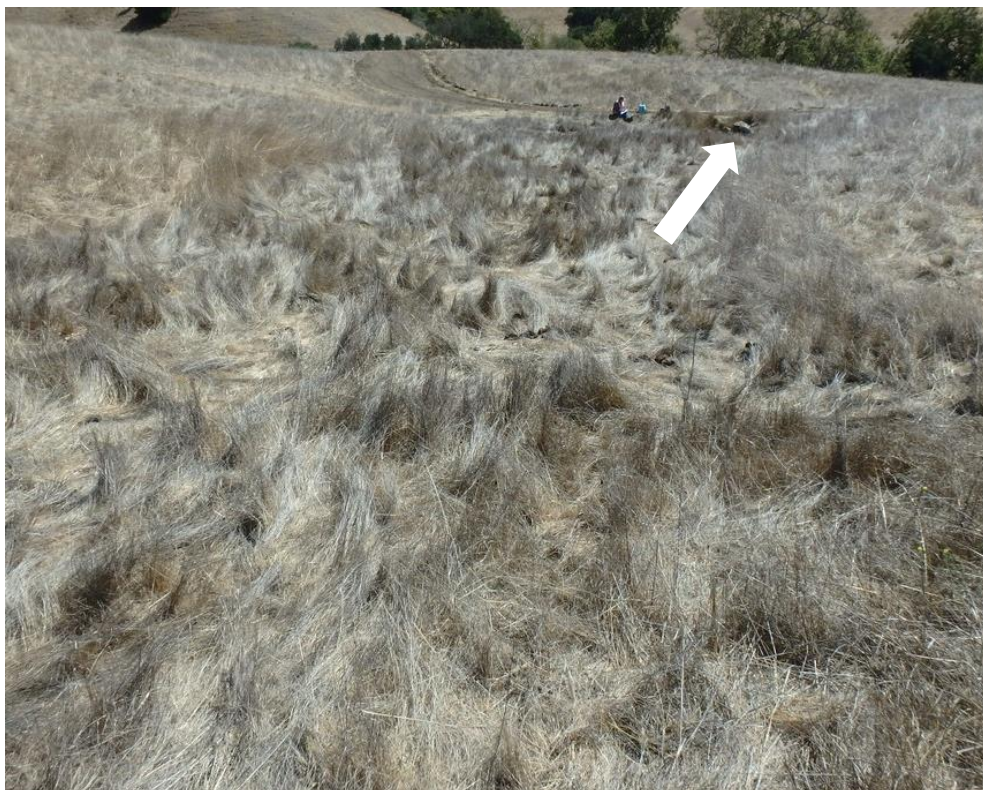
**Photo 82.** Site 227 (Peterson Ranch Rd.): View of Site 227 looking downstream at the culvert inlet area (see arrow). This 30" culvert is undersized and is recommended to be upgraded to a 36" corrugated metal culvert.

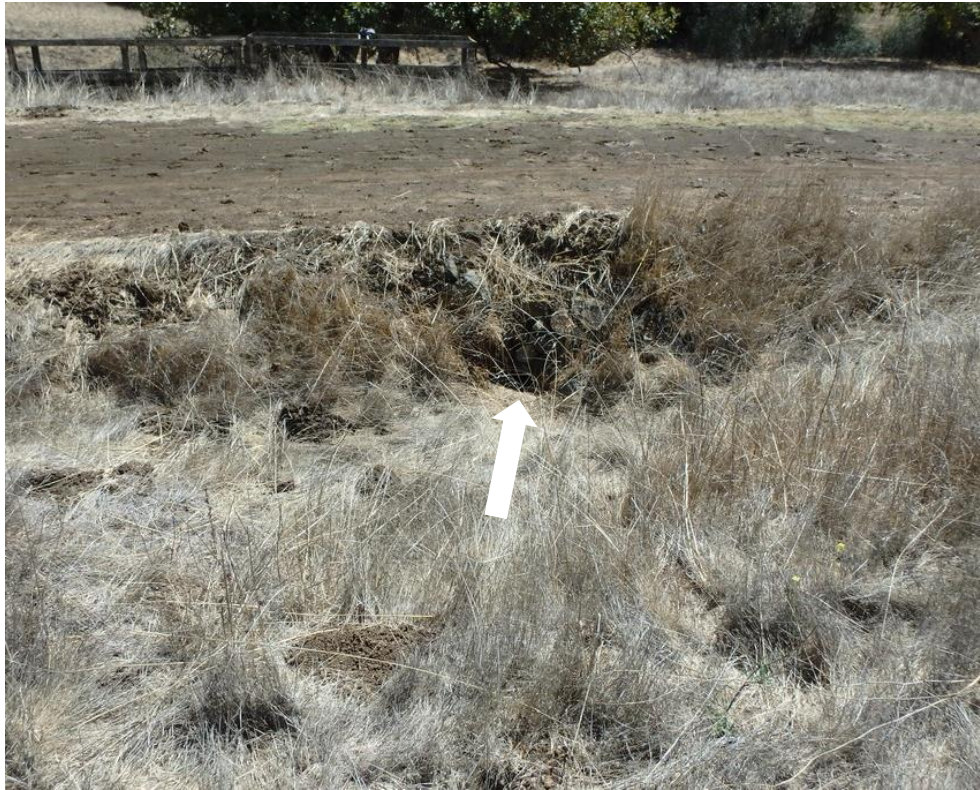
**Photo 83.** Site 227.1 (Peterson Ranch Rd.): View of Site 227.1 plugged ditch relief culvert inlet (see arrow) looking towards mainstem Brizziolari Creek. The road crossing is also visible in the top of the frame.

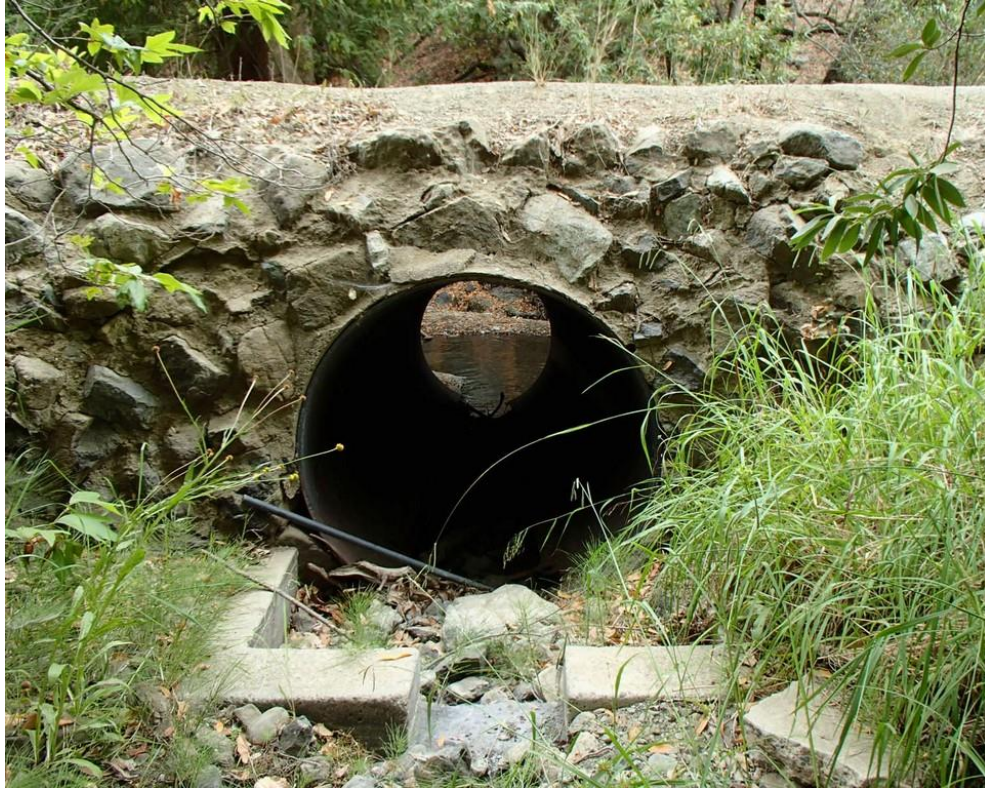
**Photo 89.** Site 230 (Poly Canyon Rd.): View of Site 230 culvert inlet and road crossing. Looking downstream at mainstem Brizziolari Creek. This culvert is not aligned properly with the stream channel.

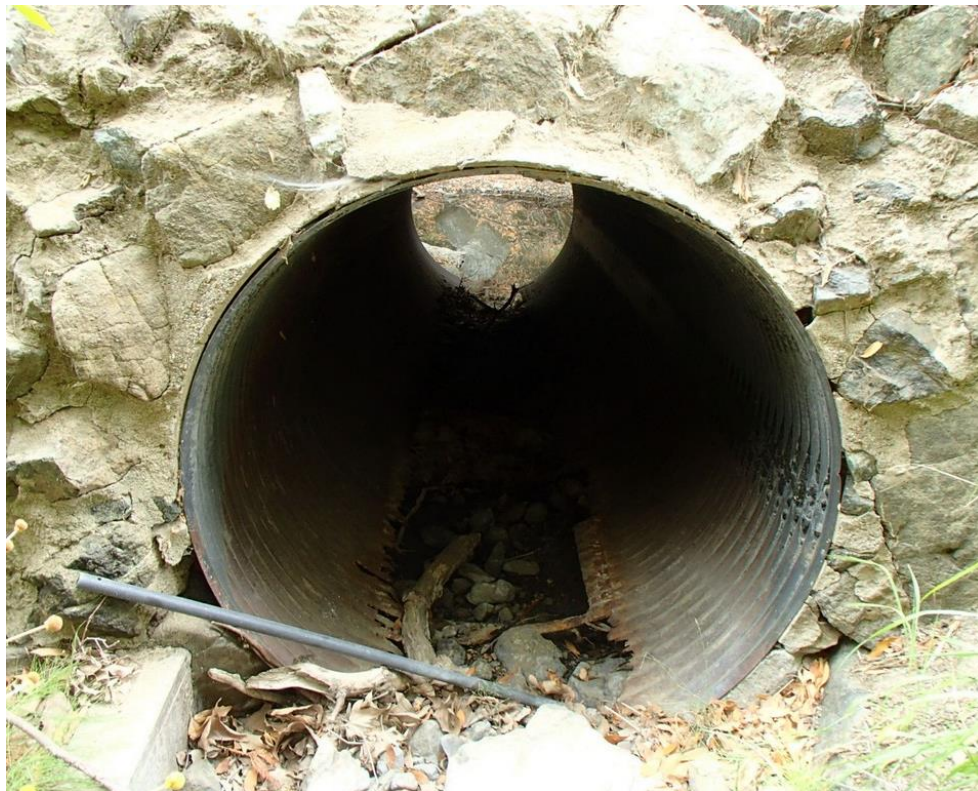
**Photo 90.** Site 230 (Poly Canyon Rd.): View of Site 230 culvert inlet. Looking downstream, notice the rusted-out bottom of the culvert and the washed-out trash rack.

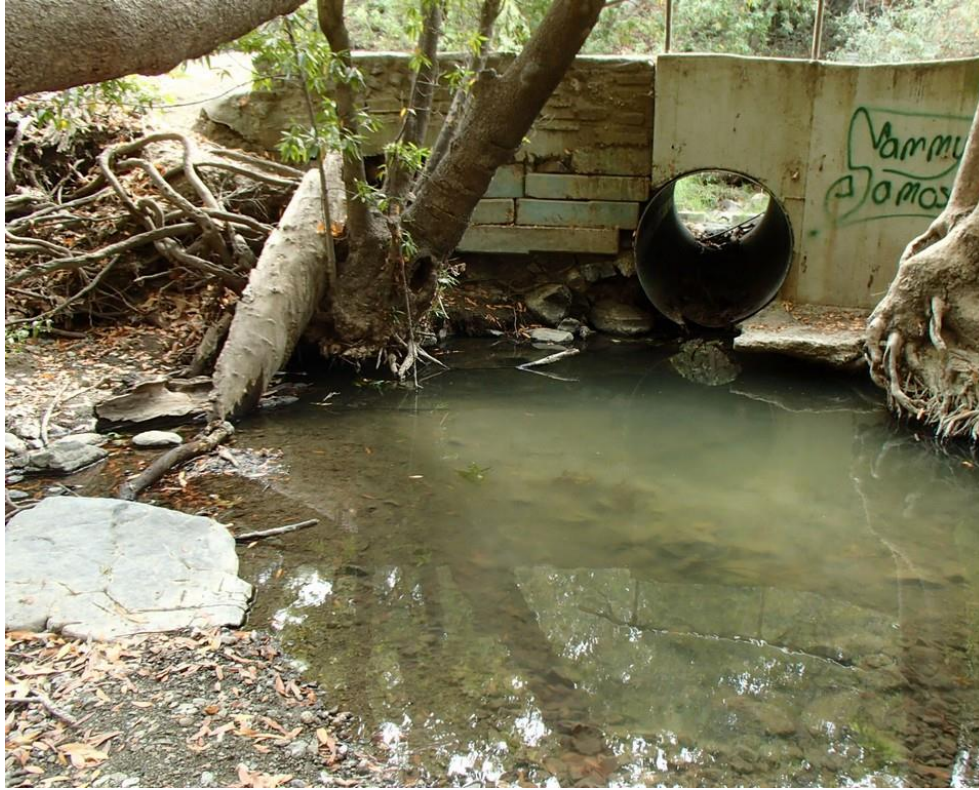
**Photo 91.** Site 230 (Poly Canyon Rd.): View of Site 230 culvert outlet and road crossing. Looking upstream at mainstem Brizziolari Creek, notice the pool of water at culvert outlet and the erosion on the left side of the frame.

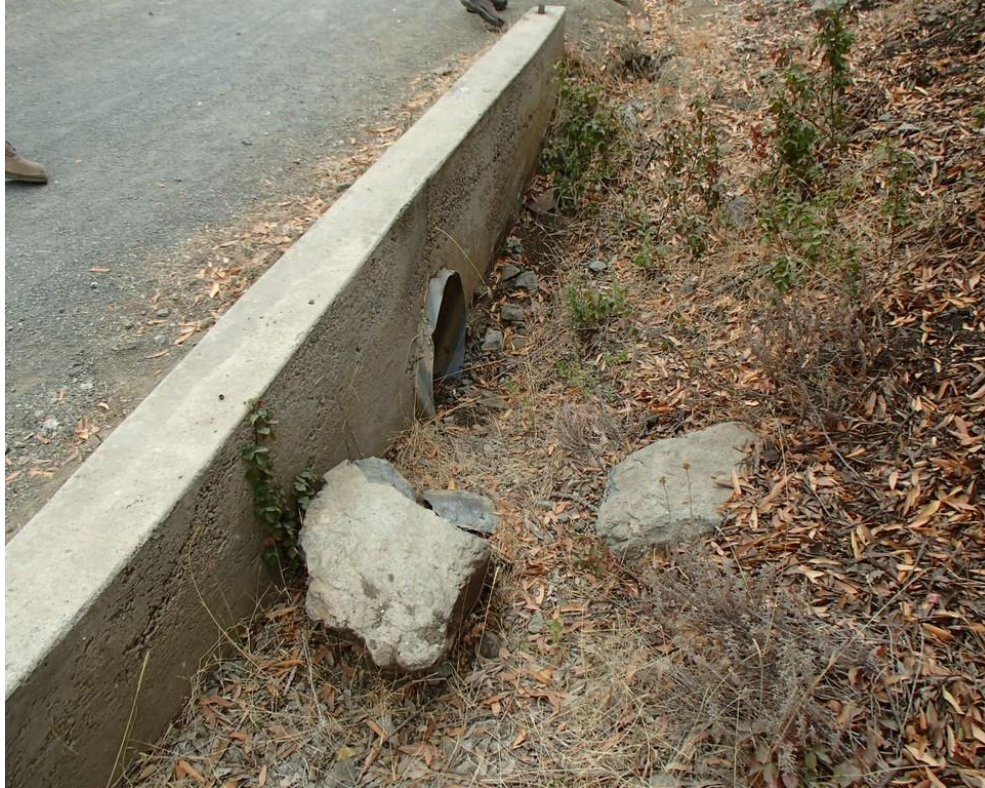
**Photo 93.** Site 231 (Poly Canyon Rd.): View of Site 231 ditch relief culvert inlet area. The inlet of the culvert has been embedded in a short concrete wall. Site 230.1 diverts to this location along the right road (upper frame).

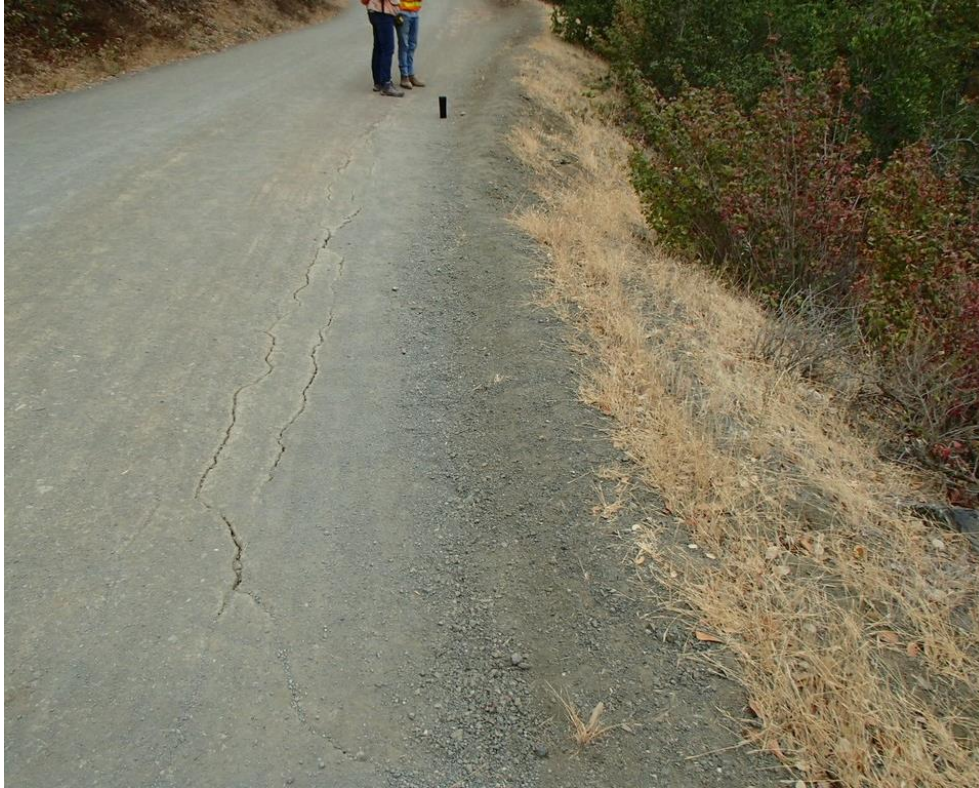
**Photo 95.** Site 232.1 (Poly Canyon Rd.): View of Site 232.1 looking southwest. Site 232.1 is located above mainstem Brizziolari Creek. Tension cracks in the road indicate a potential road fill failure.

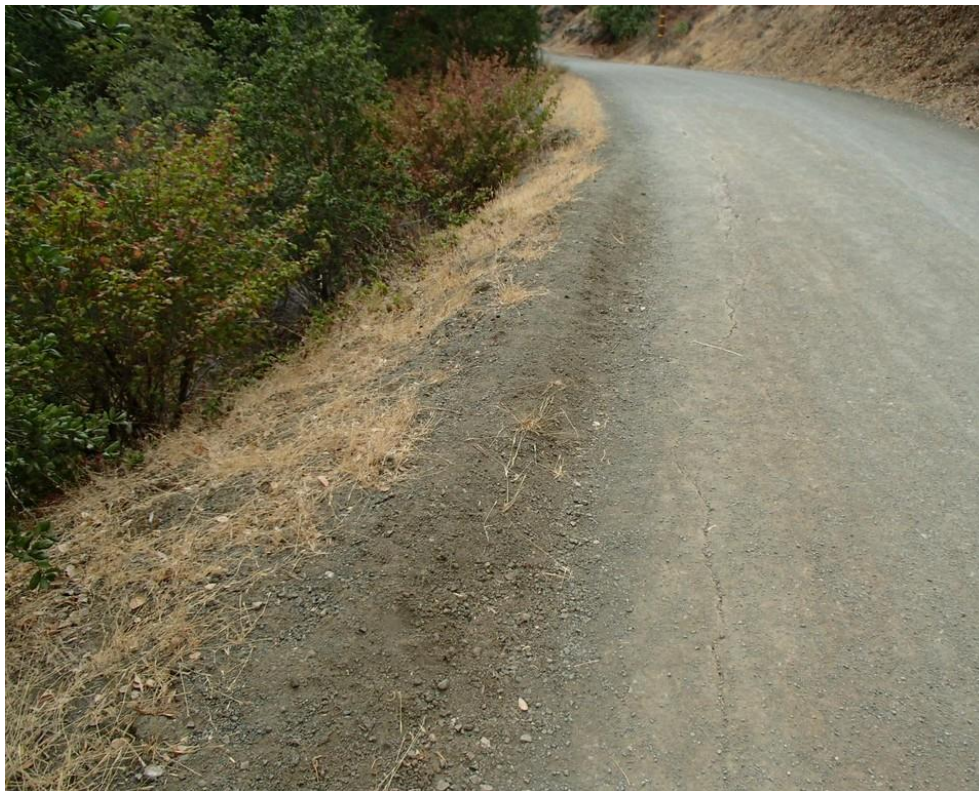
**Photo 96.** Site 232.1 (Poly Canyon Rd.): View of Site 232.1 looking northeast at tension cracks in road.

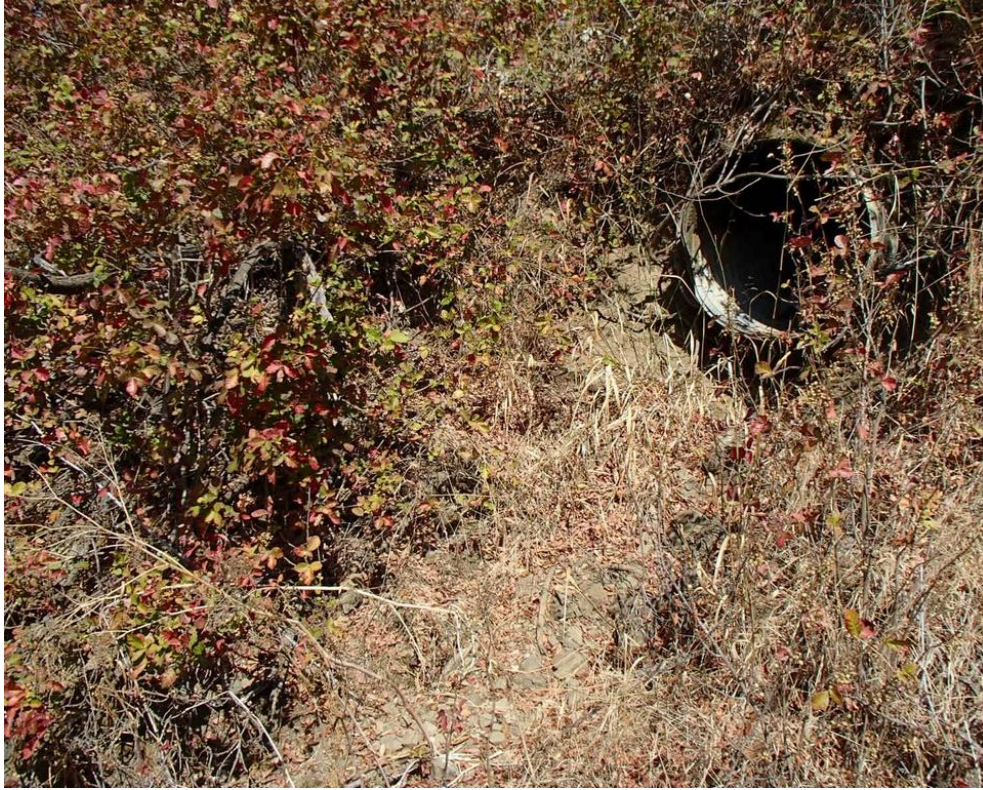
**Photo 97.** Site 234 (Poly Canyon Rd.): View of Site 234 ditch relief culvert outlet area. A gully extends from the culvert outlet towards the left side of the frame.

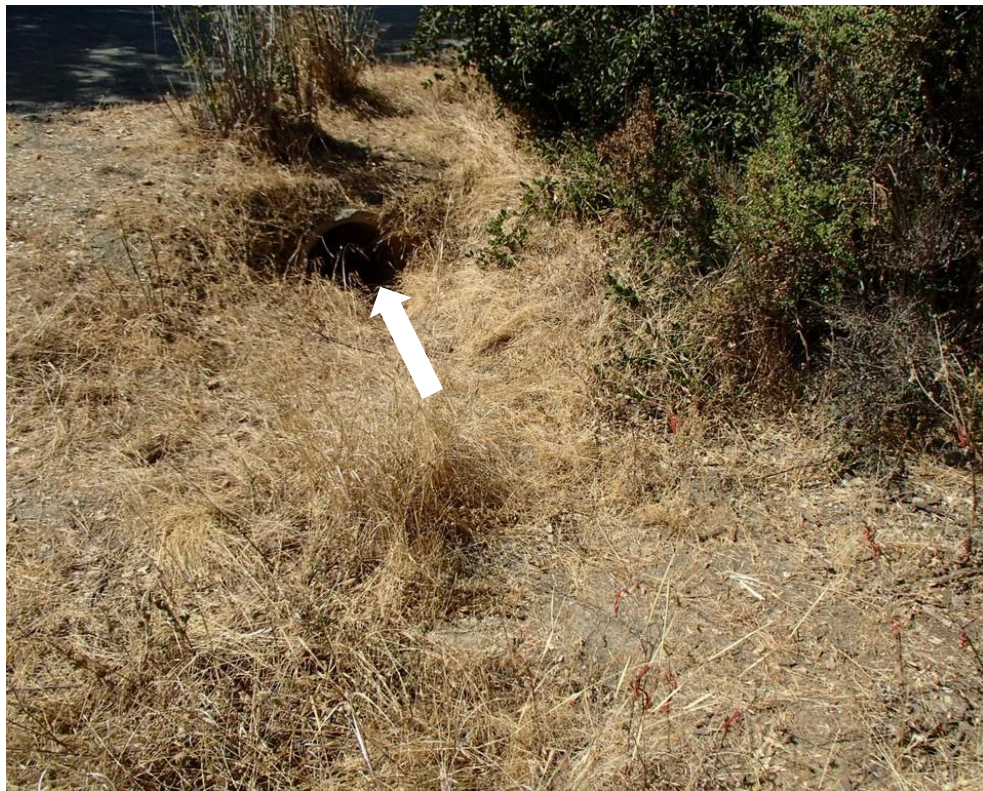
**Photo 98.** Site 234: View of Site 234 ditch relief culvert inlet area (see arrow).

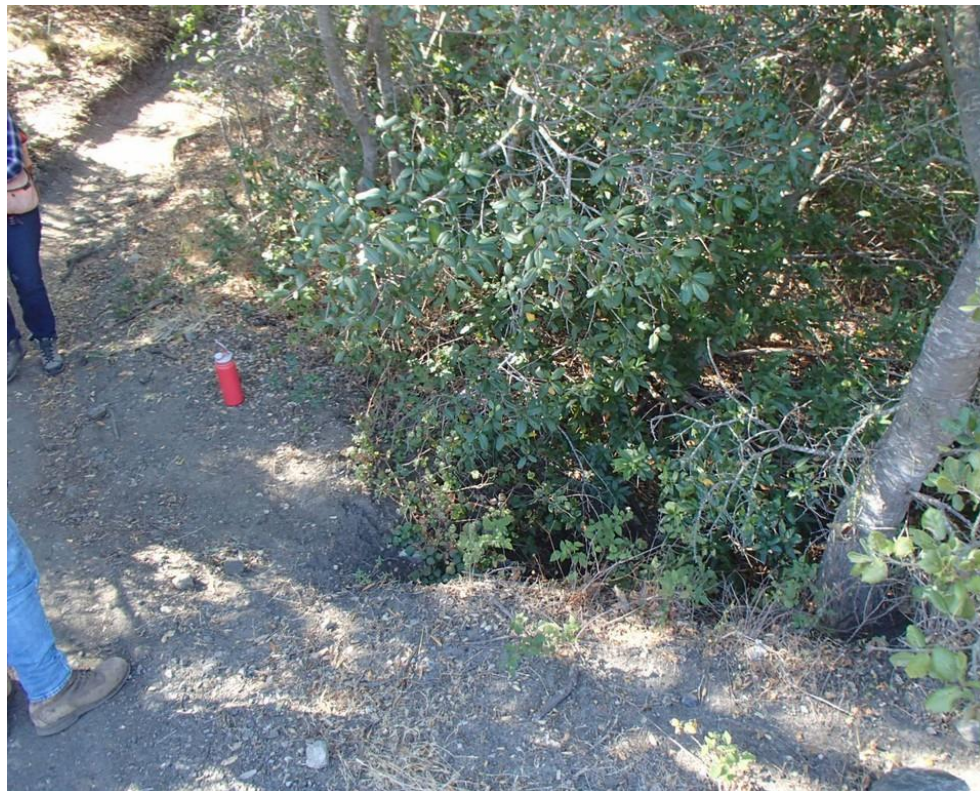
**Photo 110.** Site 410 (Yewks Trail): View of Site 410 stream crossing looking obliquely at the stream crossing. The downstream gully can be seen in this photo migrating into the outboard edge of the trail.

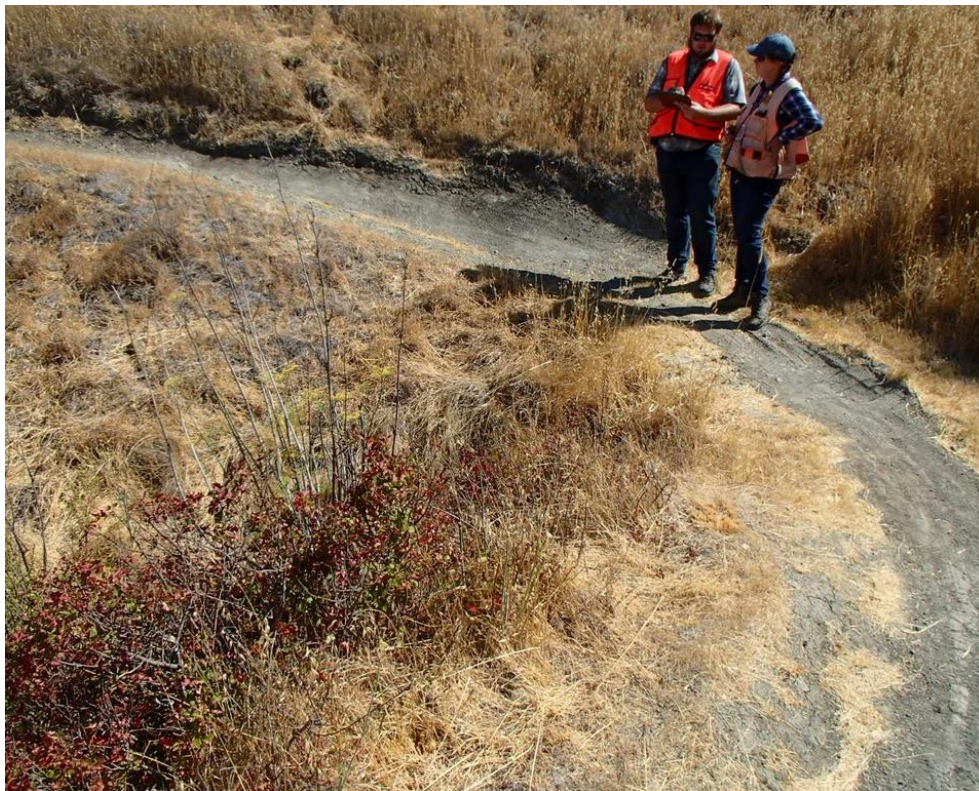
**Photo 116.** Site 413 (Yewks Trail): View of Site 413 stream crossing looking obliquely at the stream crossing. The stream flows from right to left.
