# ATTACHMENT F

## Mitigation Project PC-05-01

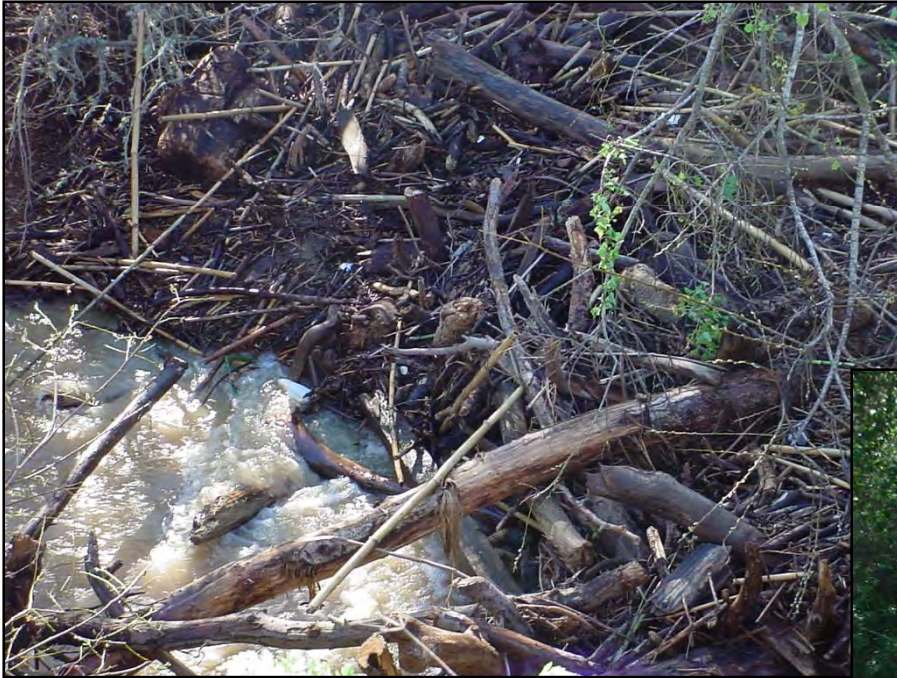
Figure 146. Substantial erosion due to debris jam.

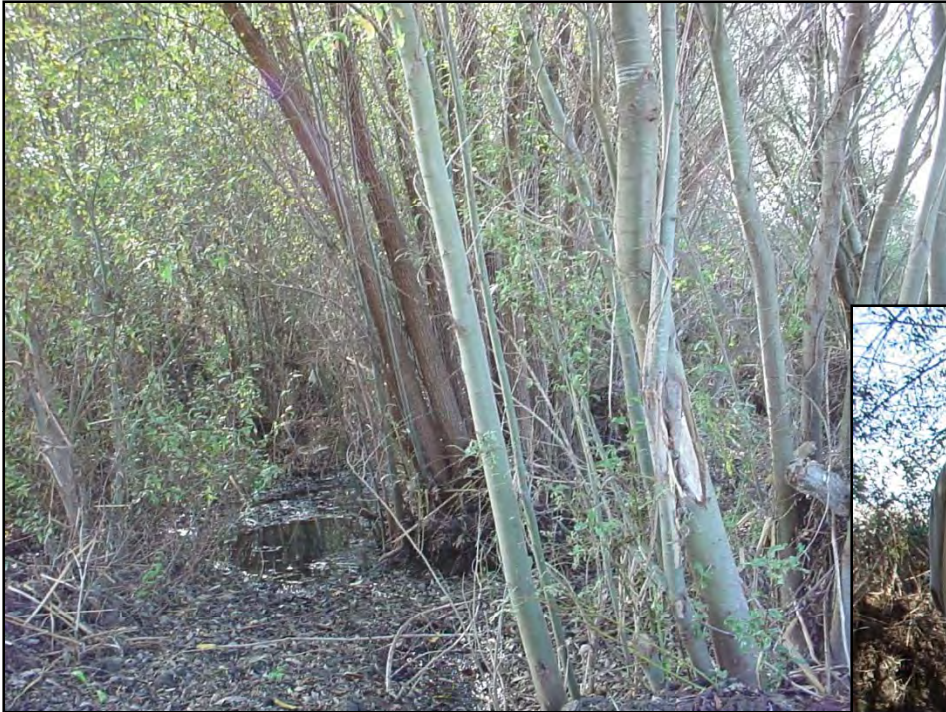
Figure 148. This reach needed pruning up for canopy and clearing debris jams.

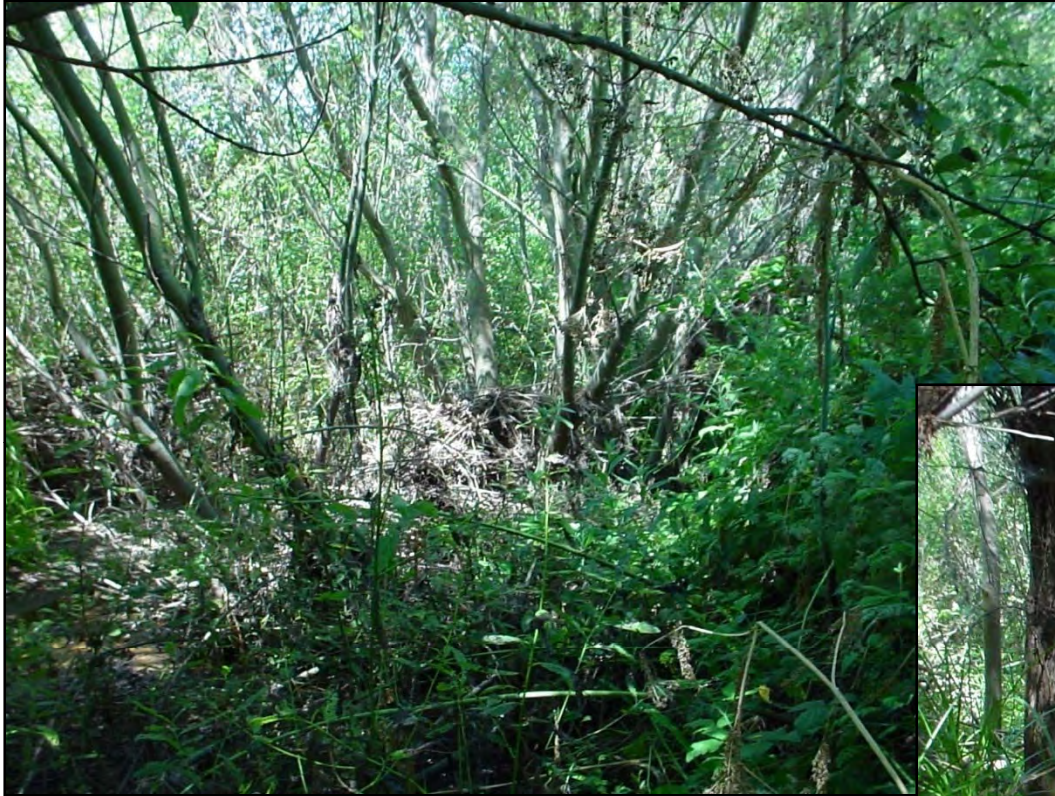
Figure 152. Mass of willow and debris jams blocking creek and fish passage and deflecting flow.

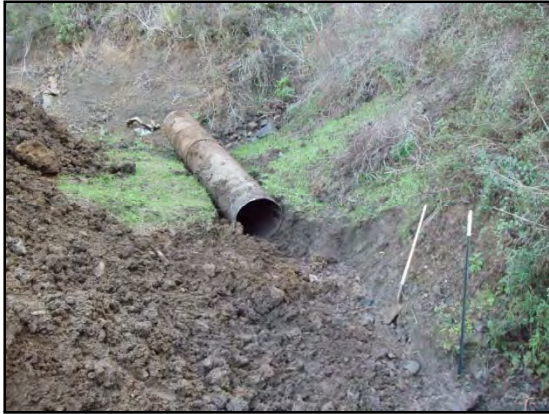
Figure 154. Failed culvert.

**Project:** During a major storm event, a culvert failed on an access road which led to scouring and erosion of the road as well as making the road impassable.

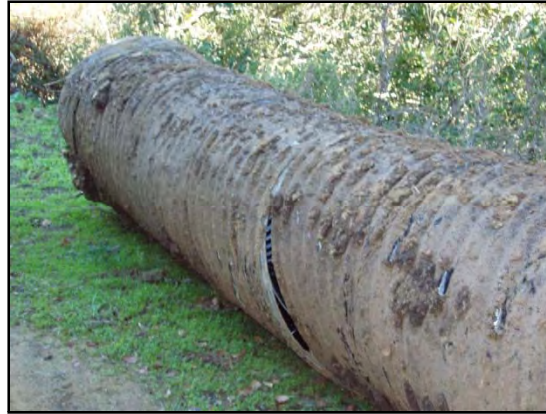
Figure 155. Failed culvert.

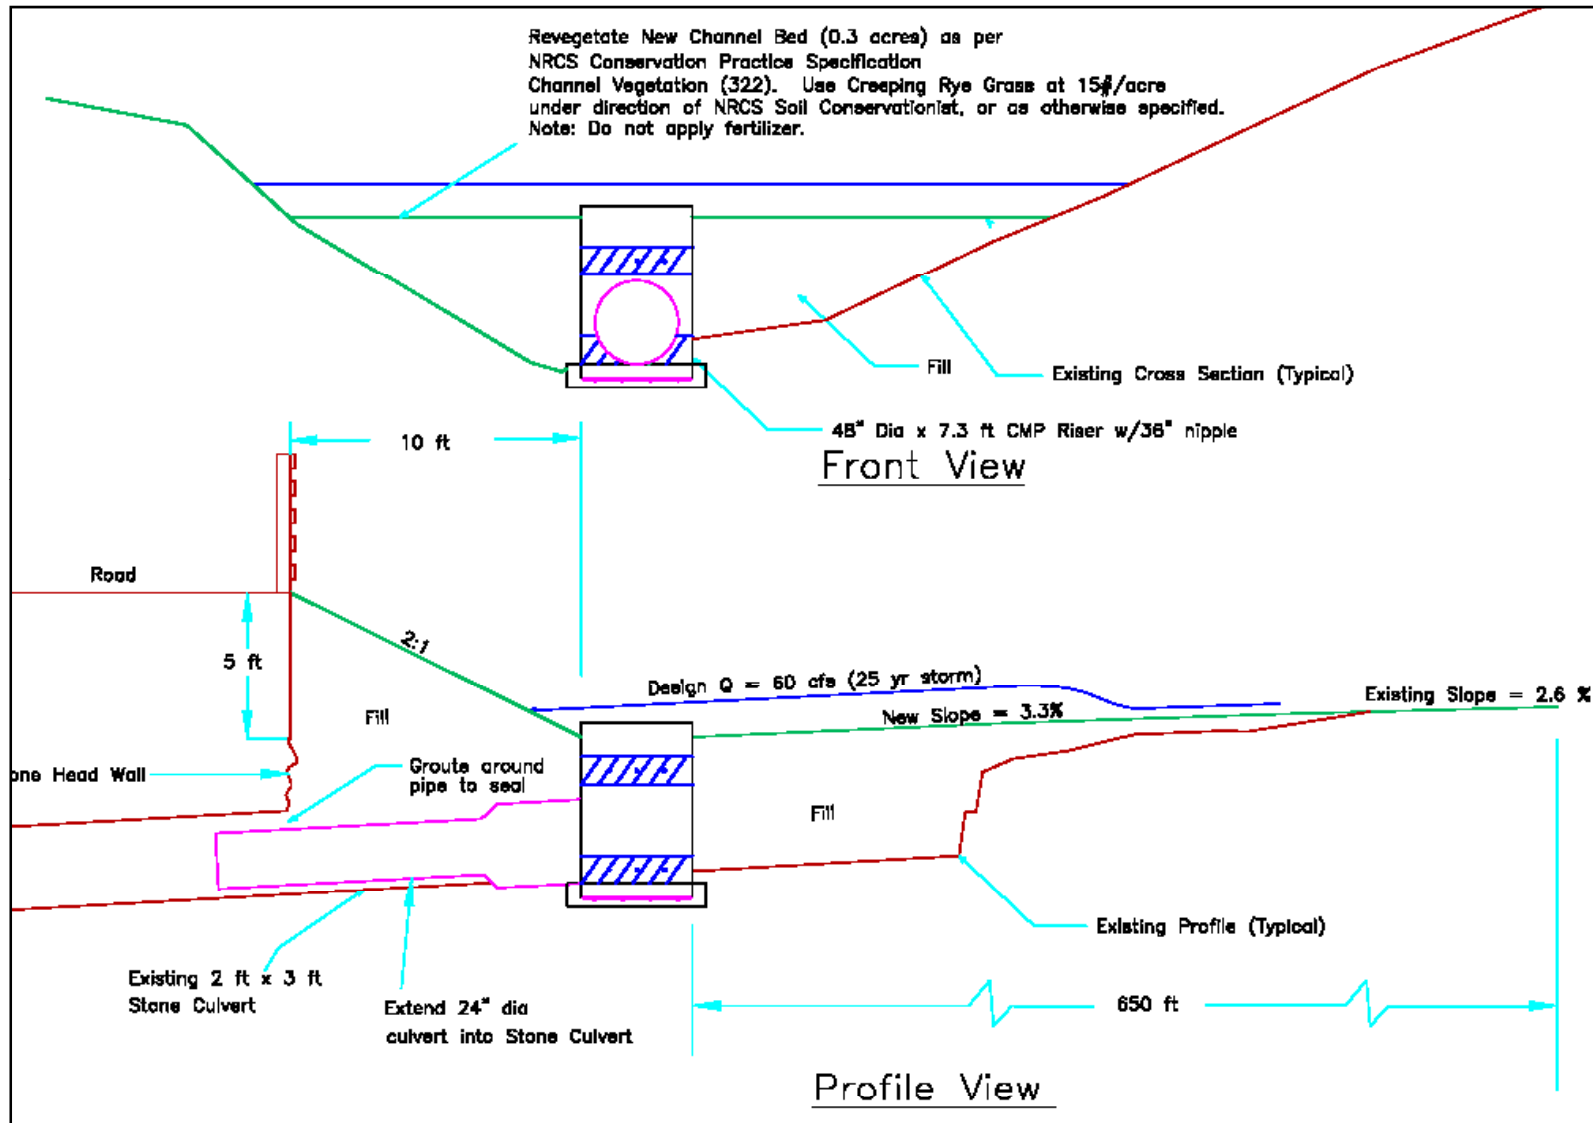
**Resource concern:** The head cut and a sloughing bank contribute to sediment loading into Warden Creek.

Figure 164. Diagram of drop structure and treatment of headcut.

**Solution:** Install drop structure to eliminate head cut; backfill around drop structure; fill in head cut to support sloughing bank.

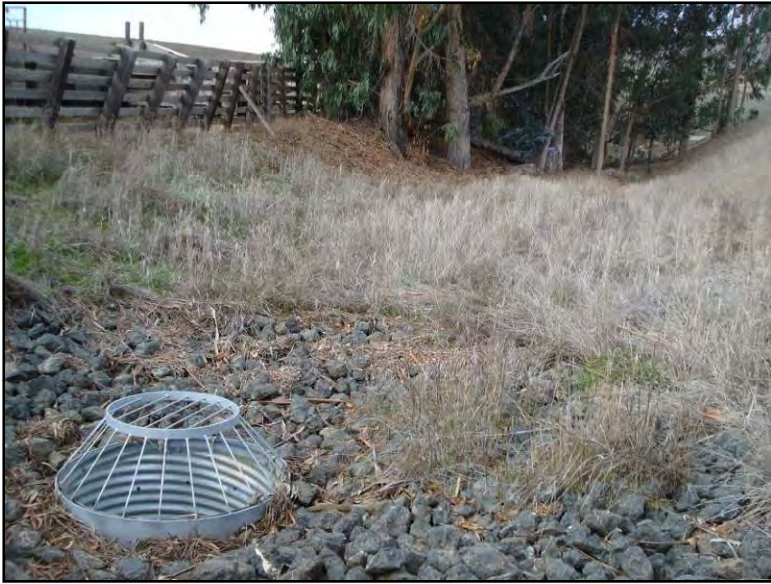
Figure 172. Looking upstream at drop structure and restored headcut, over a year after installation

**Post-implementation photos:** A site visit conducted December 1, 2008 found the stabilized headcut and drop structure on the upstream side of the rock bridge in good condition and functioning well, and the recontoured and revegetated banks on the downstream site stable with no signs of scour or down cutting.

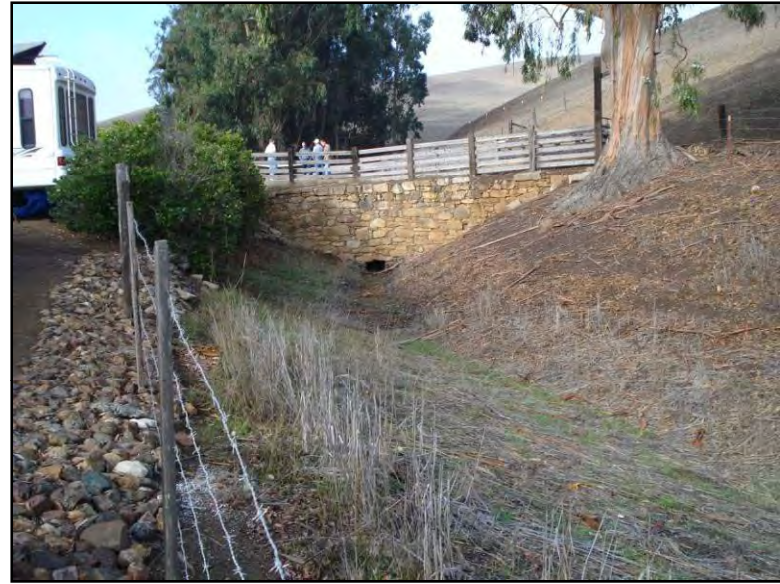
Figure 173. Looking upstream at outlet and recontoured/revegetated banks.

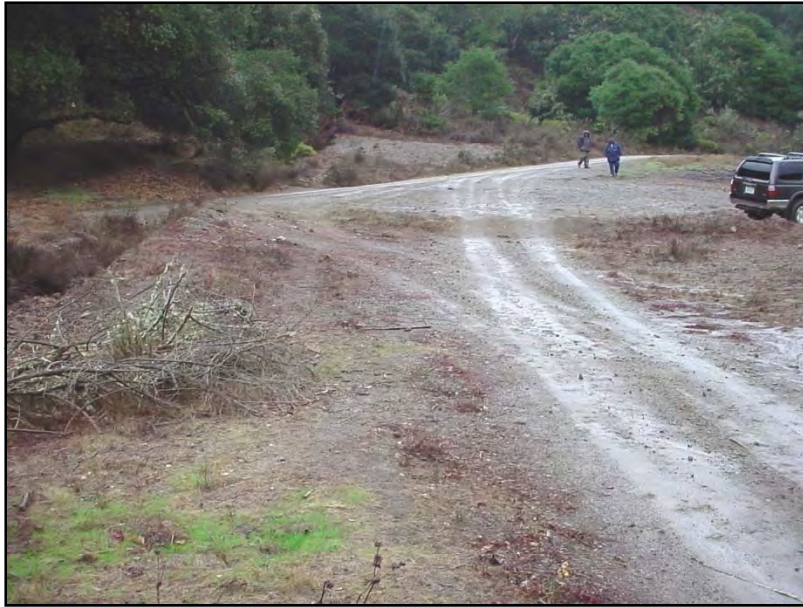
Figure 174. Road in need of repair.

**Project:** The proposed project consists of reworking an existing road to improve drainage. Existing culverts may be replaced with rolling dips or armored crossings. New water control structures will be added along certain reaches.

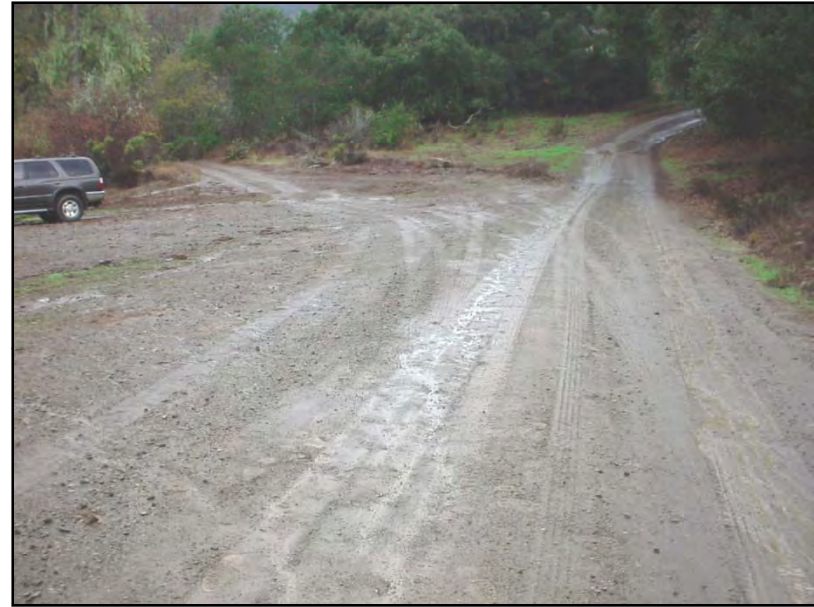
Figure 175. Road in need of repair.

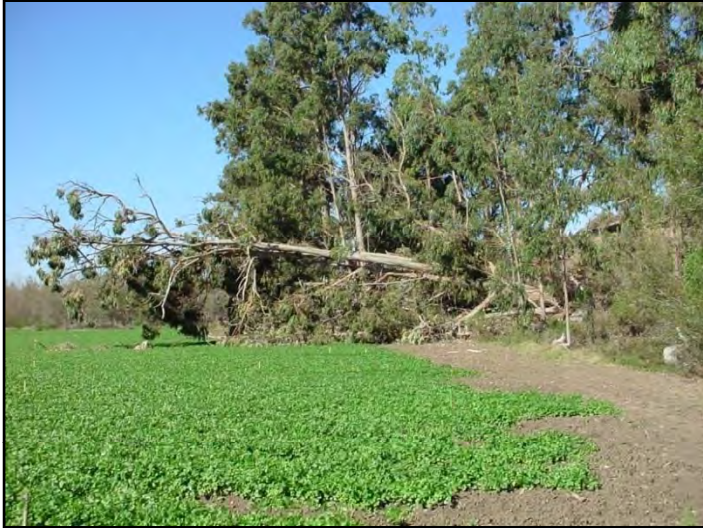
Figure 177. Five fallen Eucalyptus trees into Cilantro field.

**Project:** Emergency assistance with fallen Eucalyptus blocking Warden Creek.

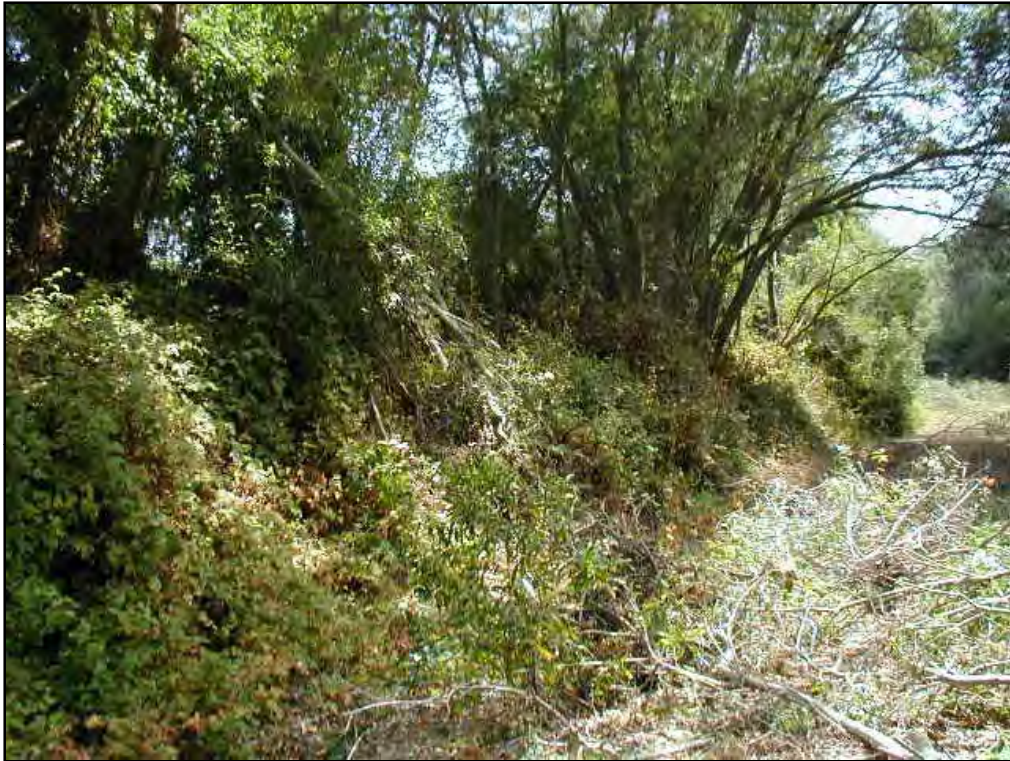
Figure 185. Fallen trees bucked up and debris removal needed.

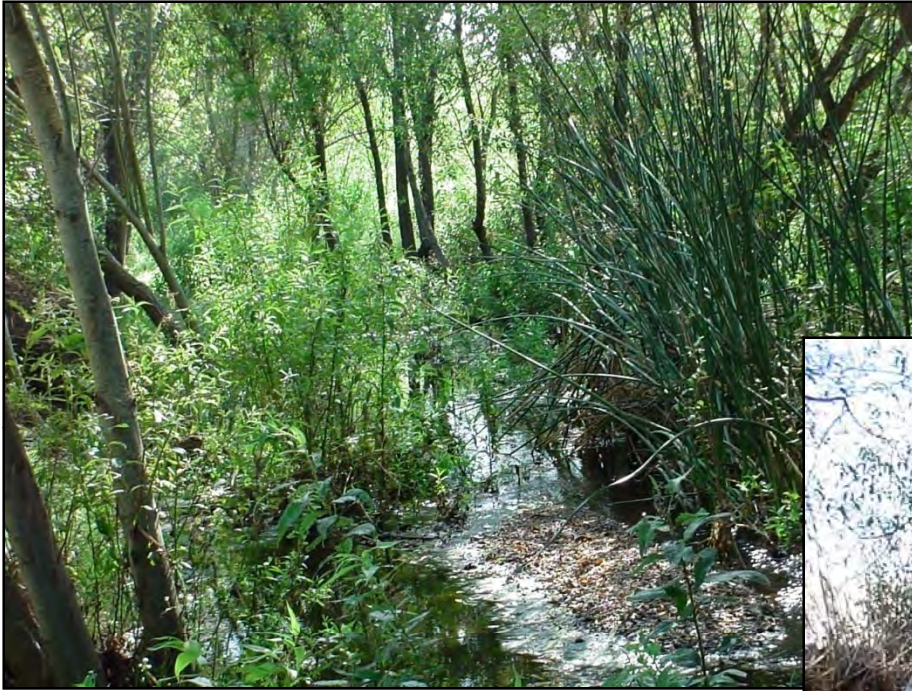
Figure 187. Pruning and debris removal needed for this reach.

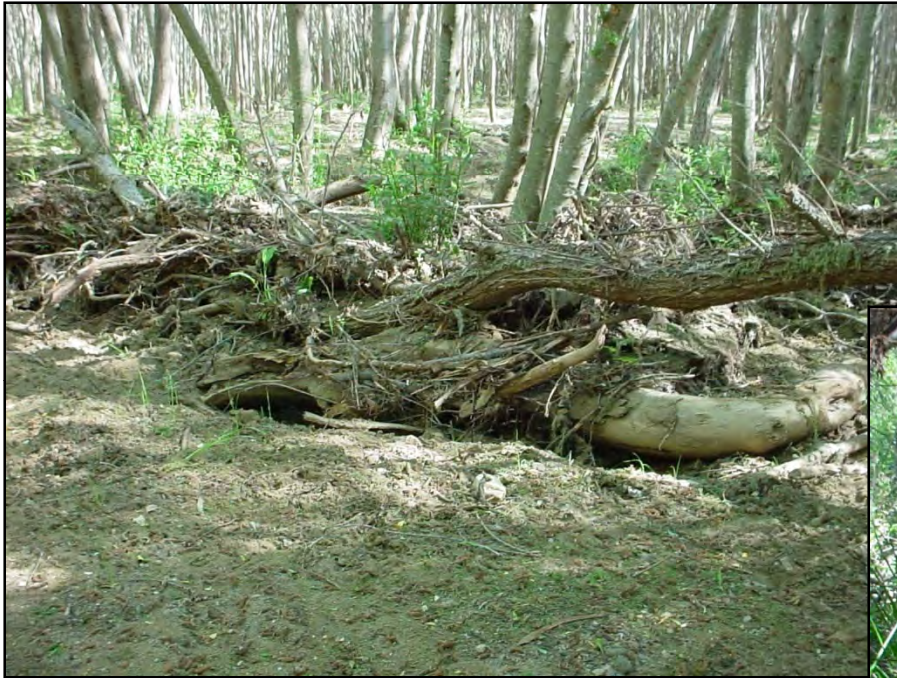
Figure 201. Debris jams and fallen trees caught in the debris jams needed to be removed to allow fish passage and reduce erosion.

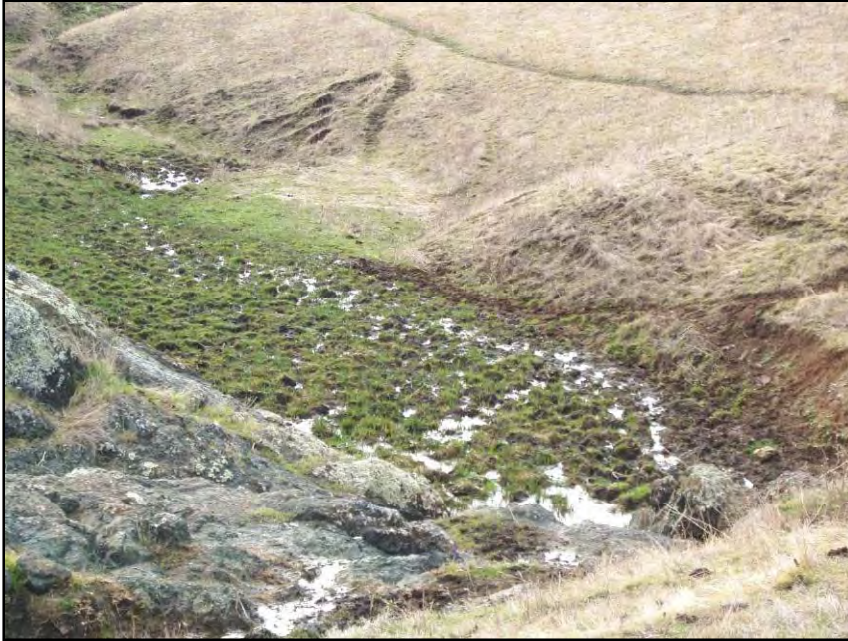
Figure 203. Site shown is just below development site of the upper spring in pasture 1. Note the hoof prints in the mud.

**Resource concern:** Impaired water quality and riparian vegetation due to cattle in creek (parameters of concern include pathogens) and limited cattle access to an off creek water supply.

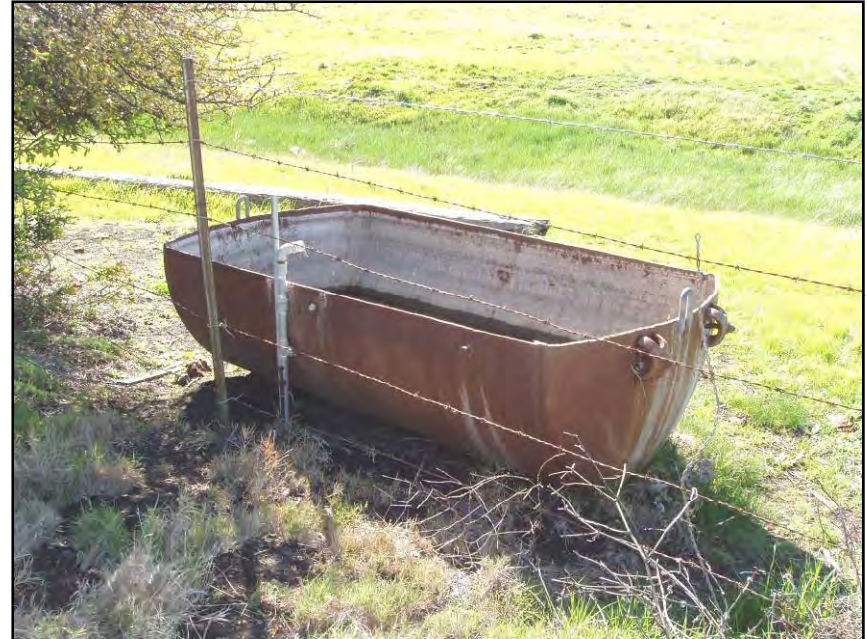
Figure 204. An existing non-functional water trough under scores the lack of an available off creek water supply for cattle.

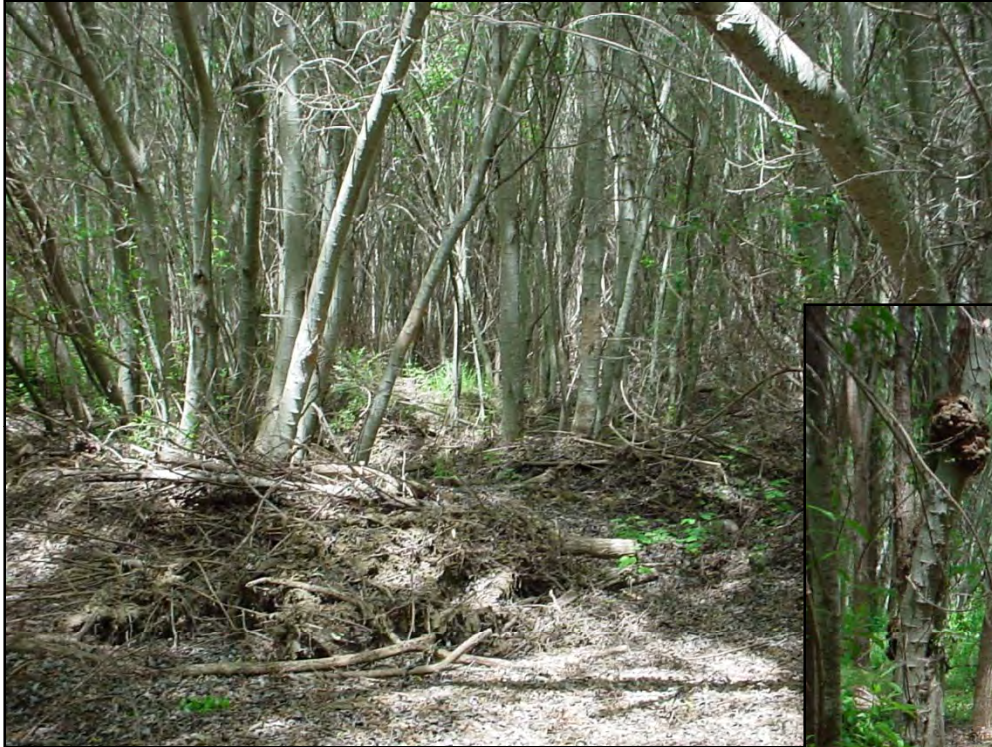
Figure 229. Debris jams and barriers will be removed and dead trees can be thinned to allow light in and encourage understory.

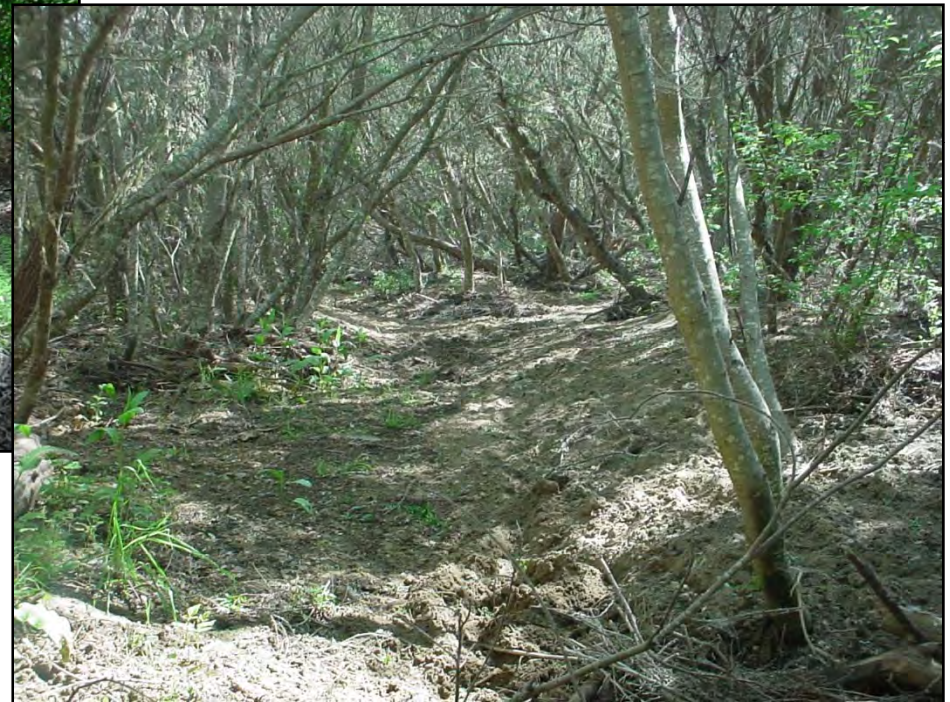
Figure 232. The channel, though clear, did catch a great deal of sediment in the 07-08 rainy season.

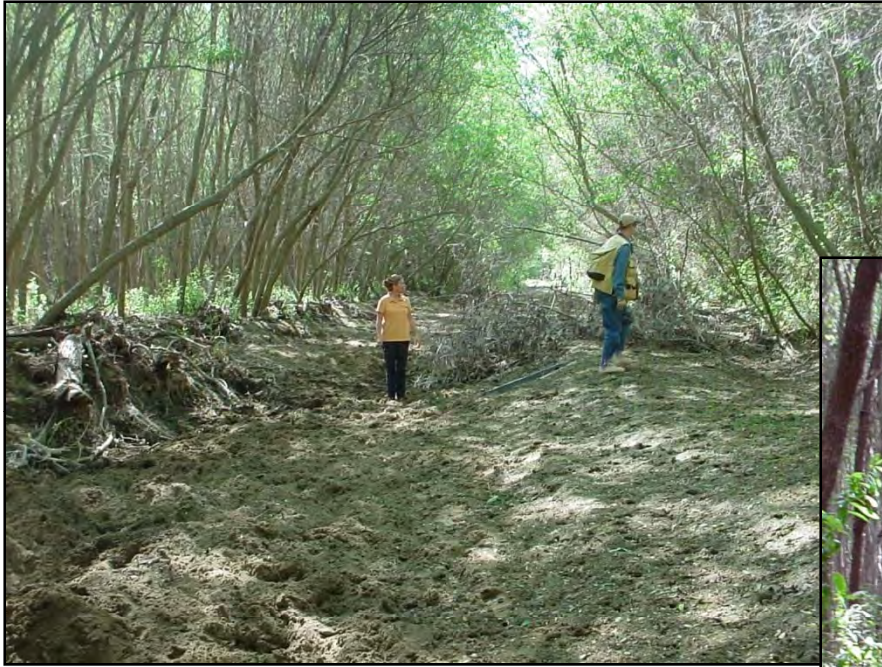
Figure 256. The channel had a larger amount of sediment and debris in 2008.
