Erosion Reduction and Sediment Capture Assessment

For Stenner and Brizzolara Creeks

EROSION REDUCTION AND SEDIMENT CAPTURE ASSESSMENT FOR STENNER AND BRIZZOLARA CREEKS

San Luis Obispo Coastal Resource Conservation District

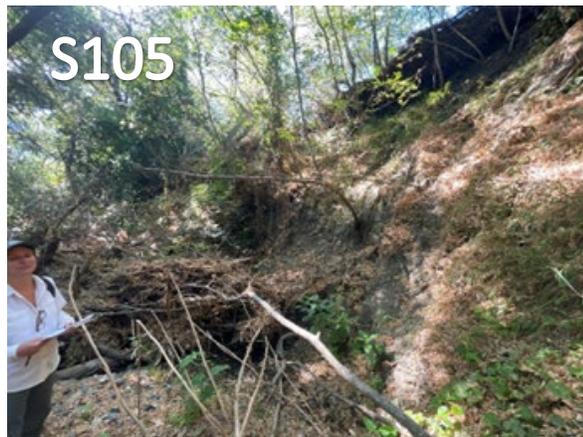
S105 consists of a large unstable bank on the right side of the creek (looking downstream). This reach is within critical steelhead habitat (NMFS 2005) and contains perennial flow conditions across water year types (Bennett 2015; CLC 2020; CLC 2022). The existing bank slope is estimated to be slightly steeper than 1:1. The bank soil is loose, with dry weather sloughing evident during the site visit. The slope is poorly vegetated but located under a more mature tree canopy. This site is chronically eroding, in both dry and wet weather. An orchard road is present at the top of the bank.

The sediment reduction potential from this site is estimated at 500-1,000 CY. The anticipated level of future engineering design and analysis effort is high and is likely to include hydraulic modeling (e.g., HEC-RAS). Repair options for this site include biostabilization and revegetation, laying back the slopes to those observed in other parts of this channel (1:2), and in-channel wood features integrated with habitat enhancement and bank protection. Due to the moderate sediment reduction potential, the threat to infrastructure, and the steelhead habitat enhancement potential, the repair priority is medium.

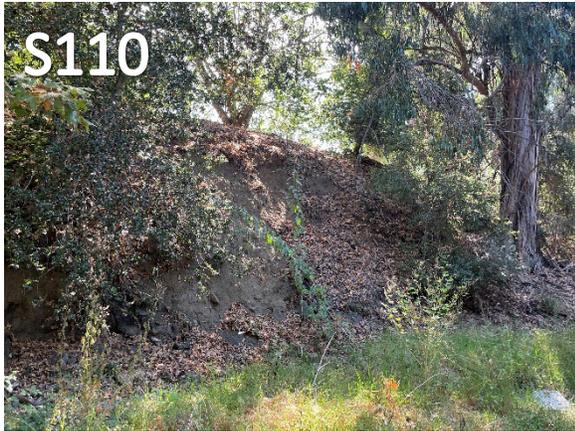
S110. Unstable bank (Mainstem Stenner)

The left bank of the Stenner Creek mainstem features a large unstable section, with a slope slightly less steep than 1:1. The loose soil in this area has poor vegetation establishment beneath the tree canopy, leading to some dry weather raveling and increased susceptibility to erosion during wet weather. The unstable bank is adjacent to a field road, though the road appears to have some protection or buffer room from immediate undermining. Stable banks in the surrounding area tend to have slopes approaching 1:2. The potential

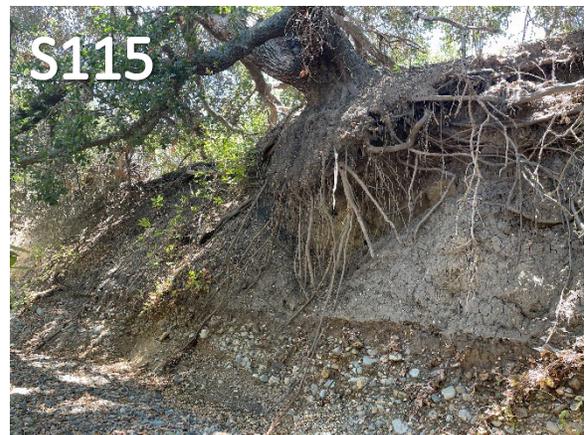
A 260-foot stretch of the right bank of the Stenner Creek mainstem is unstable. The creek is eroding laterally into the right bank, with present slopes of about 1.25:1. The bank consists of exposed bare soil, which sloughs off in dry weather and is probably very erodible by rain splashes and impinging streamflow. The toe of the bank is eroding away in higher flows and undermining a large oak tree that will likely die or fall into the creek and dislodge a large amount of soil. A dirt road runs close to this feature and may be damaged if the oak tree falls or if the bank's slope erodes back to resemble the surrounding slopes (1:1 or 1:1.5). This reach is within critical steelhead habitat (NMFS 2005) and is ephemeral across water

year types (Bennett 2015; CLC 2020; CLC 2022). Habitat enhancement at this site is possible. The anticipated level of future engineering design and analysis effort is high and may include hydraulic modeling (e.g., HEC-RAS). The erosive potential of this site is 500 to 1,000 CY. This site is given a high priority rating due to its higher sediment reduction potential, the threat to infrastructure, and high accessibility rating. Repair and enhancement options include in-channel wood structures in the channel that integrate bank protection and habitat elements, and revegetation are options at this site.

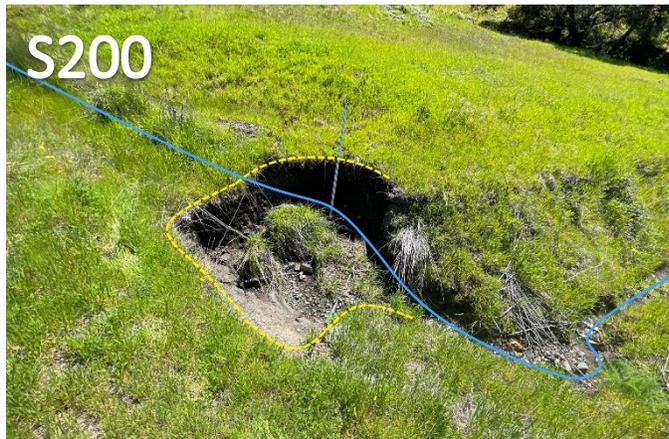
A knickpoint is propagating up a small ephemeral channel that drains along a short path to mainstem Stenner Creek. Photo shows defined headcutting action. There is undermining of the channel at the headward end of the erosion with the banks slumping to a more stable angle in sections where the

knickpoint has already moved through. The knickpoint is poised to erode headward. Starting at 70 feet upslope from the shown headcut, both the channel and hillslopes become steeper. Boulders and weak bedrock are present, but it appears that previous waves of incision have been able to cut through and around them. Small slides on the banks of the channel indicate that the upper areas are still adjusting to previous waves of incision. Sedimental reduction potential is estimated to be between 100 and 500 CY. The anticipated engineering design

and analysis is lower, and all work could be conducted manually by California Conservation Corps (CCC) trained in restoration or equivalent. The recommended fix is a headcut repair (Appendix B: Conceptual Detail B-2 or B-3) and revegetation. Revegetation should be conducted with local native species, and our local CCC team can both develop simple planting plans associated surface or erosion treatments, propagate plants in their nursery if needed, install, and monitor plants. Recommend monitoring until the fix is implemented to track the degree of on-going erosion and monitoring after the fix to ensure hand-placed repairs are functioning as intended. The repair priority is medium.

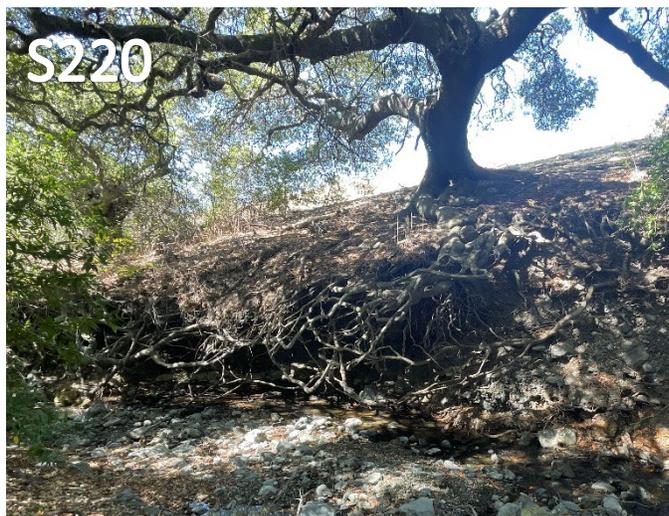
**S220. Widening and Incising Channel (Stage 3) (Mainstem Stenner)**

The channel from the Cal Poly Ranch house (where Stenner Creek Road becomes Poly Canyon Rd) to the gate adjacent to the trailhead includes vertically eroding subreaches, widening subreaches, and stable subreaches (~1,700 ft). As a result, the creek has exposed unstable vertical banks in some locations, which in turn undermines large trees and exposing their root systems (see photo). This reach is within critical steelhead habitat (NMFS 2005) and contains perennial flow conditions across water year types (Bennett 2015; CLC 2020; CLC 2022). The sediment reduction and capture potential at this site is

estimated to be 1,000 to 5,000 CY. This site is assigned a high priority due to the sediment volume and habitat value for steelhead trout. The mature vegetation limits the use of heavy equipment. A restoration engineer with restoration experience utilizing novel methods (e.g., hand placement, high-lining, adaptive restoration strategies) should evaluate this site. The repair and habitat enhancement priority is high.

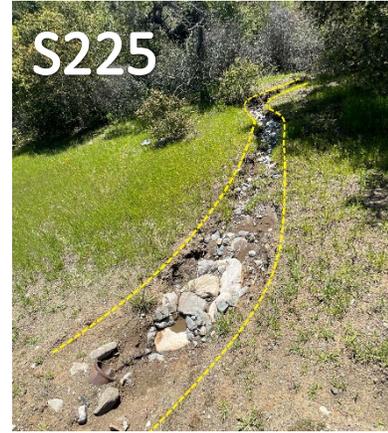
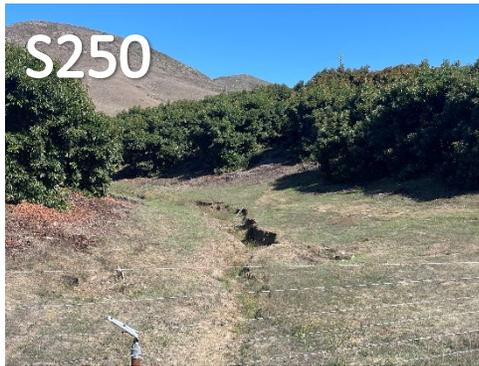
A small gully (photo, right) has formed where Stenner Creek Road runoff discharges through a ditch relief culvert into Stenner Creek. While further incision is possible, coarse rocks are slowing the process. The sediment reduction potential is estimated to be less than 100 CY. Repair includes loose rock check dams (Appendix B: Conceptual Detail B-1) or addition of loose rock. A different treatment may be required as the channel enters mainstem Stenner Creek. The anticipated priority is low. The anticipated engineering design and analysis is lower. All work could be conducted manually by California Conservation Corps (CCC) trained in restoration or equivalent with the supervision of a restoration engineer trained in manual restoration techniques. As with all handwork, monitoring is recommended post-repair. The repair priority is low.

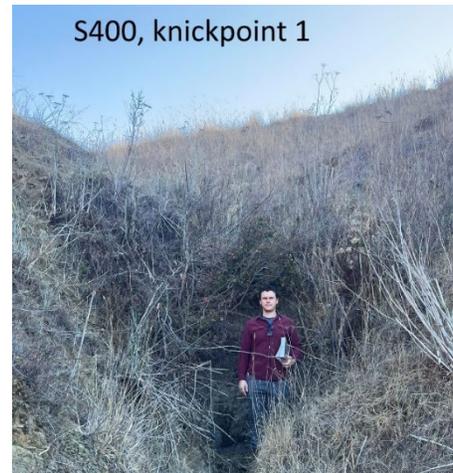
This site features an approximately 1800 ft eroding ephemeral channel with at least six erodible knickpoints, with vertical heights ranging from one to seven feet (see photo). The channel has a history of a series of incision and slumping banks. There is limited and isolated bedrock in slopes which may limit erosion in some locations, but generally, the area has semi-vegetated slopes and significant cow utilization. This site has significant sediment reduction potential from both bed and banks that is estimated to range from 500 to 1,000 CY. A series of loose rock check dams (Appendix B; Conceptual Detail B-1), loose rock or vegetated headcut repairs (Appendix B; Conceptual Details B-2 and B-3), and revegetation are recommended. Revegetation should be conducted with local native species, and our local CCC team can both develop simple planting plan including associated surface or erosion control treatments, propagate plants in their nursery if needed, install and surface treatment or revegetation repair. The anticipated engineering design and analysis is lower. All work could be conducted manually by California Conservation Corps (CCC) trained in restoration or equivalent with the supervision of a restoration engineer trained in manual restoration techniques. The anticipated repair priority is high.

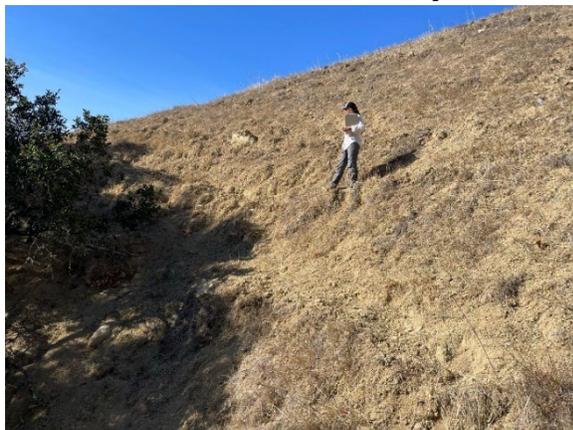
This site features an active slump from channel incision in erosive soils with heavy cattle utilization. The area has highly erosive loose loamy soils, with a large, naturally stabilized (due to boulders and large roots) knickpoint immediately upstream. The vertical incision in the channel at the toe of the slope in the picture appears finished and is now laterally widening. The sediment reduction potential is between 100 and 500 CY. No repair in the channel is recommended due to access limitations but

fencing and surface treatment and/or revegetation are suggested on the slope to arrest chronic unraveling and cow trail erosion. Monitoring the toe of the slump is also recommended. Surface treatment and/or revegetation should be conducted with local native species, and our local CCC team can both develop the approach, propagate plants in their nursery if needed, install and monitor the surface treatment/ revegetation repair. Repair priority is high due to the sediment volume, low-cost fix, and the chronic nature of erosion.

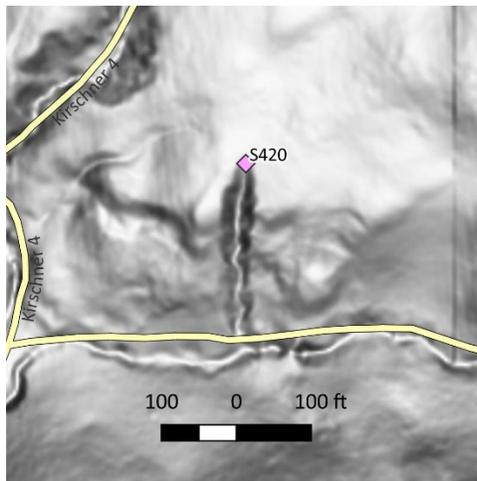
**S420. Gully (Mainstem Kirschner Creek)**

A gully has cut into the left bank of the mainstem of Kirschner Creek, about 200 feet upstream of the confluence of tributary 4 (Figure 5). The gully is 240 feet long and about 40 feet wide on average, with a slope of approximately 27 percent. Historical aerial images from 1937, 1972, and 2005 show that the feature has not expanded significantly over the last 80 years. Recent storms in the beginning of 2023 did not cause a large amount of new erosion in this gully despite being one of the top three wettest years in this watershed since

1870 (Cal Poly 2023), but dry ravel was observed on the sides of the gully in the preceding dry season. Although this feature is relatively stable, long-term monitoring is recommended. This gully is downslope from an area containing ephemeral slope wetlands maintained by groundwater seepage.

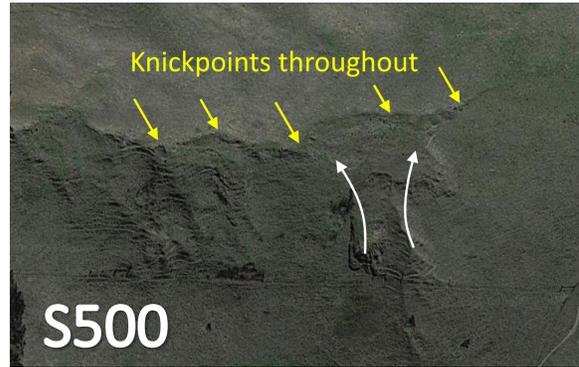
This site is an ephemeral tributary. The channel is actively vertically incising (Stage 2) and beginning to widen in some areas. This an unstable channel that is causing banks to slump and a landslide to form (see photo) delivering sediment directly to the channel. The slumps and landslide will be a chronic sediment source for the foreseeable future. There are approximately five active erodible knickpoints with heights ranging from 1 to 4 feet in height. The site has easy access, and the sediment reduction potential is 1,000 to 5,000 CY. The anticipated level of engineering design and analysis is high for this site due to the presence of the landslide. The repair could include a series of loose rock check dams (Appendix B; Conceptual Detail B-1), loose rock or vegetated headcut repairs (Appendix B; Conceptual Details B-2 and B-3) and building up the bed to stabilize the slumps and slides. The priority for this site is high. Due to the easy access and clear line of this site, this site is ideal for education and developing concept repairs in partnership with Cal Poly Civil Engineering Program.

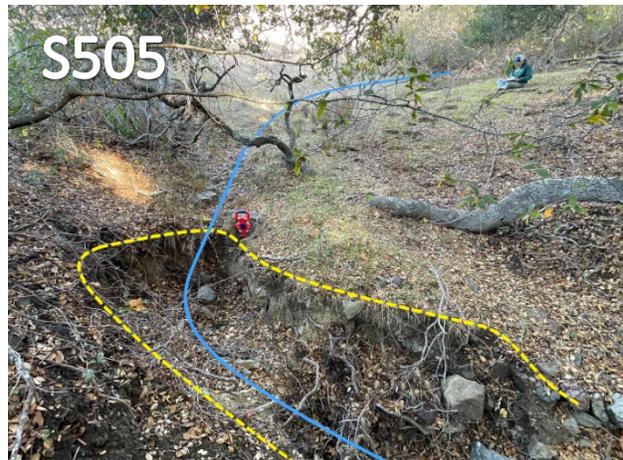
The site features a vertically incising channel with knickpoints, as well as channel widening. Although access for heavy machinery is limited, the site can be accessed utilizing motorized wheelbarrows. A loose rock headcut repair (Appendix B; Detail B-2) of the three-foot high knickpoint (see photo) is recommended. Further migration of the knickpoint is anticipated to generate between 100 and 500 CY. The anticipated engineering design and analysis is lower. All work could be conducted manually by California Conservation Corps (CCC) trained in restoration or equivalent with the supervision of a restoration engineer trained in manual restoration techniques.

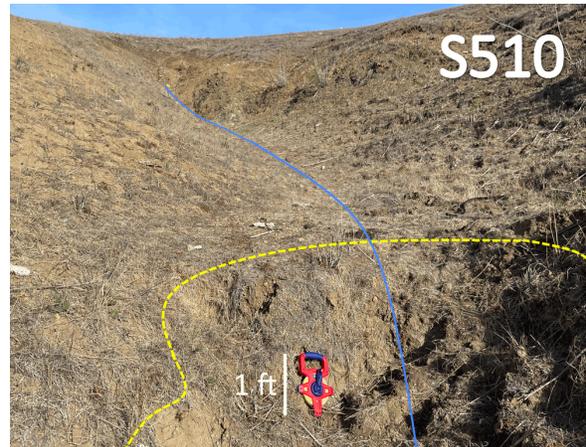
This gully is 150 feet long and extends up from where Peterson Ranch Road crosses tributary 5. It is a well-developed gully, but there is a headcut starting near the road that could propagate up the gully. The sediment would spill onto the road and then into the stream. This site is considered a low priority but has an easy fix. The recommended approach is a loose rock headcut repair (Appendix B; Conceptual Detail B-2). The anticipated engineering design and analysis is lower, and all work could be conducted manually by California Conservation Corps (CCC) trained in restoration or equivalent. Monitoring is suggested to track the site's progress and condition. The area in and around the gully would also benefit from some revegetation to reduce dry ravel erosion.

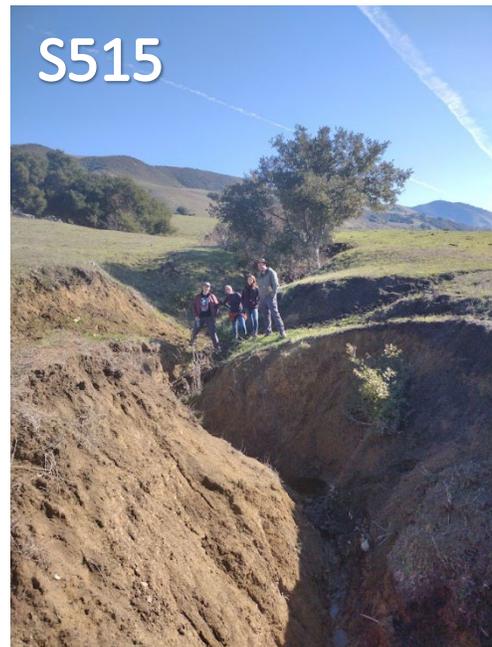
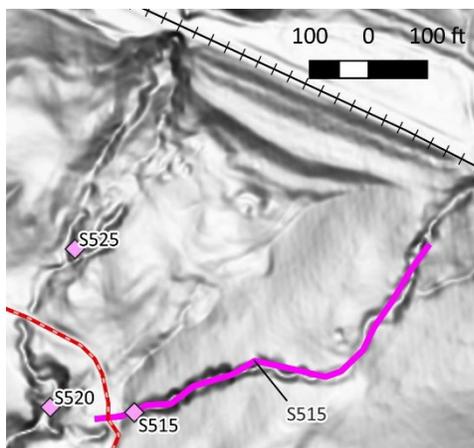
**S515: Incising Ephemeral Channel (Stage 2) (Tributary 4)**

This site should be approached on a reach scale, as it consists of several actively incising knickpoints along 700 feet, up to the railroad track. This site begins upstream of site S520, where Peterson Ranch Road crosses over the channel. There are approximately 10 knickpoints ranging from 1 to 10 feet in height. There is sporadic mature vegetation slowing erosion in some areas, but throughout the channel there is active toe scour undercutting the banks and roots, leading to instability and slumping. The estimated sediment reduction potential is between 1,000 and 5,000 CY. Repairs could include grading the banks to create an inset floodplain, check dams, or wood structures

in the channel to aggrade the bed. Mobilization to the site would not be very difficult because of its proximity to the road and relatively gentle slopes surrounding the channel. The priority for this site is high because it has a large sediment production potential. This site could benefit from a combination of heavy machinery work with hand work. The anticipated level of engineering design and analysis is high for this site.

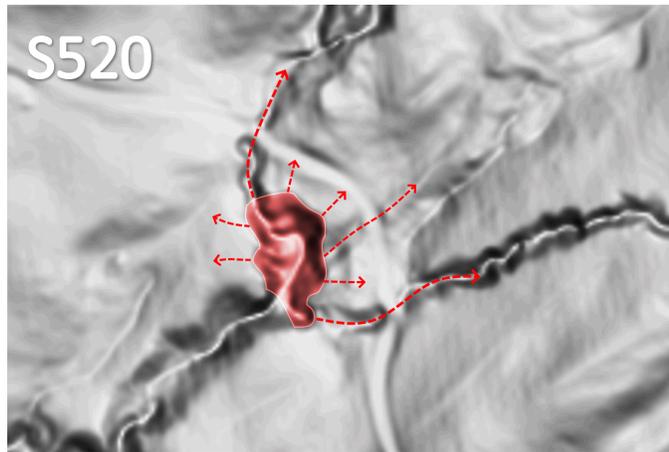
This site is incising and widening, resulting in a bowl-shaped feature. The feature is located on the east fork of tributary 4, where its two branches meet. Incision has been migrating up the east fork of tributary 4 for some time, incising the channel and laying back the bank slopes. The bank slopes in this area are unstable and may expand at the margins toward the road. The road provides easy access to the site, but the steepness and depth of the feature might make in-channel work challenging. A perennial spring along this tributary keeps this site wet year-round.

This feature is a high-priority and has a sediment reduction potential from 1,000 to 5,000 CY.

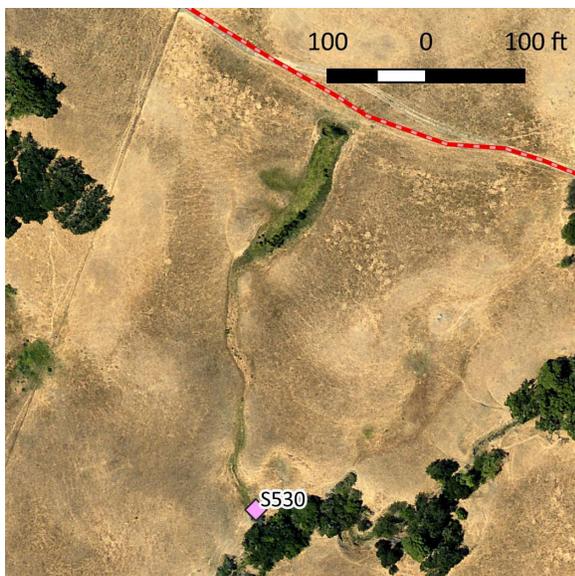
S530: Gully Initiation into High Value Wetlands (Tributary 4)

There is a persistent slope wetland adjacent to Peterson Ranch Road that drains into tributary 4. The swale that drains this feature is shallow, wide, and well vegetated with grass. There are two knickpoints where this swale meets the tributary. The knickpoints are also influenced by a cattle trail that crosses the swale, which may contribute to the rate of erosion. Continued knickpoint migration is anticipated to form a gully up the swale and into the wetland, causing the wetland to drain more quickly, erode, or dry out. Stabilizing the knickpoint is important for preserving this wetland. Perennial springs keep this site wet year-round. This site could be repaired with handwork using loose rock and/or vegetated headcut repairs (Appendix B; Conceptual Details B-2 and B-3). Cattle fencing should also be

processes in the swale. The potential sediment reduction at this site is between 100 and 500 CY. The sediment reduction potential and habitat value of the site make this a high repair priority.

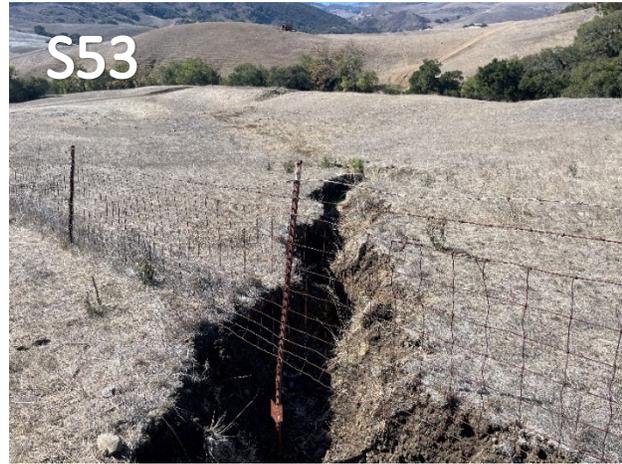
The site features a gully that runs up into the railroad track fill. It was already present as early as August 2010. It significantly expanded between April 2015 and June 2017, likely during the winter of 2016-2017. The gully is 300 feet long and ends in a shallow depression that drains toward the west fork of tributary 4. The banks of the gully are nearly vertical and are expected to widen and lay back, which will produce more sediment. This gully seems to have initiated upslope at the railroad tracks and expanded downhill, unlike other gullies and knickpoints observed in the watershed.

The solution, besides controlling the runoff patterns on railroad property is the construction of a series of loose rock check dams (Appendix B; Conceptual Detail C-1). The total sediment reduction from reducing gully expansion would range from 100 to 150 CY, and the sediment capture potential behind the check dams could be between 10 to 100 CY.

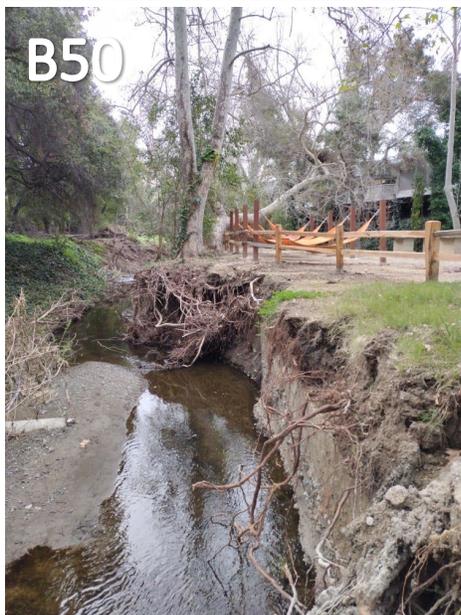
B50: Incising and Widening Channel (Stage 2/3) (Mainstem Brizzolara)

This site is a reach of mainstem Brizzolara Creek that starts at the confluence with Stenner Creek and extends to Highland Ave (~1,500 feet). This reach is within critical steelhead habitat (NMFS 2005) and is hypothesized to contain perennial flow conditions across water year types. Flow mapping by Creek Lands Conservation to determine dry season flow conditions is in progress. This reach is still both vertically incising (Stage 2) and widening (Stage 3). Downstream of Cal Poly land the reach becomes significantly confined by housing infrastructure. This reach presents an opportunity to slow or arrest channel incision, manage channel widening patterns, and develop in-channel habitat features that capture sediment. The sediment reduction and capture potential are estimated at 1,000 to 5,000 CY. The anticipated level of future engineering design and analysis effort is high and is likely to include hydraulic modeling (e.g., HEC-RAS). We recommend that this site is combined with

adjacent sites (e.g., S100 and S105) when funding for design is sought. Repair and enhancement options include natural channel reconstruction that integrates habitat and sediment capture elements (e.g., log weirs). The repair priority is high due to the sediment reduction and capture potential combined with the steelhead habitat enhancement potential.

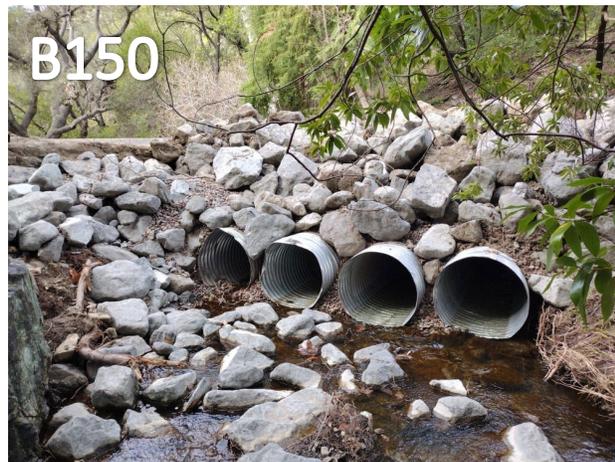
Upstream of the culverts a series of newly formed knickpoints were observed in the spring of 2023. Because this site is the downstream most of all rangeland sites identified by both PWA (2022) and CLC (this report), stabilizing the knickpoints at this site is a very high priority rating to prevent knickpoint retreat upstream which would exacerbate existing upstream erosion and incision. This reach is within critical steelhead habitat (NMFS 2005) and is hypothesized to contain perennial flow conditions across water year types. Flow mapping by Creek Lands Conservation to determine dry season flow conditions is in progress. In addition to any culvert and grade control repairs that may be recommended by PWA in the vicinity of the road crossing, the channel upstream of the road crossing for at least 300 feet should be evaluated for knickpoint stabilization and habitat enhancement potential. Because the knickpoints have the potential to travel upstream and cause a new wave of upstream incision, the sediment reduction potential is estimated as 1,000 to 5,000 CY. The repair priority is high.

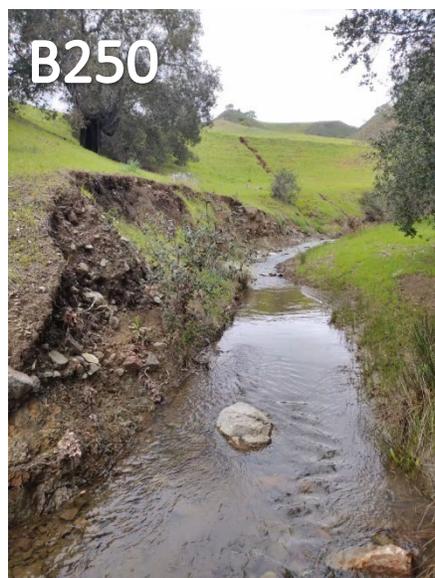
**B250: Incising and Widening Channel (Stage 2/3) (Mainstem Brizzolara)**

This site is an incising and widening (Stage 2/3) reach with an unstable bank, a small gully, and the potential for habitat enhancement. This reach is within critical steelhead habitat (NMFS 2005) and could be perennial in some water year types. Flow mapping by Creek Lands Conservation to determine dry season flow conditions is in progress. The sediment reduction and capture potential are estimated at 500 to 1,000 CY. The anticipated level of future engineering design and analysis effort is moderate and will include hydraulic analysis. This reach presents an opportunity to slow or arrest channel incision, manage bank erosion patterns, and develop in-channel habitat features that capture sediment utilizing California Conservation Corps (CCC) trained in restoration or equivalent, with the supervision of a restoration engineer trained in manual restoration techniques. All hand repair sites are recommended for monitoring before and after the fix is implemented. The pre-repair monitoring is to track the erosional process to inform

repair and monitoring after the fix to ensure hand-placed repairs are functioning as intended, and to allow for adaptive management of repair elements.

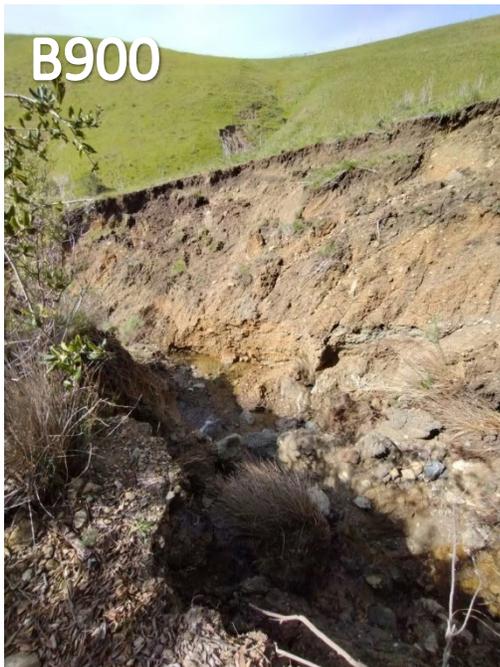
B900: Incising Ephemeral Channel (Stage 2)

This site is approximately 1,000 feet of massively incising ephemeral channel with knickpoints, unstable banks, and gullies, many downstream of the road crossing. The largest knickpoint is about 8 feet high and 100 feet downstream of the road crossing. This knickpoint poses a significant risk to the road. The sediment reduction potential is estimated at 1,000 and 5,000 CY. The anticipated level of future engineering design and analysis effort is high and could include adding roughness elements to slow erosion and capture sediment, in-channel check dams and headcut repairs, among others. Along sections that have lost mature riparian vegetation, revegetation with local native species is recommended. Our local CCC team can both develop a simple planting plan including associated surface and erosion control treatments, propagate plants in their nursery if needed, and install plants. This site could benefit from a combination of heavy machinery work with hand work.
