ATTACHMENT F

Los Osos Creek Vegetation Management and Debris Removal PC-01-01

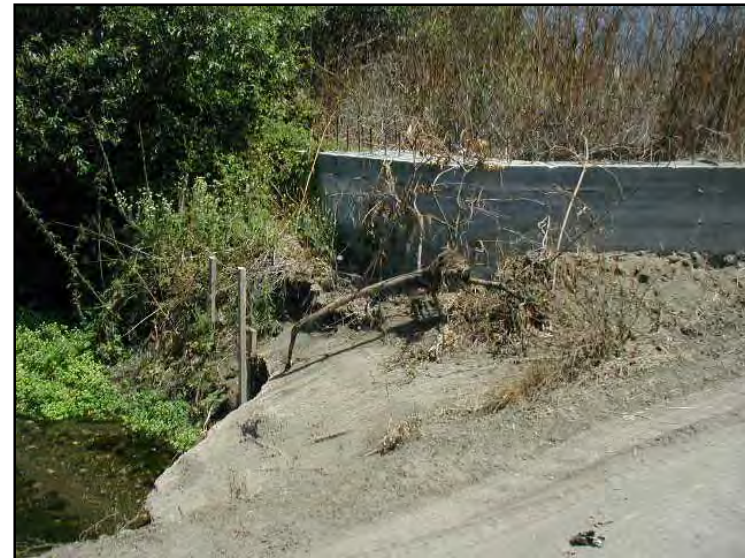
Figure 37. View of failing Arizona crossing.

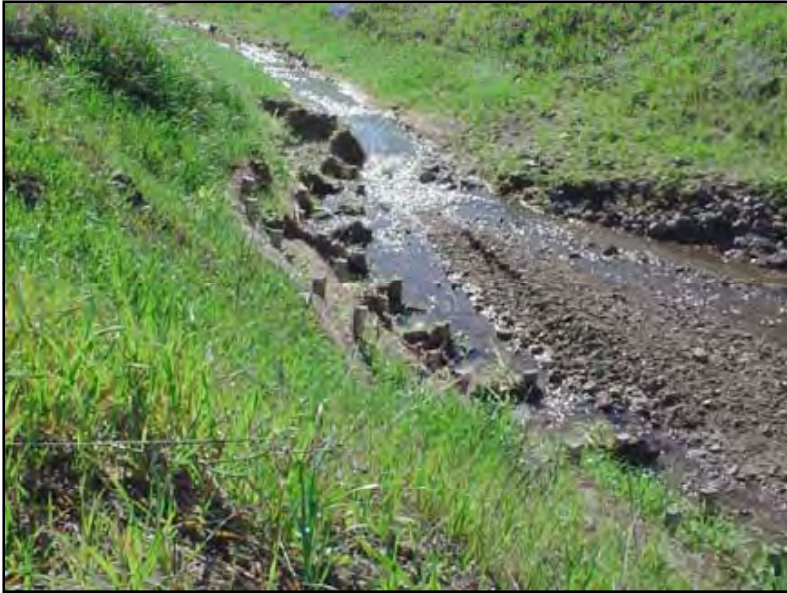
Figure 54. Grasses on bank behind coir logs.

Post Completed project: This project had some success and some failure as can be seen above.

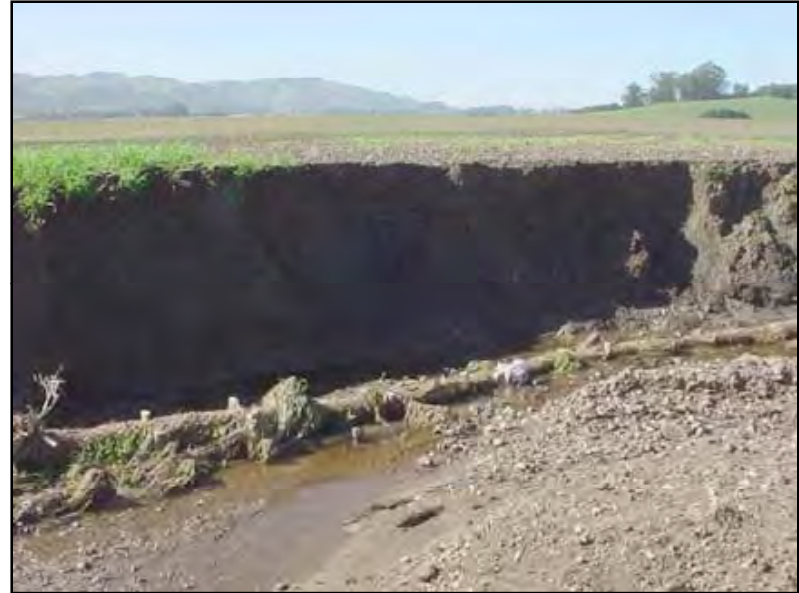
Figure 55. Bank erosion behind anchored coir logs.

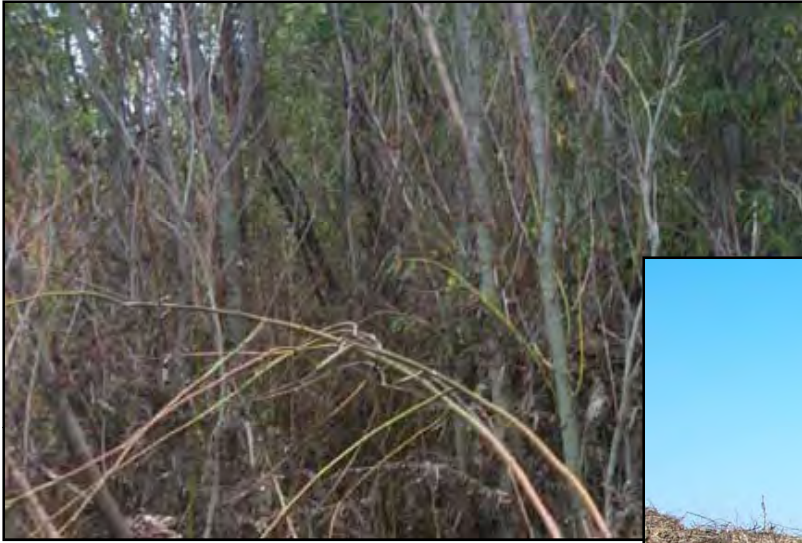
Figure 80. Small Willow growing so close that all of the middle portion are dead trees. Debris was found 10 feet high in the trees.

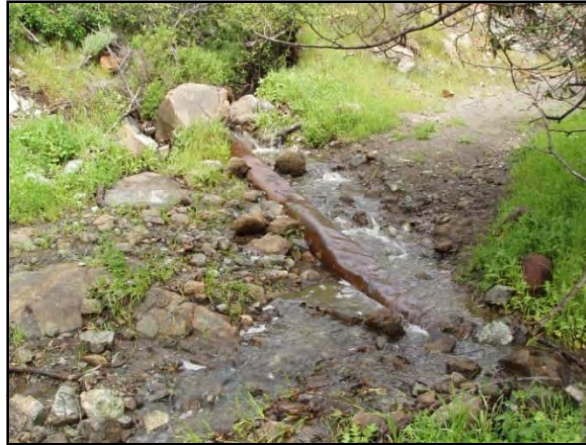
Figure 101. Failed culvert was replaced

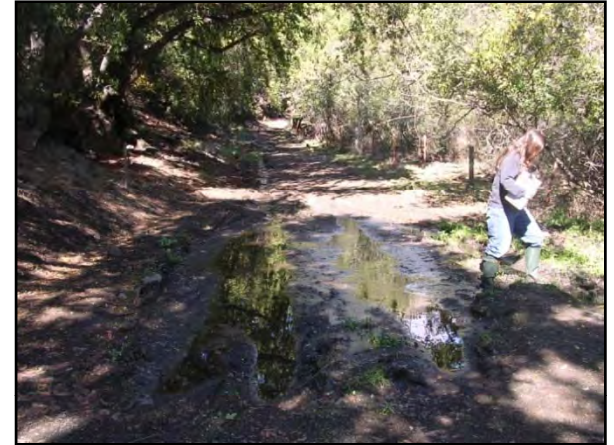
Figure 102. View of a seep in the road.

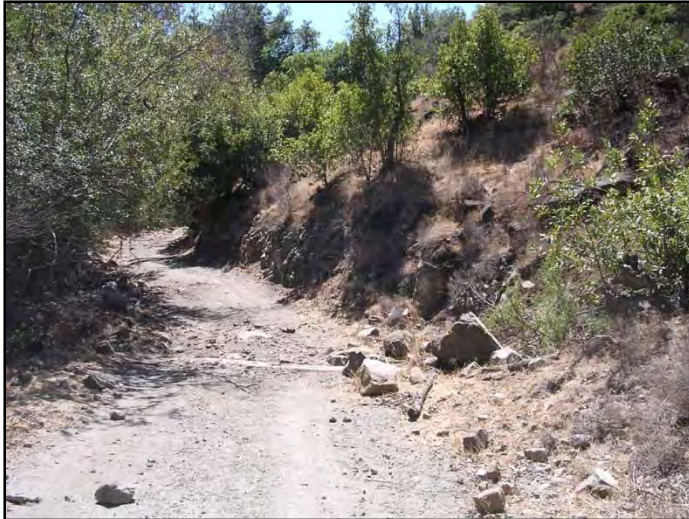
Figure 106 & 107. Views of clogged culvert before it was replaced

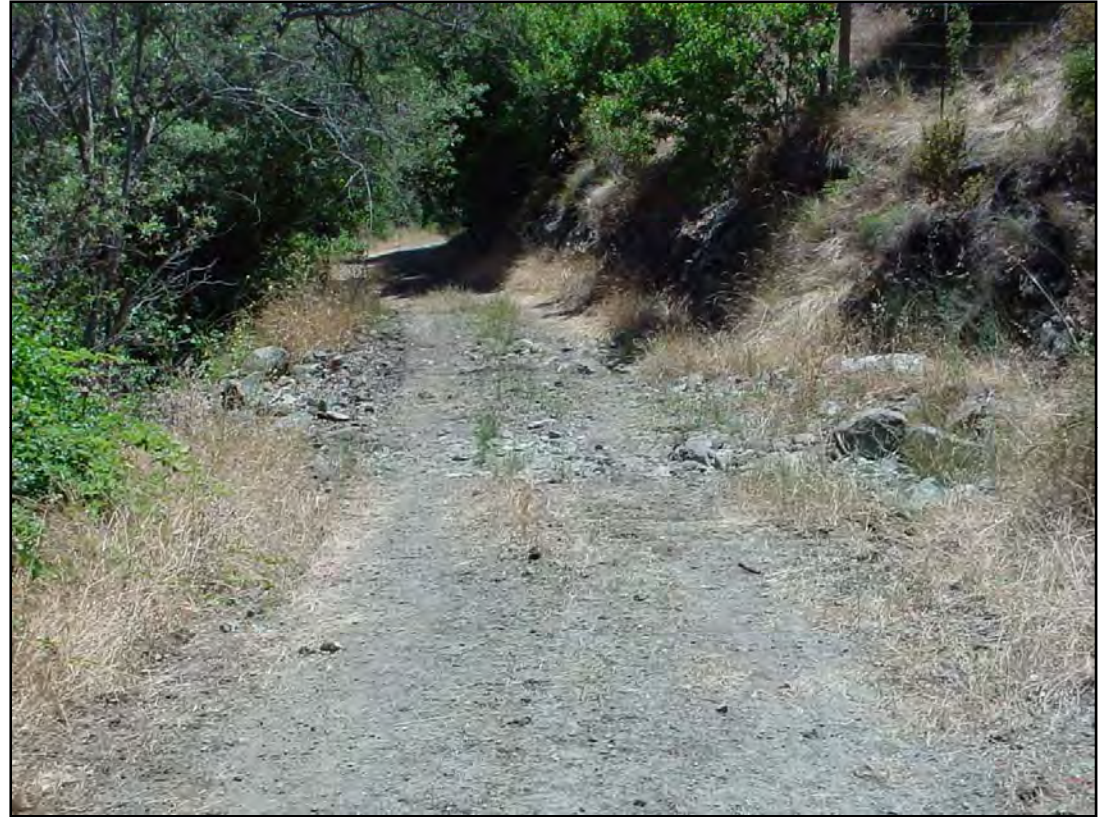
Figure 108. View of culvert after it was replaced with armored crossing.

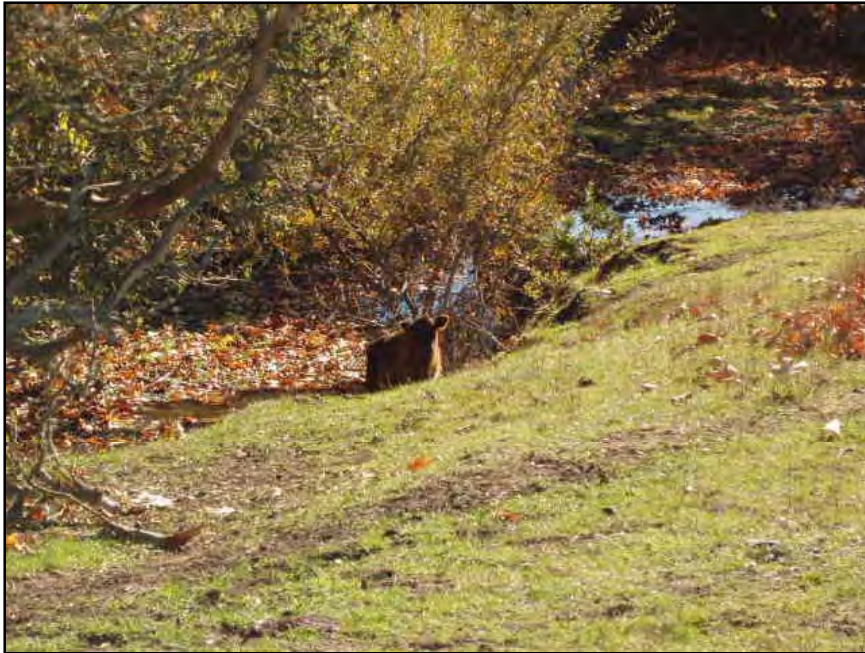
Figure 109. Cattle in creek

Resource concern: impaired water quality and riparian vegetation due to cattle in creek; water quality parameters of concern include pathogens.

Solution: Develop a Comprehensive Conservation Plan that includes riparian fencing and an off-creek watering system for cattle.

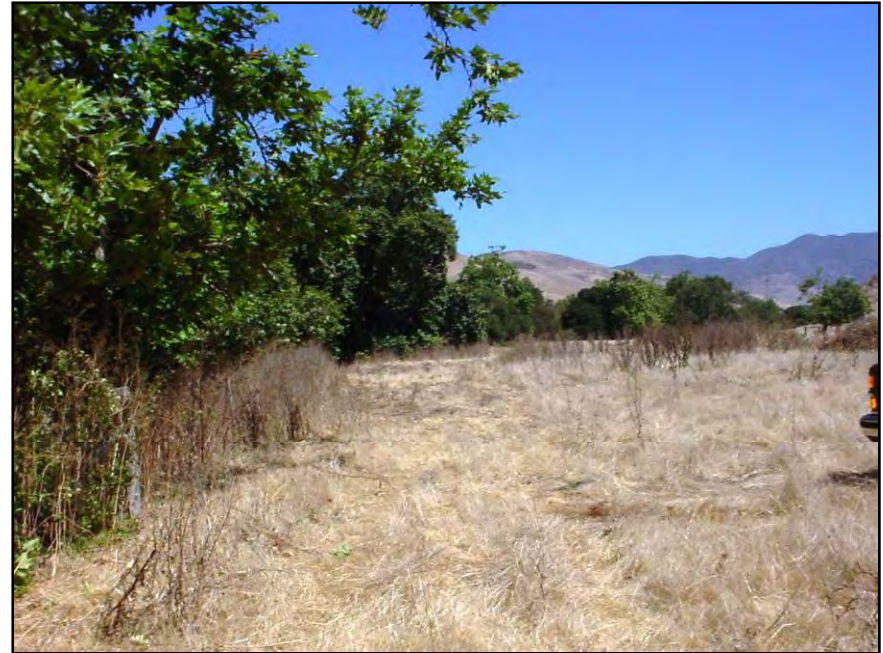
Figure 110. No fence or barrier to cattle access to creek.

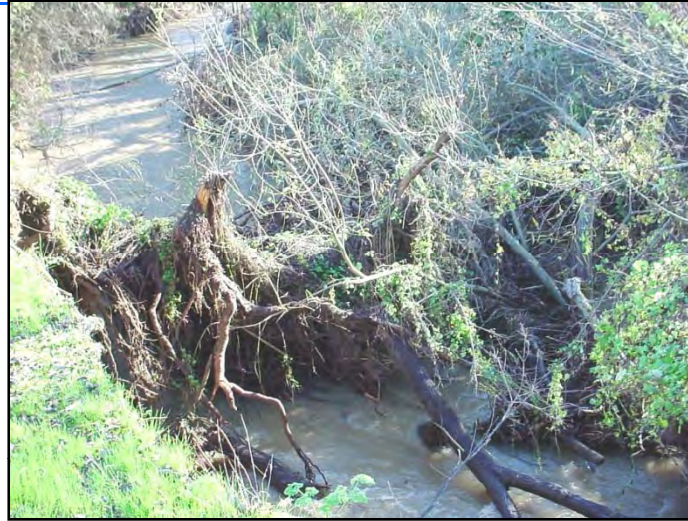
Figure 126 This is the kind of damage downed trees can cause in a high flow storm.

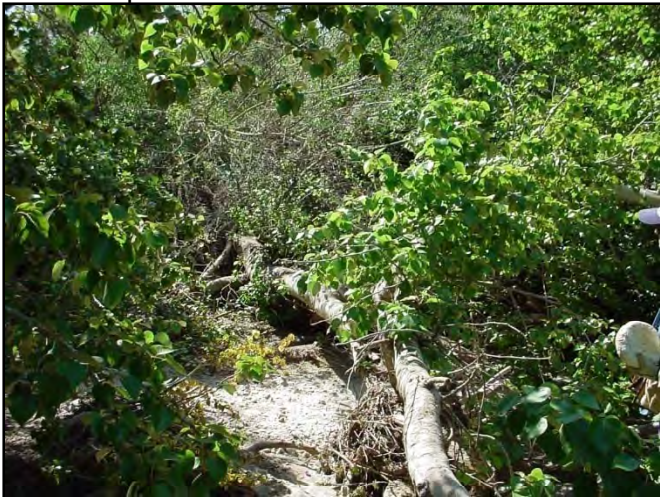
Figure 127. Downed cottonwoods need to be bucked up and removed before storm season.

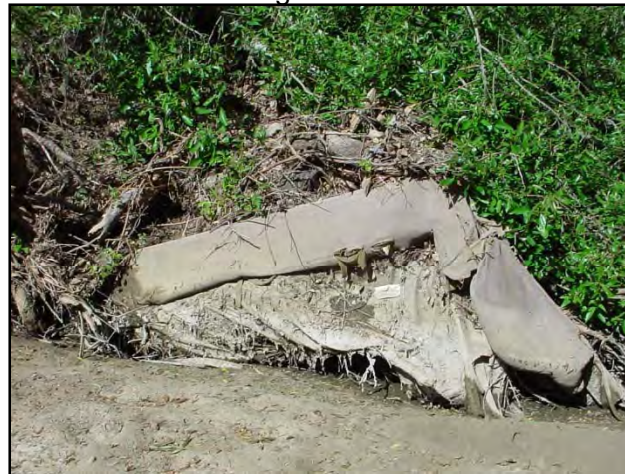
Figure 128 Broken limbs and downed trees often catch large trash debris (part of a sofa).

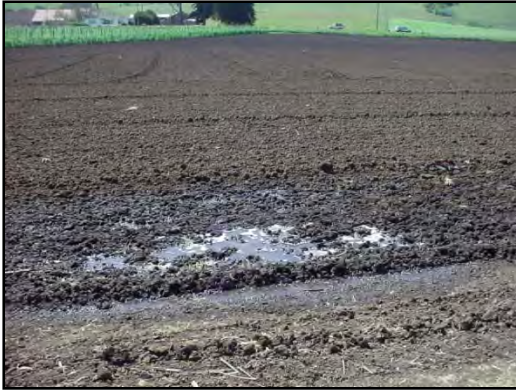
Figure 134. Leaky pipeline.

Project: Replaced 1,200 feet of leaky 6" pipe with a new 8" line.

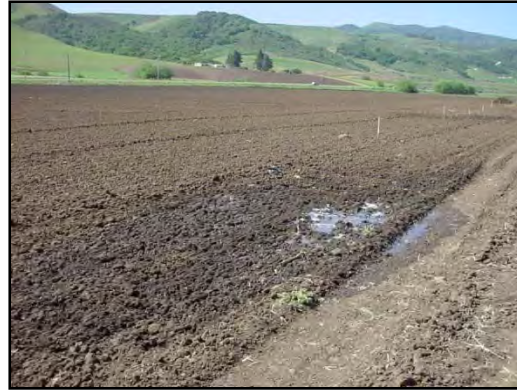
Figure 135. Leaky pipeline.
