MORRO BAY WATERSHED STEELHEAD RESTORATION PLANNING PROJECT

STREAM INVENTORY REPORT

CHORRO CREEK, 2001

Prepared to:
Coastal San Luis Resource Conservation District

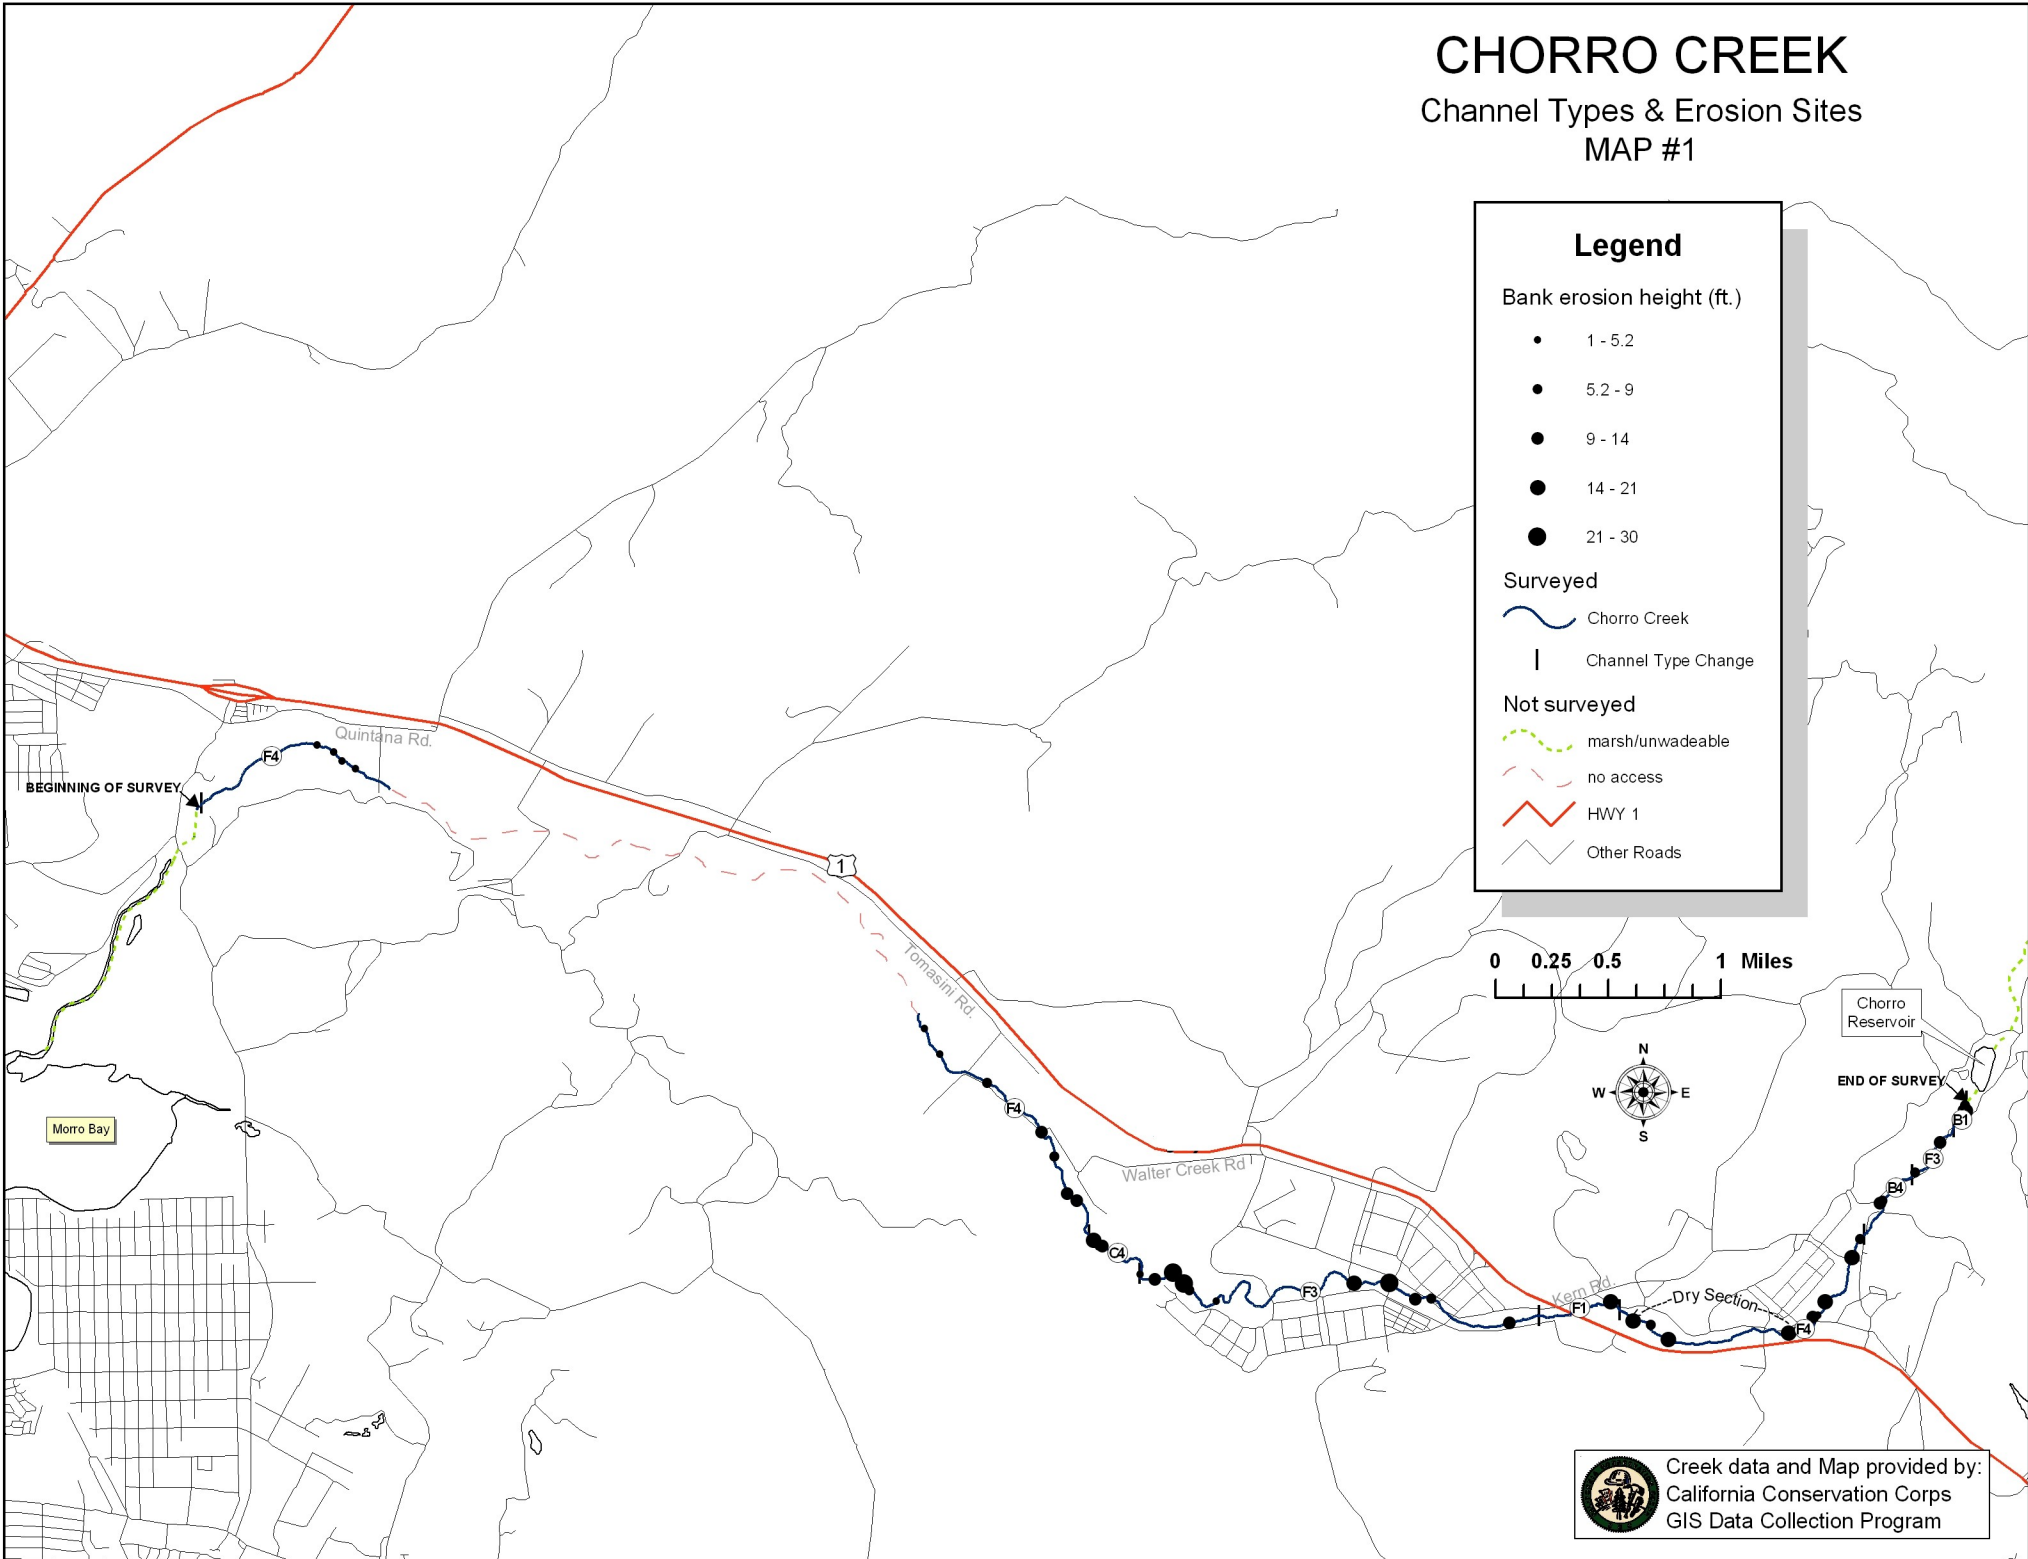
Channel Types & Erosion Sites MAP #1

For the stream length surveyed, the mean percent right bank vegetated was 35%. The mean percent left bank vegetated was 34%. The dominant elements composing the structure of the stream banks consisted of 12% bedrock, 3% boulder, 16% cobble/gravel, and 68% sand/silt/clay (Graph 10). Deciduous trees were the dominant vegetation type observed in 66% of the units surveyed. Additionally, 17% of the units surveyed had brush as the dominant vegetation type, and 15% had grass as the dominant vegetation (Graph 11). Areas of eroded banks along Chorro Creek were mapped using a global positioning device and are shown on Map 1.

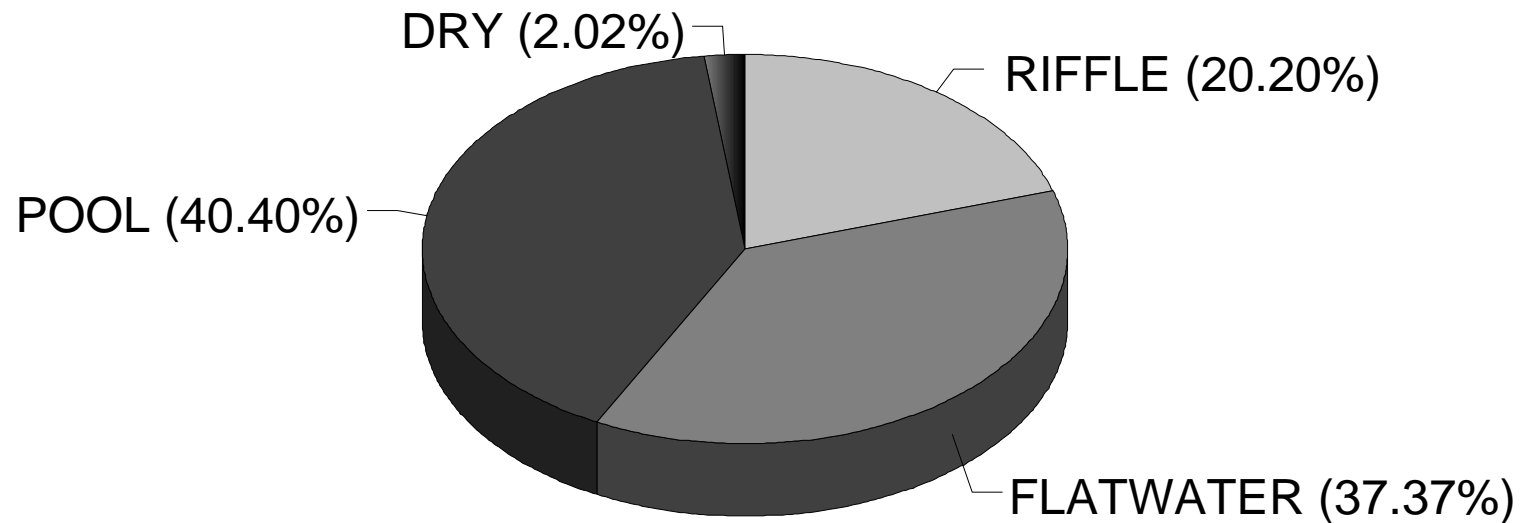
GRAPH 1

Table 1 summarizes the Level II riffle, flatwater, and pool habitat types. Based on frequency of occurrence there were 20% riffle units, 37% flatwater units, and 40% pool units (Graph 1). Based on total length of Level II habitat types there were 14% riffles, 43% flatwater units, and 33% pools (Graph 2).

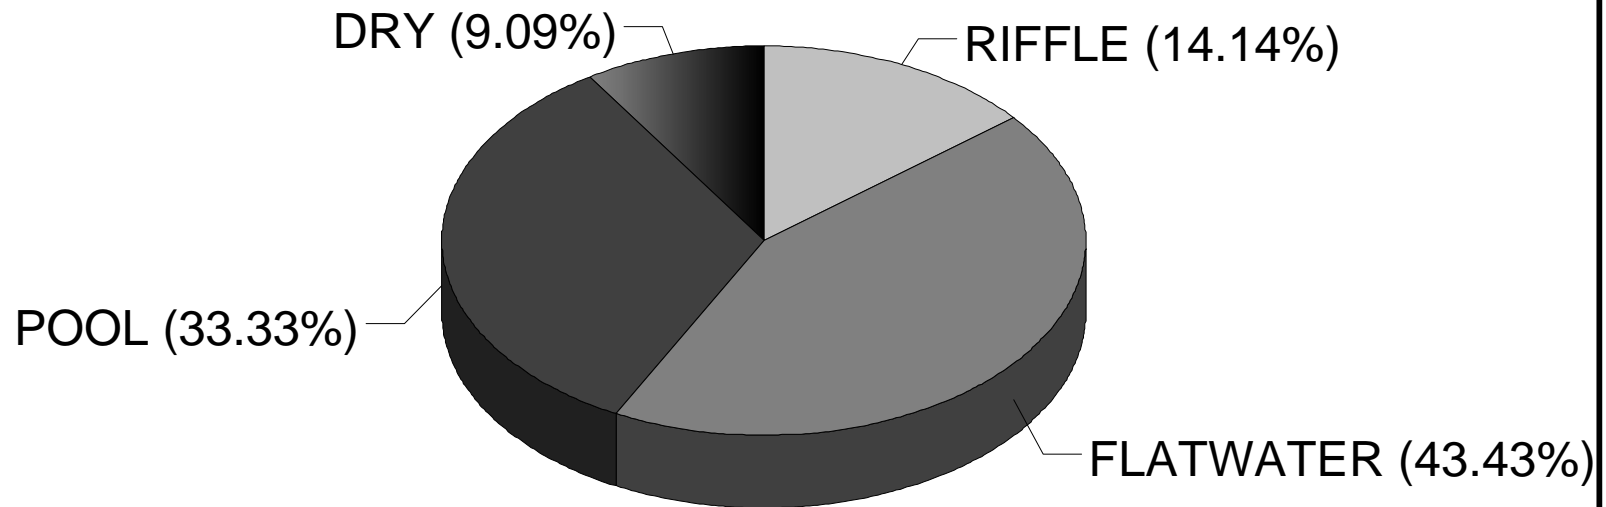
GRAPH 2

Flatwater habitat types comprised 43% of the total length of this survey, riffles 14%, and pools 33%. The pools are relatively deep, with 129 of the 241 pools (54%) pools having a maximum depth greater than 2 feet. In general, pool enhancement projects are considered when primary pools comprise less than 40% of the length of total stream habitat. In first and second order streams, a primary pool is defined to have a maximum depth of at least two feet, occupy at least half the width of the low flow channel, and be as long as the low flow channel width. Installing structures that will increase or deepen pool habitat is recommended in the B4 channel type.

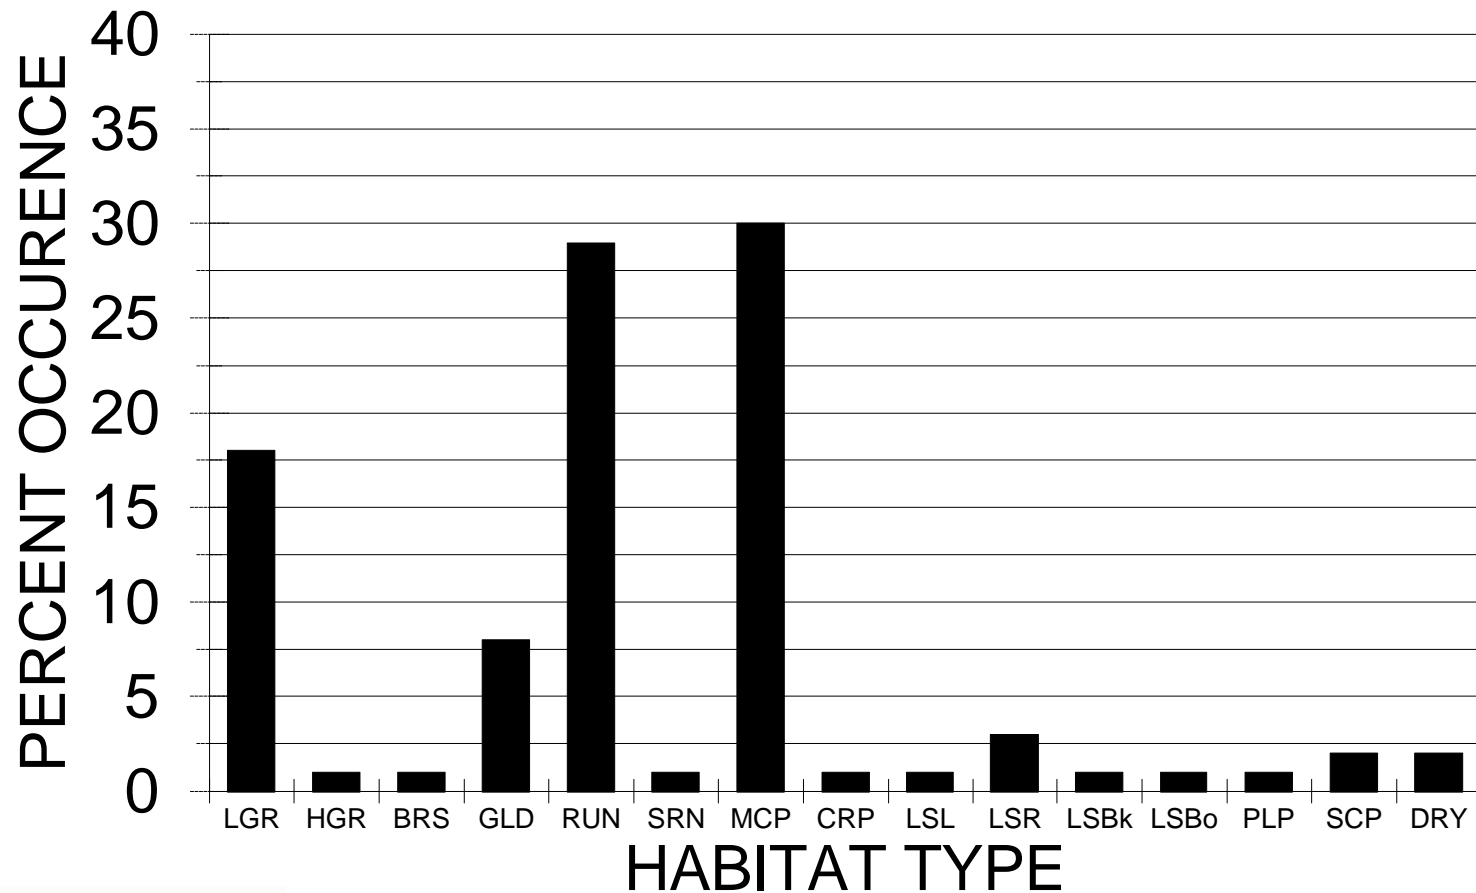
GRAPH 3

Fifteen Level IV habitat types were identified (Table 2). The most frequent habitat types by percent occurrence were mid-channel pool units, 30%; run units, 29%; and low gradient riffle units, 18% (Graph 3). Based on percent total length, run units made up 20%, mid-channel pool units 17%, and glide units 8%.

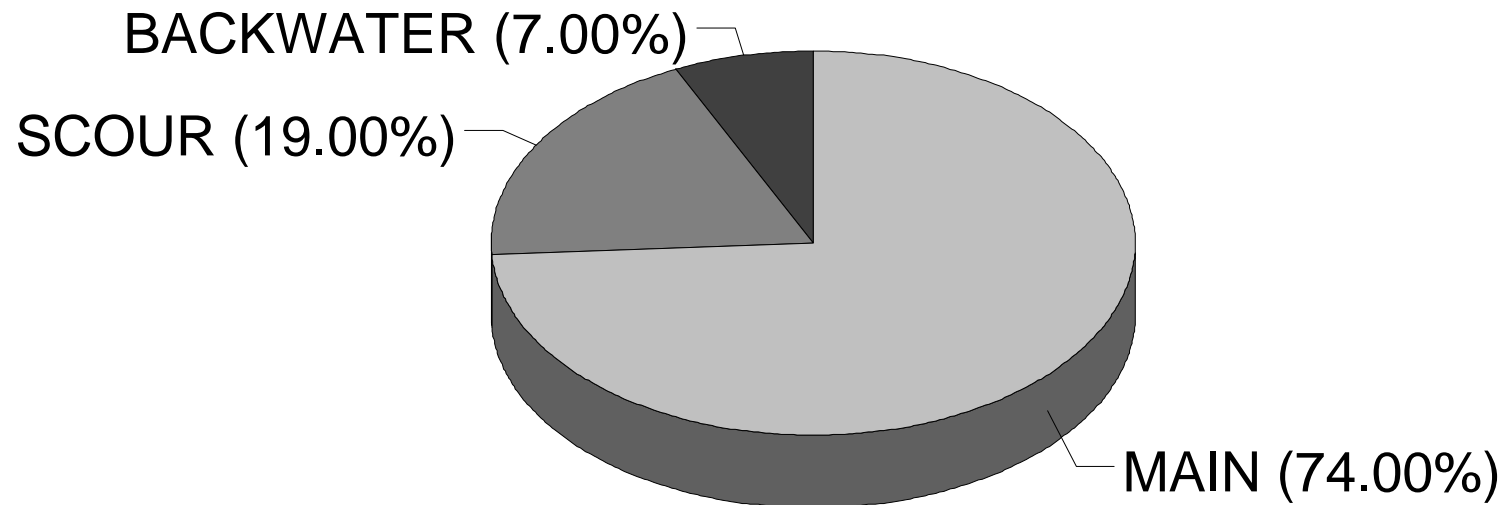
GRAPH 4

A total of 241 pools were identified (Table 3). Main-channel pools were most frequently encountered at 74% and comprised 82% of the total length of all pools (Graph 4).

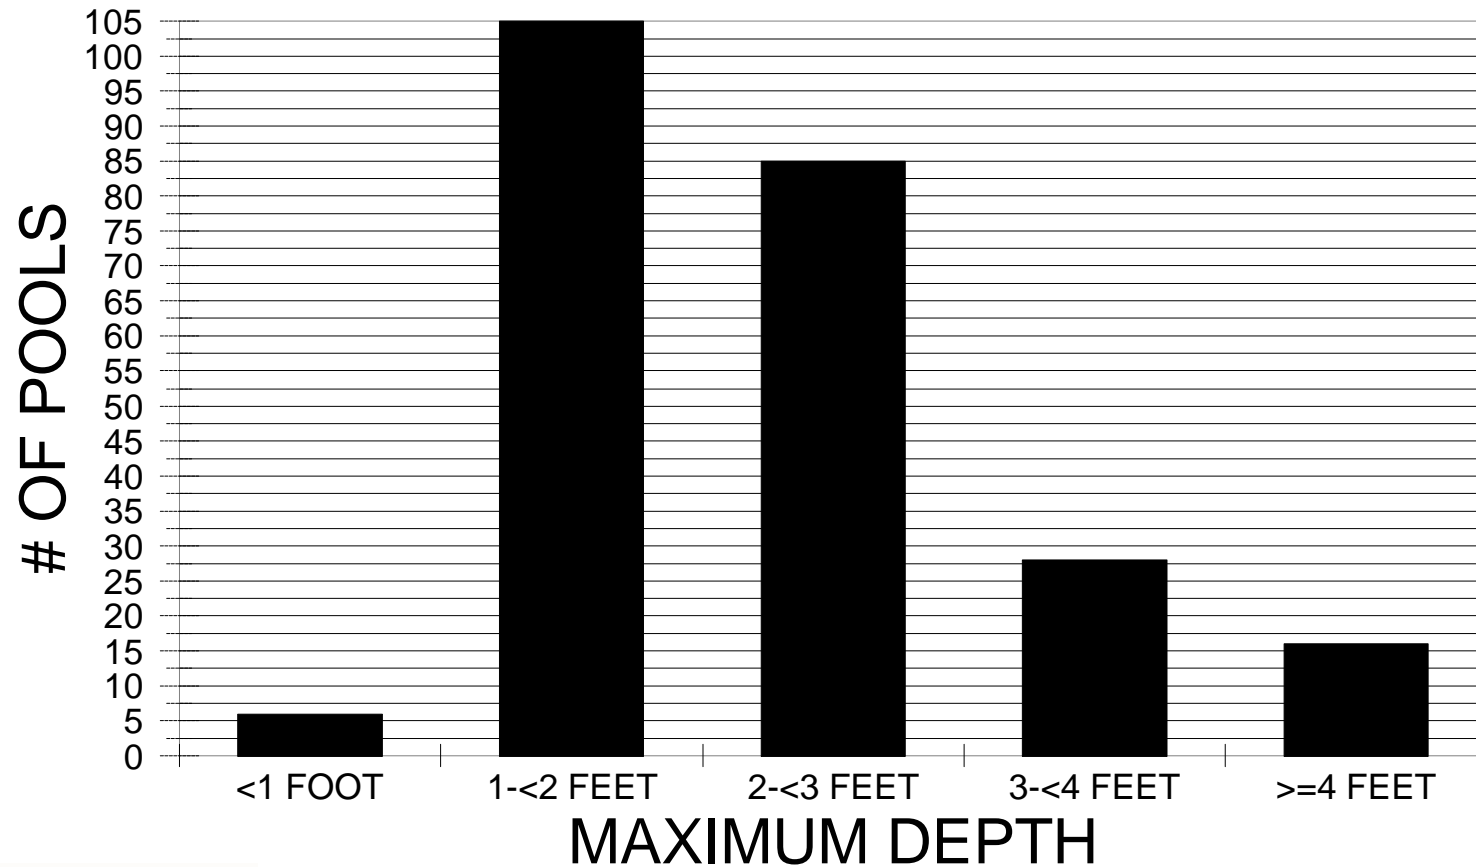
GRAPH 5

Table 4 is a summary of maximum pool depths by pool habitat types. Pool quality for salmonids increases with depth. One hundred and twenty-nine of the 241 pools (54%) had a depth of two feet or greater (Graph 5).

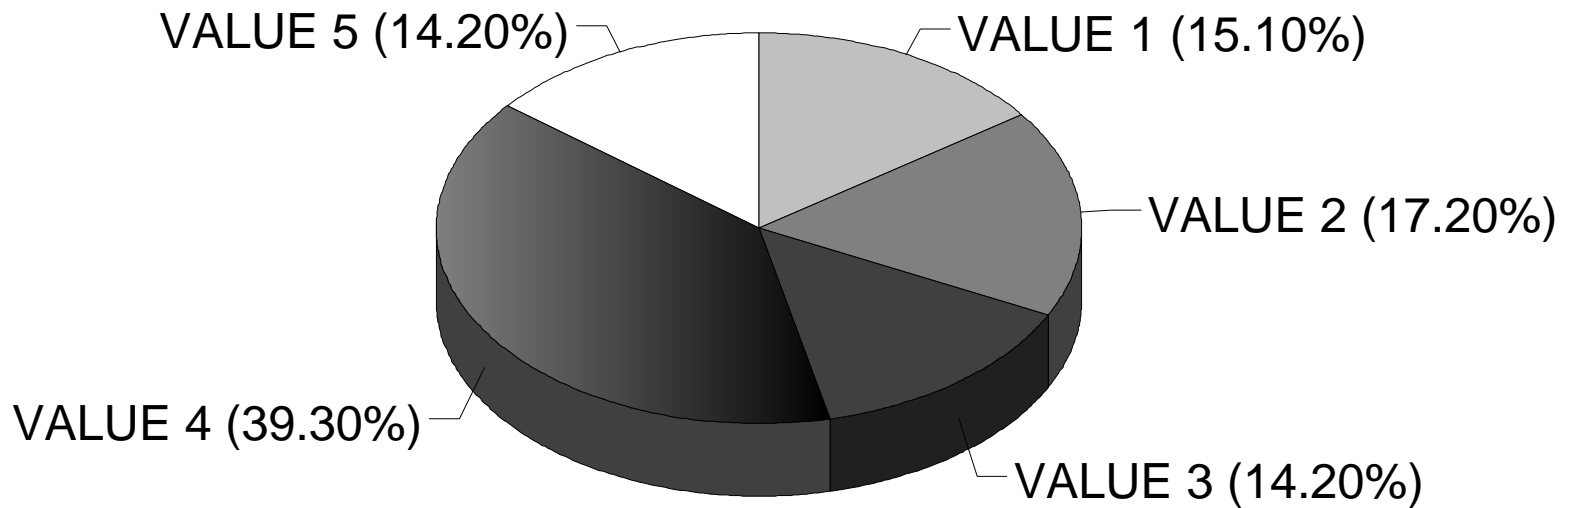
GRAPH 6

The depth of cobble embeddedness was estimated at pool tail-outs. Of the 239 pool tail-outs measured, 36 had a value of 1 (15%); 41 had a value of 2 (17%); 35 had a value of 3 (14%); 94 had a value of 4 (39%) and 33 had a value of 5 (14%) (Graph 6). On this scale, a value of 1 indicates the highest quality of spawning substrate and a value of 5 indicates the tail-out is not suitable for spawning. In Chorro Creek, five of the 241 pool tail-outs which were valued at 5 had silt/clay/sand or gravel too small to be suitable for spawning as the substrate. The other 28 tail-outs, valued at 5, were unsuitable for spawning due to the tail-outs being comprised of large cobble, boulder, bedrock or wood.

Thirty-six of the 239 pool tail-outs measured had an embeddedness rating of 1. Forty-one of the pool tail-outs had embeddedness rating of 2, and 129 pool tail-outs had ratings of 3 or 4. Thirty-three of the pool tail-outs had a rating of 5 or were considered unsuitable for spawning. Five of the 239 were unsuitable for spawning due to the dominant substrate being silt/sand/clay or gravel. Cobble embeddedness measured to be 25% or less, a rating of 1, is considered to indicate good quality spawning substrate for salmon and steelhead. In Chorro Creek, sediment sources should be mapped and rated according to their potential sediment yields, and control measures should be taken. An effort to map sediment sources is currently underway by the Morro Bay National Estuary Program.

- 4) Inventory and map sources of stream bank erosion and prioritize them according to present and potential sediment yield. Identified sites should then be treated to reduce the amount of fine sediments entering the stream.

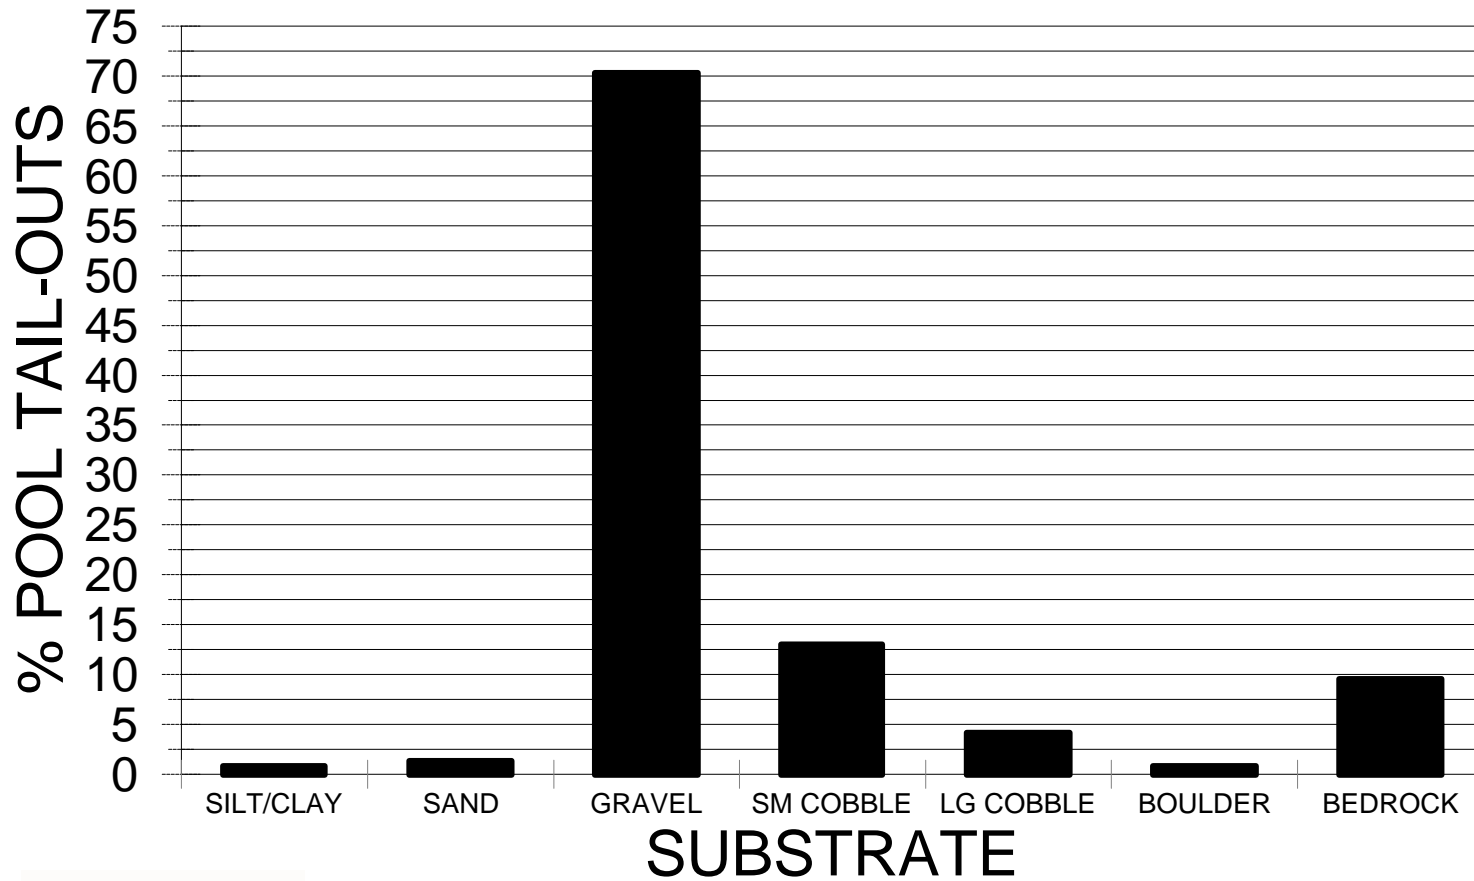
GRAPH 8

Table 6 summarizes the dominant substrate by habitat type. Graph 8 shows the dominant substrate observed in pool tail-outs. Gravel was the dominant substrate observed in 70% of the pool tail outs; small cobble was the next most frequently observed substrate type at 13%.

One hundred and ninety-nine of the 239 pool tail outs measured had gravel or small cobble as the dominant substrate. This is generally considered good for spawning salmonids.

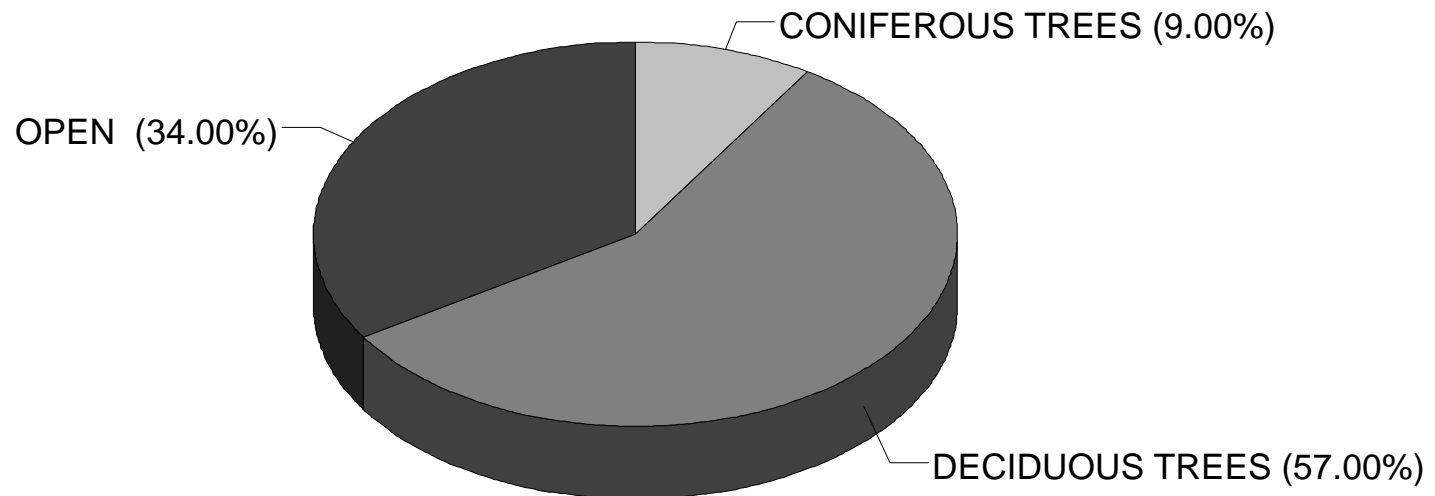
GRAPH 9

The mean percent canopy density for the surveyed length of Chorro Creek was 66%. The mean percentages of deciduous and coniferous trees were 87% and 13%, respectively. Graph 9 describes the canopy in Chorro Creek.

The mean percent canopy density for the stream was 66%. This is a relatively low percentage of canopy. In general, revegetation projects are considered when canopy density is less than 80%. Each reach in Chorro Creek had less than 80% mean percent canopy density (Table 8). A planting project has already been implemented in Reach 2 at the Chorro Flats section, which should eventually increase canopy cover in this area. Reaches 6 and 7 have the lowest relative canopy levels, and also visually appear to have the longest stretches of little to no canopy. Therefore, these areas should be given high priority for revegetation projects.
