STREAM INVENTORY REPORT

PENNINGTON CREEK

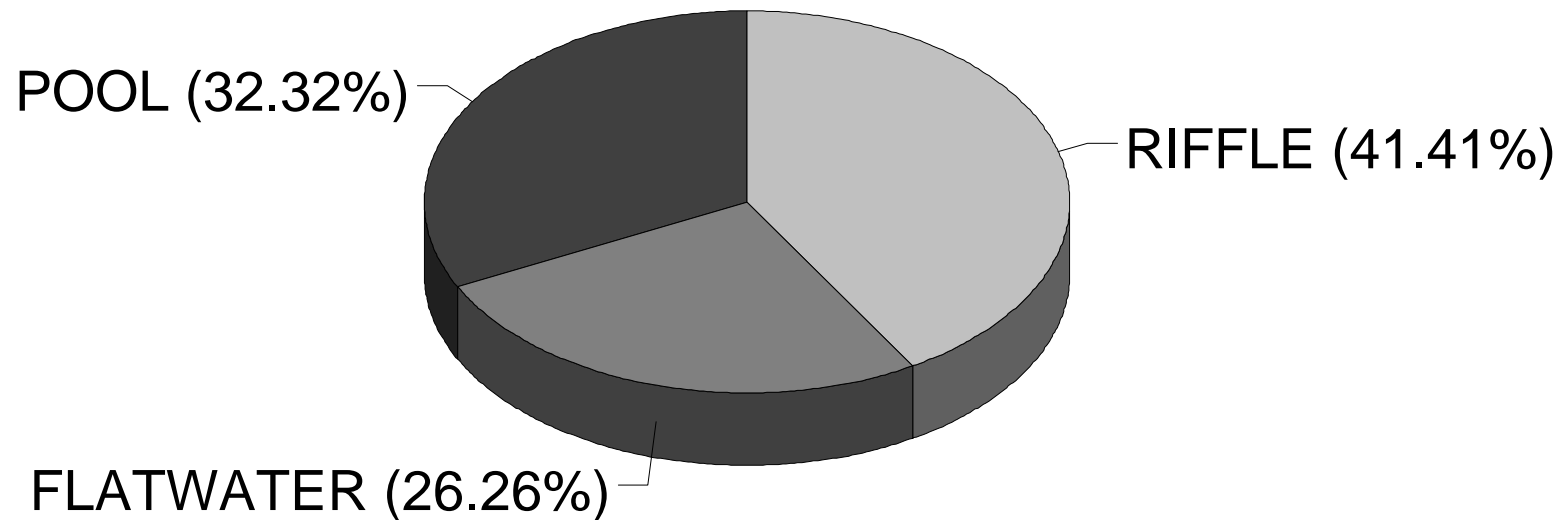
GRAPH 1

Table 1 summarizes the Level II riffle, flatwater, and pool habitat types. Based on frequency of occurrence there were 41% riffle units, 26% flatwater units, and 32% pool units (Graph 1). Based on total length of Level II habitat types there were 42% riffles, 29% flatwaters, and 27% pools (Graph 2).

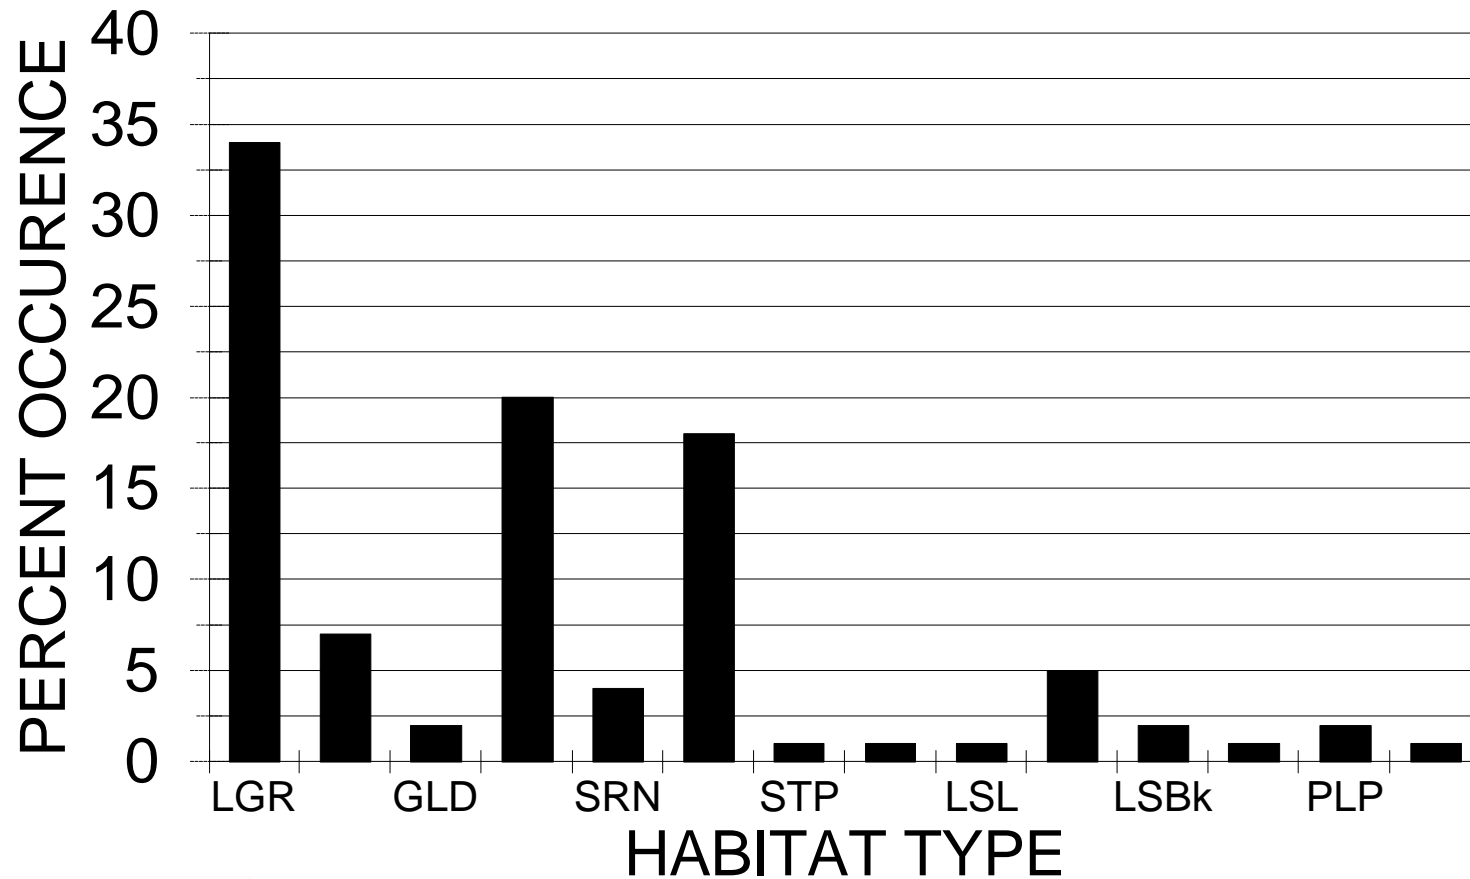
GRAPH 3

Fourteen Level IV habitat types were identified (Table 2). The most frequent habitat types by percent occurrence were low gradient riffles, 34%; runs, 20%; and mid-channel pools, 18% (Graph 3). Based on percent total length, low gradient riffle units made up 35%, run units 20%, and mid-channel pools units 16%.

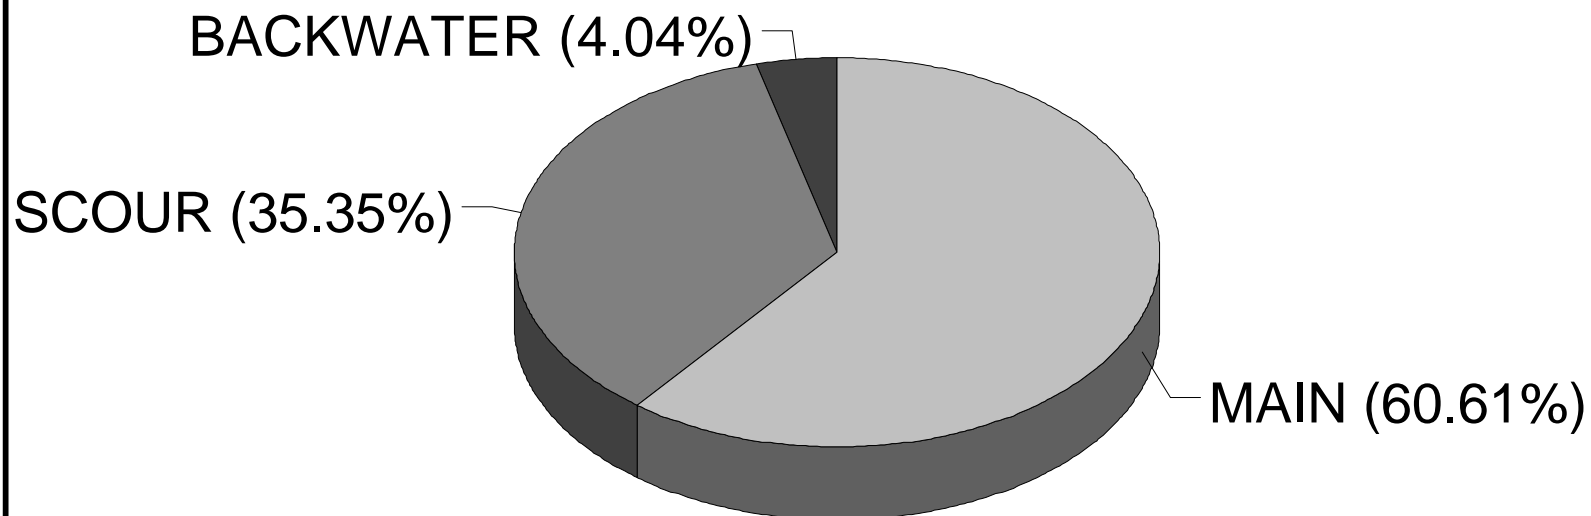
GRAPH 4

A total of 248 pools were identified (Table 3). Main-channel pools were most frequently encountered, at 60%, and comprised 65% of the total length of all pools (Graph 4).

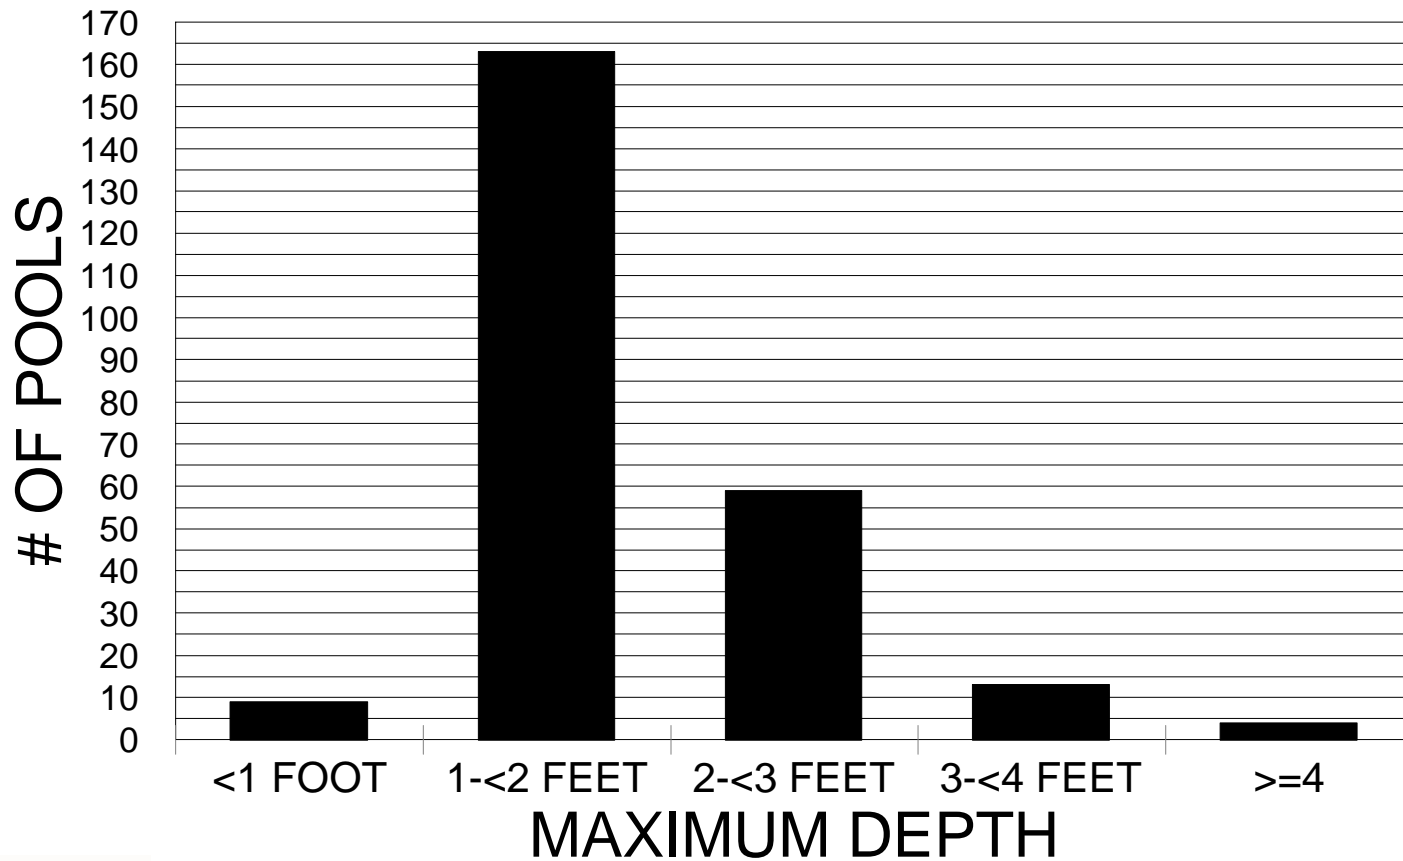
GRAPH 5

Table 4 is a summary of maximum pool depths by pool habitat types. Pool quality for salmonids increases with depth. Seventy-six of the 248 pools (31%) had a depth of two feet or greater (Graph 5).

Flatwater habitat types comprised 29% of the total length of this survey, riffles 42%, and pools 27%. The pools are relatively shallow, with only 76 of the 248 (31%) pools having a maximum depth greater than 2 feet. In general, pool enhancement projects are considered when primary pools comprise less than 40% of the length of total stream habitat. In first and second order streams, a primary pool is defined to have a maximum depth of at least two feet, occupy at least half the width of the low flow channel, and be as long as the low flow channel width. Installing structures that will increase or deepen pool habitat is recommended for in the B2 channel type in locations where their installation will not be threatened by high stream energy, or where their installation will not conflict with the modification of the numerous log and small woody debris accumulations in the stream. Many of the woody debris accumulations in the system are retaining needed gravel. Any necessary modifications to them should be done with the intent of metering the gravel out to downstream reaches that will trap the gravel for future spawning use. Therefore, gravel retention features may need to be developed prior to any woody debris accumulation modification.

- 4) Where feasible, design and engineer pool enhancement structures to increase the number of pools. This must be done where the banks are stable or in conjunction with stream bank armor to prevent erosion.

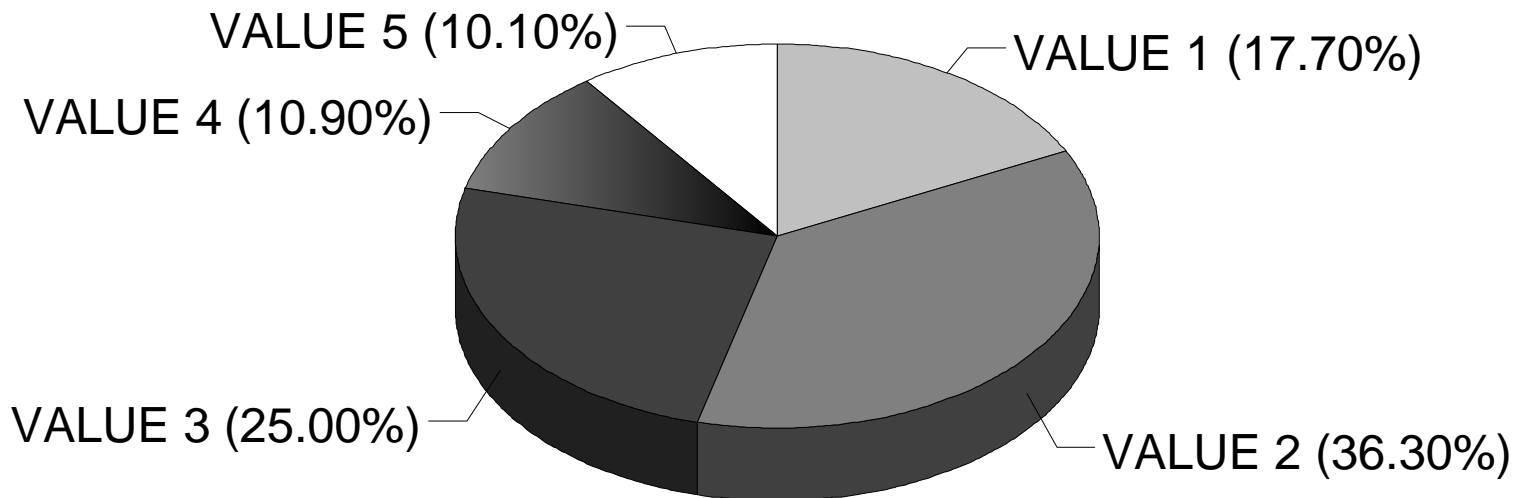
GRAPH 6

The depth of cobble embeddedness was estimated at pool tail-outs. Of the 248 pool tail-outs measured, forty-four had a value of 1 (18%); ninety had a value of 2 (36%); sixty-two had a value of 3 (25%); twenty-seven had a value of 4 (11%) and twenty-five had a value of 5 (10%) (Graph 6). On this scale, a value of 1 indicates the highest quality of spawning substrate and a value of 5 indicates the tail-out is not suitable for spawning. In Pennington Creek, three of the twenty-five pool tail-outs which were valued at 5 had silt/clay/sand or gravel too small to be suitable for spawning as the substrate. The other tail-outs were unsuitable for spawning due to the tail-outs being comprised of large cobble, boulder, bedrock or wood.

Forty-four of the 248 pool tail-outs measured had an embeddedness rating of 1. Ninety of the pool tail-outs had embeddedness rating of 2, and 89 pool tail-outs had ratings of 3 or 4. Twenty-five of the pool tail-outs had a rating of 5 or were considered unsuitable for spawning. Three of the twenty-five were unsuitable for spawning due to the dominant substrate being silt/sand/clay or gravel. Cobble embeddedness measured to be 25% or less, a rating of 1, is considered to indicate good quality spawning substrate for salmon and steelhead. In Pennington Creek, sediment sources should be mapped and rated according to their potential sediment yields, and control measures should be taken. Reach 1 has tremendously high degree of fine sediment, which is the predominant substrate in the channel; although the pool tail-outs in reach 1 do not appear to have higher embeddedness values on average than the other reaches. An effort to map sediment sources is currently underway by the Morro Bay National Estuary Program.

- 5) Inventory and map sources of stream bank erosion and prioritize them according to present and potential sediment yield. Identified sites should then be treated to reduce the amount of fine sediments entering the stream.

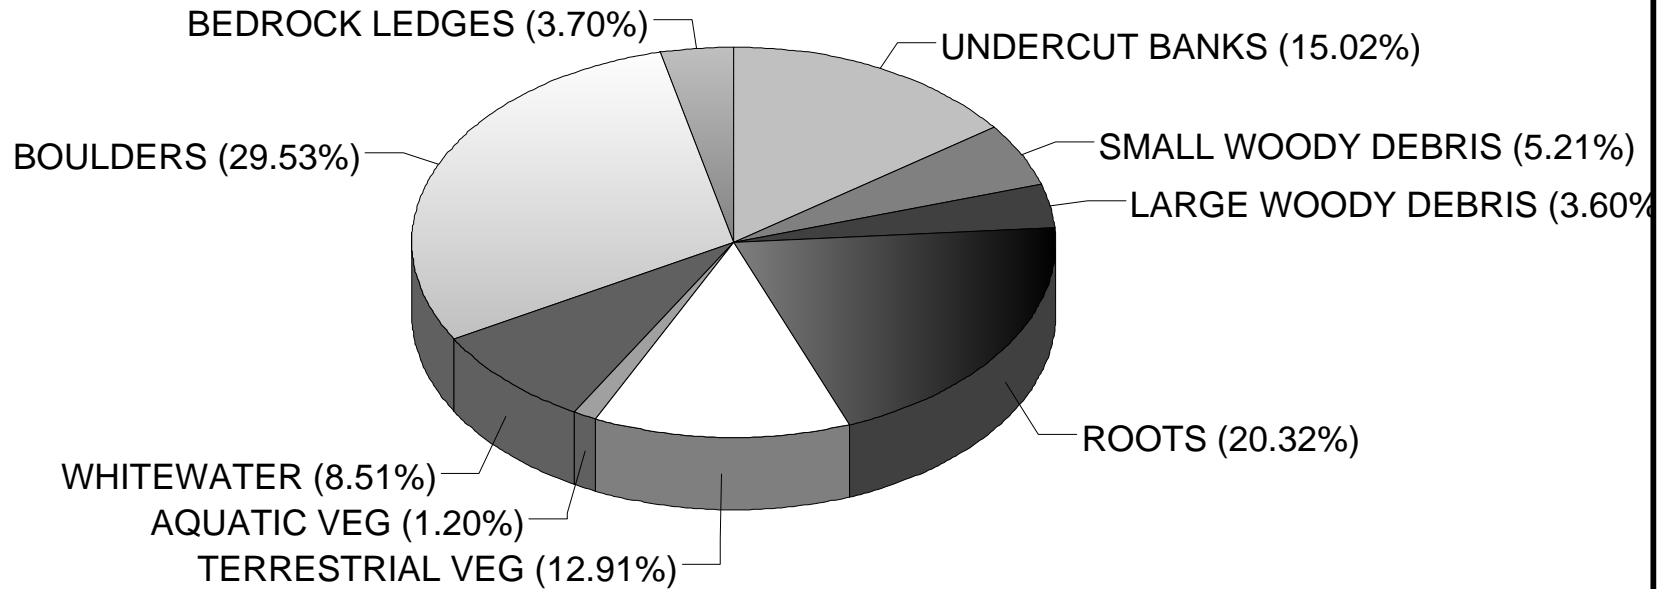
GRAPH 7

Table 5 summarizes mean percent cover by habitat type. Boulders are the dominant cover type in Pennington Creek. Graph 7 describes the pool cover in Pennington Creek.

The mean shelter rating for pools was very low with a rating of 5. The shelter rating in the flatwater habitats was slightly better at 23. A pool shelter rating of approximately 100 is desirable. The relatively small amount of cover that now exists is being provided primarily by boulders in all habitat types. Additionally, root wads contribute a small amount to cover as well. Log and root wad cover structures in the pool and flatwater habitats are needed to improve both summer and winter salmonid habitat. Log cover structures provide rearing fry with protection from predation, rest from water velocity, and also divides territorial units to reduce density related competition.

- 3) Increase woody cover in the pools and flatwater habitat units. Most of the existing cover is from boulders. Adding high quality complexity with woody cover is desirable.

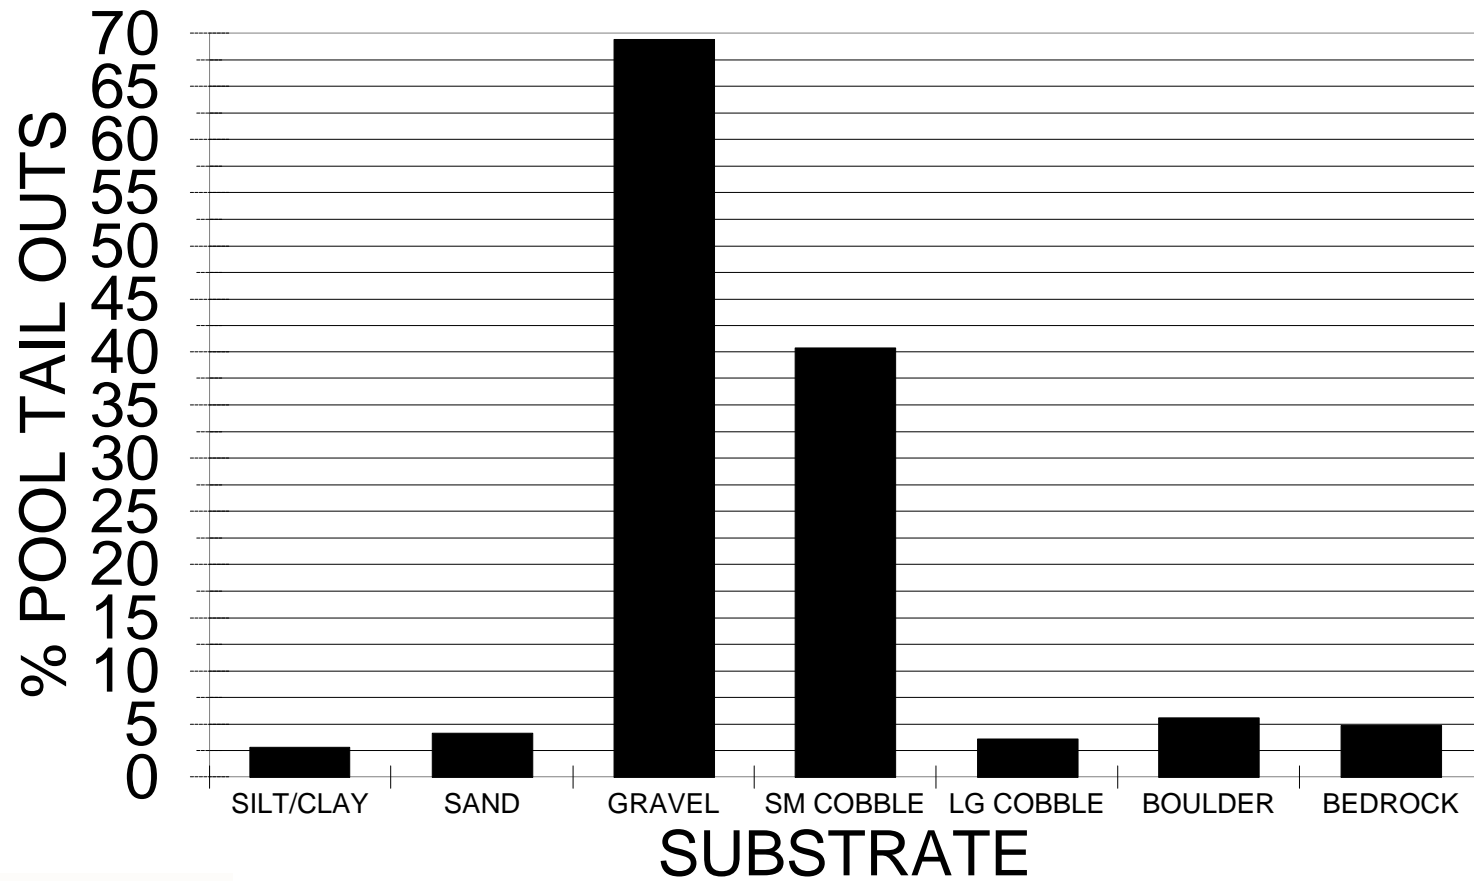
GRAPH 8

Table 6 summarizes the dominant substrate by habitat type. Gravel was the dominant substrate observed in 172 of the 248 pool tail-outs measured (69%). Small cobble was the next most frequently observed dominant substrate type and occurred in 40% of the pool tail outs (Graph 8).

Seventy-nine percent of the pool tail-outs measured had gravel or small cobble as the dominant substrate. This is generally considered good for spawning salmonids.

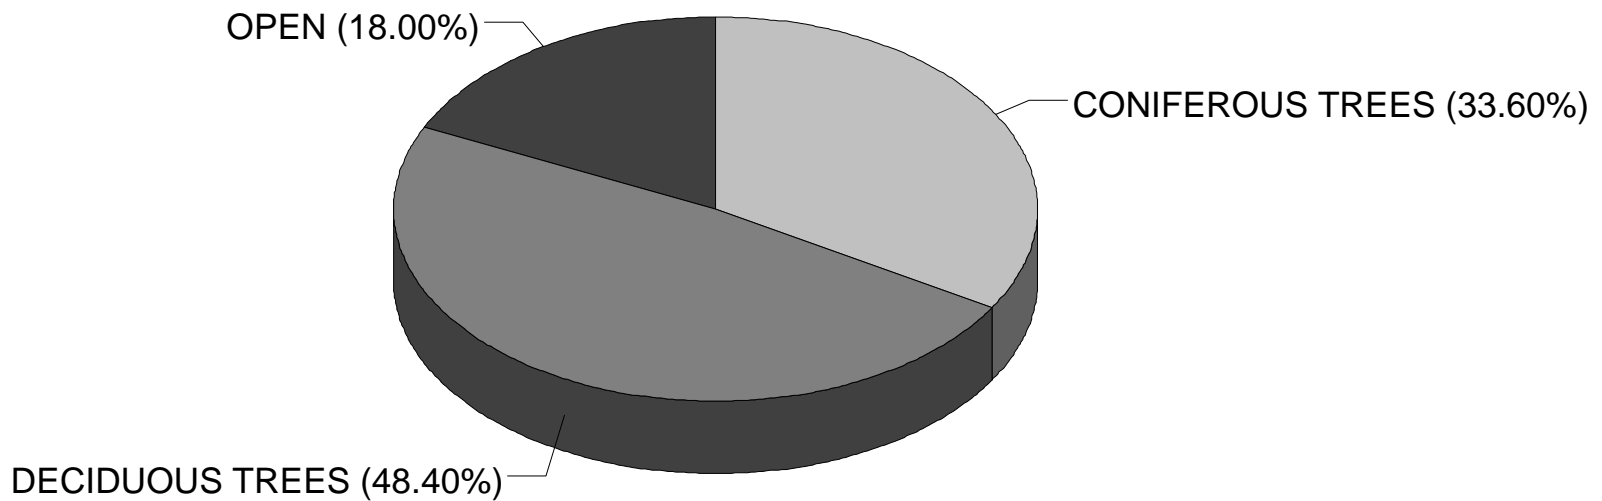
GRAPH 9

The mean percent canopy density for the surveyed length of Pennington Creek was 82%. The mean percentages of deciduous and coniferous trees were 41% and 59%, respectively. Graph 9 describes the canopy in Pennington Creek.

The mean percent canopy density for the stream was 82%. This is a relatively moderate percentage of canopy. In general, revegetation projects are considered when canopy density is less than 80%.

- 7) The water temperature data suggest that maximum temperatures are near the upper acceptable range for juvenile salmonids. Revegetation with native riparian plants along the banks is recommended in areas with suboptimal canopy or where water temperatures are highest in the creek from July through September.

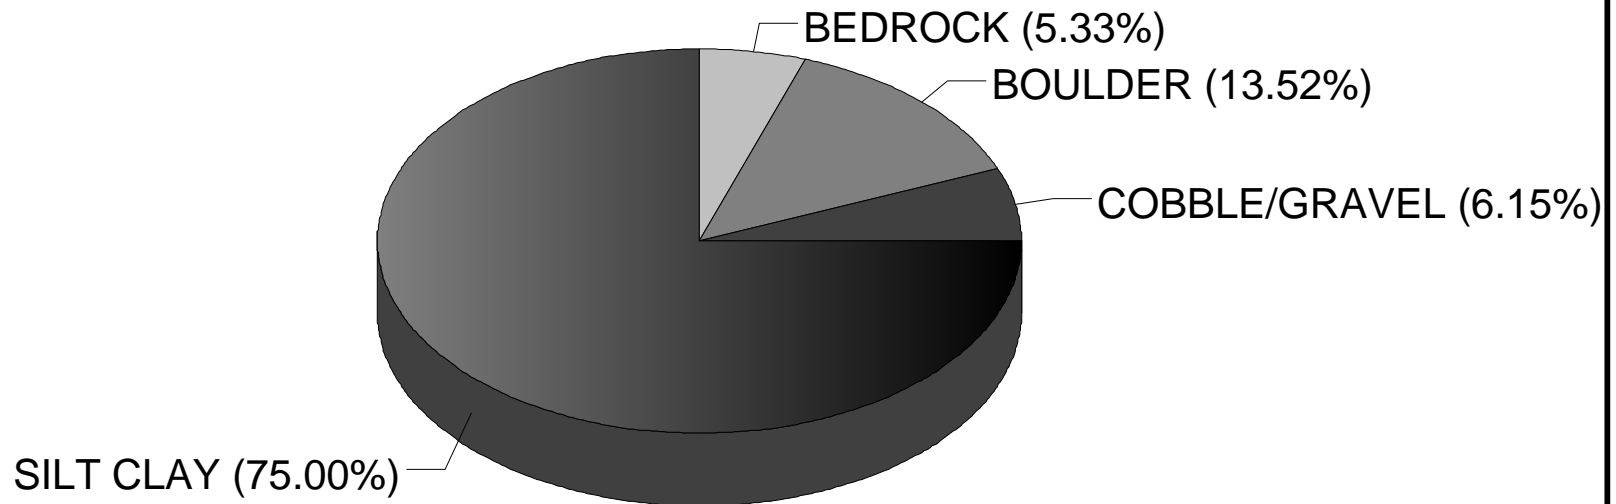
GRAPH 10

For the stream length surveyed, the mean percent right bank vegetated was 26%. The mean percent left bank vegetated was 29%. The dominant elements composing the structure of the stream banks consisted of 5% bedrock, 14% boulder, 6% cobble/gravel, and 75% sand/silt/clay (Graph 10). Deciduous trees were the dominant vegetation type observed in 48% of the units surveyed. Additionally, 21% of the units surveyed had coniferous trees as the dominant vegetation, including down trees, logs, and root wads (Graph 11). Areas of eroded banks along Pennington Creek were mapped using a global positioning device and are shown on Map 1.

The percentage of right and left bank covered with vegetation was low at 26% and 29%, respectively. In areas of stream bank erosion or where bank vegetation is not at acceptable levels, planting endemic species of coniferous and deciduous trees, in conjunction with bank stabilization, is recommended. Eroded banks along Pennington Creek are also likely contributing sediment to spawning gravels. Map 1, which shows locations of eroded banks and their maximum height classes, can help prioritize stream bank stabilization projects in the future.
