## **Geomorphic and Hydrologic Conditions Assessment**

Final Technical Report

## Arroyo Grande Creek Watershed Management Plan Geomorphic and Hydrologic Conditions Assessment

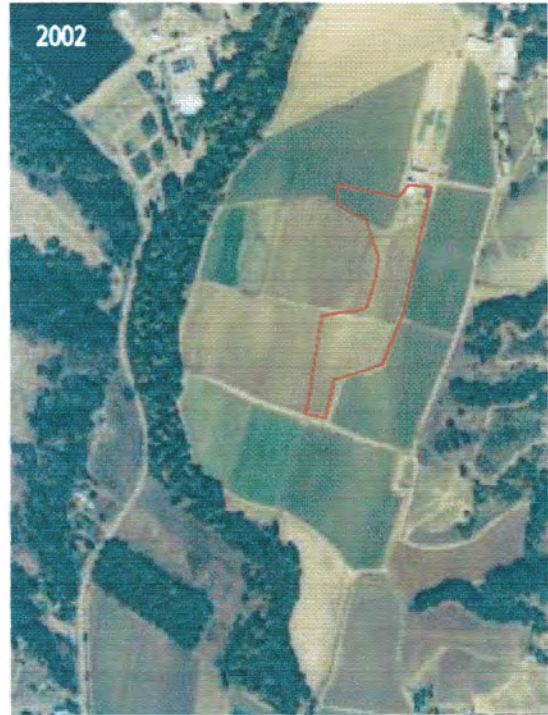
A: Remnant riparian area evident in 1939 aerial photo, (highlighted in red), no longer exists in 2002 aerial photo.

Several lines of evidence suggest that the channel exhibited these characteristics including remnant channel and floodplain areas observed on historic aerial photos and historic accounts from early settlers. Figure 4a shows a historic aerial photo from 1939 depicting a remnant floodplain and channel occurring in the middle of a farm field. The photo displayed with it is a recent aerial photo from 2002. Historic accounts from early settlers, presented below, are taken from a book by Robert Brown, a local historian, entitled, "Story of the Arroyo Grande Creek", published in 2002:

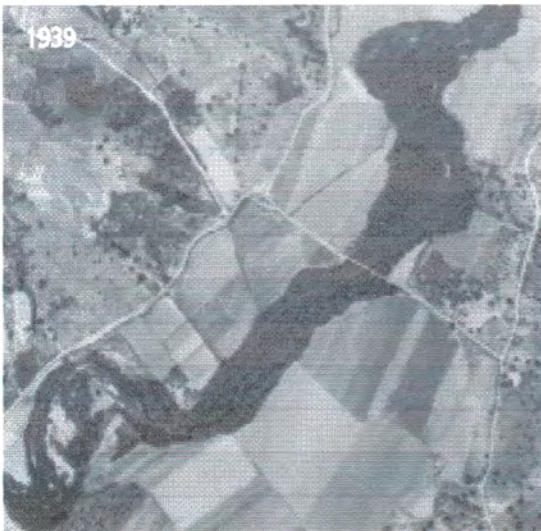
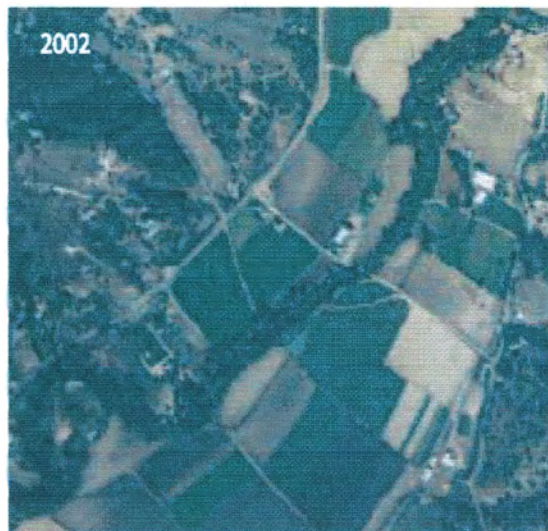
B: Wide floodplain / riparian area evident in 1939 aerial photo, in 2002 aerial photo riparian area is confined by agricultural fields.

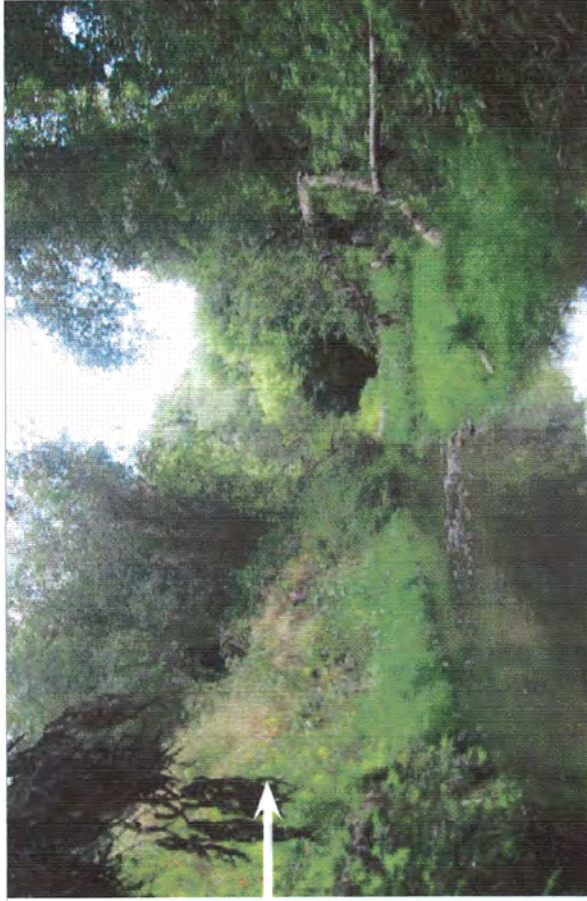
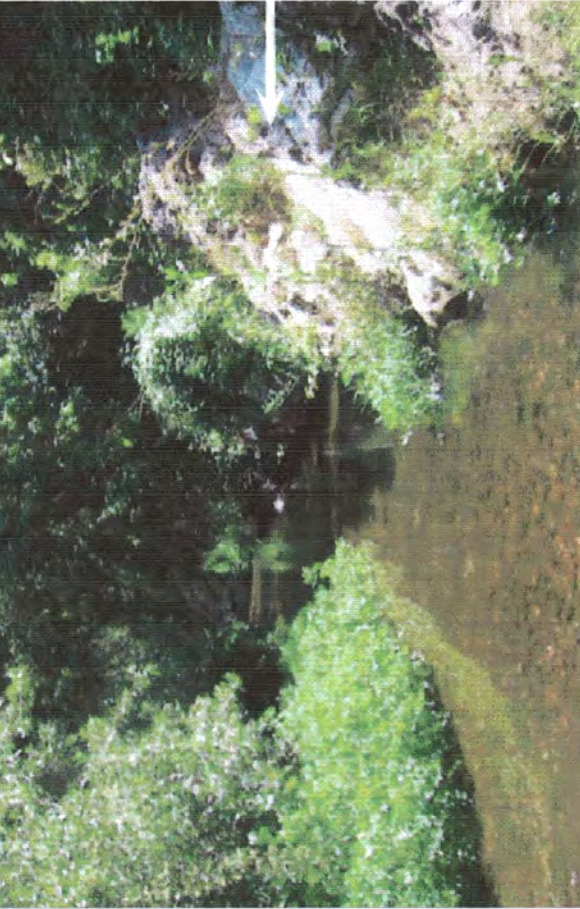
**Cross Section #1**

**FIGURE 6:** Cross-section and channel geometry results from survey conducted in Summer 2004. Bankfull was estimated from field indicators.

Additionally, SH+G conducted a reconnaissance-level survey of channel conditions within the Arroyo Grande Creek watershed. Cross-section data, local channel slope, and grain size information was collected at 8 sites within the watershed, including 6 sites on the mainstem of Arroyo Grande Creek and 2 sites on Los Berros Creek (Figure 1). Figures 6 - 10 show the results of the cross-section survey and grain size sampling. Surface grain size was estimated at depositional features, such as bars, using the pebble count method (Wolman, 1954).

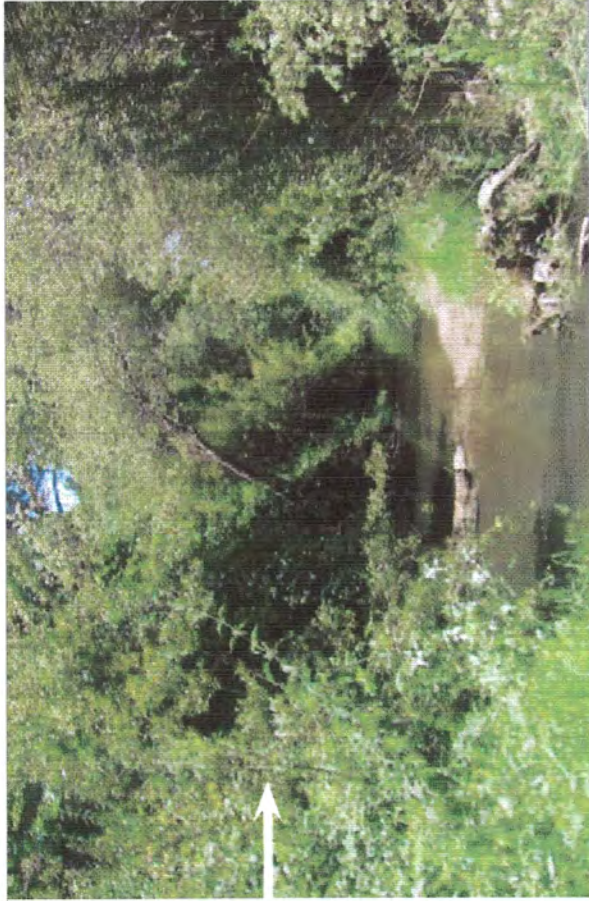
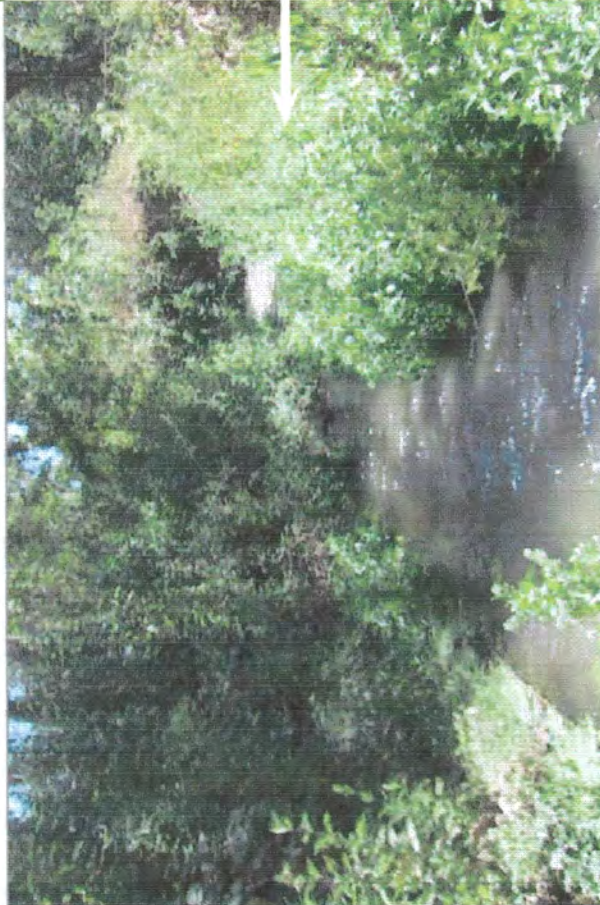
**Cross Section #4**

**FIGURE 7:** Cross-section and channel geometry results from survey conducted in Summer 2004. Bankfull was estimated from field indicators.

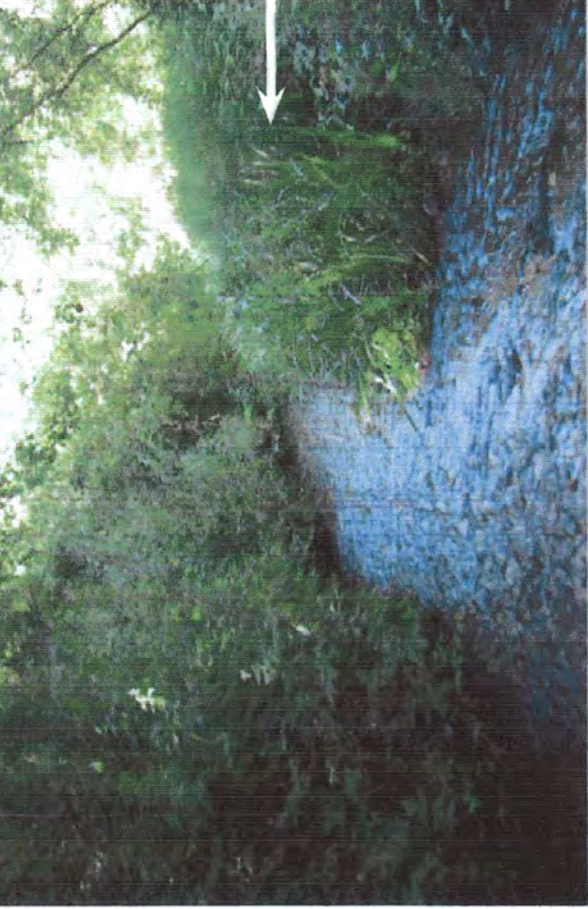
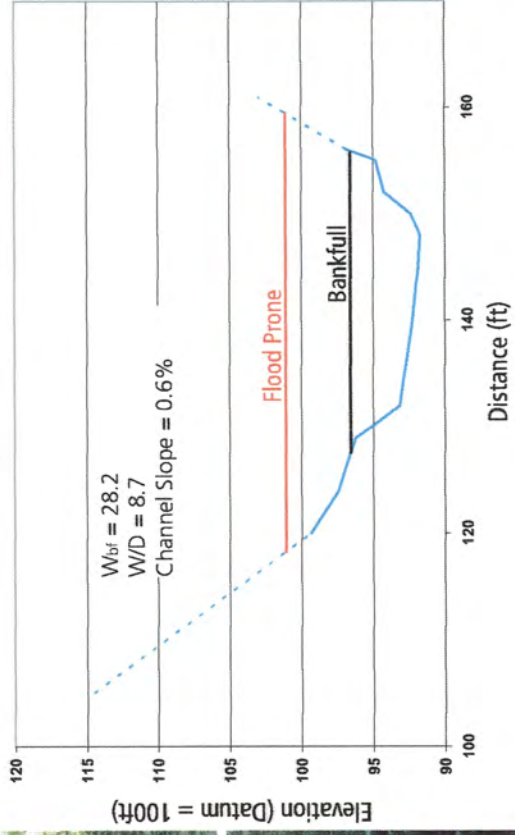
### Cross Section #5

**FIGURE 8:** Cross-section and channel geometry results from survey conducted in Summer 2004. Bankfull was estimated from field indicators.

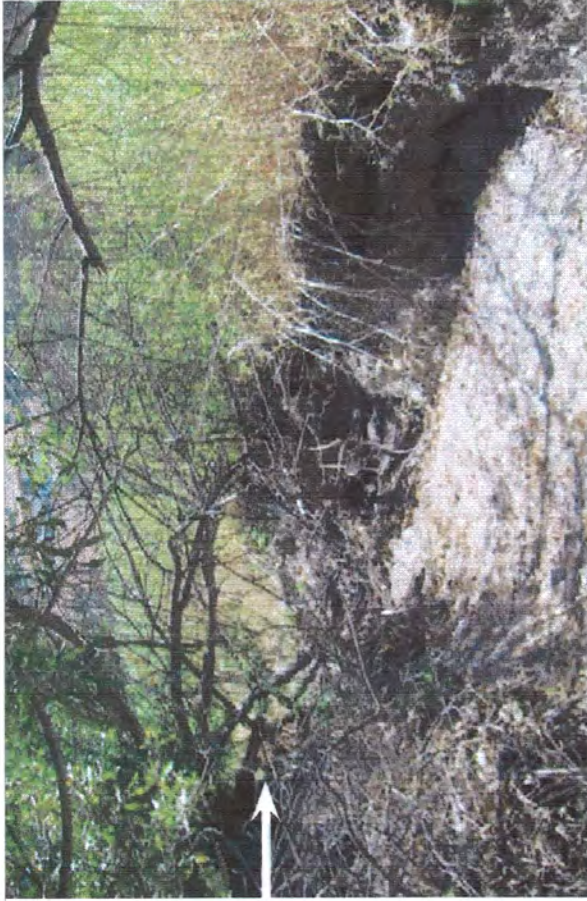
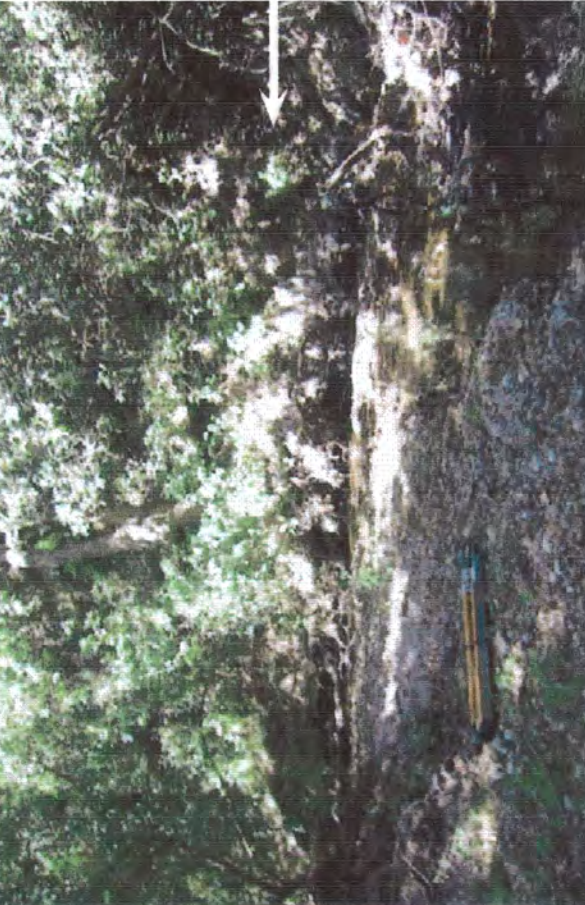
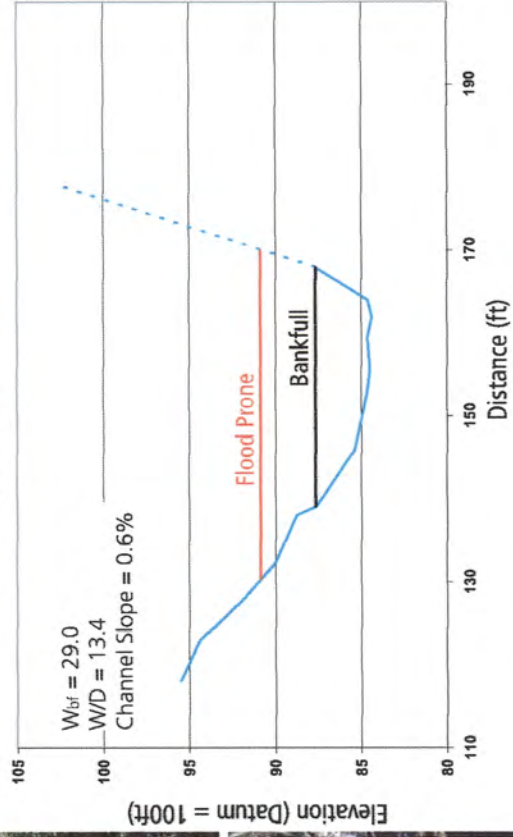
**Cross Section #7**

**FIGURE 9:** Cross-section and channel geometry results from survey conducted in Summer 2004. Bankfull was estimated from field indicators.

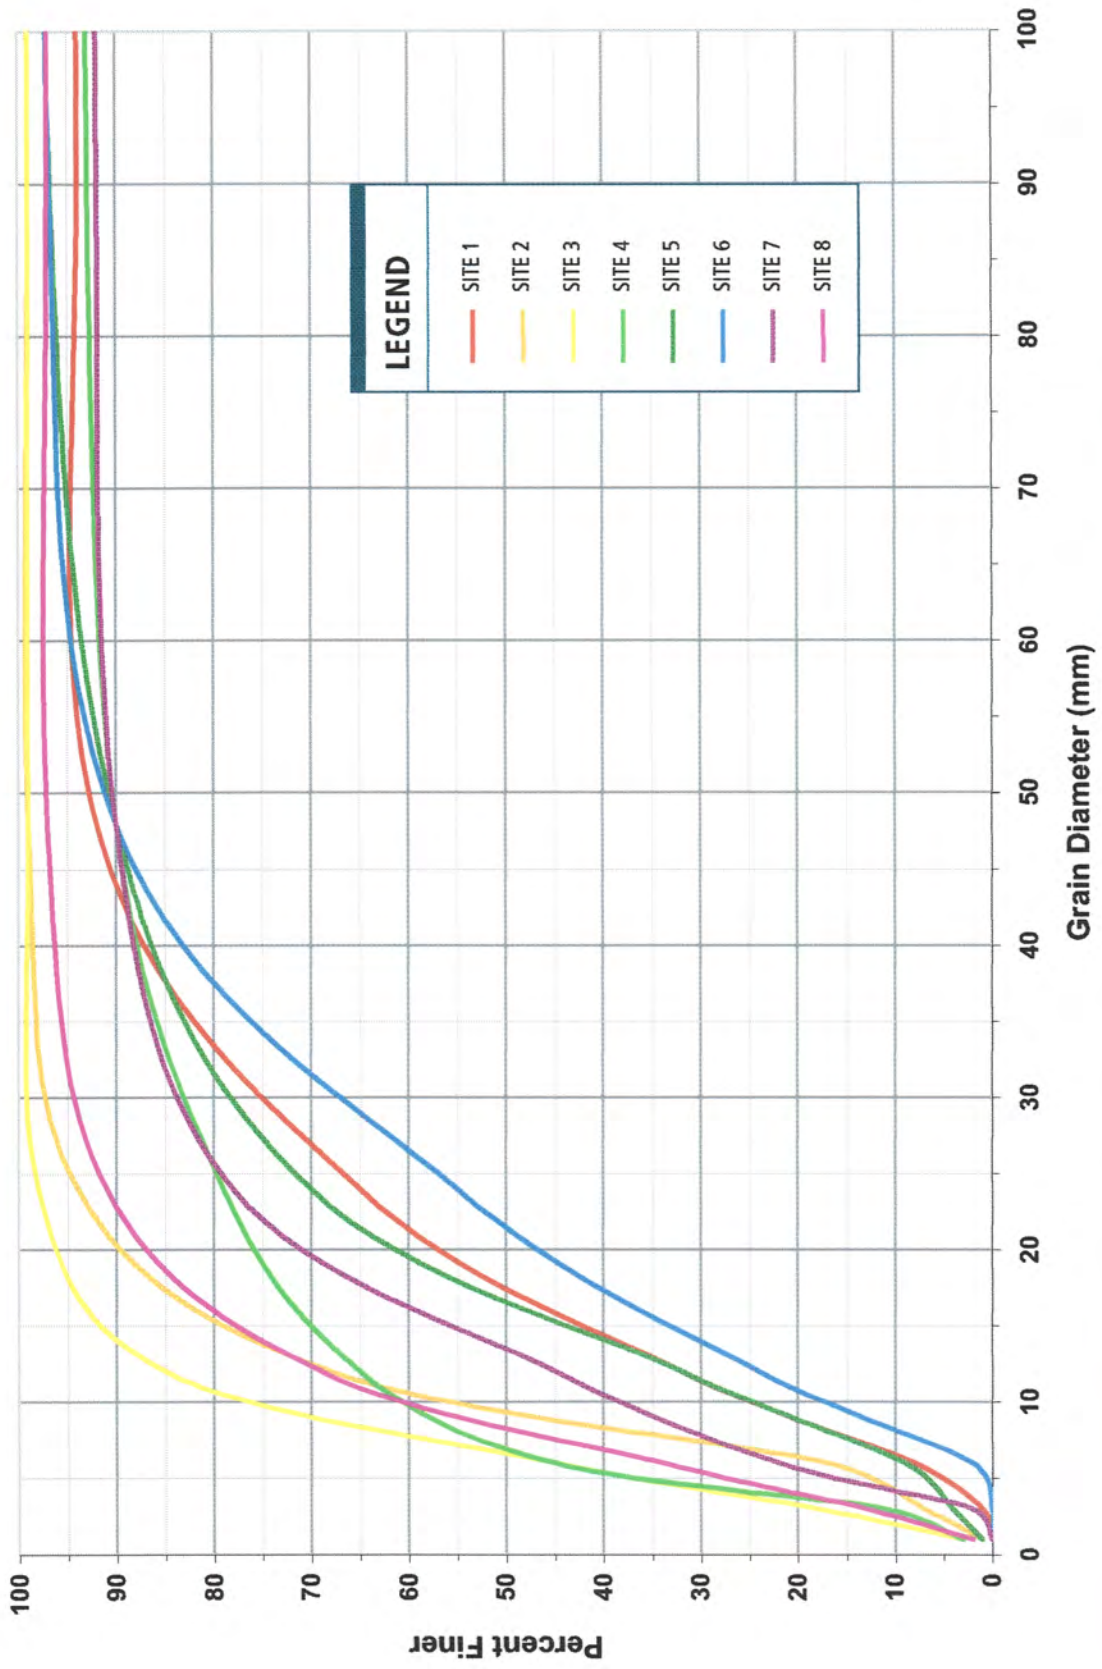
**FIGURE 10:** Grain size analysis based on pebble counts for each cross-section site surveyed in Summer 2004.

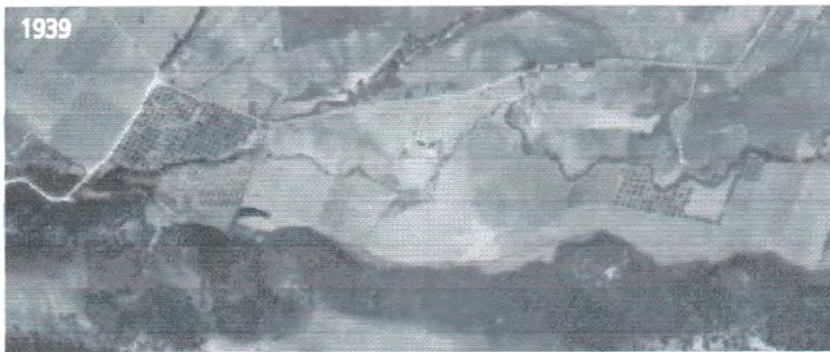
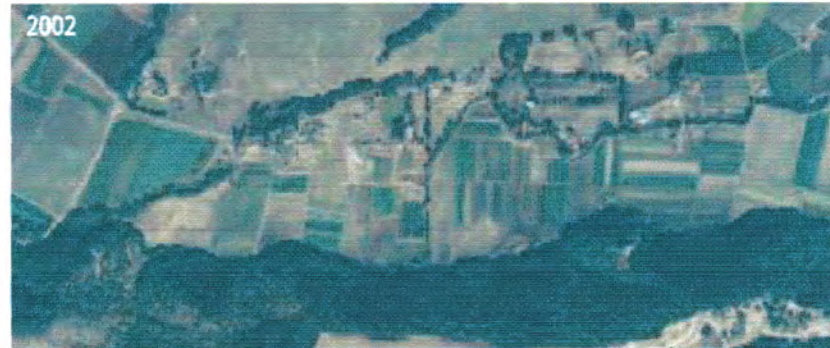
A: Changes in channel location (Tar Spring Creek) to accommodate agricultural fields and homes.

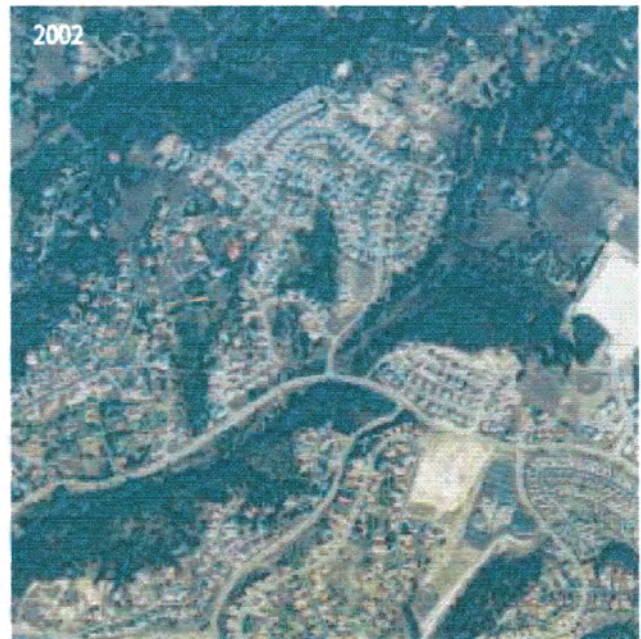
B: 1939 aerial photo, (left), highlighted areas represent examples of areas with natural cover, surrounding areas have been converted from natural cover types to grazing land and orchards, evident rilling and erosion in disturbed areas. In 2002, (right), much of the general area has been developed with high increases in impervious cover.

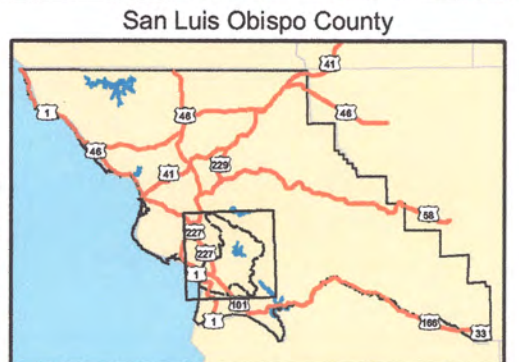
Map 3

# Arroyo Grande Creek Channel Changes

Total Survey Mileage: 13.9 mi.  
F4 Channel Type: 6.14 F6 Channel Type: 2.72  
Not Classifiable: 1.98 Unsurveyed: 3.09

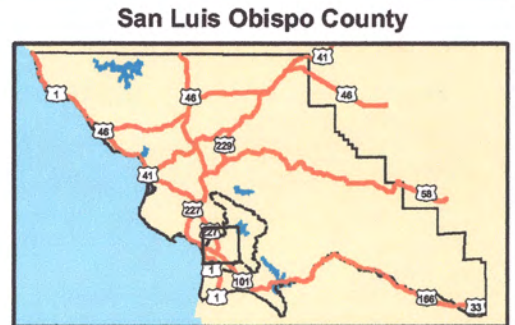
Erosion Sites along 13.9 miles of creek = 179  
Erosion Statistics (area measured in square feet)  
Min: 18      Max: 7920  
Sum: 140,151      Mean: 783

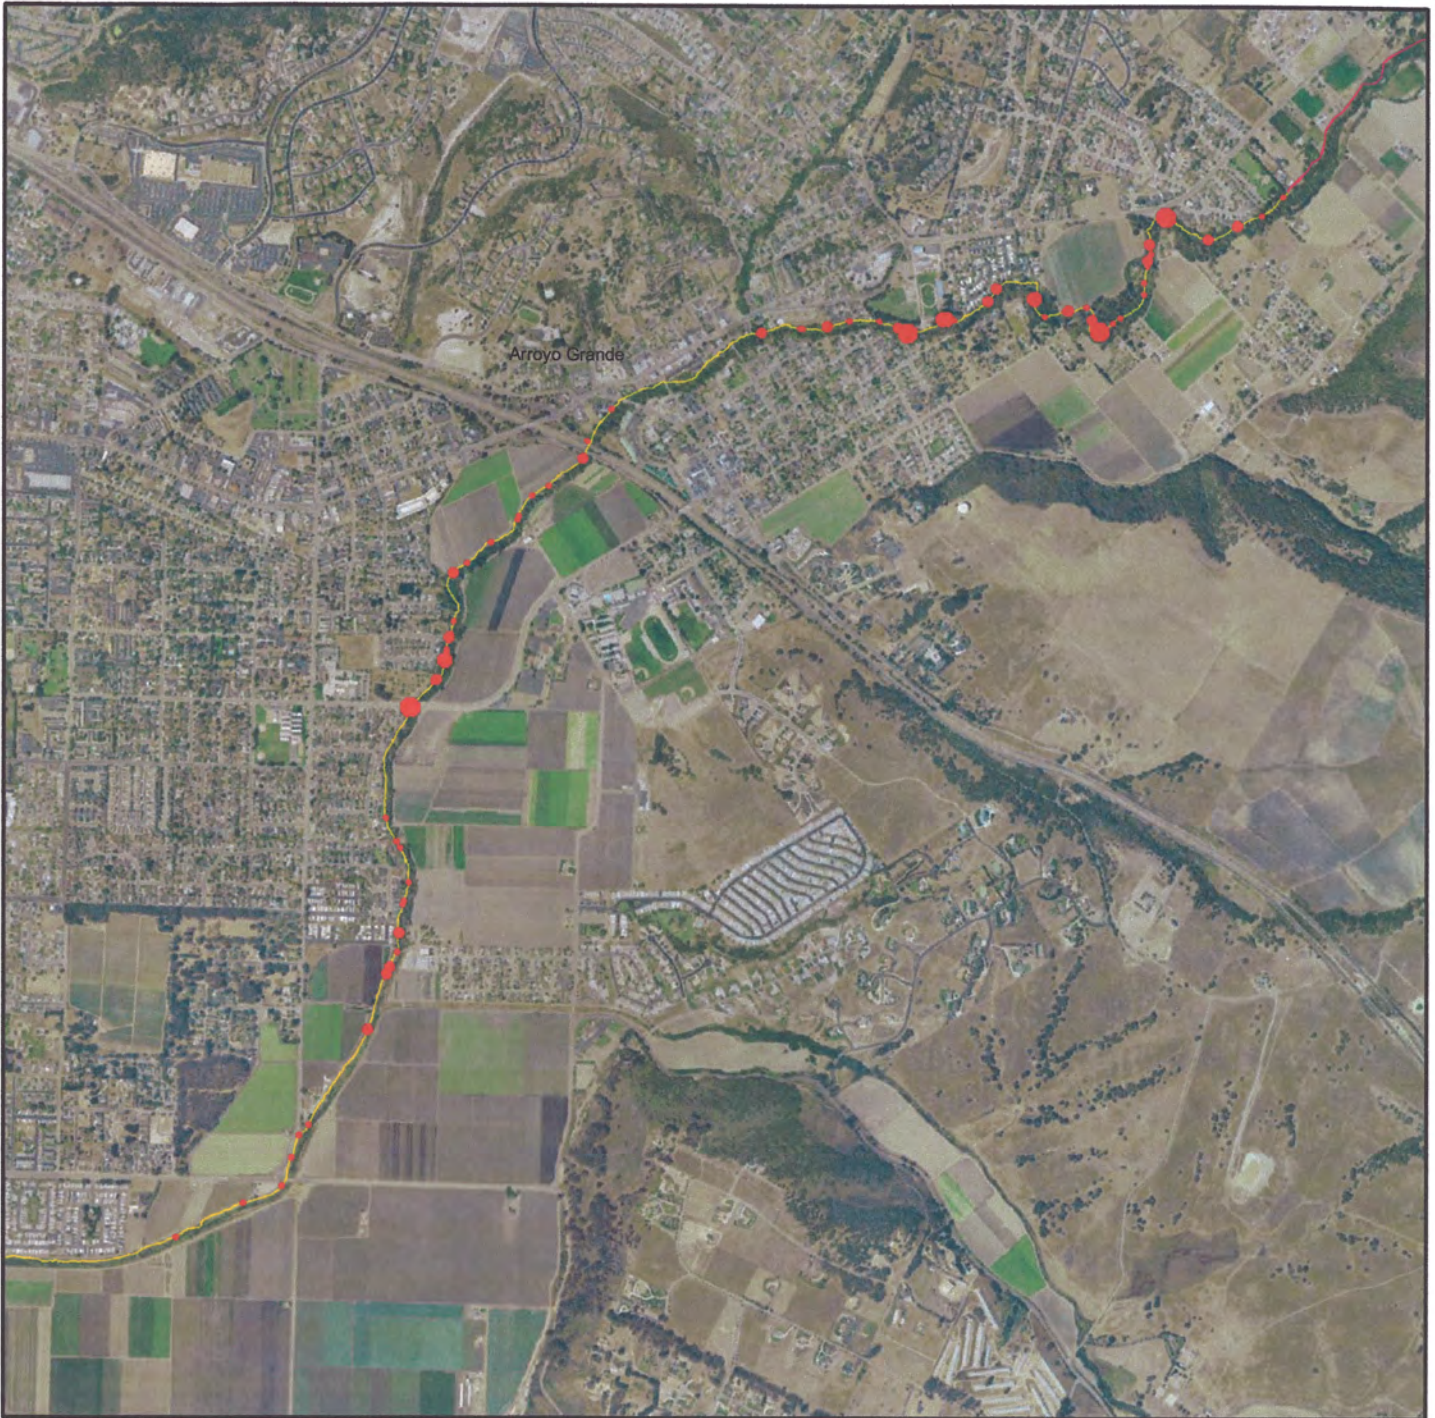
# Arroyo Grande Creek Erosion Sites - Lower Section

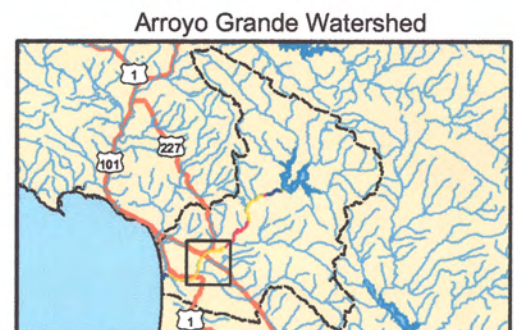
Number of Erosion Sites in Lower Section= 74  
 Erosion Statistics (area measured in square feet)  
 Min: 18    Max: 7920  
 Sum: 94,508    Mean: 1277

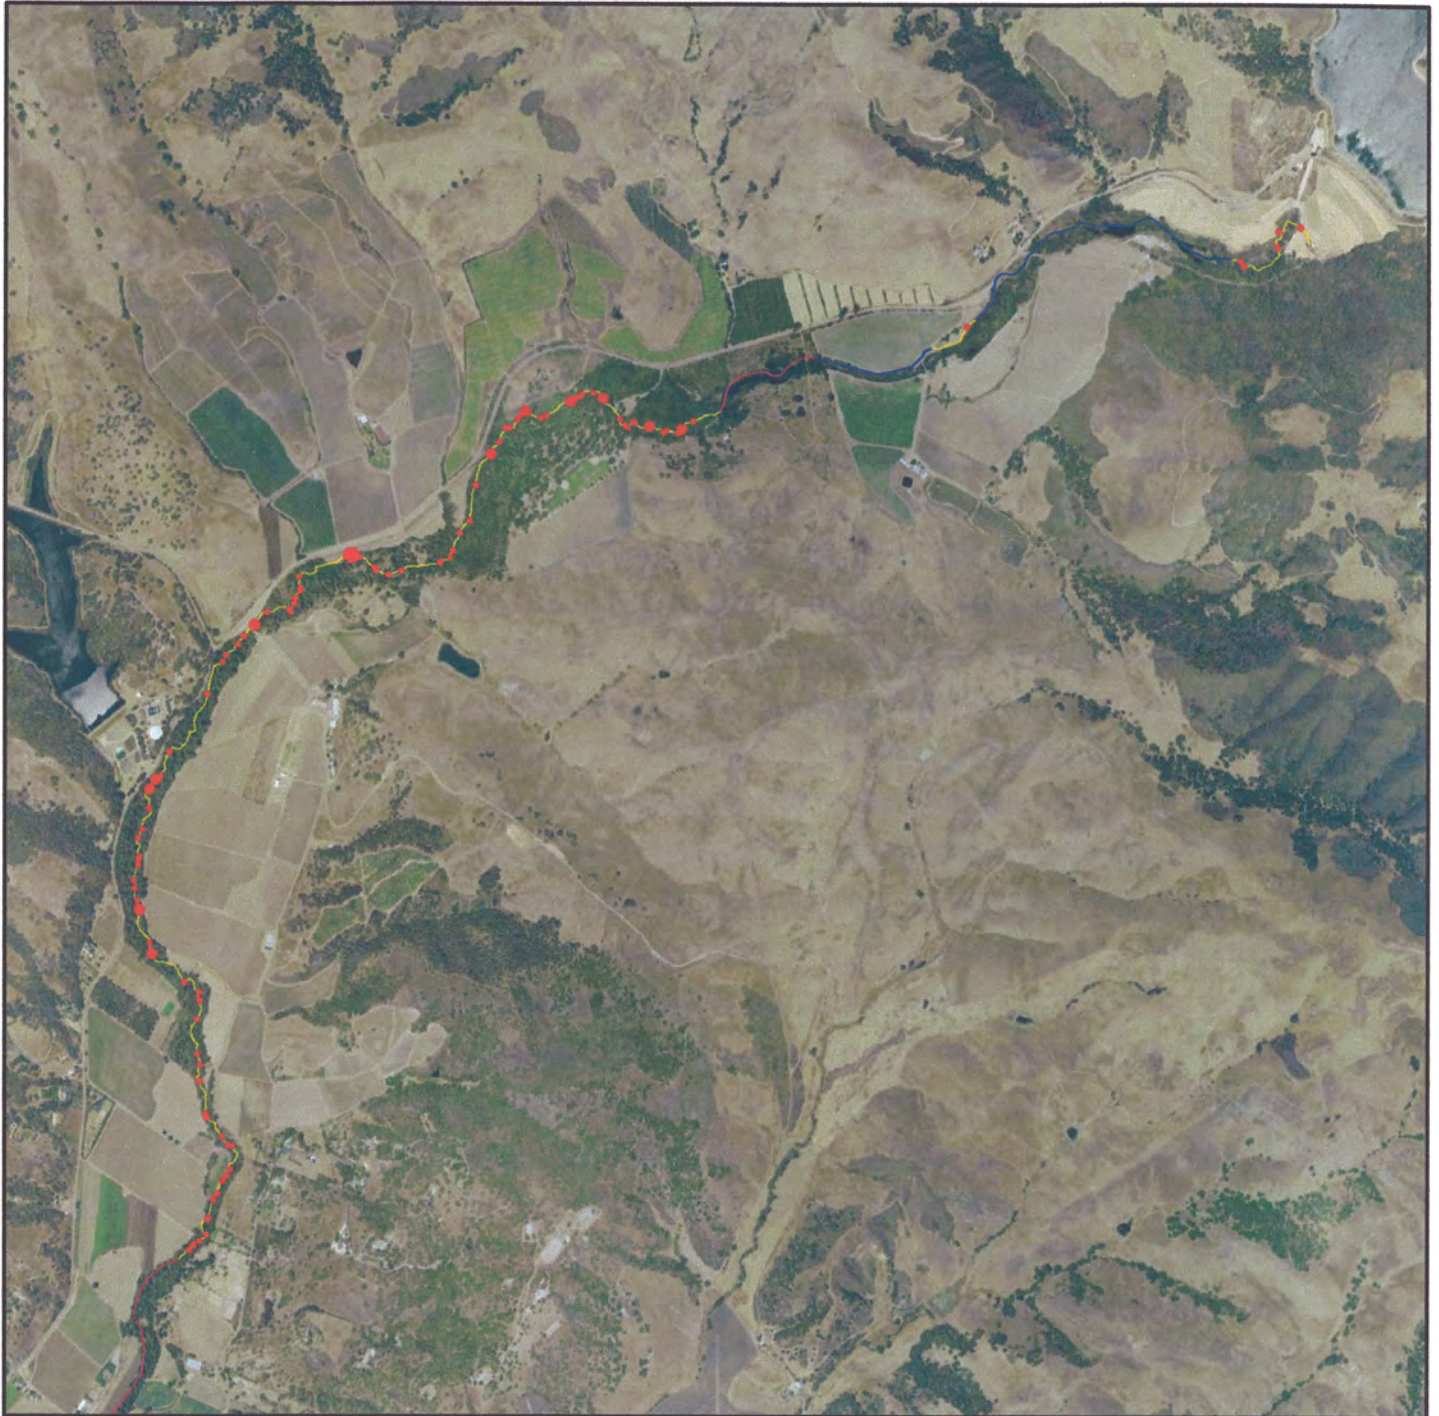
# Arroyo Grande Creek Erosion Sites - Upper Section

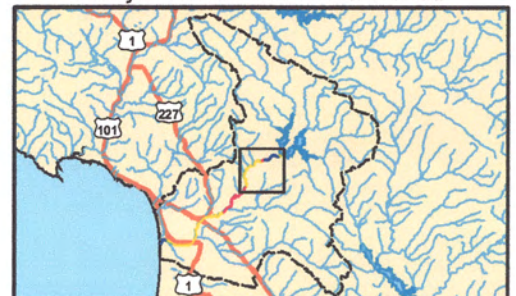
Number of Erosion Sites in Upper Section = 105  
Erosion Statistics (area measured in square feet)  
Min: 18      Max: 3,230  
Sum: 45,643      Mean: 435

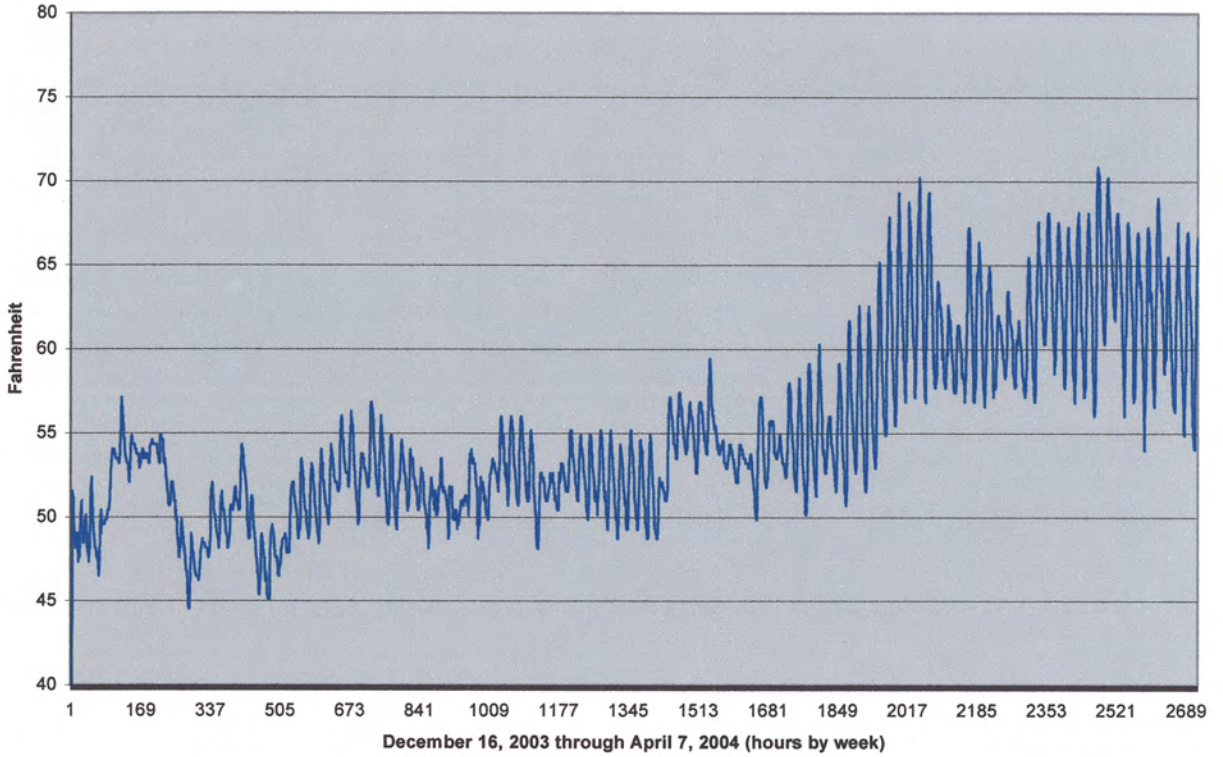
Arroyo Grande Lagoon Temperature  
HOURLY

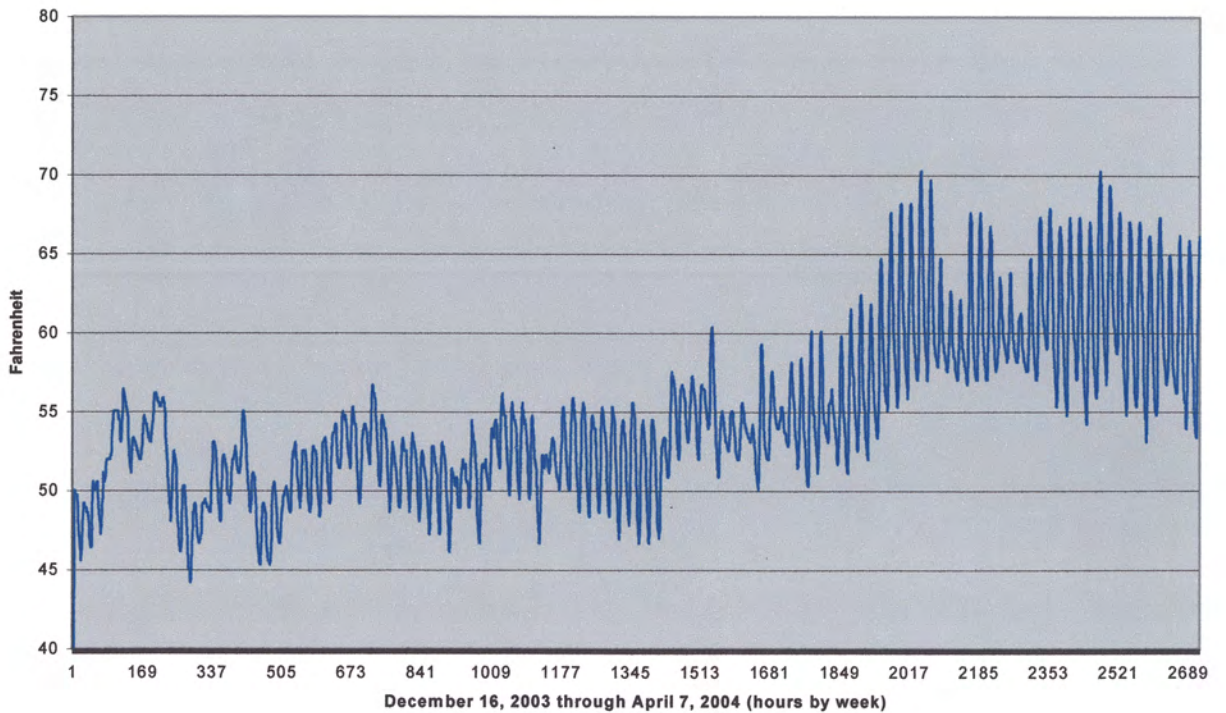
Arroyo Grande Creek Temperature  
HOURLY
