# **Morro Bay Watershed Partners in Restoration**

# **Permit Coordination Program**

2006 Implementation Report

Report prepared by
USDA – Natural Resources Conservation Service
and the Coastal San Luis Resource Conservation District

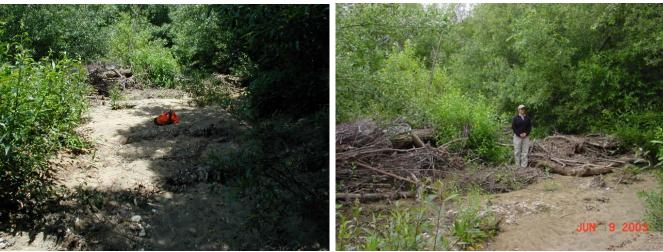
Fig 3 & 4. Pictures taken of Los Osos Creek in 2003 before CCC hand clearing of debris jams took place. All 4 figures of same area in Los Osos Creek.

the creek channel has also suffered severe debris jams from high flows and shrinking channels due to sedimentation. Selective pruning, hand removal of debris jams, cutting, hauling or reuse of the debris, was performed by the California Conservation Corps Watershed Crew. Exotic weed infestations of Pampas Grass and *Arundo donax* were removed upon contact in work vicinity, as well. Work was performed in approximately 2000 linear feet of Los Osos Creek. This project took place. October 5 to October 12, 2006.
