TALLY HO CREEK PLANNING PROJECT

TECHNICAL MEMORANDUM

Re: Tally Ho Creek Planning Project

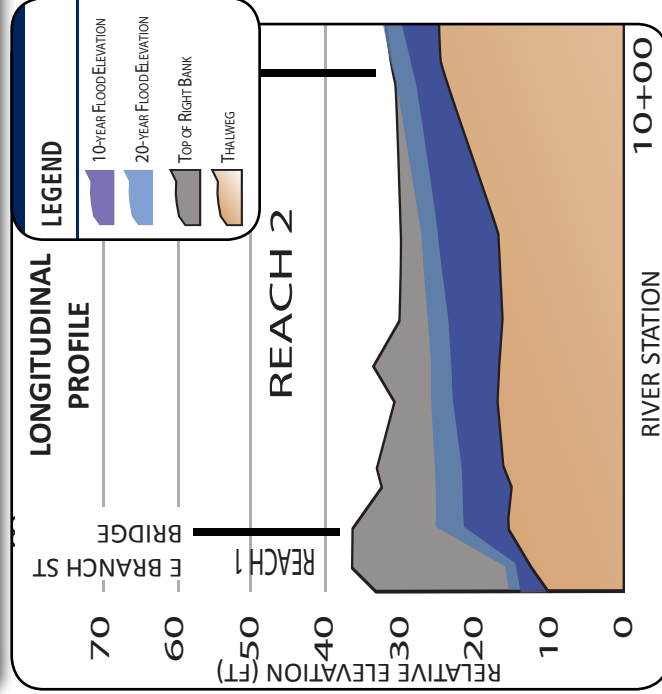
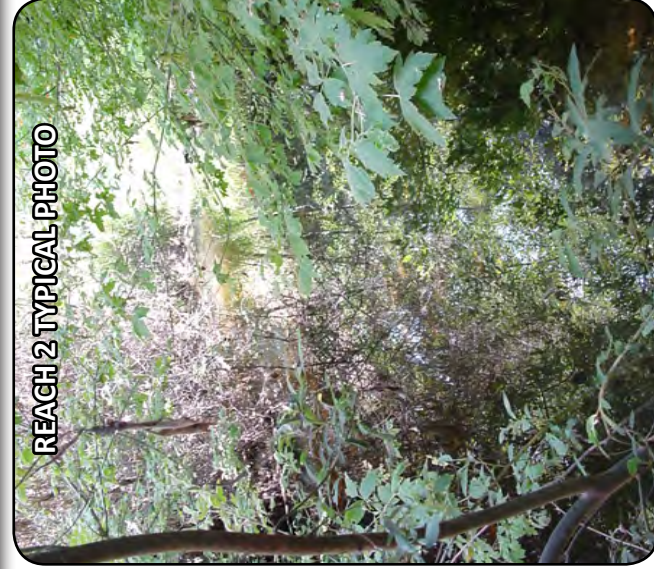
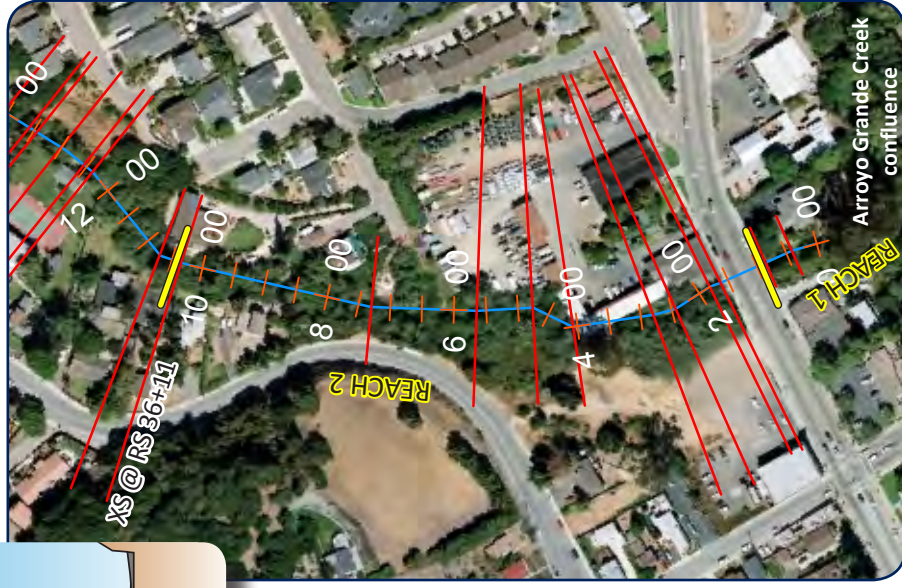
FIGURE 5
Existing conditions for Reaches 1 & 2

Cross-section at RS 10+35 Reach 2

Results for the existing conditions HEC-RAS model are presented in Figures 5, 6, 7, and 8, for Reaches 2, 3, 4, and 5, respectively. In addition, we have provided the complete output from HEC-RAS in Appendix A. The results suggest that Reach 4 is the area where flood risks are highest with nuisance flooding and threats to infrastructure occurring at around the 5-year event and homes directly affected at around the 10-year event. Flood risks are also substantial in Reach 3 with nuisance flooding occurring between the 5-year and 10-year event and homes and infrastructure being affected just above the 10-year event. Flooding in Reach 2 is limited to flows above the 20-year event and flooding in Reach 5 occurs somewhere between the 50-year and 100-year event.¹

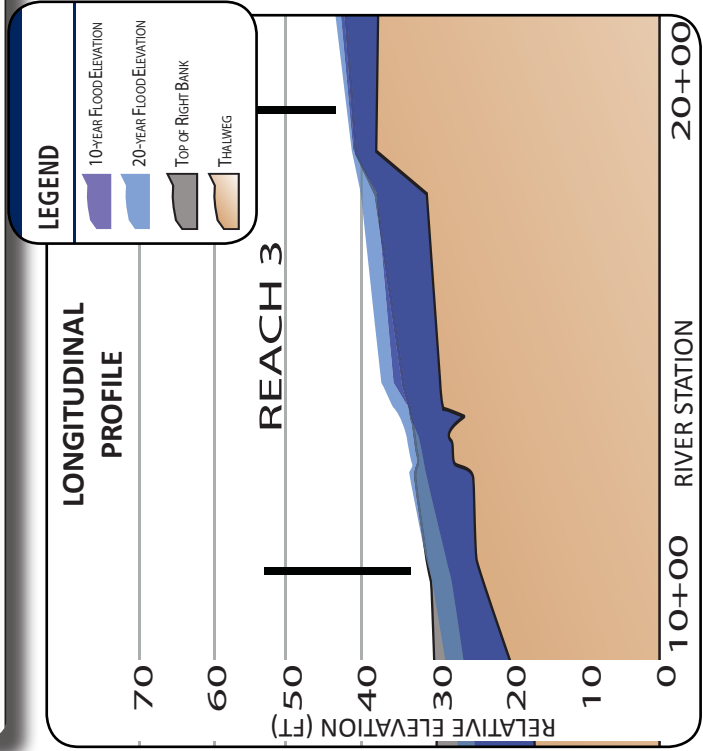
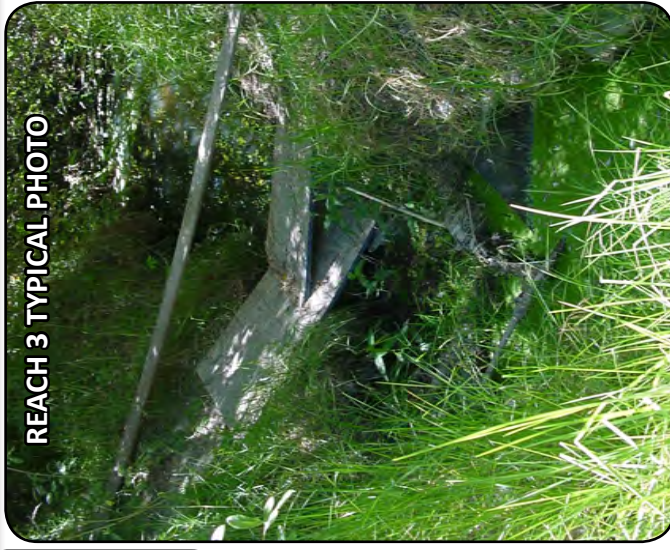
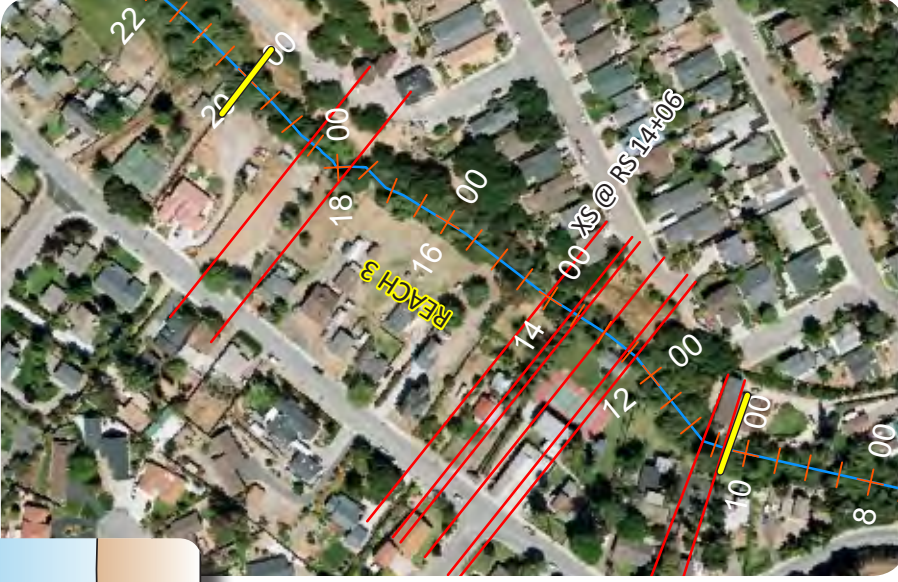
FIGURE 6
Existing conditions for Reach 3

Cross-section at RS 14+06 Reach 3

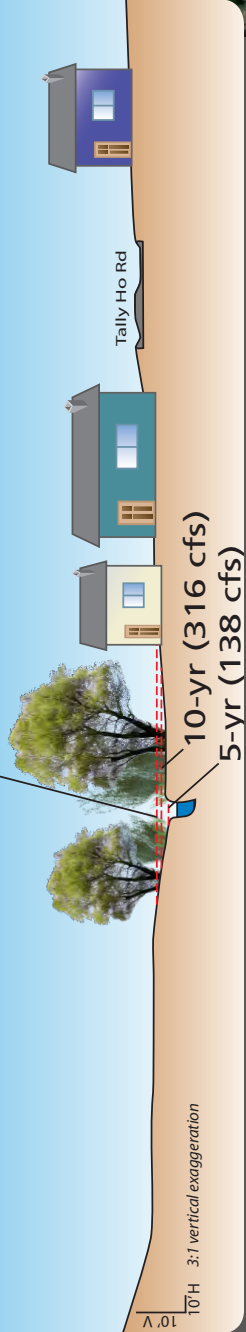
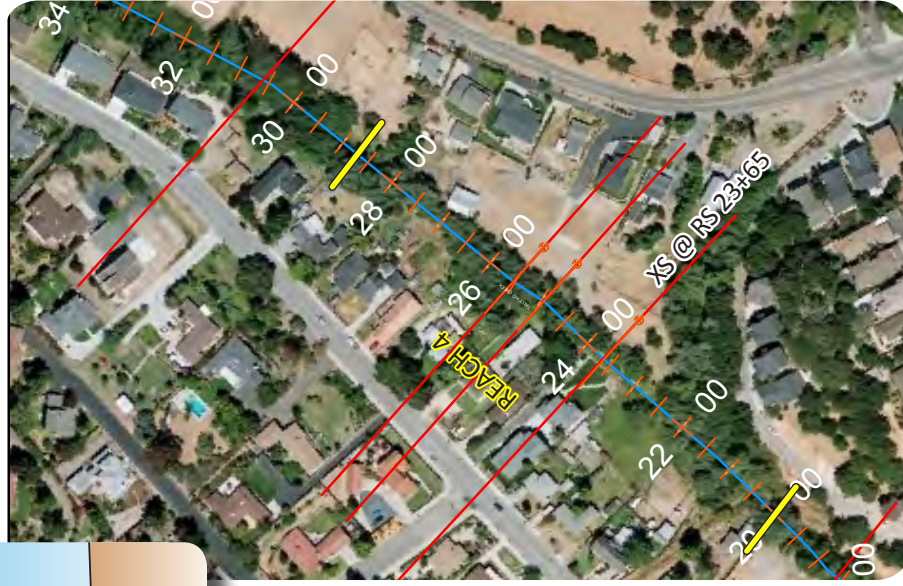
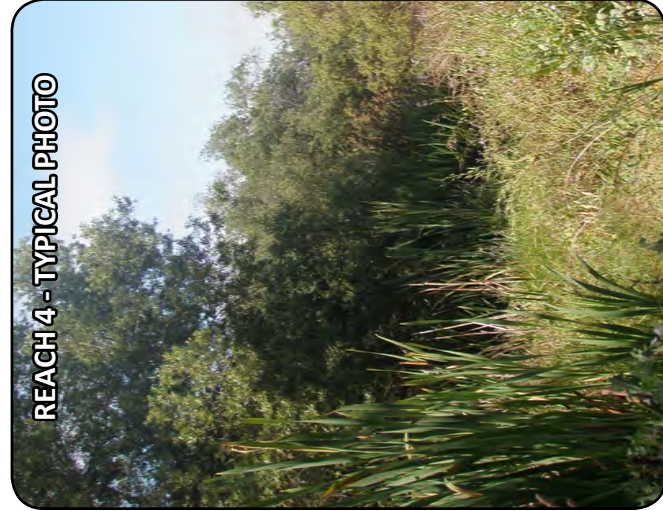
FIGURE 7
Existing conditions for Reach 4

Cross-section at RS 23+65 Reach 4

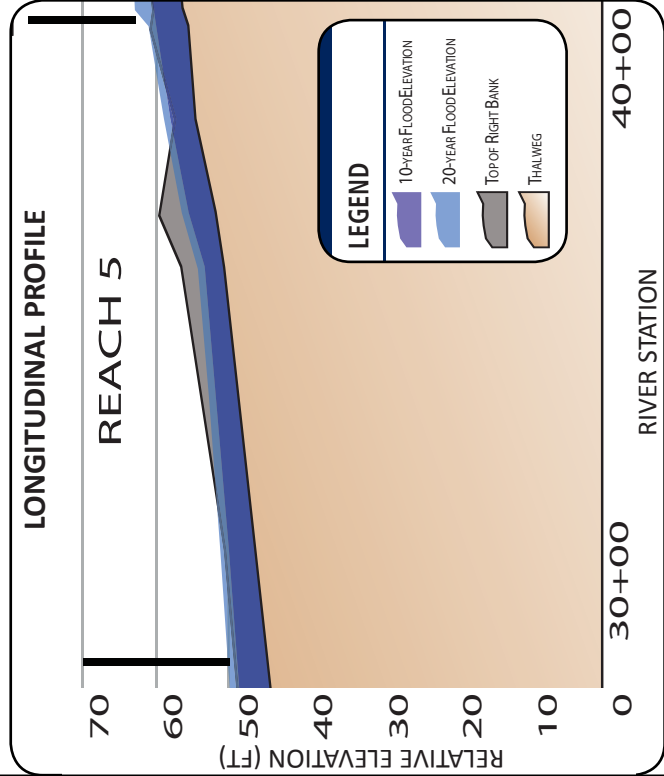
FIGURE 8
Existing conditions for Reach 5

Cross-section at RS 36+11 Reach 5

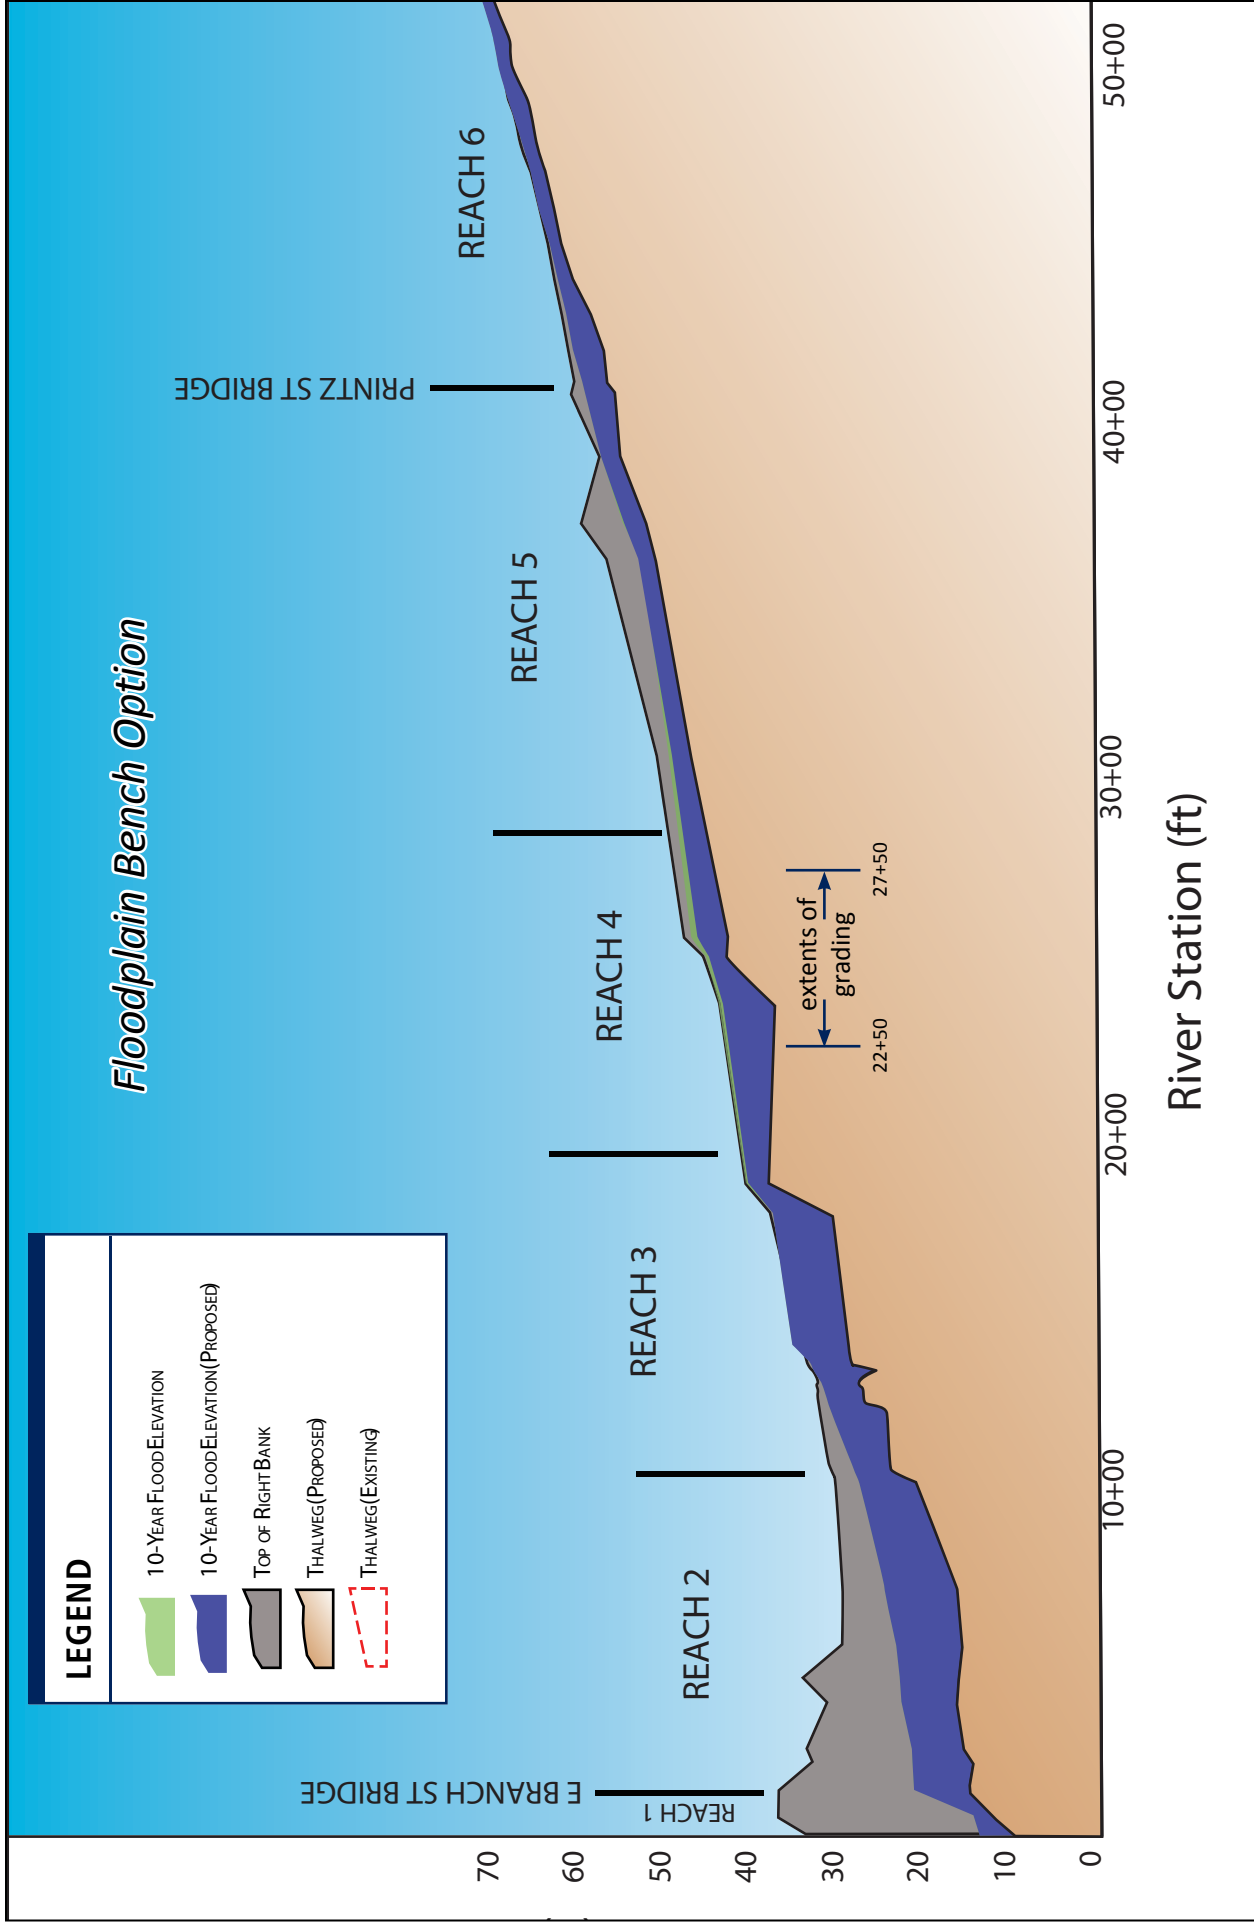
FIGURE 20 Longitudinal profile and water surface elevations for existing and proposed conditions with the floodplain bench enhancement option

During our reconnaissance level survey, a site was identified along the left bank of Reach 4 that may provide an opportunity to enhance floodplain and riparian conditions while moderately lowering local water surface elevations. The site is currently privately owned, but is mostly vacant except for what appears to be an abandoned out-building along the margins of the existing riparian area. This project could be combined with the Low Flow Channel Option or the Headcut Option to reduce local water surface elevations and provide an area of on-site mitigation for any impacts associated with those projects.
