ATTACHMENT F

Los Osos Creek Vegetation Management and Debris Removal PC-01-01

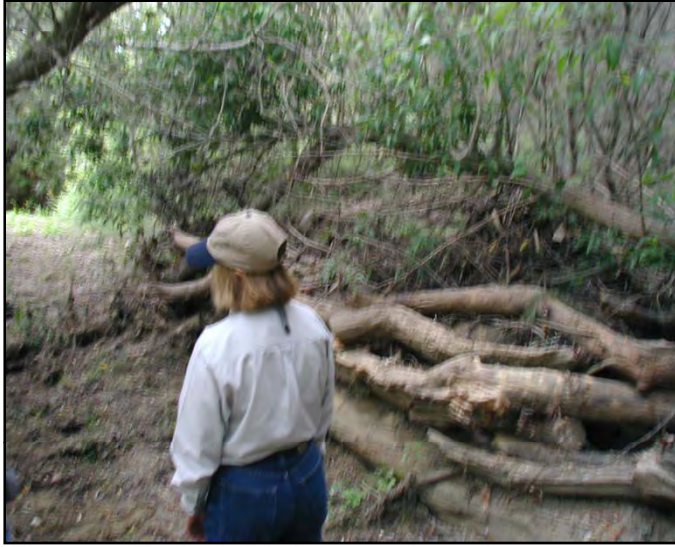
Figure 1. Typical debris to be cleared.

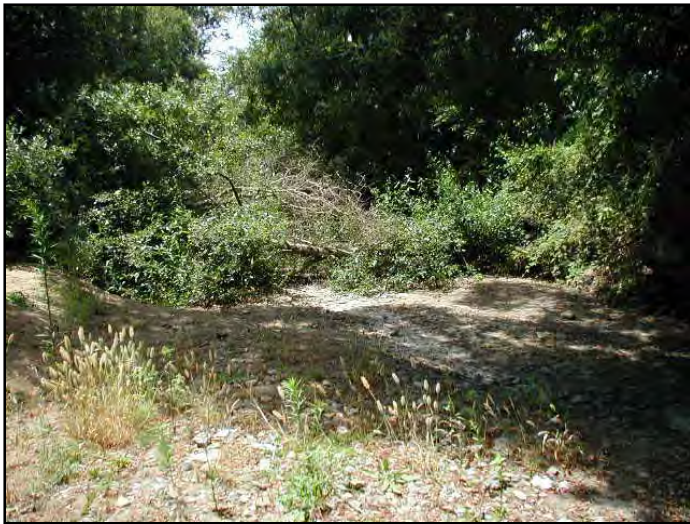
Figure 3. Typical brush to be cleared.

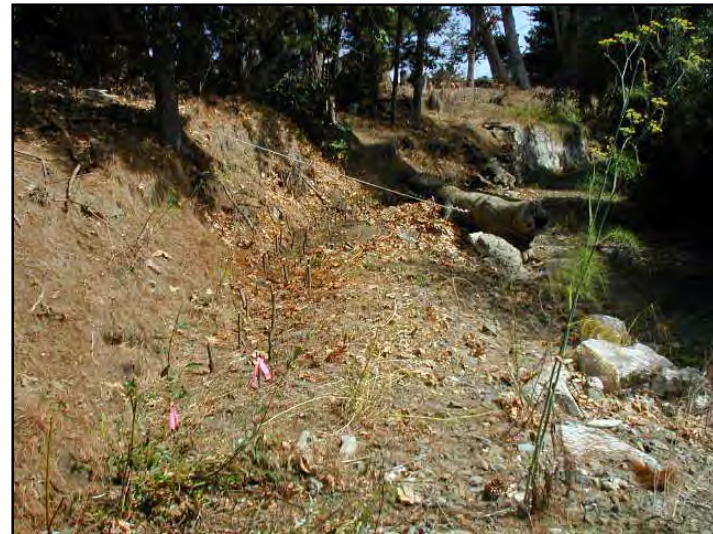
Figure 12. Note cable securing log.

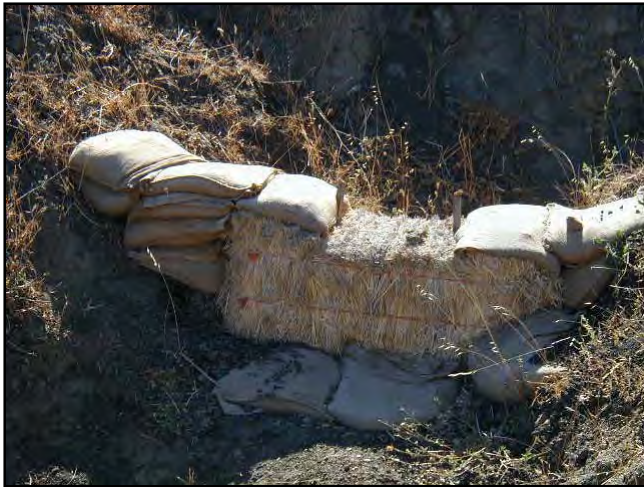
Figure 25. Straw bale and sand bag check dam

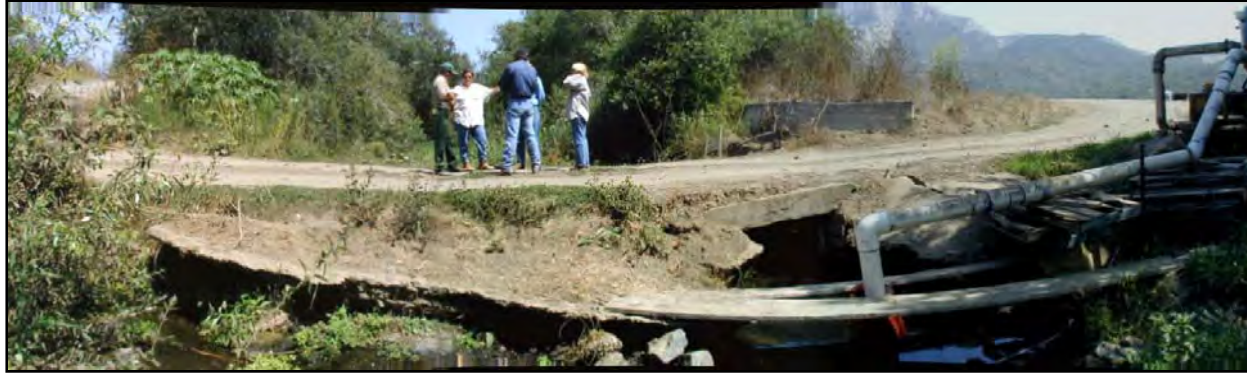
Figure 35. Existing Arizona stream crossing that was removed.

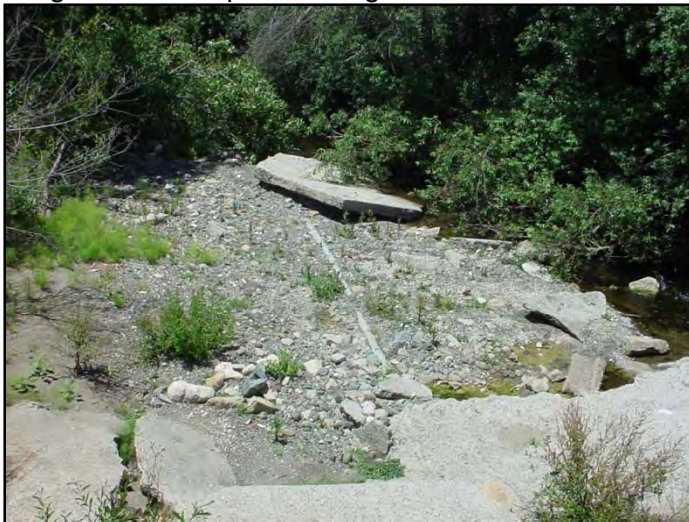
Figure 40. Concrete debris before removal.

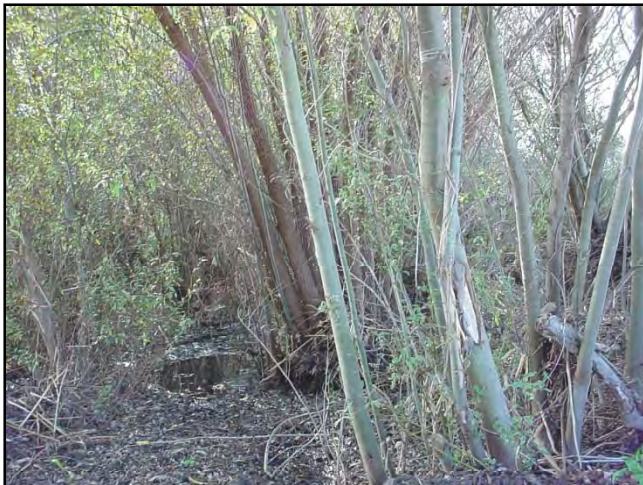
Figure 44. Channel partially pruned.

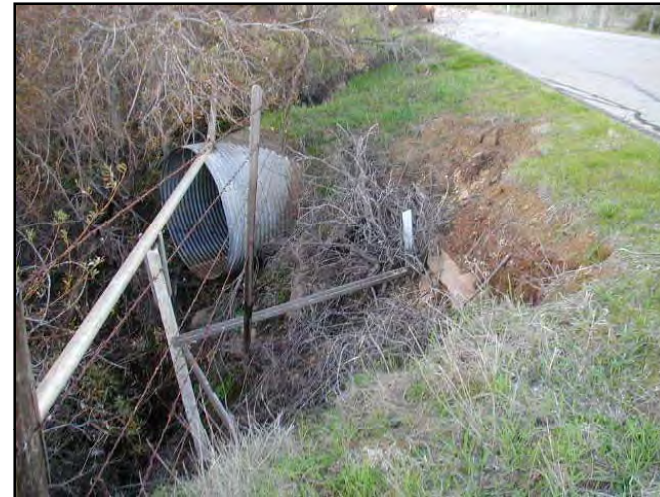
Figure 47. Source of head cut; 15 foot drop off.

Resource concern: The head cut at the culvert and sloughing bank contribute to sediment loading into this tributary to Warden Creek.

Solution: Installed coir logs to stabilize bank.

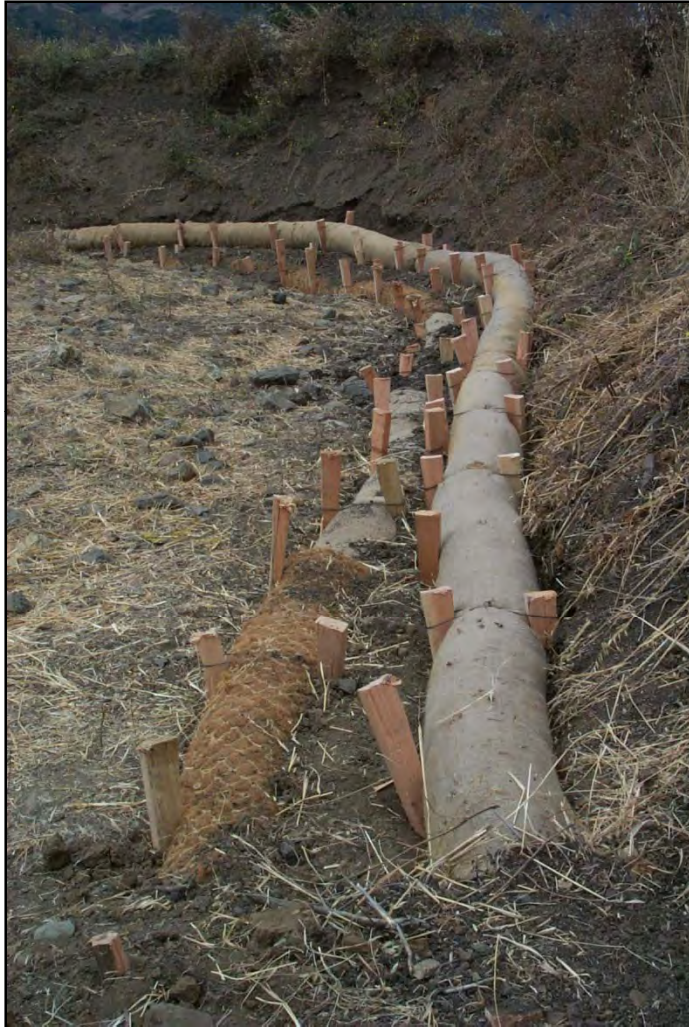
Figure 51. Installed coir logs.

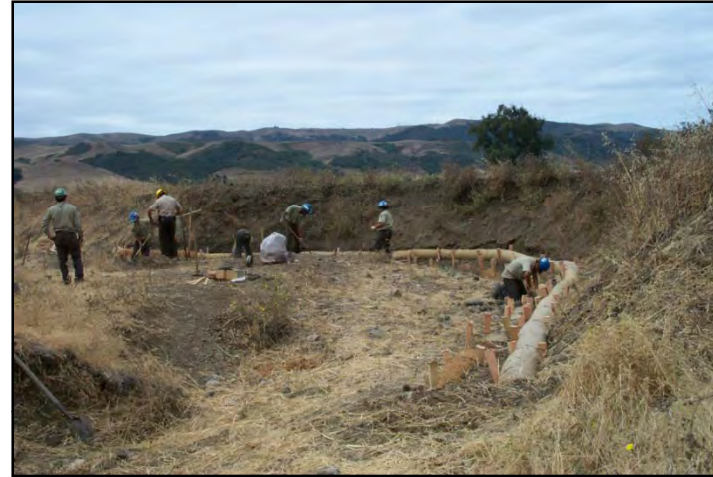
Figure 52. Installing coir logs.

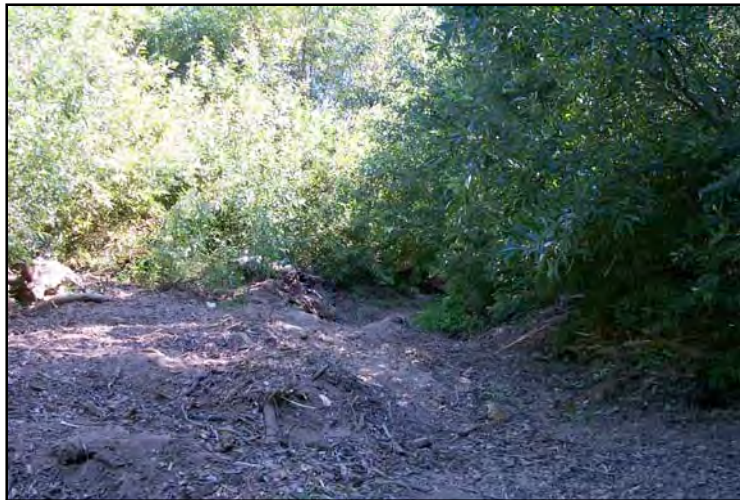
Figure 58. Same debris jam as above after CCC crews cleared it.

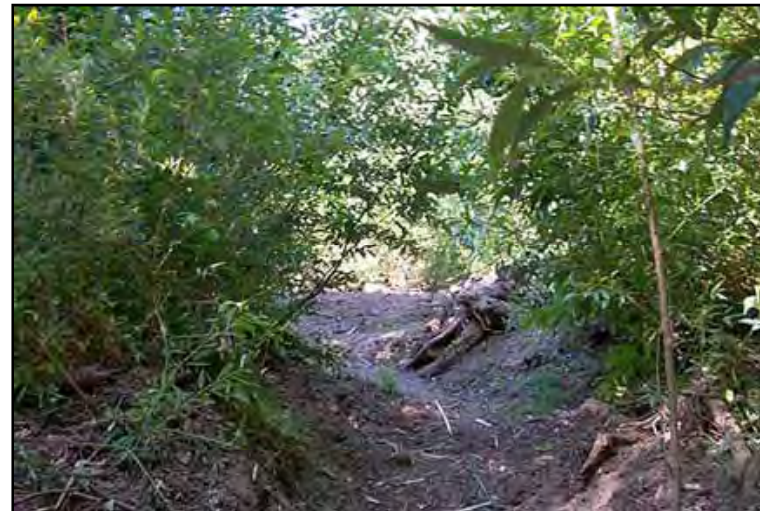
Figure 59. Channel opened up after CCC crews cleared debris

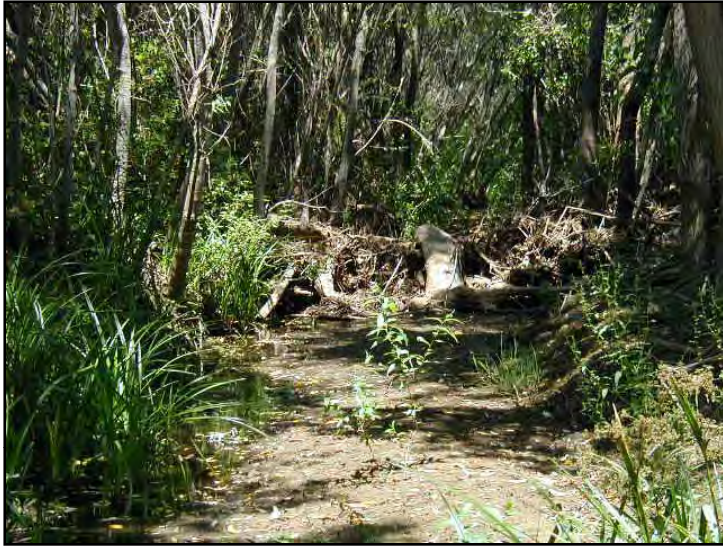
Figure 60. Debris jam in Los Osos Creek

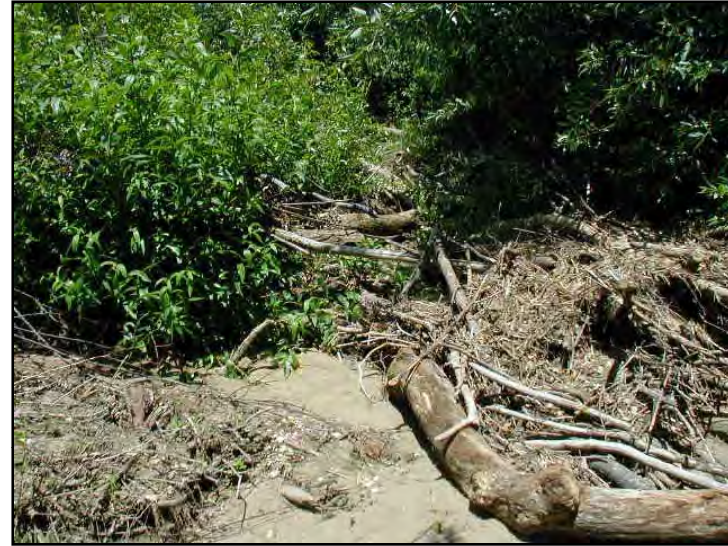
Figure 61. Debris jam in Los Osos Creek

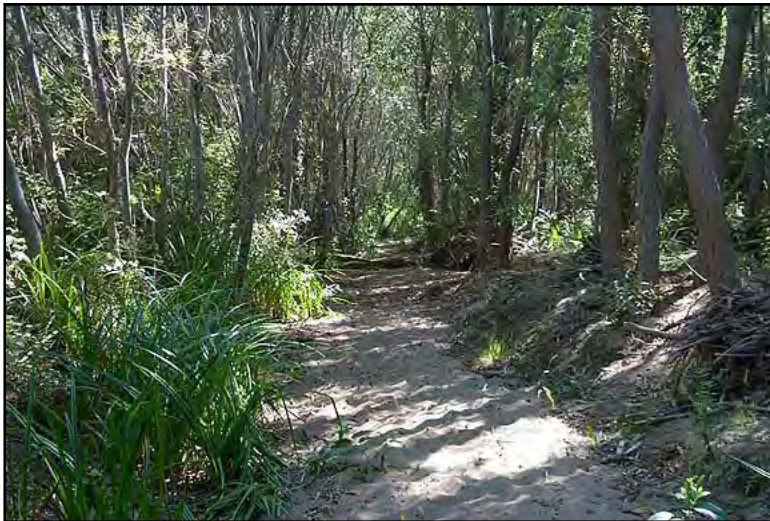
Figure 62. Debris jam in Los Osos Creek after CCC clearing

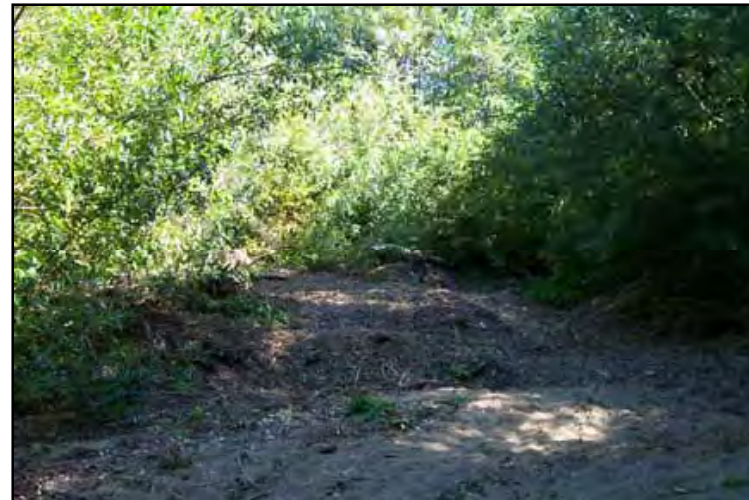
Figure 63. Debris jam in Los Osos Creek after CCC clearing

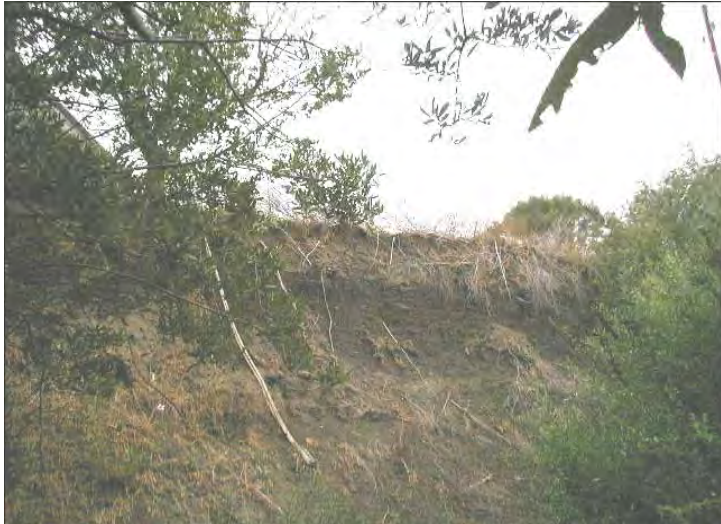
Figure 70. Eroding stream bank.

Project: The RCD funded the CCC's to install 60 feet of stream bank restoration downstream of Canet Road on Chorro Creek.

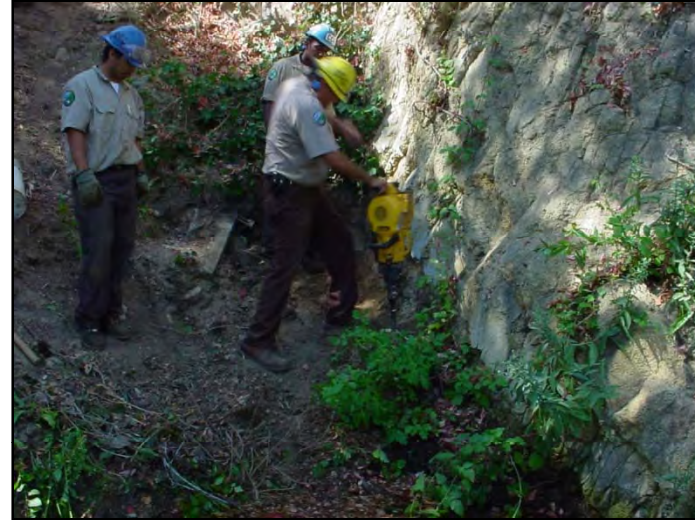
Figure 71. CCC hand digging and jack-hammering rock & soil out of site .

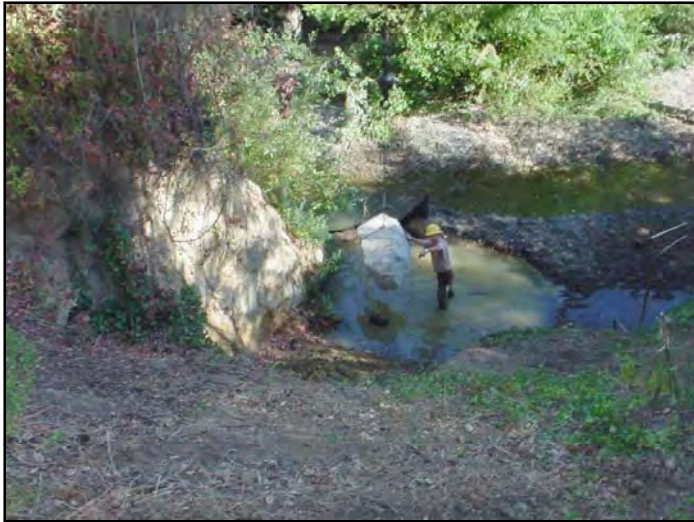
Figure 74. Boulders were craned in and guided into place by CCC.

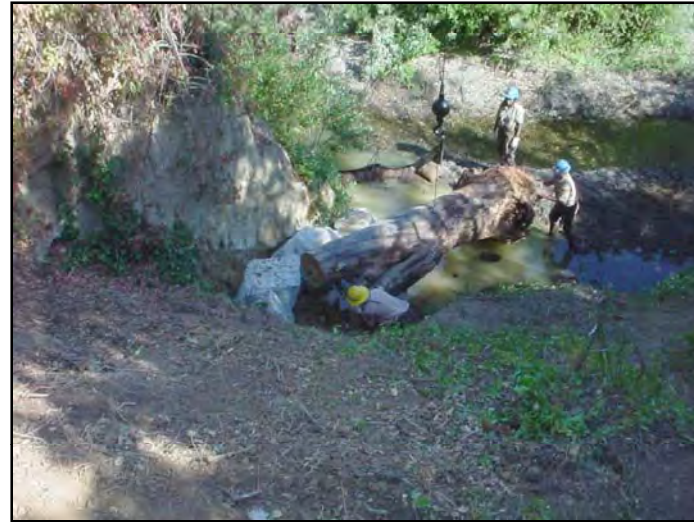
Figure 75. Corps members installing craned in root wad.

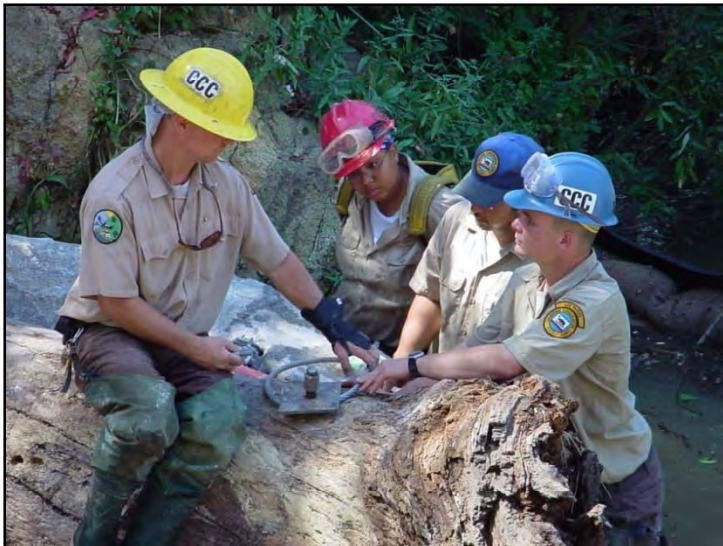
Figure 76. Corps members installing cabled boulders and root wad.

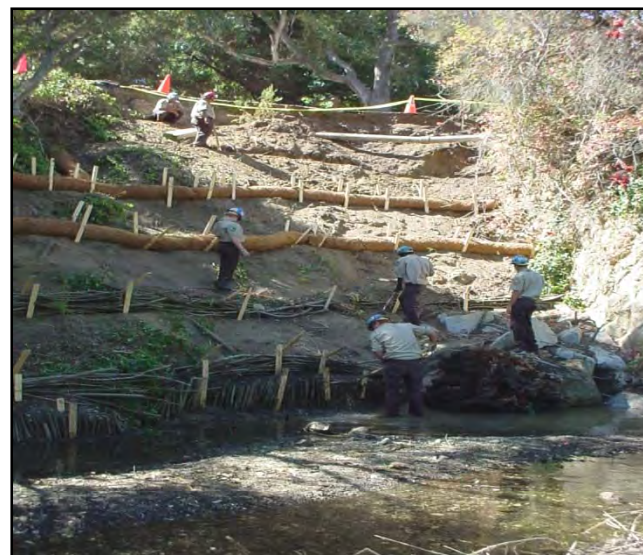
Figure 77. View of bio logs and laid back slope.

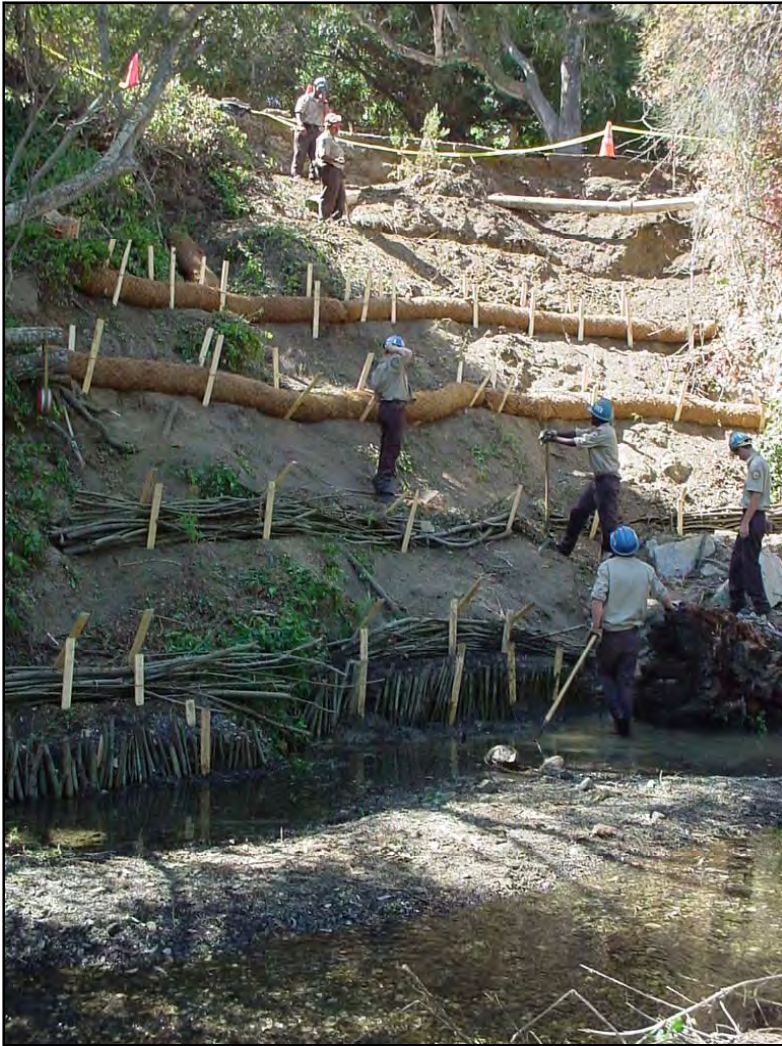
Figure 78. Willow stakes and facines being installed by CCC.

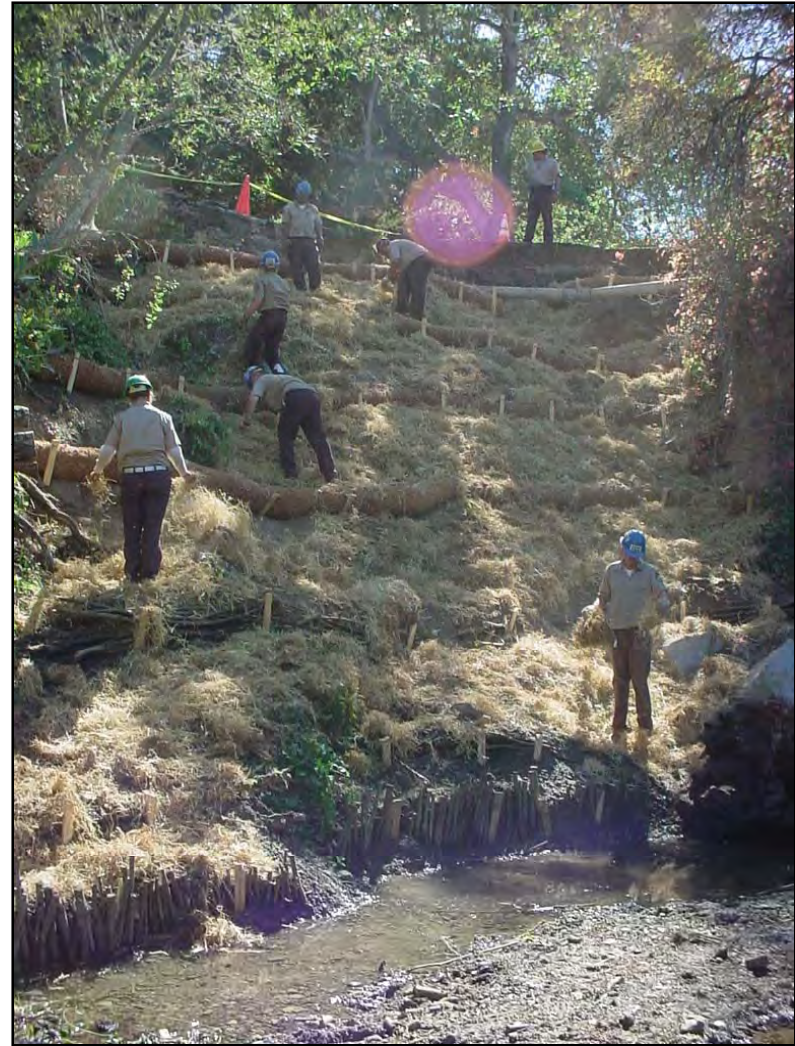
Figure 79. Straw applied for erosion protection being secured by CCC crews.

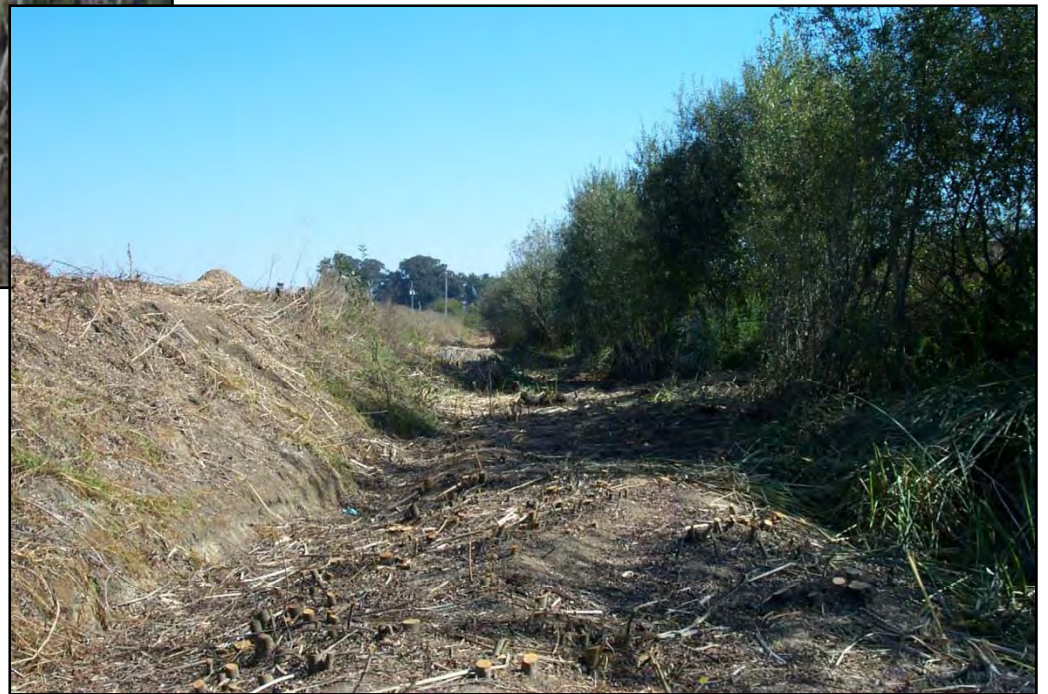
Figure 81. After pruning of willow in the center of the channel. Re-vegetation planting took place the following winter on the north side of channel.

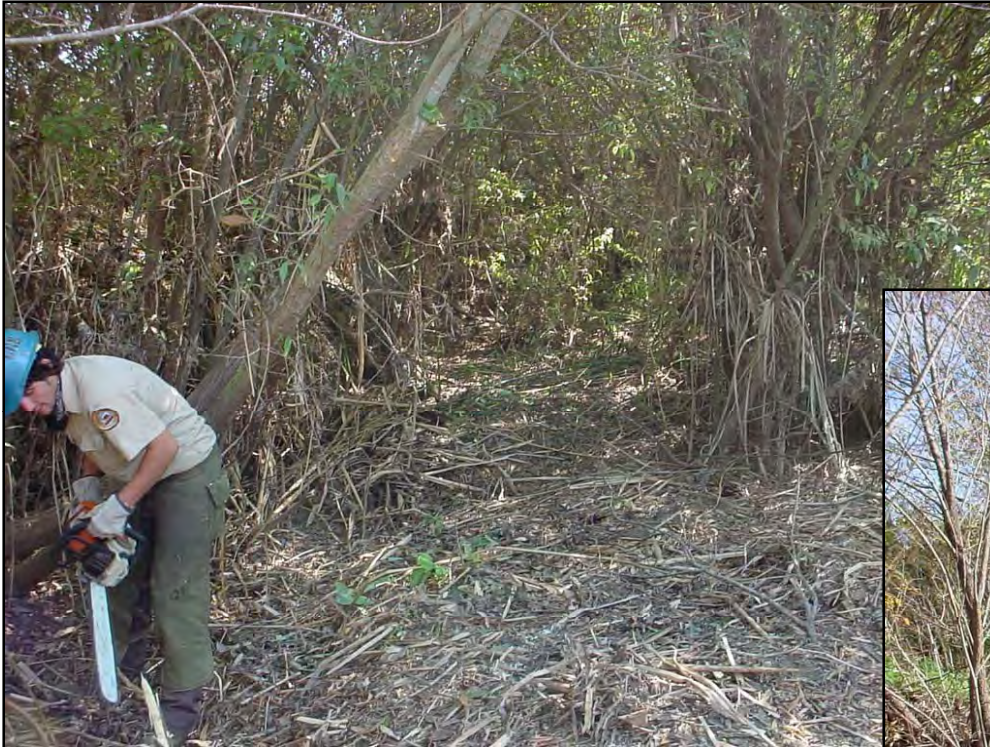
Figure 82. Small willow thinned and large willow in the center of the channel were pruned up for canopy.

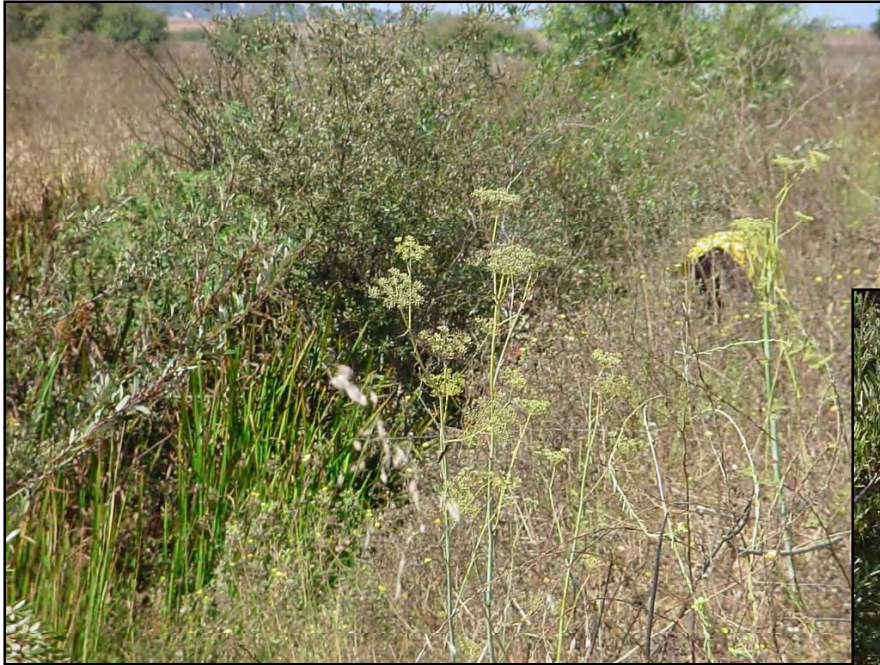
Figure 84. This reach included pruning willow in the center of the channel and pruning up larger willow for canopy.

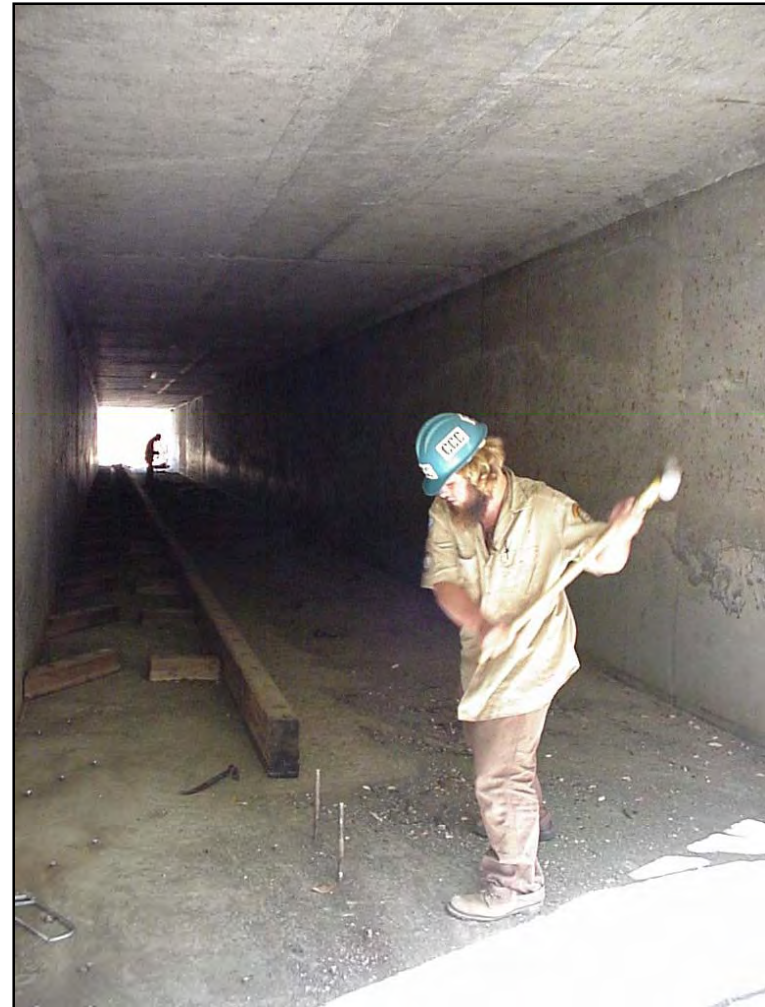
Figure 88. CCC crew member removing baffles.

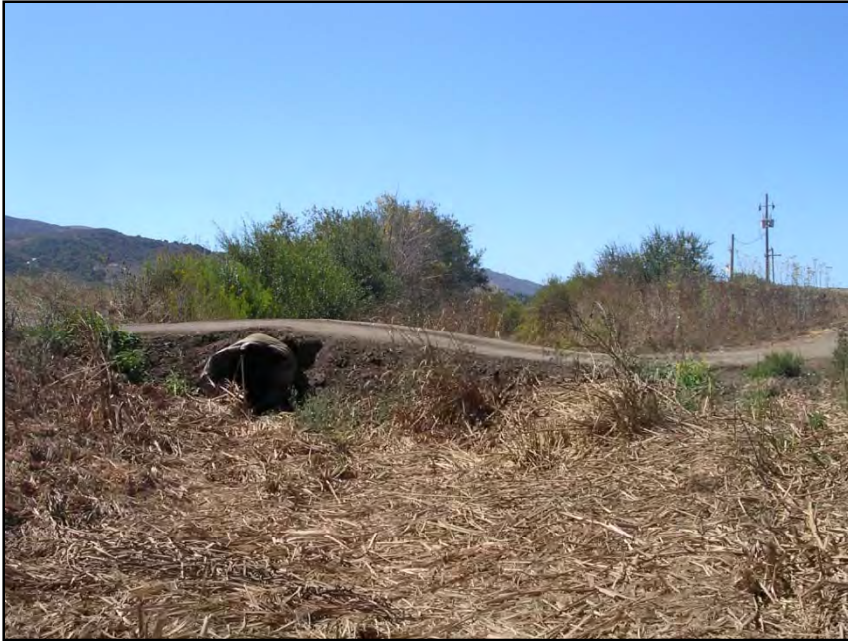
Figure 89. Looking downstream at Warden Creek crossing.

Project: The RCD designed a creek crossing to replace an Arizona type crossing that regularly washes out in winter storms.

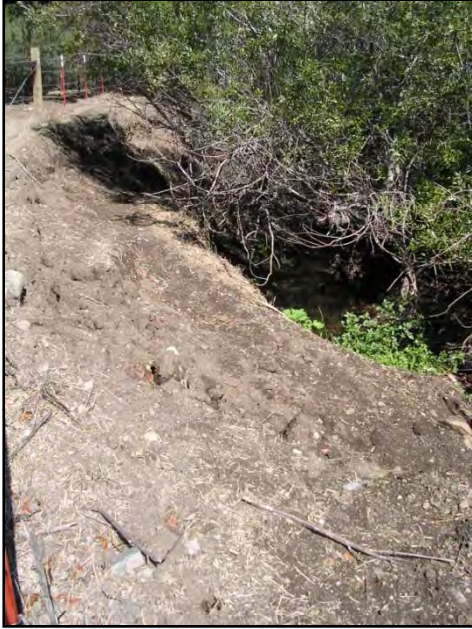
Figure 100. Sloughing bank due to seep.

Project: At the request of Cal Poly, the RCD designed and funded a series of road improvement projects along an access road paralleling Pennington Creek as well as removed a failed stream crossing and installed 3,000 feet of riparian fencing.

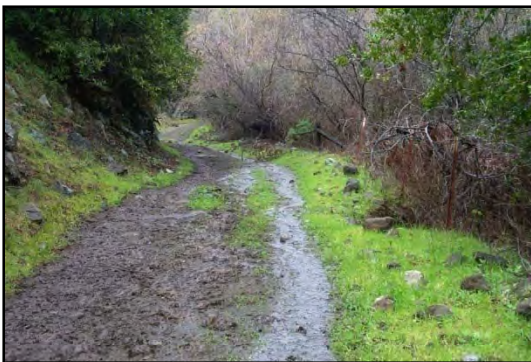
Figure 103. Water running down road.

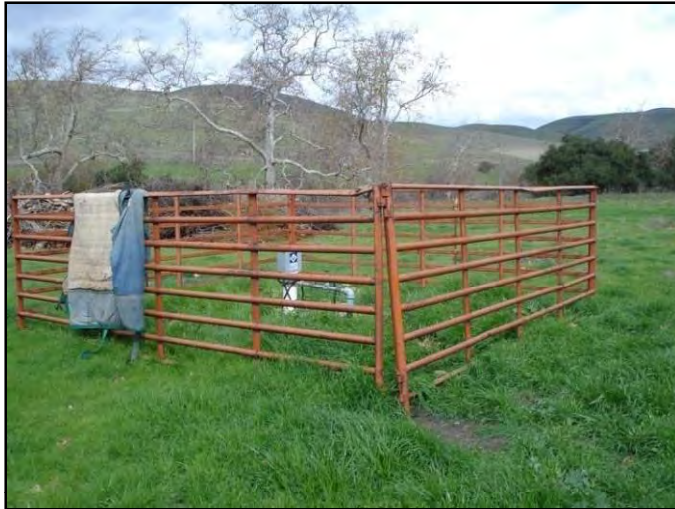
Figure 122. Well and generator (Feb 2009).

Post-implementation photos: A site visit conducted February 6, 2009 found the riparian fencing and off-creek watering system in excellent condition.

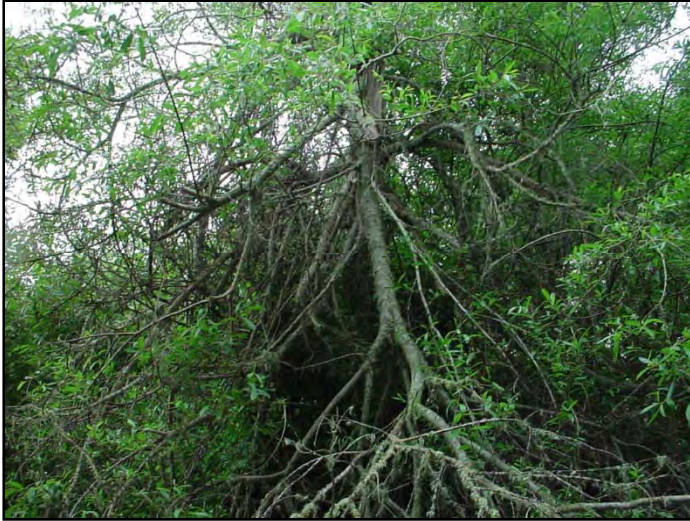
Figure 125. Broken limbs and downed trees are bucked up and removed.

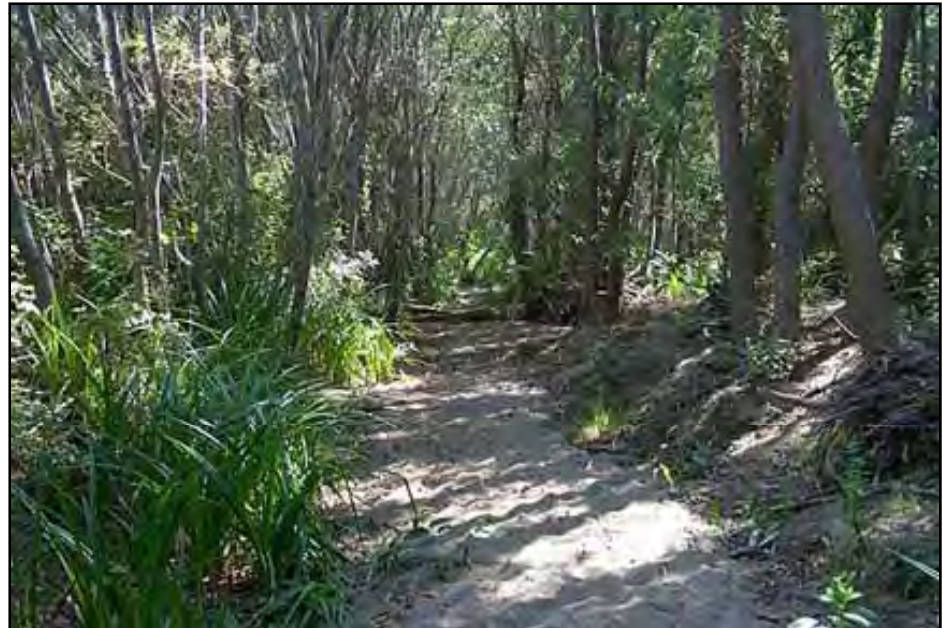
Figure 130. Channel after debris jams are cleared.

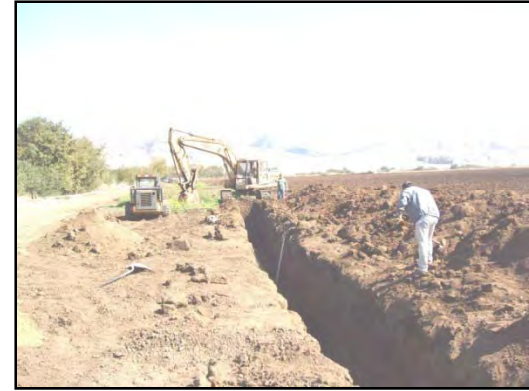
Figure 136. Installation by excavator.

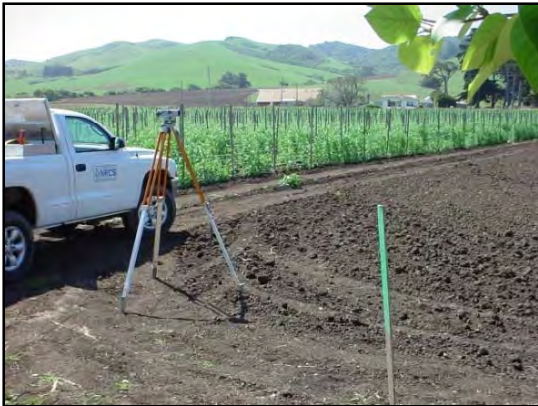
Figure 137. The pipeline was surveyed.

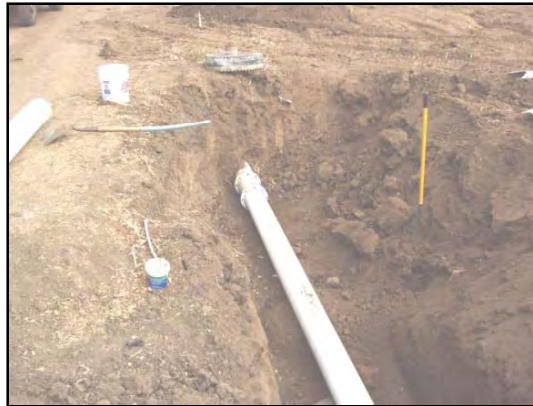
Figure 138. Connected to an existing line.

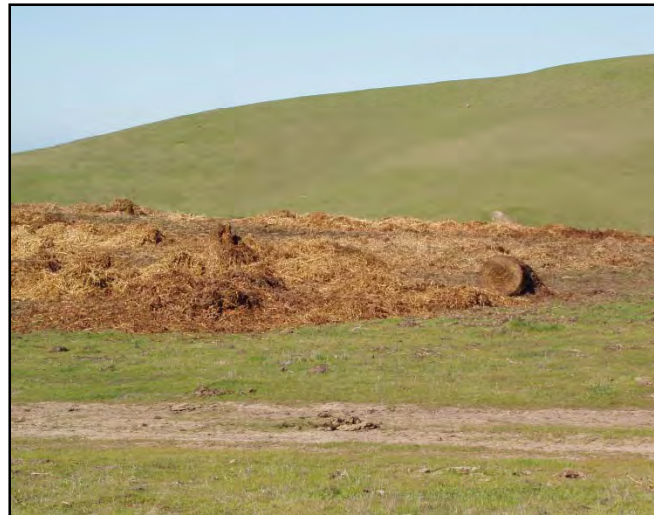
Figure 142. Hay bales were used to minimize erosion.
