**San Luis Obispo County
Flood Control and Water Conservation District**

**2005/2006 Annual On-Site Inspection of the
Arroyo Grande Creek Channel and
Los Berros Creek Diversion Channel**

December 15, 2006

Report prepared by:
Nola Engelskirger
San Luis Obispo County Public Works Department

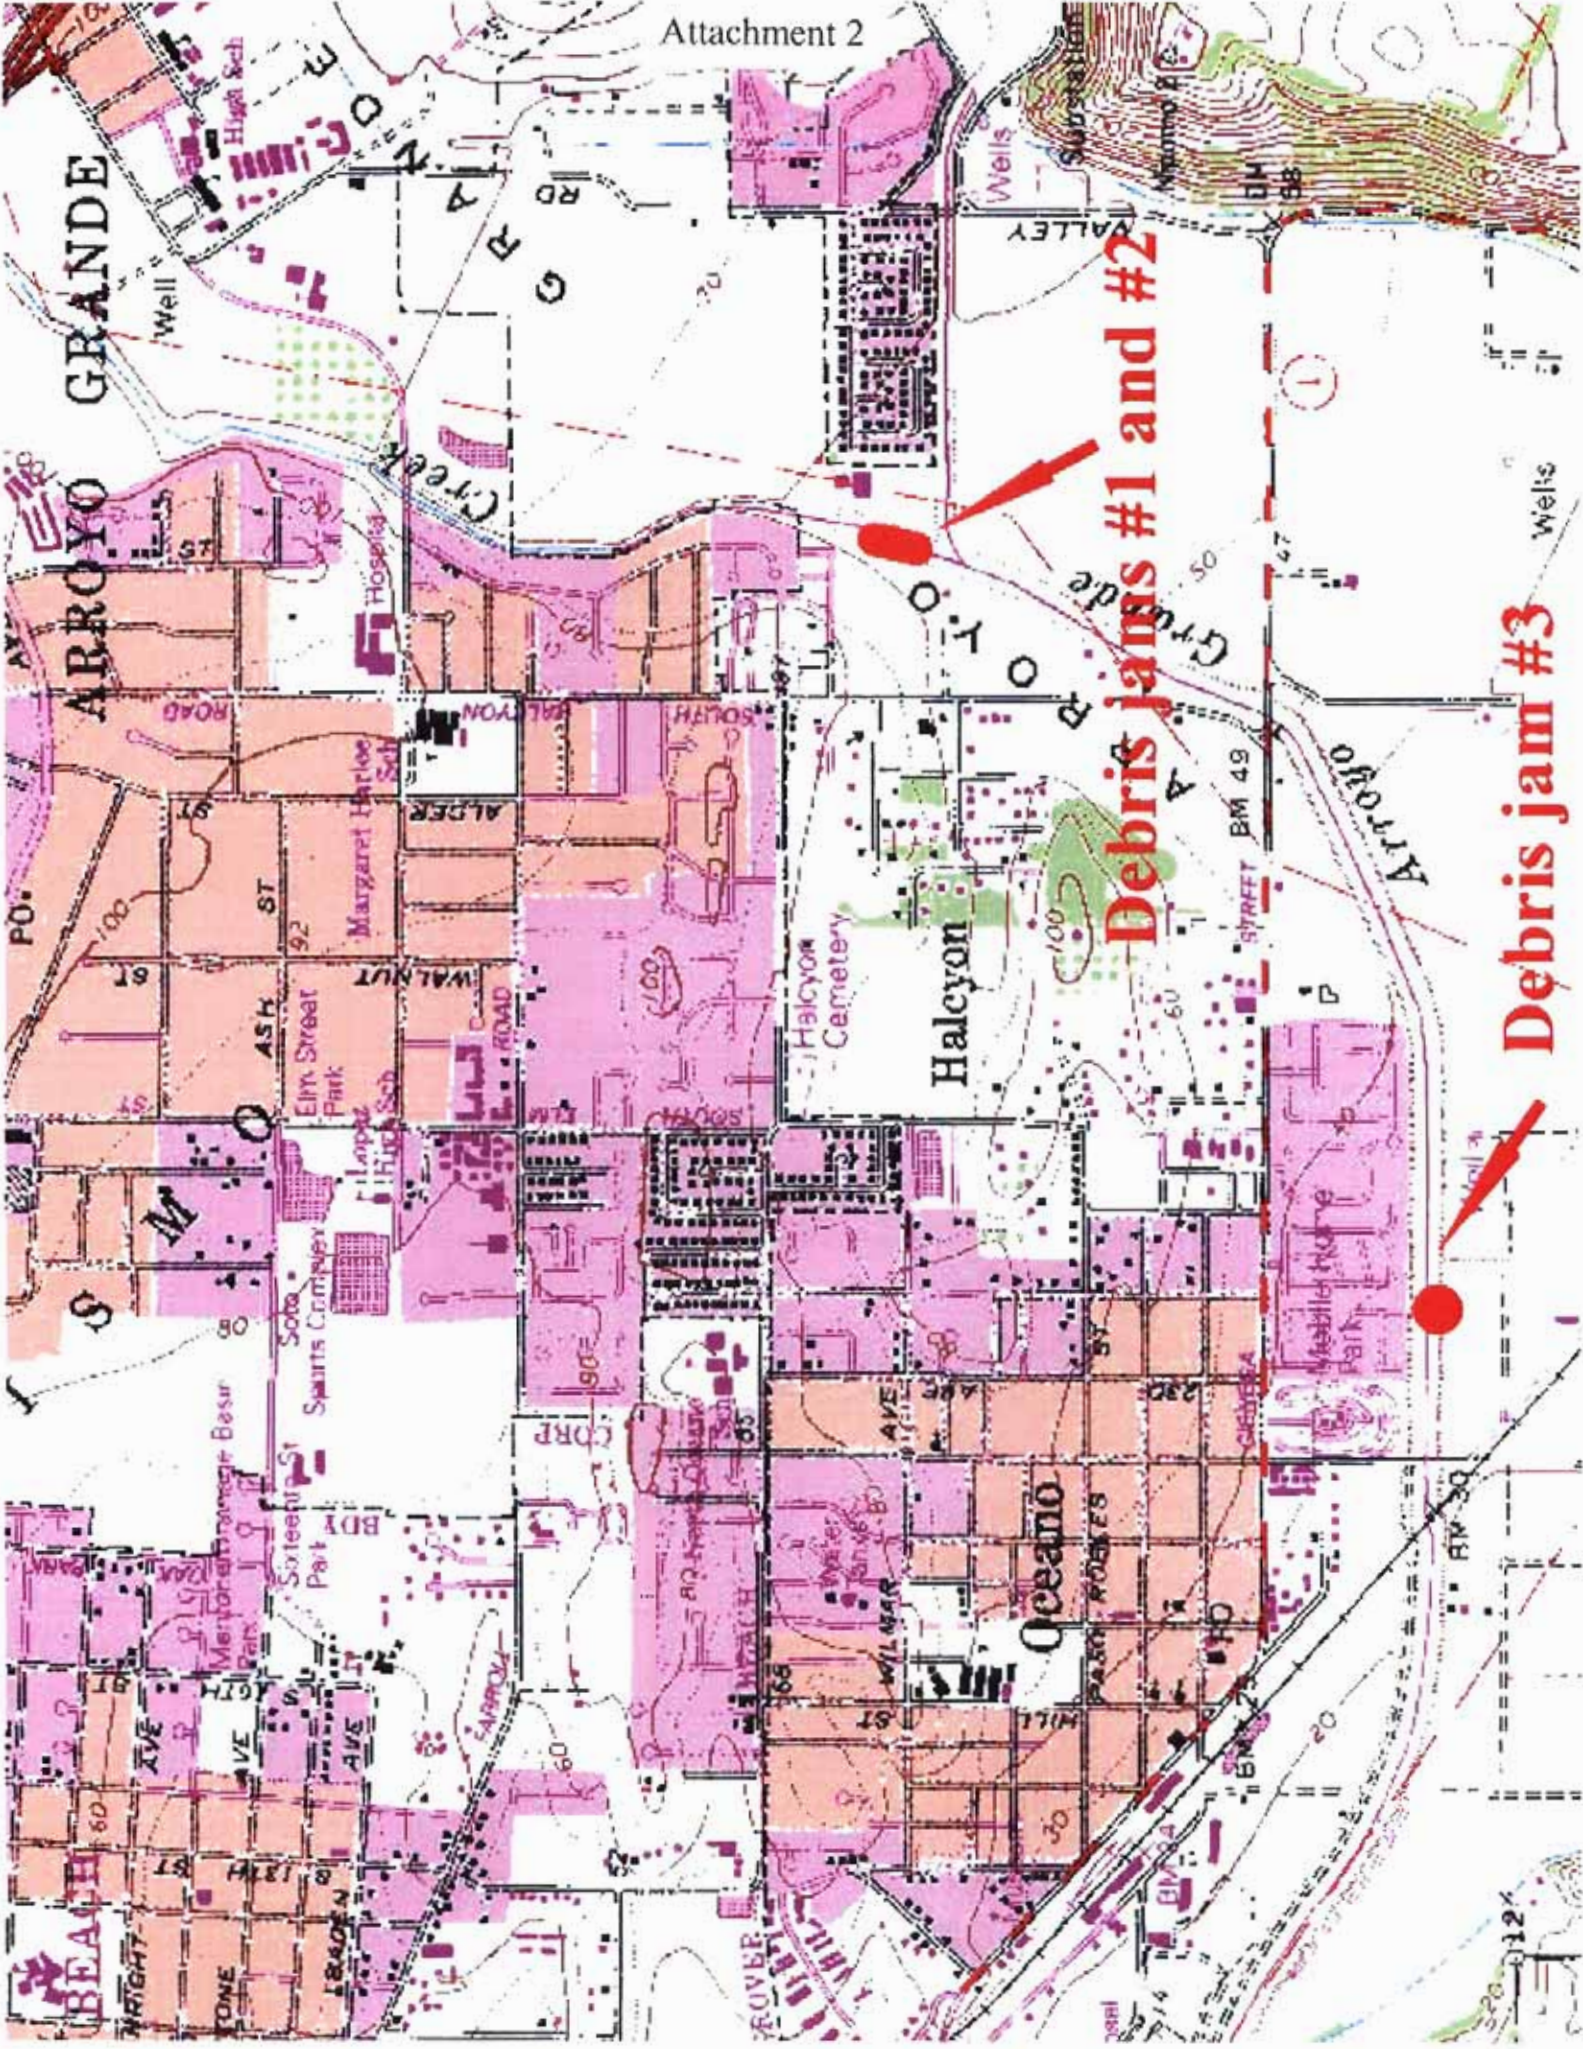
Two debris jams were located approximately 100-feet downstream of the northern Zone 1/1A boundary. The first debris jam is upstream of an arundo stand and the other was downstream from the first, atop a beaver dam. The location of the third debris jam was located downstream of the Highway 1 bridge in the vicinity of the mobile home parks. Photos of the debris jams have been attached to this report as reference.

The debris jams appeared to be caused by trees that had been chopped down on the banks of the channel, but had not been removed from the channel. The trees were not chopped down during the vegetation maintenance coordinated by the CSLRCD or the SLCFC&WCD, but had apparently been chopped down and left by a resident who probably thought that they were helping by cutting down the trees, not knowing that the cut limbs would cause jams if left on the bank.

Debris jams #1 and #2

Debris jam #3

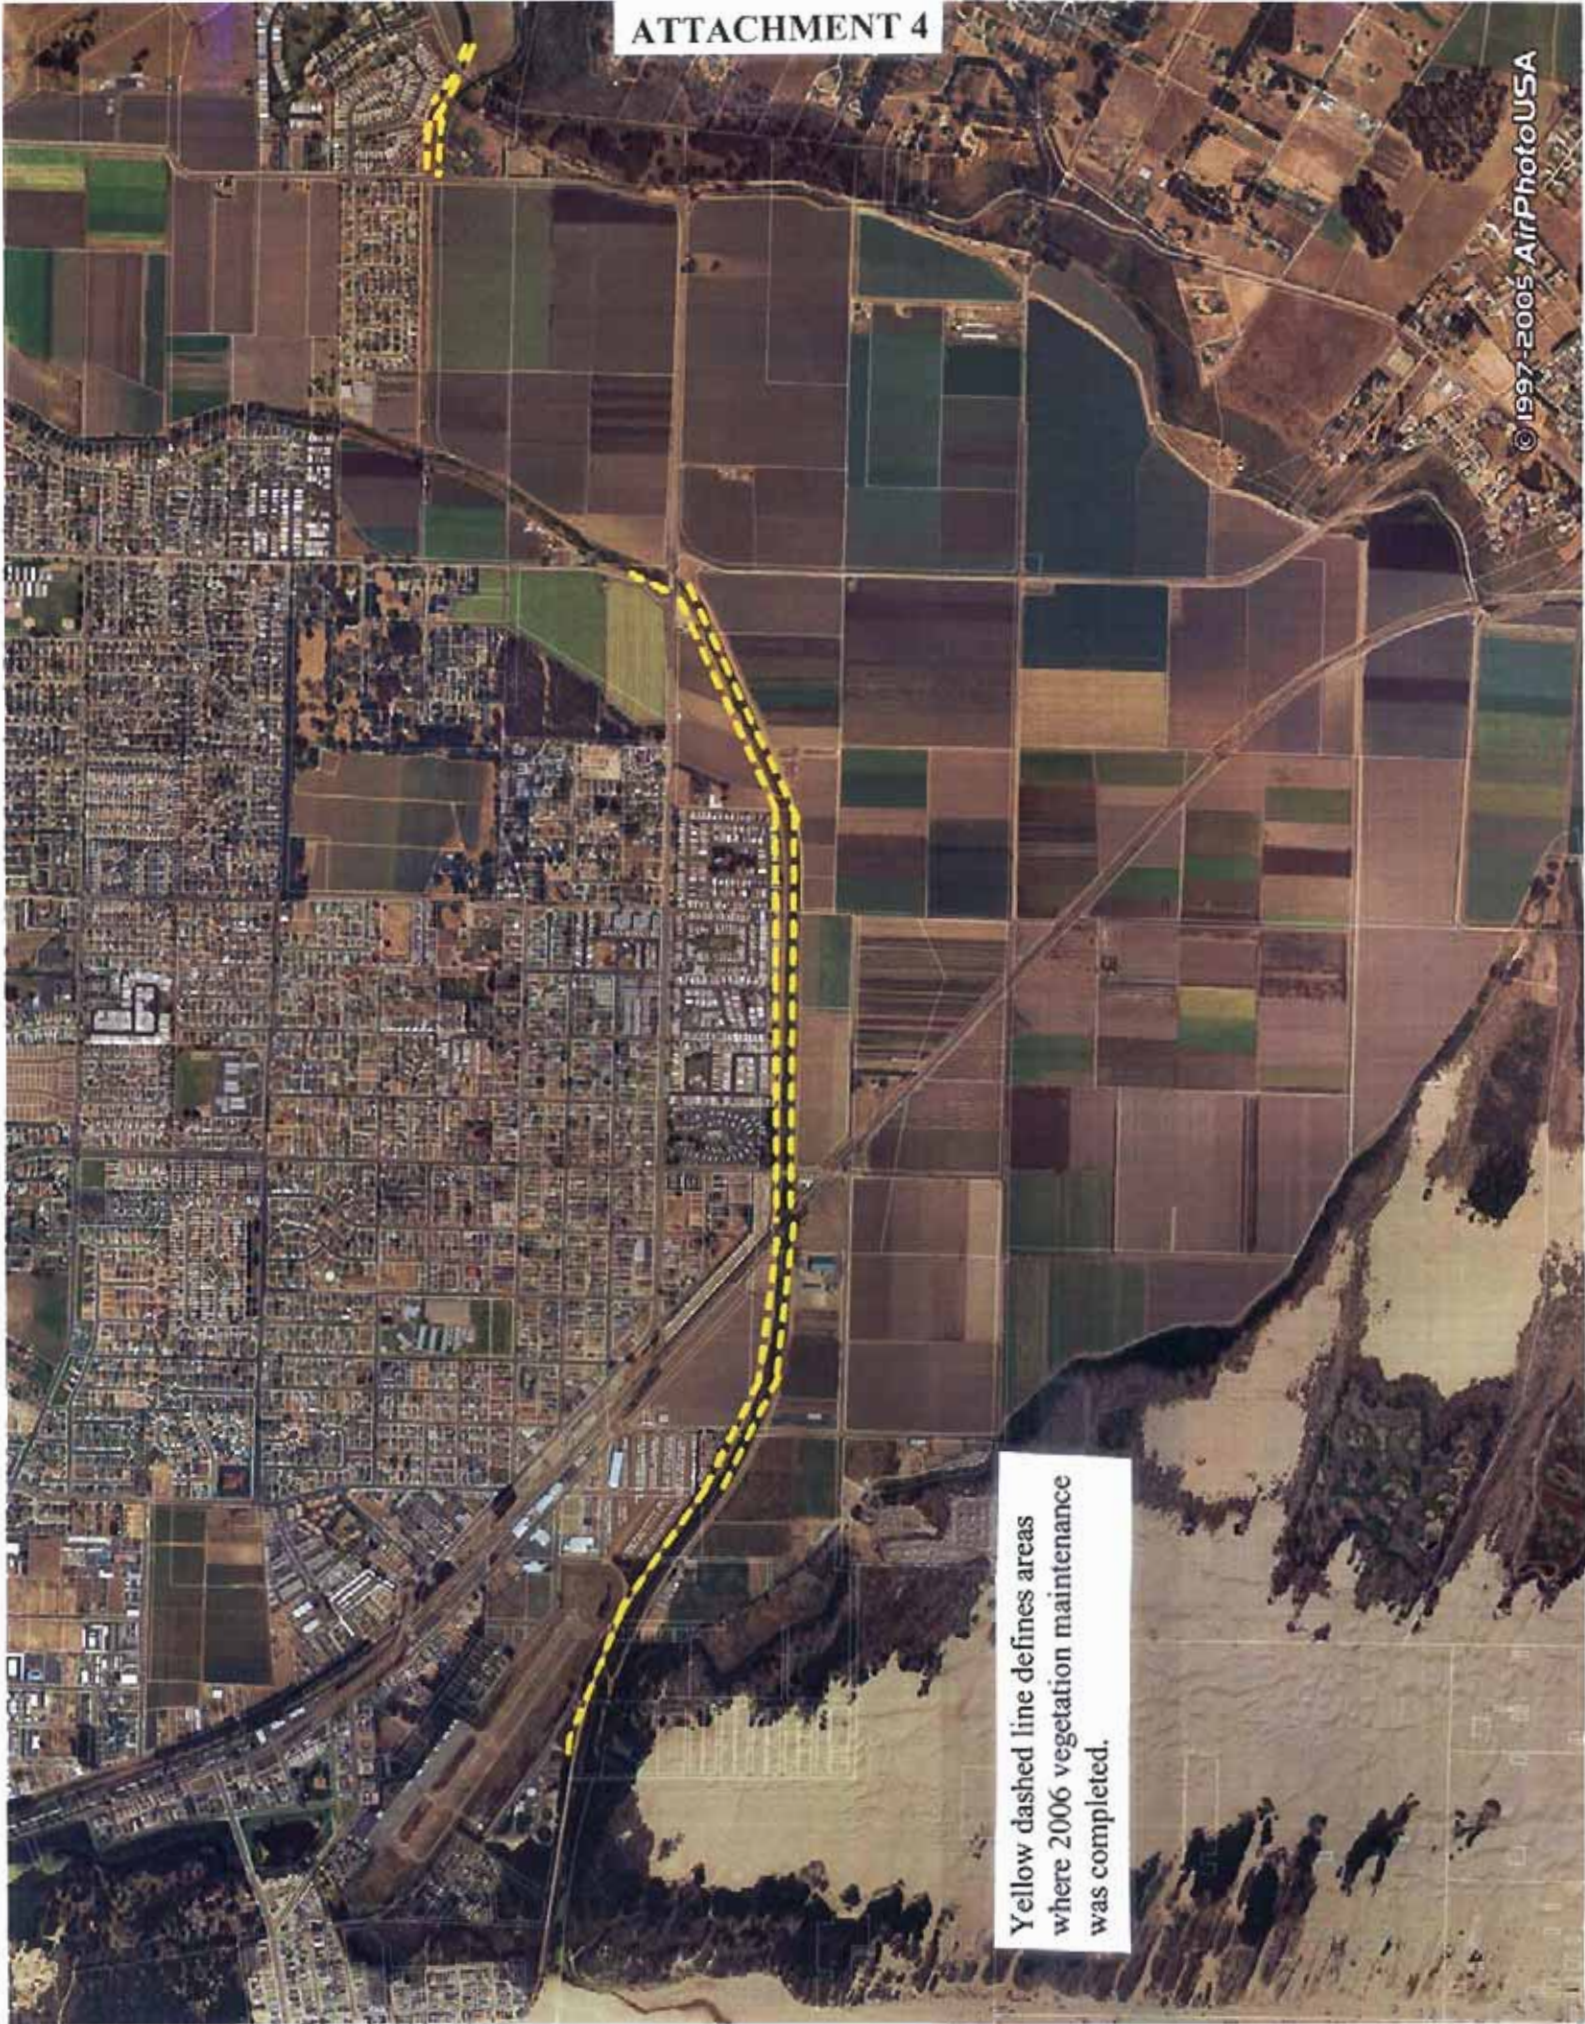
- c. In vicinity of Station 55+00 on north levee, a homeless camp was observed. See Attachment 5, photos 1 and 2.
 - d. Along the north levee, east of the 22nd Street bridge, several bags of garbage and a truck liner filled with garbage were dumped. See Attachment 5, photo 3.

Photo 1:
Homeless Camp on north levee, below the railroad bridge – view from south levee
