**Stenner Creek Erosion Control and  
Sediment Reduction Plan,  
California Polytechnic State University,  
San Luis Obispo County, California**

**PWA Report No. 231039902  
April 2023**

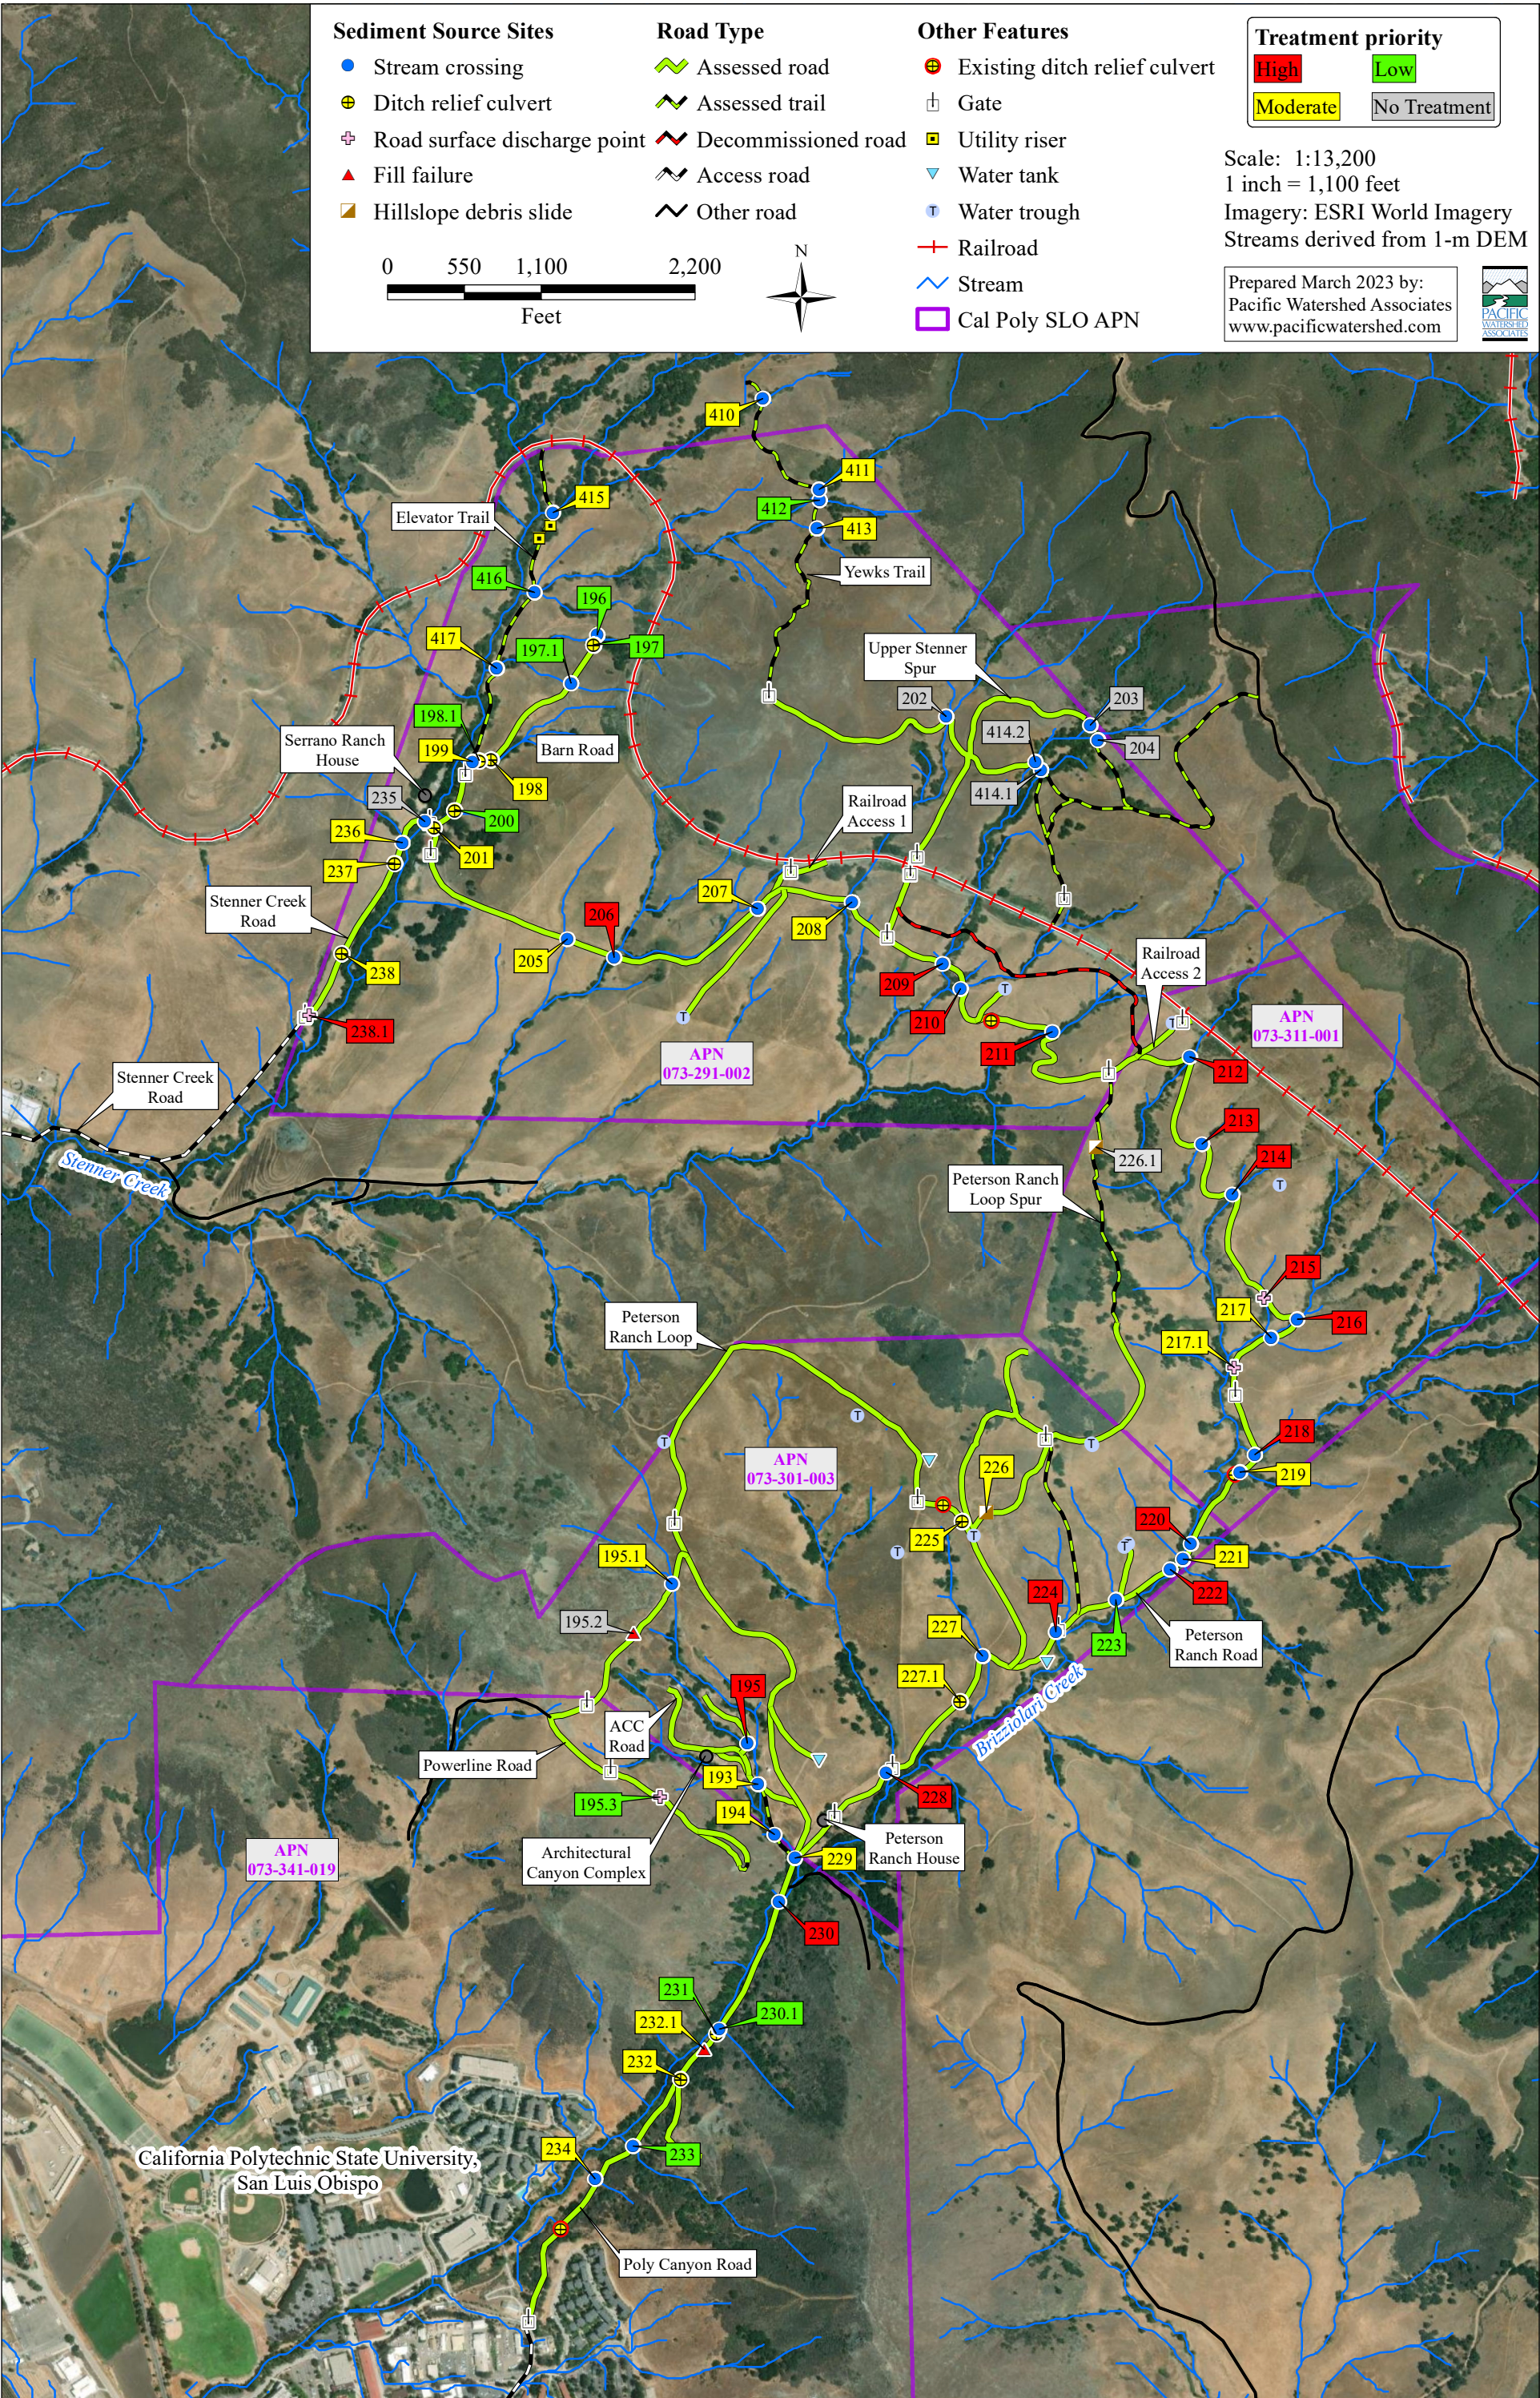
Map 2. Sediment Delivery Sites and Assessed Roads with Prioritization, Stenner Creek Erosion Control and Sediment Reduction Plan, California Polytechnic State University, San Luis Obispo, California

of rain<sup>2</sup>. Extensive damage to existing stream crossings, roads, and trails on the Serrano Ranch and Peterson Ranch occurred as a result of that and other high intensity rainstorms throughout the winter 2023 months. The damage included two culvert washouts at two stream crossing sites along mainstem Brizziolari Creek, one moderate size landslide along Poly Canyon Road (Map 2).

Inventoried sites for this assessment area primarily consist of stream crossings, gullies below ditch relief culverts, isolated fillslope failures, and various discharge points (e.g., roadside gullies, berm breaks, waterbars) for uncontrolled road surface and/or inboard ditch runoff. For each site identified as a potential sediment delivery source, PWA staff plotted its location on the GIS-generated base map, and recorded a series of field observations on a data form including (1) detailed site description, (2) nature and magnitude of existing and potential erosion problems, (3) likelihood of erosion or slope failure, (4) length of hydrologically connected road surface associated with the site, and (5) treatments needed for prevention or elimination of future sediment delivery. The data collected for each site also includes an evaluation of treatment immediacy, based on the potential or likelihood of sediment delivery from the site to stream channels in the watershed, and the level of urgency, i.e. priority, for addressing erosion problems at that location. Stream crossing sites were additionally evaluated for potential fish barrier problems.

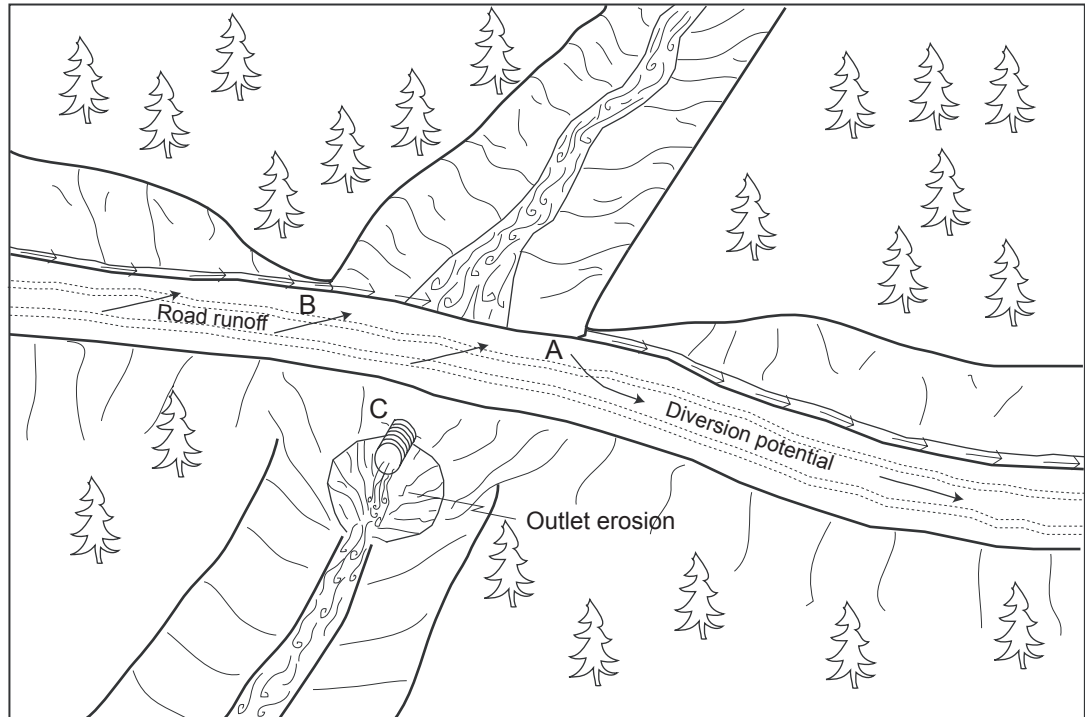
## Problem condition (before)

- A - Diversion potential
- B - Road surface and ditch drain to stream
- C - Undersized culvert high in fill with outlet erosion

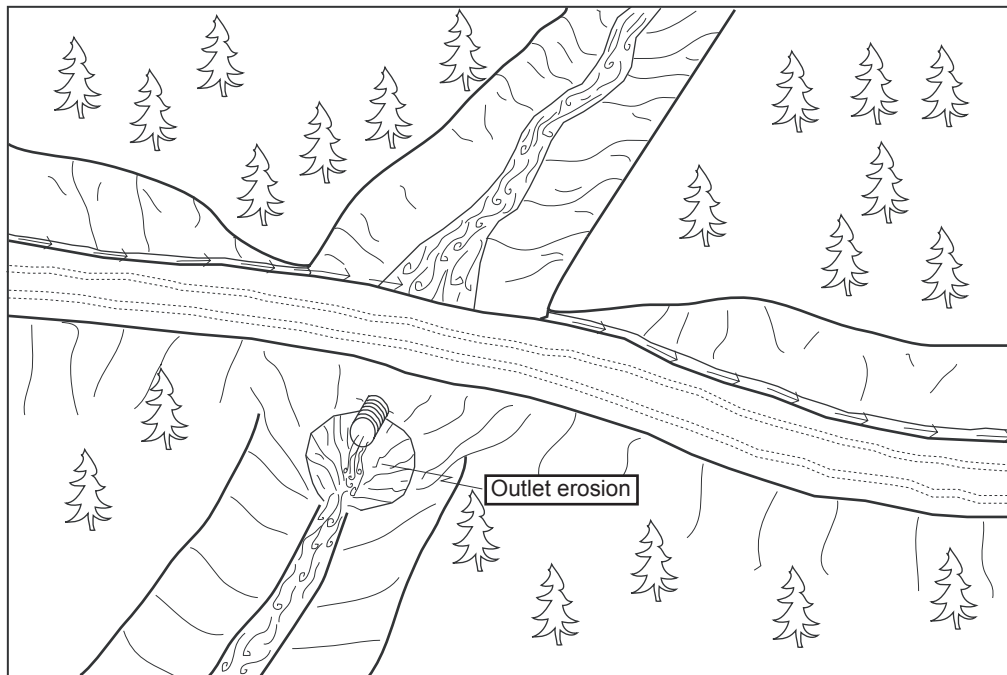
PWA Typical Drawing #1a

**Problem:** Culvert set high in outboard fill has resulted in scour of the outboard fill face and natural channel.

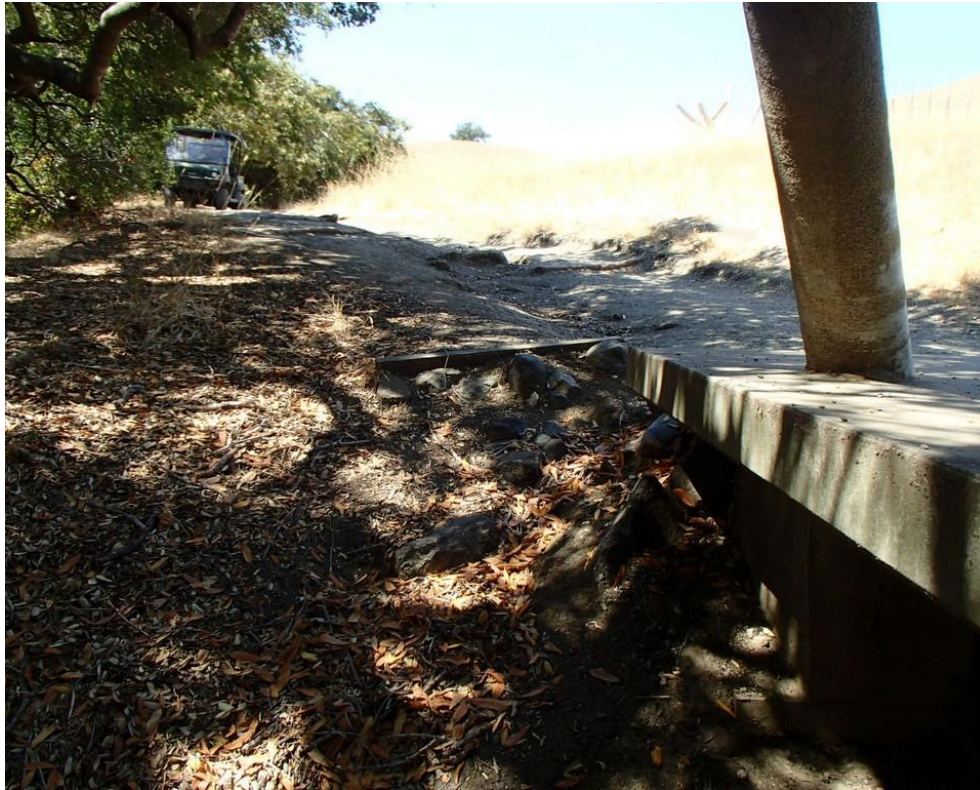
**Photo 3.** Site 194 (Architectural Canyon Complex Rd.): Looking up the left trail at road surface discharge point adjacent to stream crossing Site 194. Concrete bridge is visible in the right edge of the frame. No proposed work at the bridge, trail only.

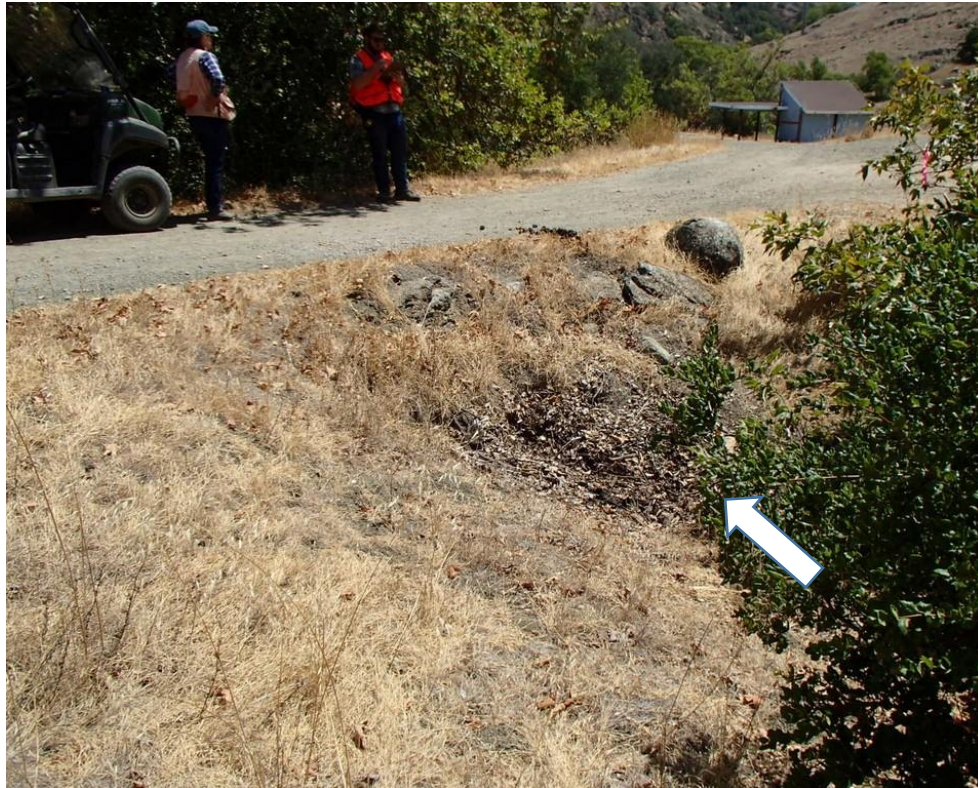
**Photo 5.** Site 195 (Architectural Canyon Complex Rd.): View of Site 195 looking obliquely at the stream crossing. The undersized culvert inlet is plugged with organic matter at the center of the frame (see arrow). Partial view of right approach.

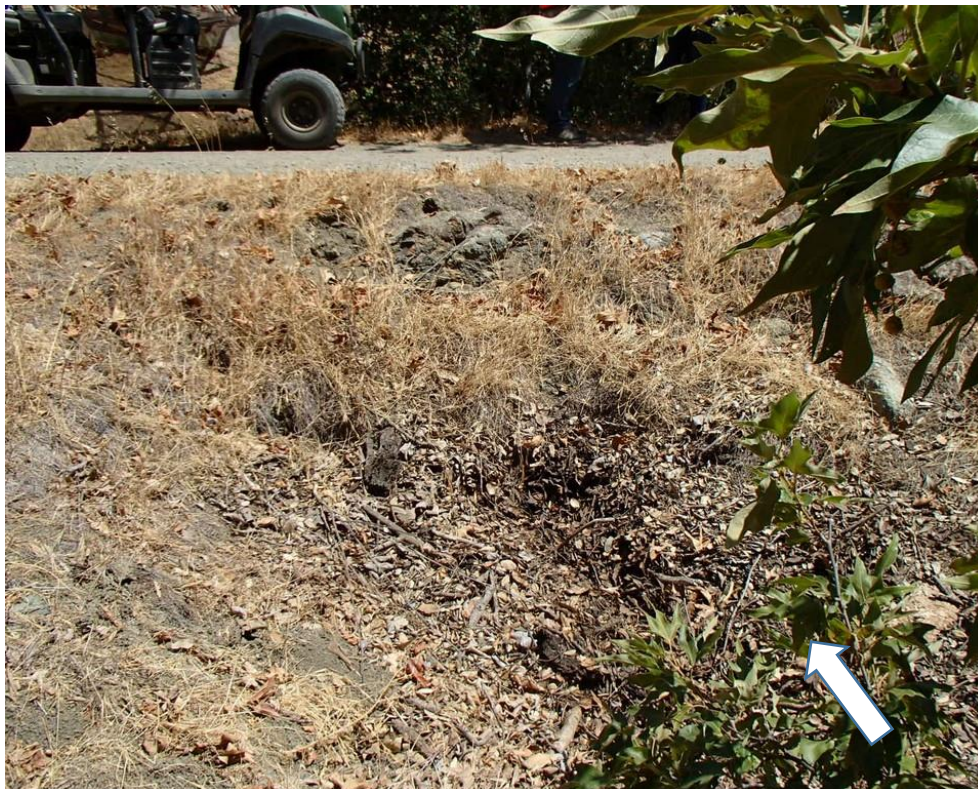
**Photo 6.** Site 195 (Architectural Canyon Complex Rd.): View of Site 195 looking downstream. The culvert is plugged with detritus at the center of the frame (see arrow). The road crossing is visible at the top of the frame. The stream flows from right to left.

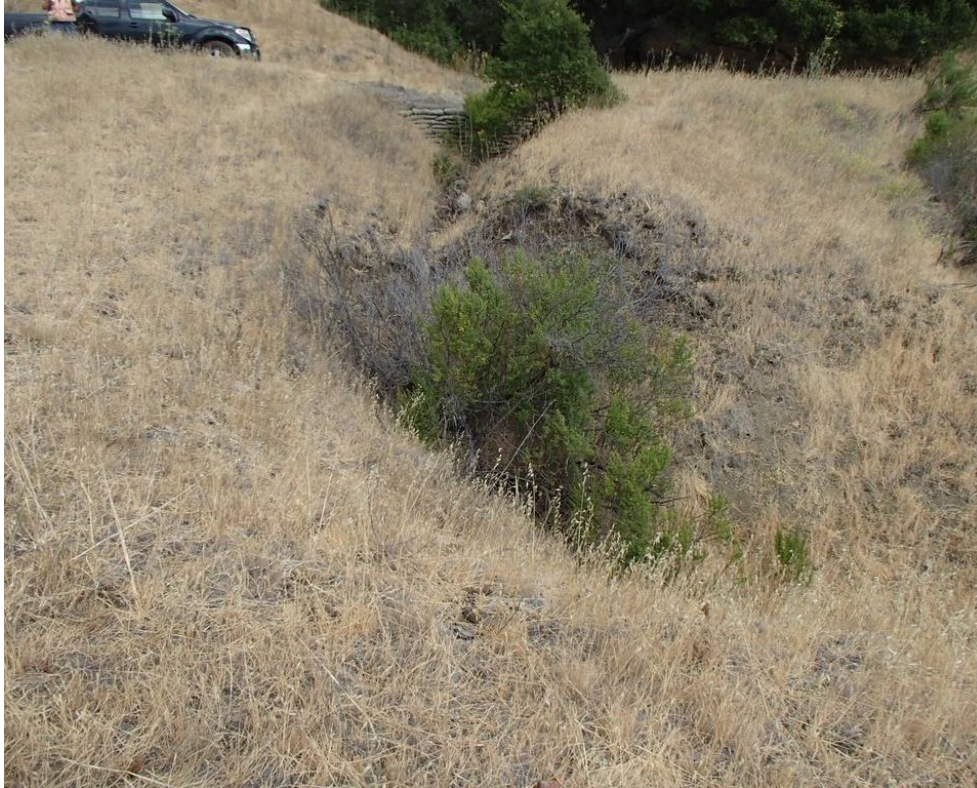
**Photo 13.** Site 196 (Barn Rd.): View of Site 196 looking upstream. The outboard fill of this ford crossing is buttressed with solidified sacks of concrete. An erosional gully has formed below the outboard edge.

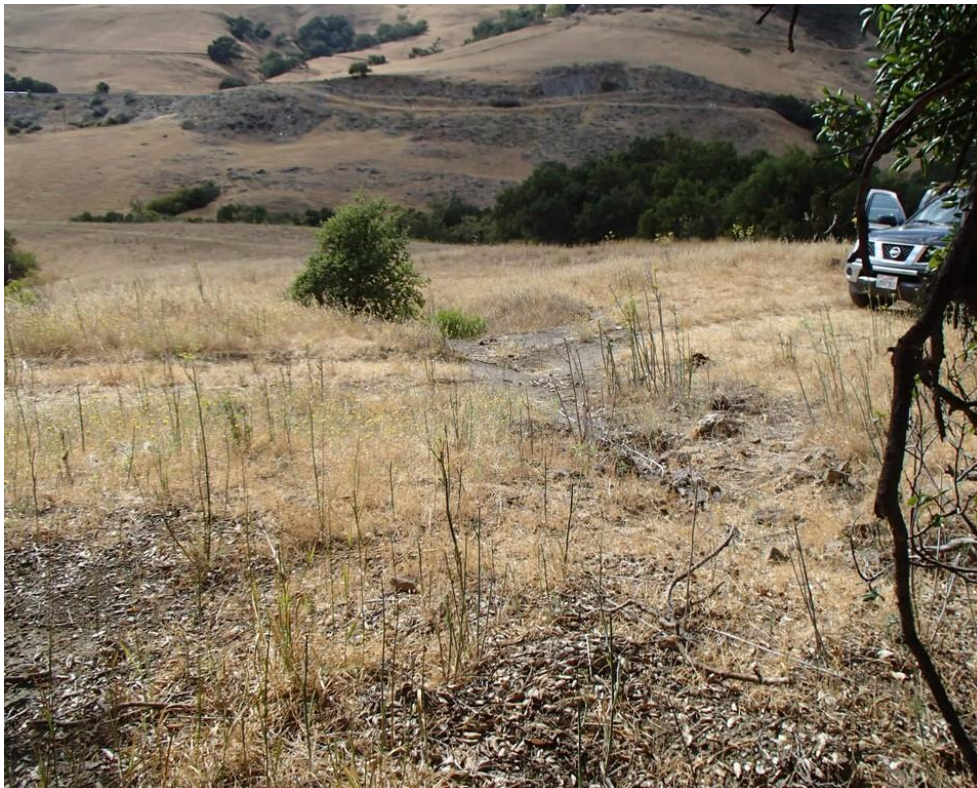
**Photo 14.** Site 196 (Barn Rd.): View of Site 196 looking downstream at the ford crossing. The right and left road approach are visible in the center of the frame.

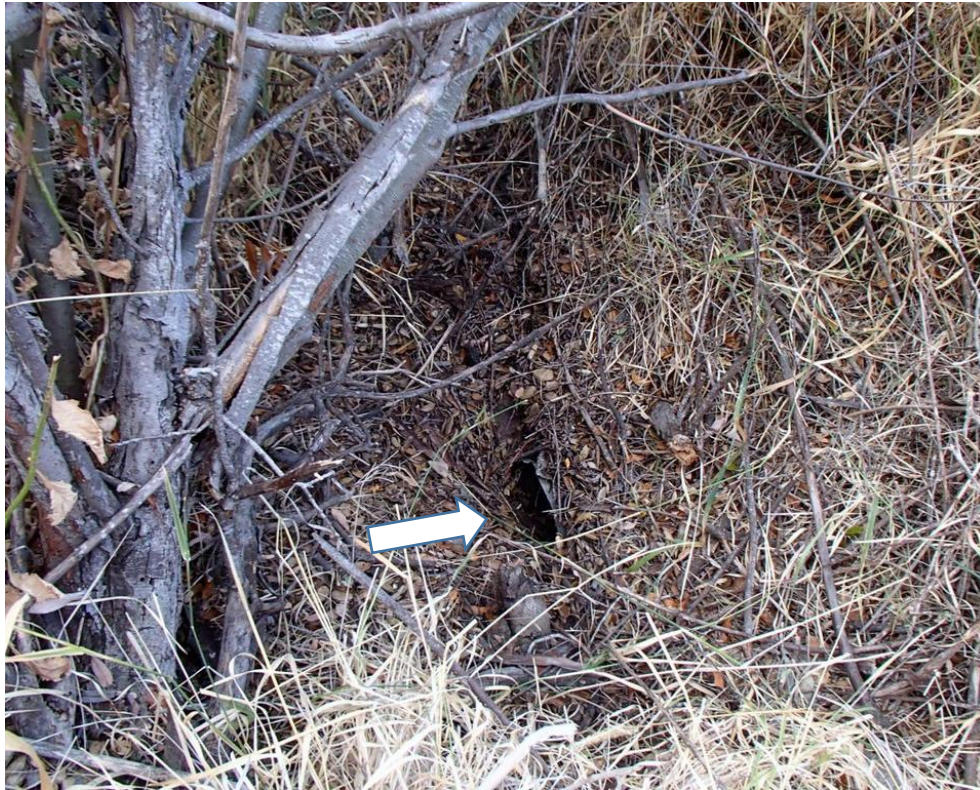
**Photo 15.** Site 197 (Barn Rd.): View of Site 197 looking obliquely at ditch relief culvert outlet. The culvert outlet is at the center of the frame and is approximately 90% plugged with organic matter (see arrow). The stream flows from right to left.

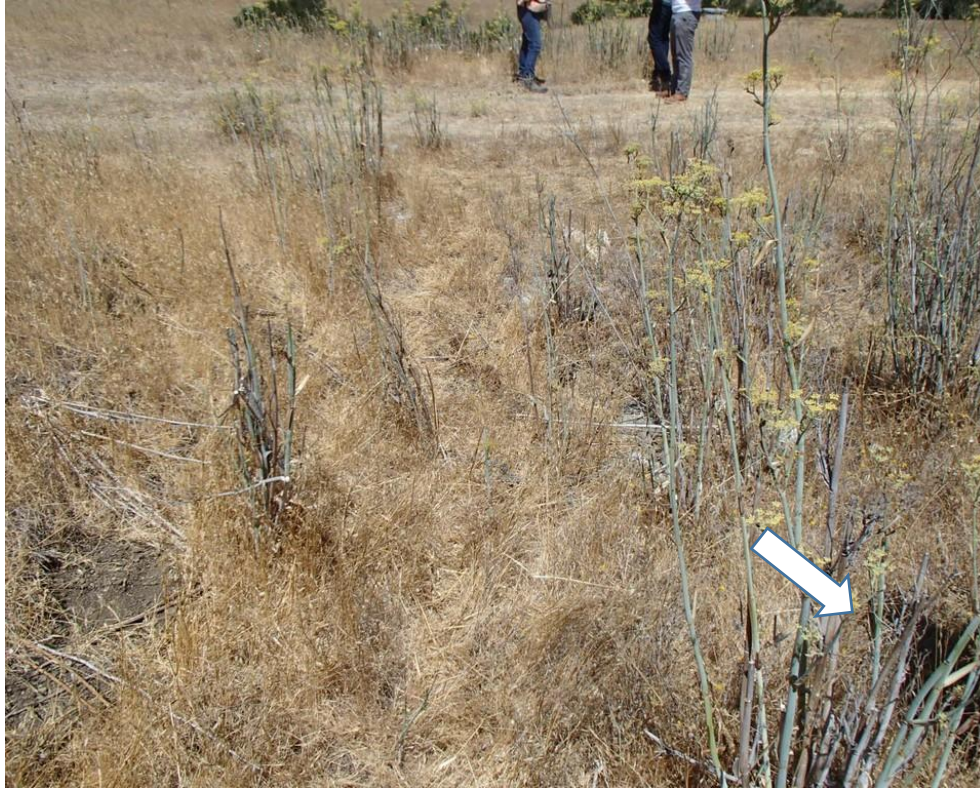
**Photo 17.** Site 197.1 (Barn Rd.): View of Site 197.1 looking downstream. The culvert inlet is plugged in this location and not easily discernible (see arrow). The road crossing is visible in the top of the frame.

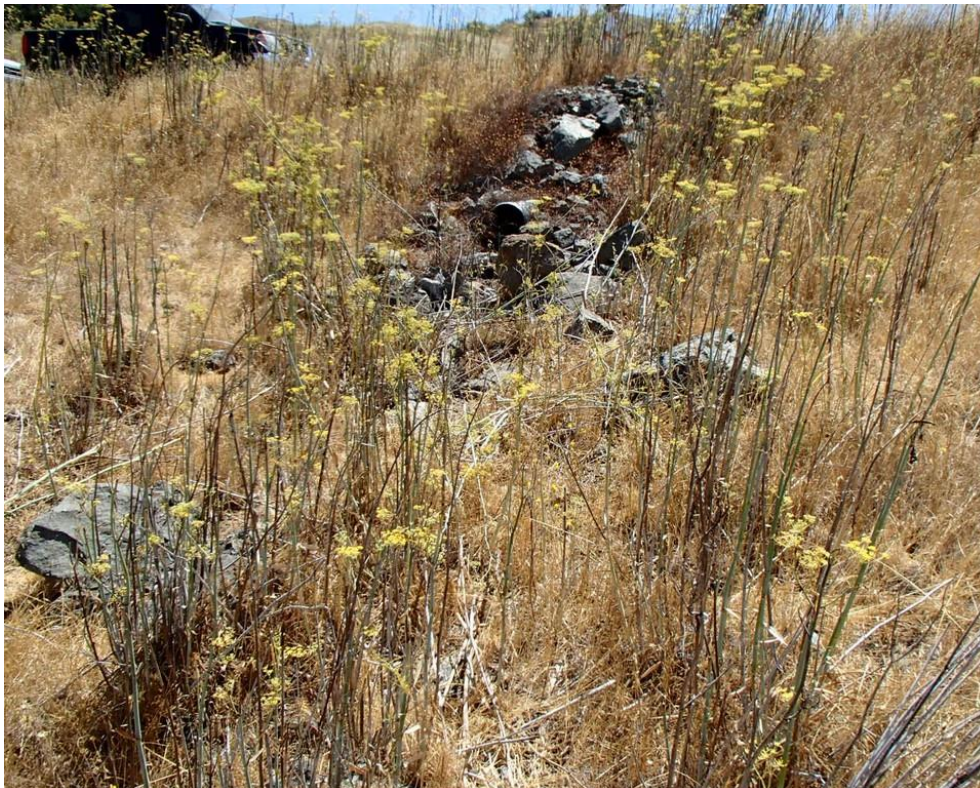
**Photo 18.** Site 197.1 (Barn Rd.): View of Site 197.1 looking upslope towards culvert outlet. The road crossing is visible in the upper frame and the culvert outlet is protruding from the riprap in the center of the frame.

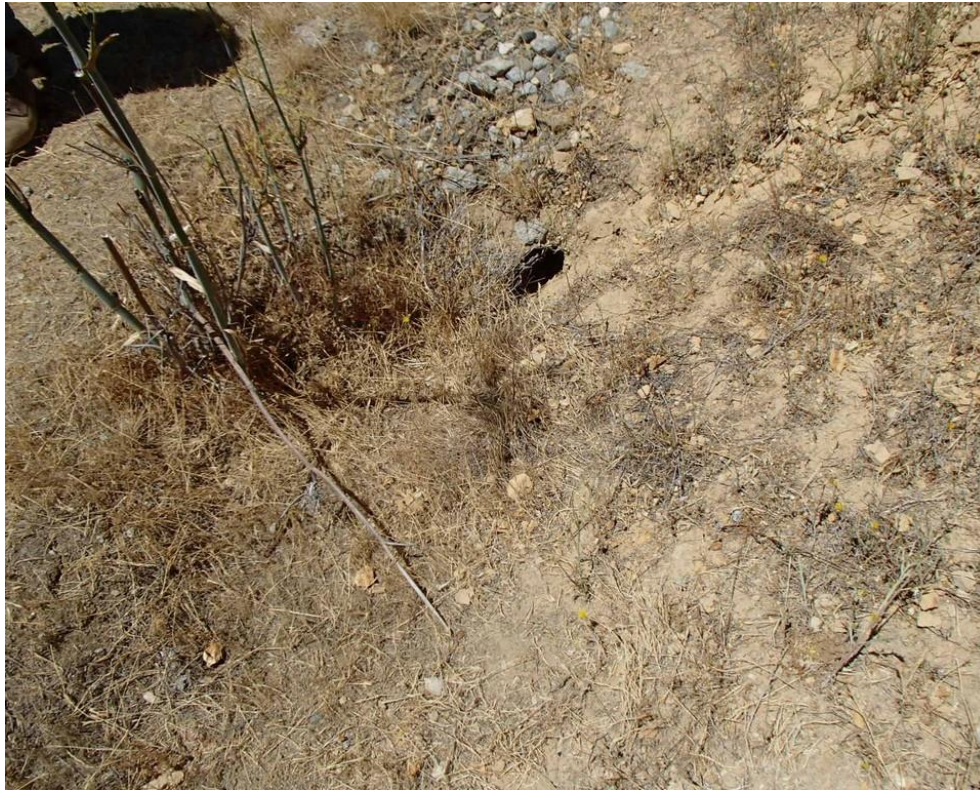
**Photo 21.** Site 198.1 (Barn Rd.): View of Site 198.1 looking downslope at the ditch relief culvert inlet area. The culvert inlet is approximately 50% plugged with sediment.

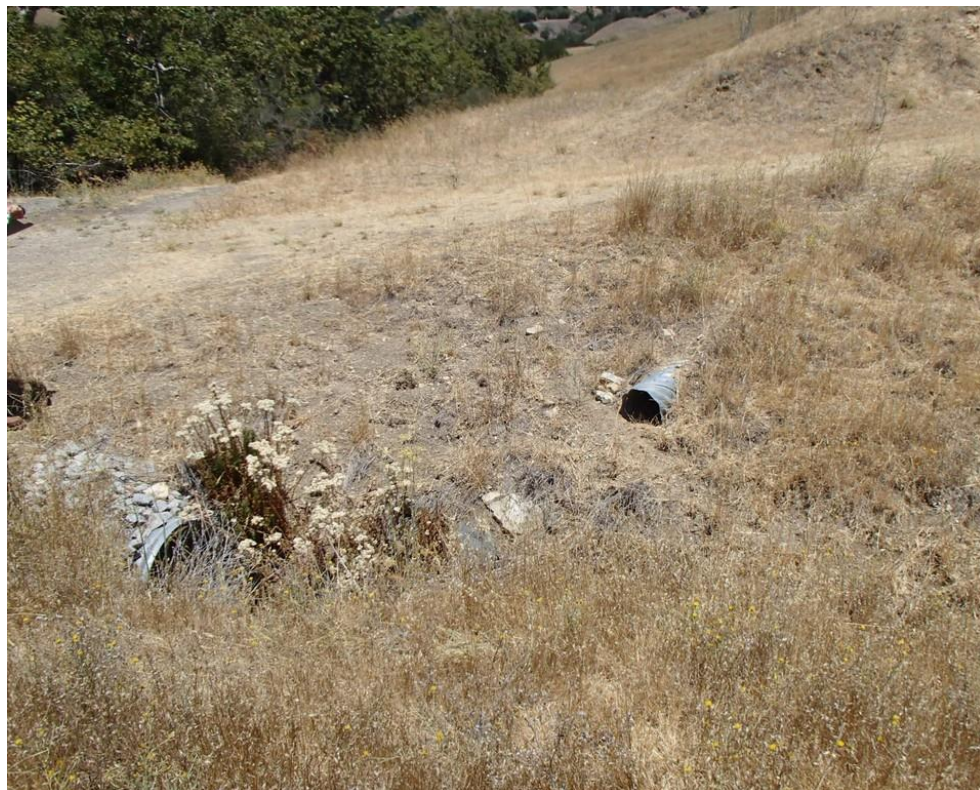
**Photo 22.** Site 198.1 (Barn Rd.): View of Site 198.1 looking obliquely/upslope at the ditch relief culvert outlet. The culvert outlet is visible in the middle of the frame and the road is above. Site 199 culvert inlet is located on the left.

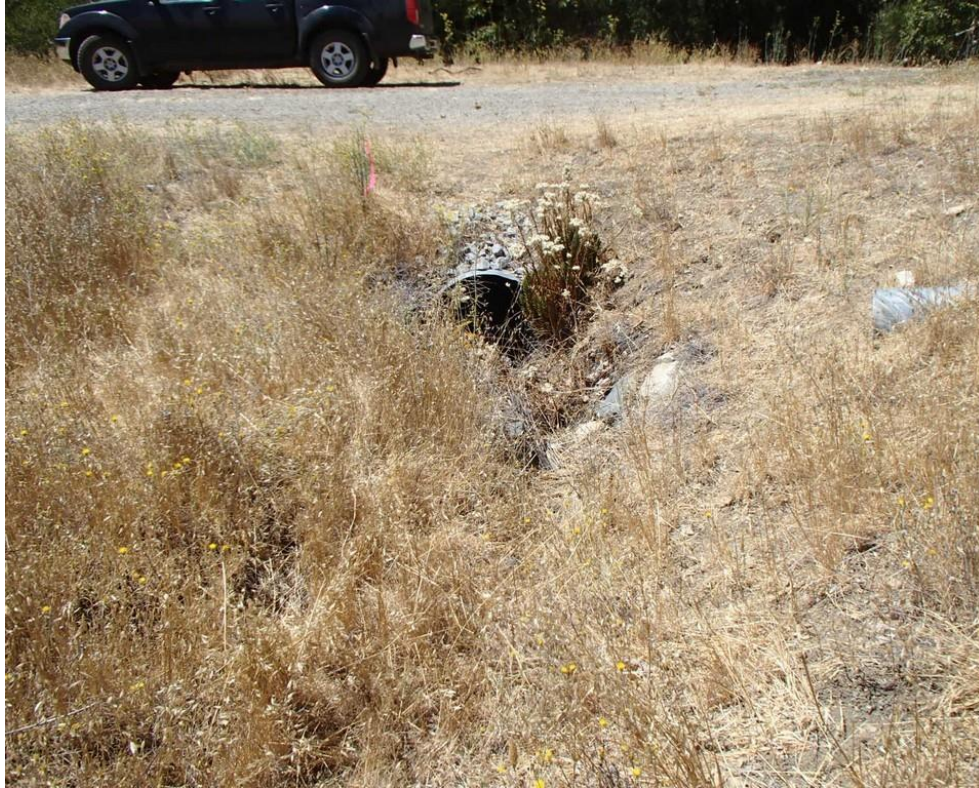
**Photo 23.** Site 199 (Barn Rd.): View of the Site 199 Looking downstream towards the culvert inlet area. The crossing is present in the top of the frame. This culvert flows to mainstem Stenner Creek. Site 198.1 is in the right of the frame.

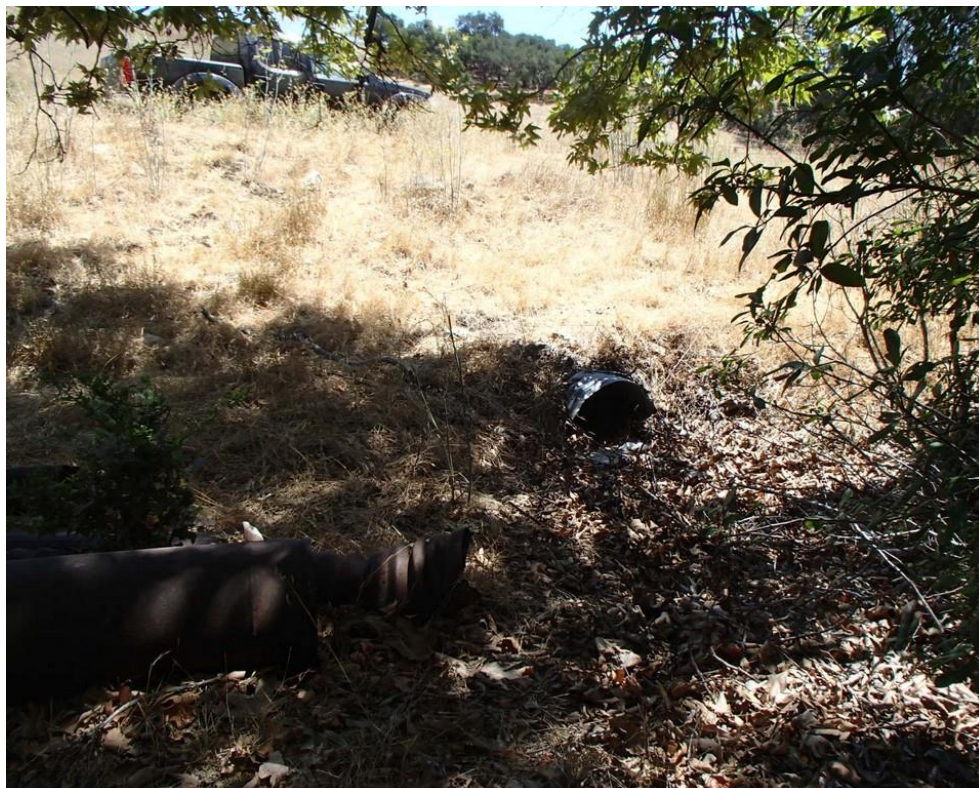
**Photo 24.** Site 199 (Barn Rd.): View of the Site 199 looking upstream at the culvert outlet area. The culvert outlet is visible in the center of the photo.

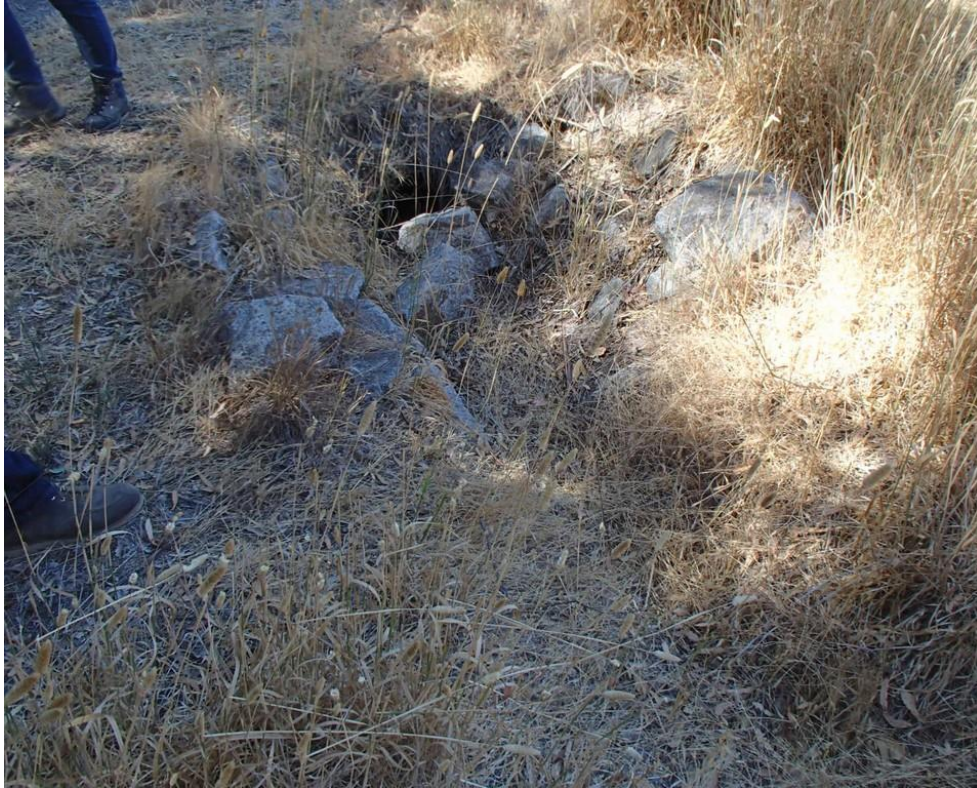
**Photo 25.** Site 200 (Barn Rd.): View of Site 200 ditch relief culvert inlet area. This culvert inlet is approximately 30% plugged due to the long, wide, and grassy swale that feeds this location.

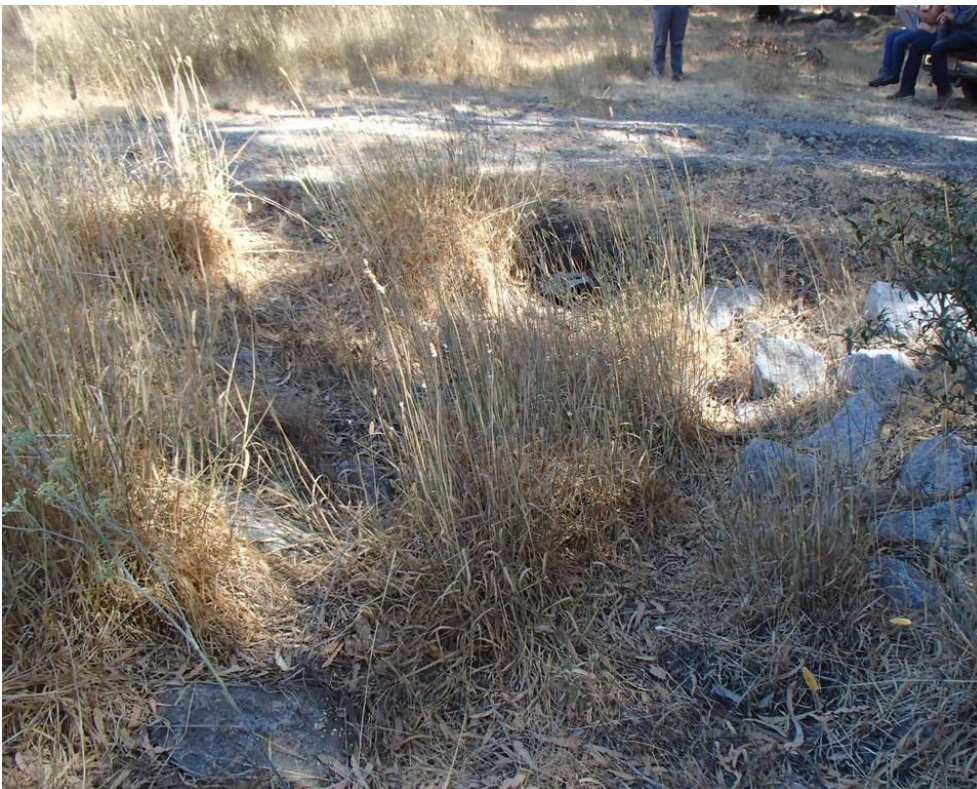
**Photo 26.** Site 200 (Barn Rd.): View of Site 200 ditch relief culvert outlet area. Looking upslope, the outlet is present in the center of the photo and is approximately 30% plugged.

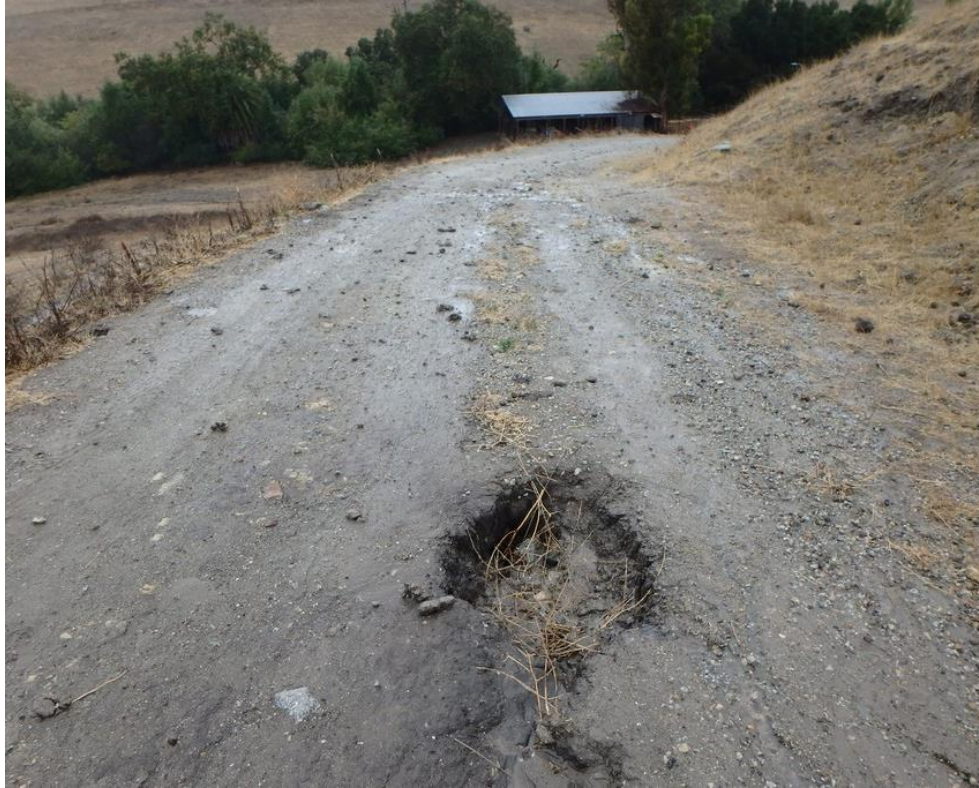
**Photo 27.** Site 201 (Peterson Ranch Rd.): View of Site 201 looking down left road towards mainstem Stenner Creek. This road approach leads to Site 201 which outlets directly into Stenner Creek. Road erosion is visible in the bottom of the frame.

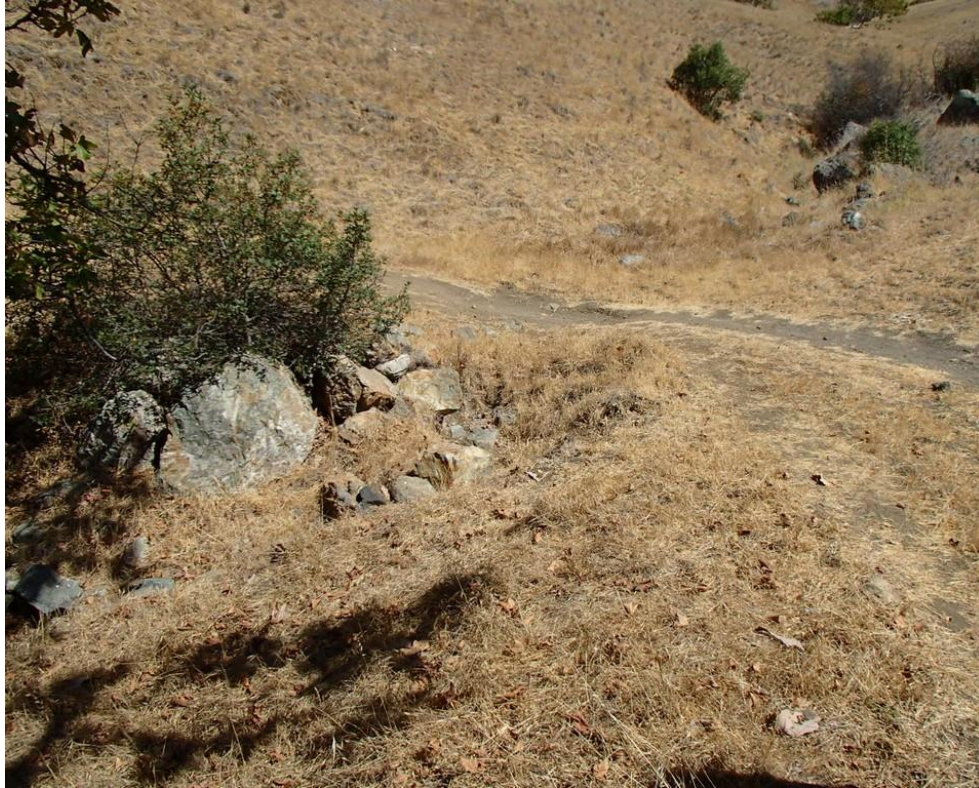
**Photo 29.** Site 202 (Upper Stenner Spur): View of Site 202 looking obliquely at the stream crossing. The outboard fill riprap has dislodged in this location and a gully is migrating into the trail.

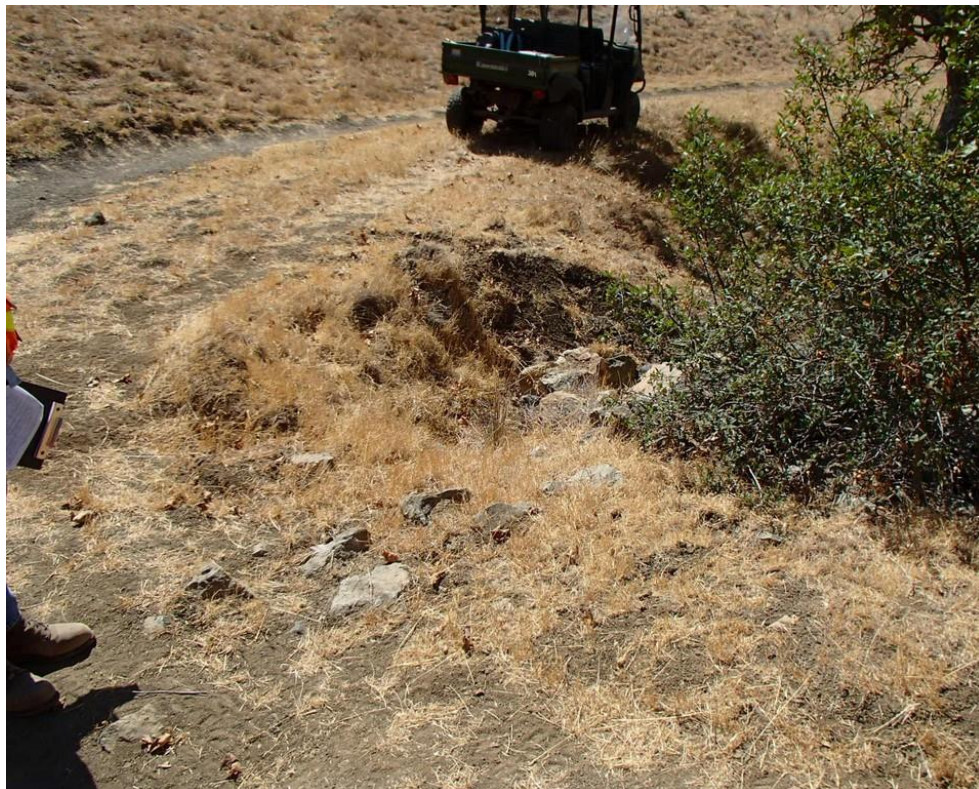
**Photo 30.** Site 202 (Upper Stenner Spur): View of Site 202 looking down the left trail. Erosion is visible in the center of the frame. The stream flows from left to right.

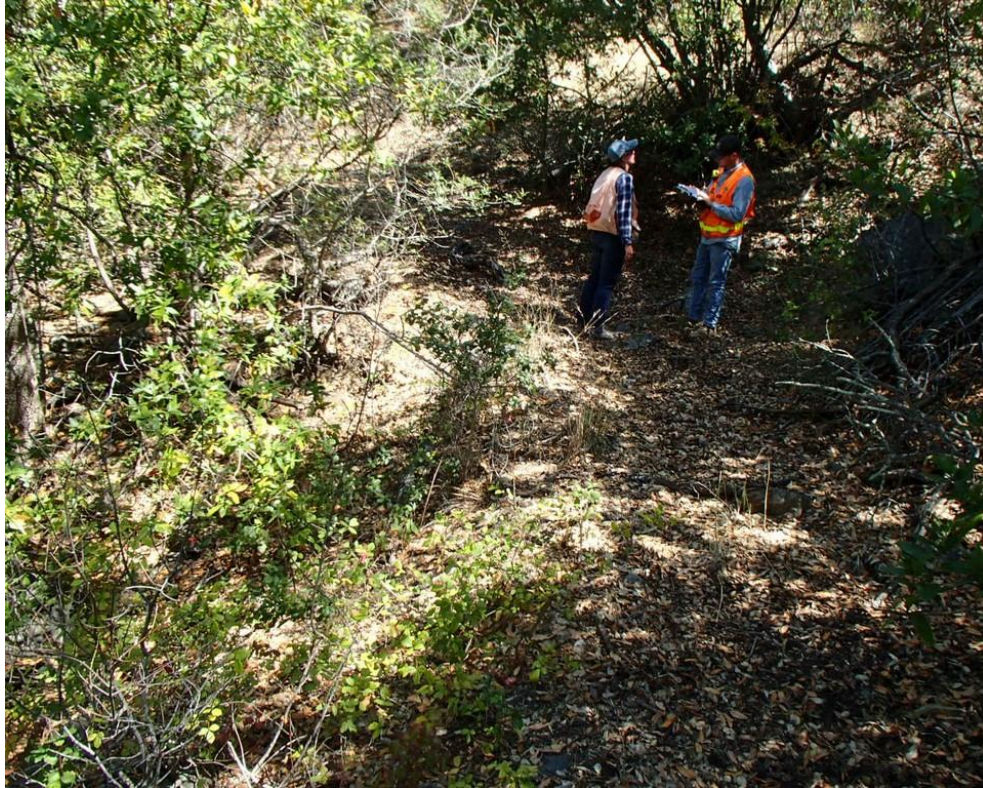
**Photo 33.** Site 204 (Upper Stenner Spur): View of Site 204 looking obliquely at stream crossing. This portion of the trail is heavily overgrown and not currently usable.

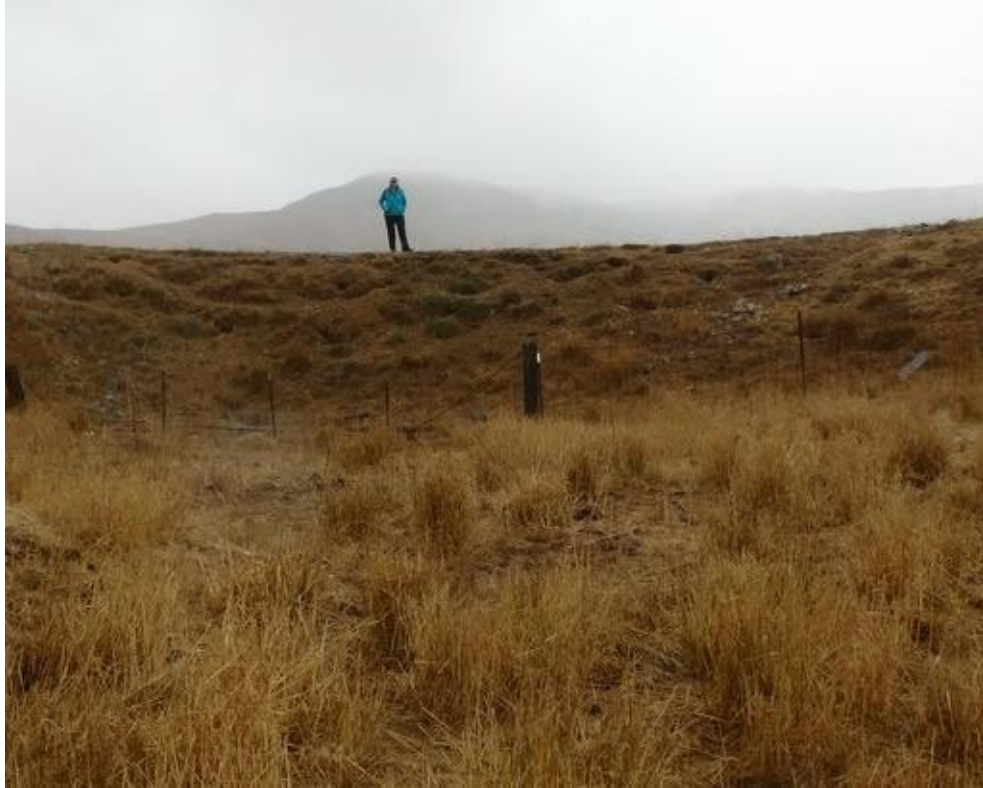
**Photo 35.** Site 205 (Peterson Ranch Rd.): View of Site 205 looking downstream. The undersized culvert inlet is 90% plugged at the center of the frame. The inboard fillslope is visible beginning at the fence line.

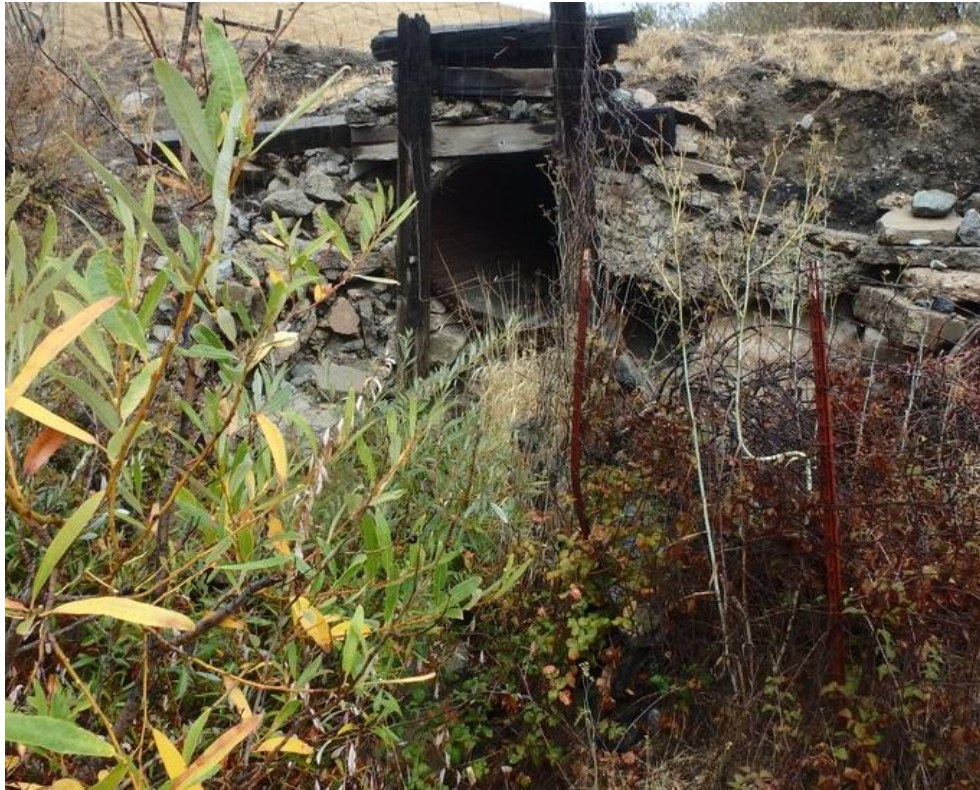
**Photo 37.** Site 206 (Peterson Ranch Rd.): View of Site 206 looking downstream at the culvert inlet area. The inboard fill area has been shored up by old railroad ties and concrete.
