**Stenner Creek Erosion Control and  
Sediment Reduction Plan,  
California Polytechnic State University,  
San Luis Obispo County, California**

**PWA Report No. 231039902  
April 2023**

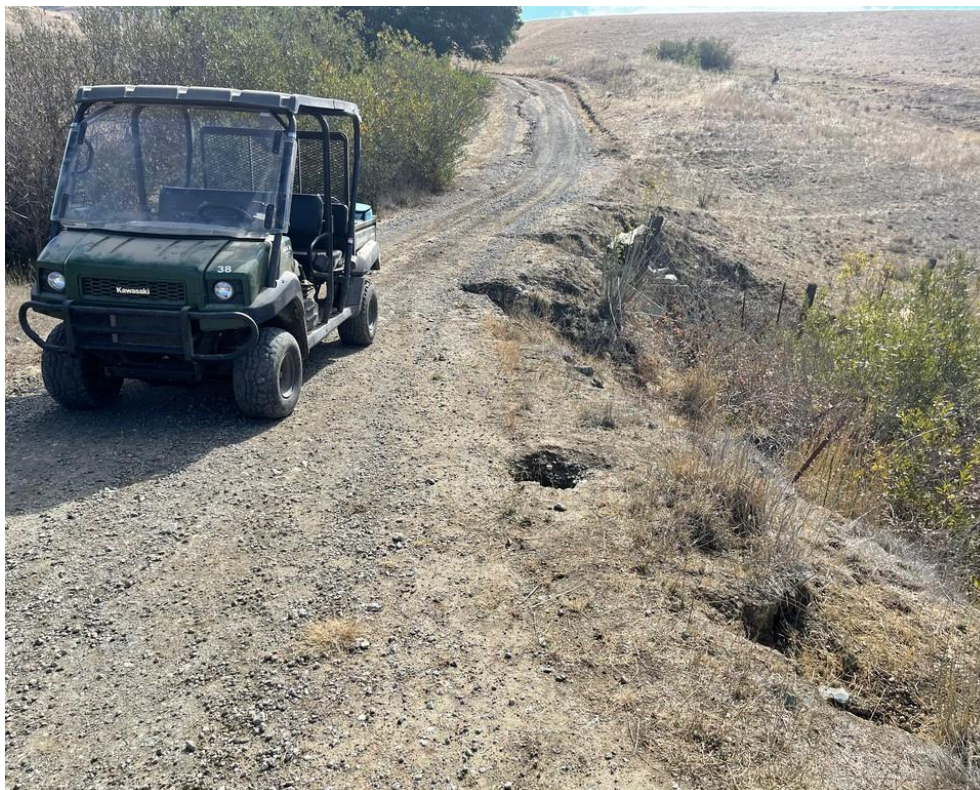
**Photo 38.** Site 206 (Peterson Ranch Rd.): View of Site 206 looking up left road and obliquely at stream crossing. Evidence of sediment discharge from road erosion is visible along the outboard edge of the road in the center of the frame.

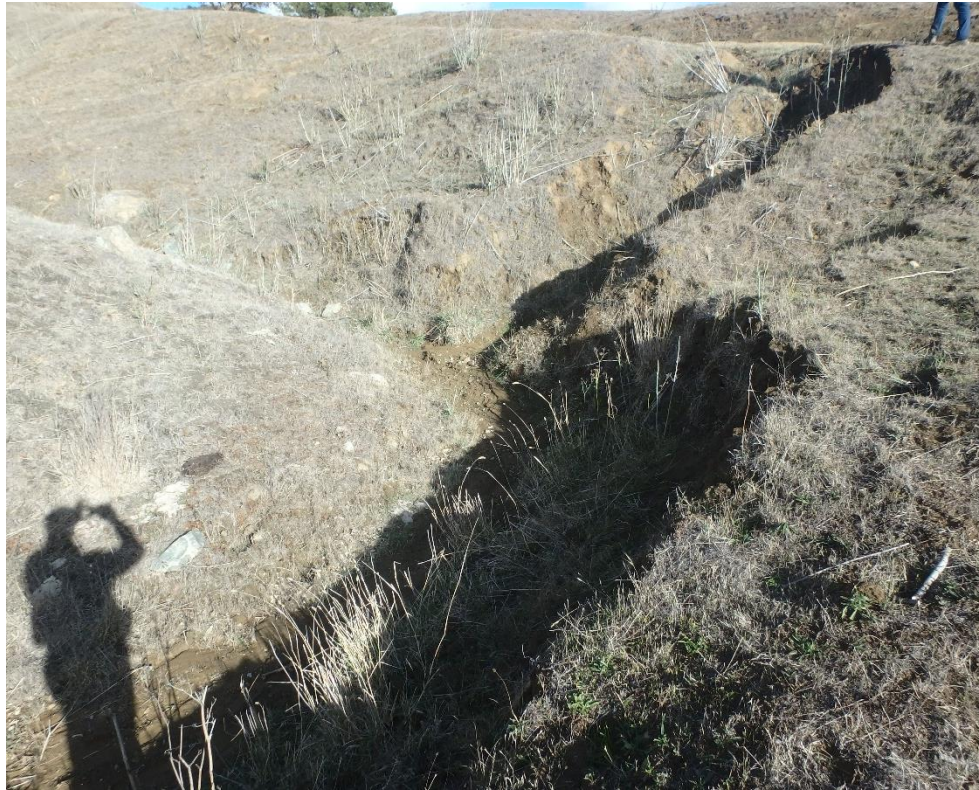
**Photo 39.** Site 207 (Peterson Ranch Rd.): View of Site 207 looking up at the road surface discharge point from the Class II stream. The discharge point is in the upper right corner of the frame and has created the 15' wide x 25' long erosional gully.

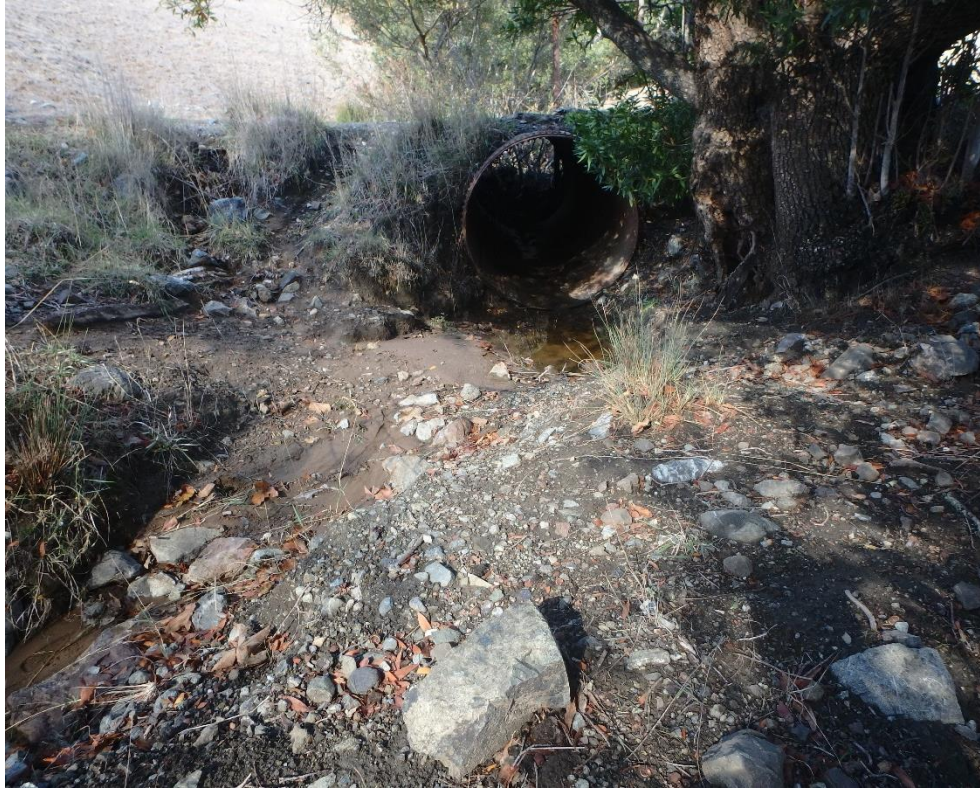
**Photo 41.** Site 208 (Peterson Ranch Rd.): View of Site 208 looking upstream at the culvert outlet area. Fine sediment generated from road surface erosion is visible below and to the left of the culvert outlet. The culvert is adequately sized but vertical fillslopes are eroding and unstable.

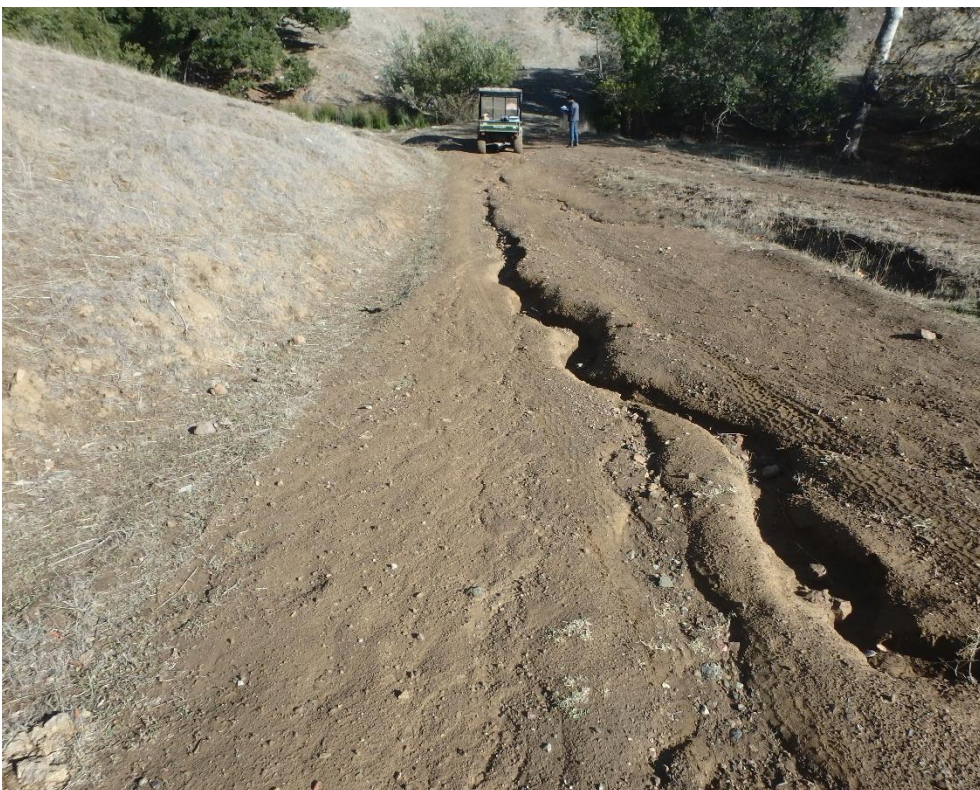
**Photo 42.** Site 208 (Peterson Ranch Rd.): View of Site 208 road approach looking down the right road approach with stream crossing located in the upper frame. Two gullies have formed on the road surface from excessive road drainage, which funnel sediment to the stream.

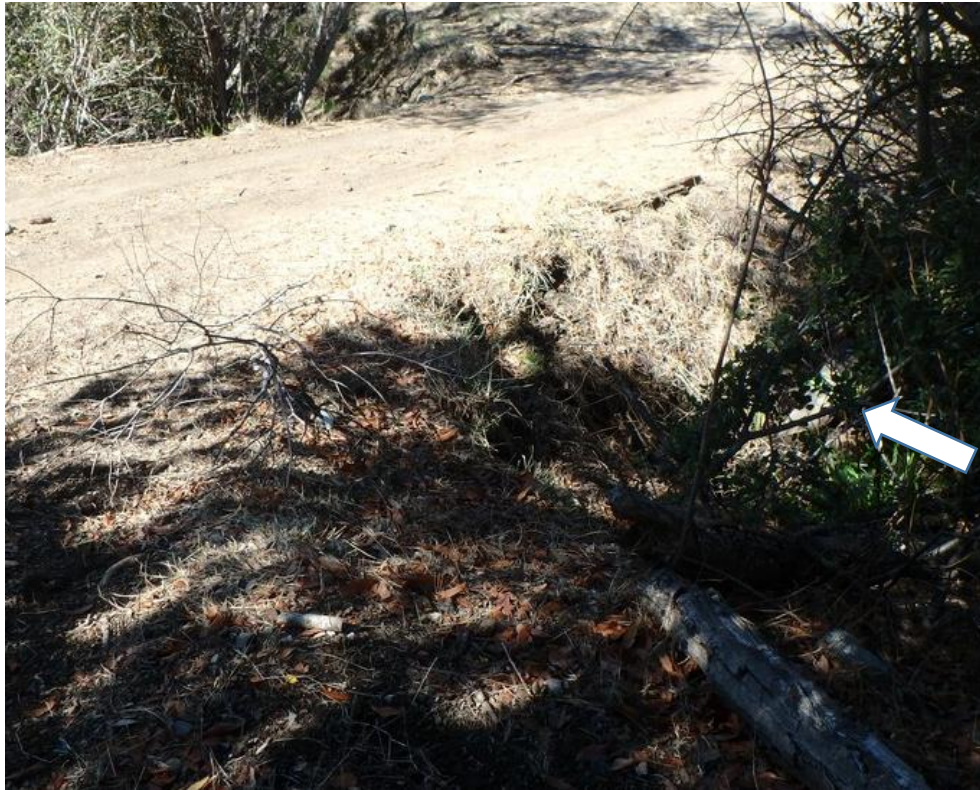
**Photo 43.** Site 209 (Peterson Ranch Rd.): View of Site 209 looking obliquely at the undersized stream crossing (see arrow). The right road is visible in the uppermost right frame. The stream flows from right to left.

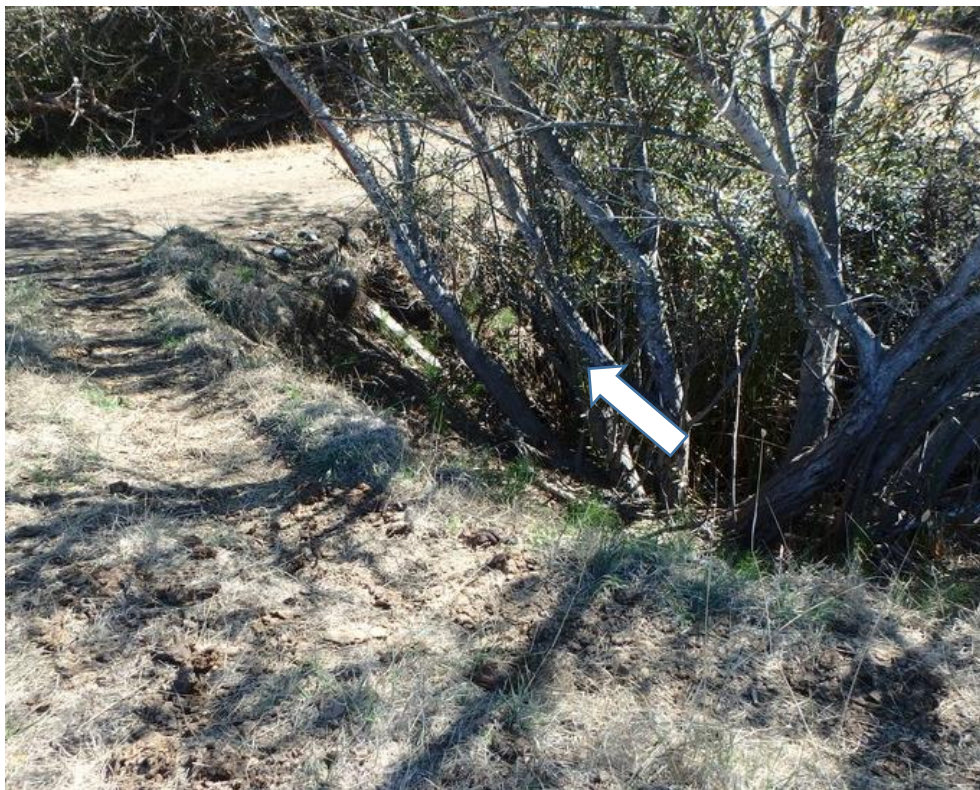
**Photo 44.** Site 209 (Peterson Ranch Rd.): View of Site 209 looking obliquely/upstream. The culvert outlet area is visible in the center of the frame (see arrow) and the inlet area is visible in the upper left corner. The stream flows from left to right.

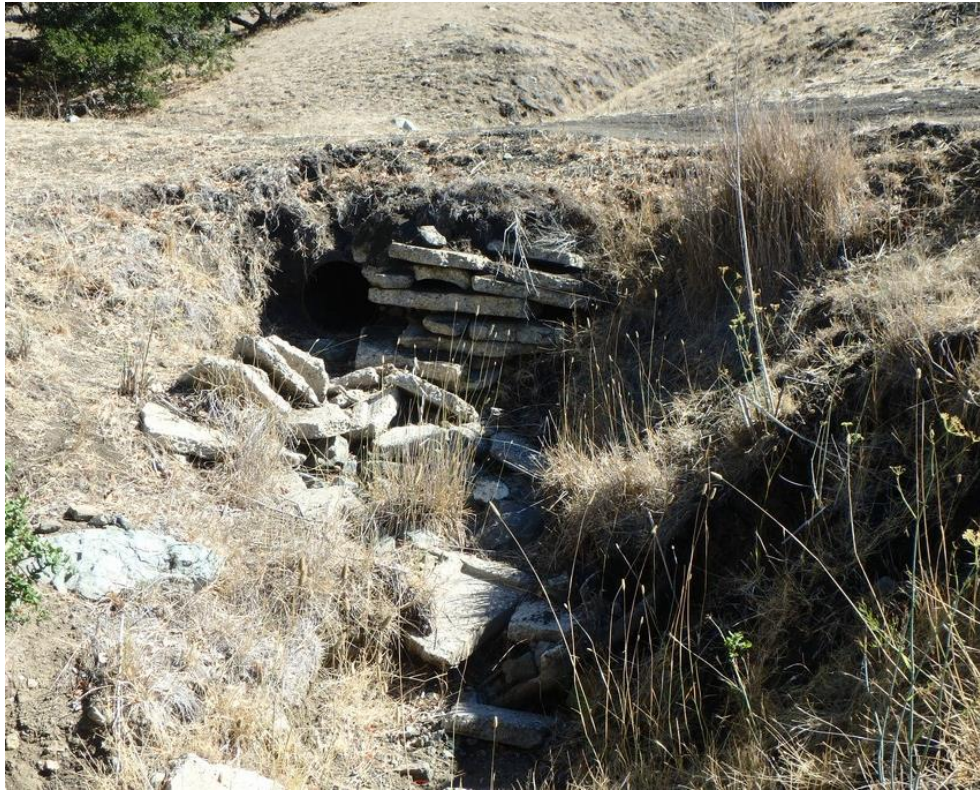
**Photo 45.** Site 210 (Peterson Ranch Rd.): View of Site 210 looking upstream at the undersized culvert outlet. Concrete blocks and eroding fill are visible in the center of the frame. Upper channel area is visible in the top of frame.

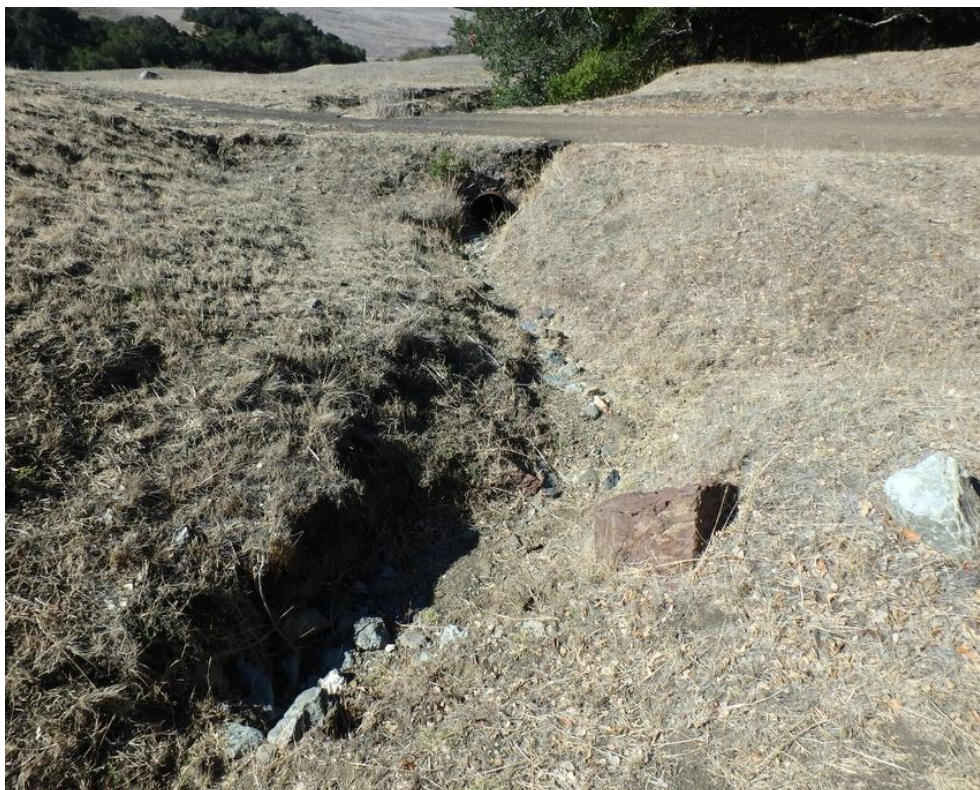
**Photo 46.** Site 210 (Peterson Ranch Rd.): View of Site 210 looking downstream at the undersized culvert inlet. The stream overtops the road crossing, visible in the top frame, during peak events.

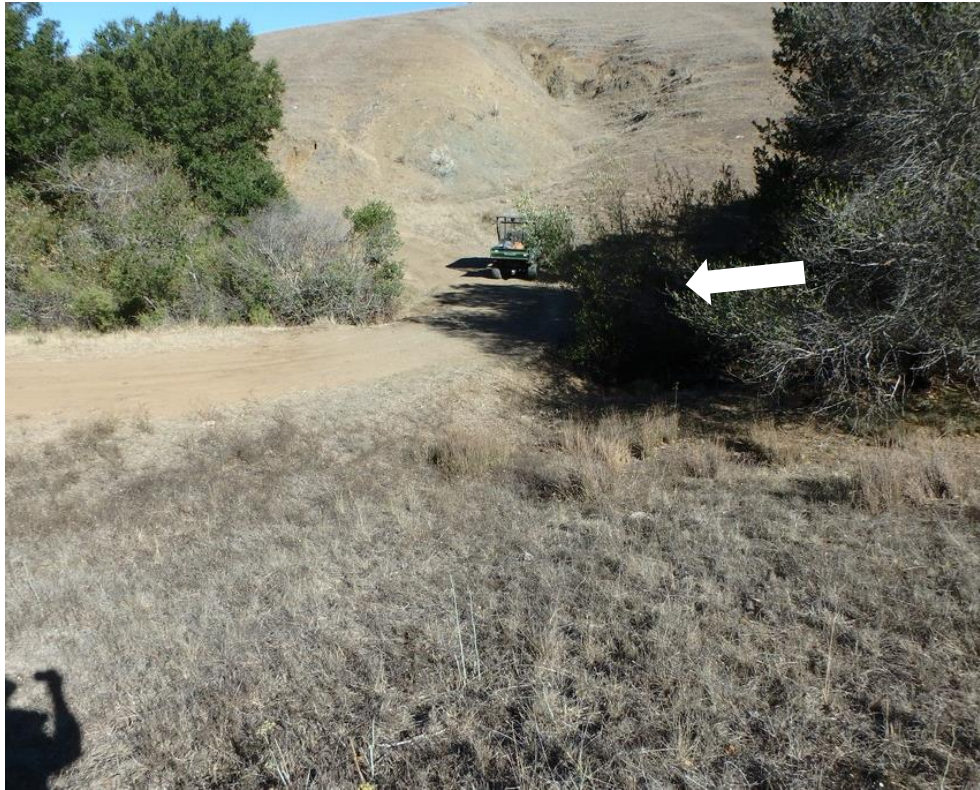
**Photo 47.** Site 211 (Peterson Ranch Rd.): View of Site 211 looking up the right road and obliquely at the stream crossing. The culvert inlet area is visible in the right frame (see arrow).

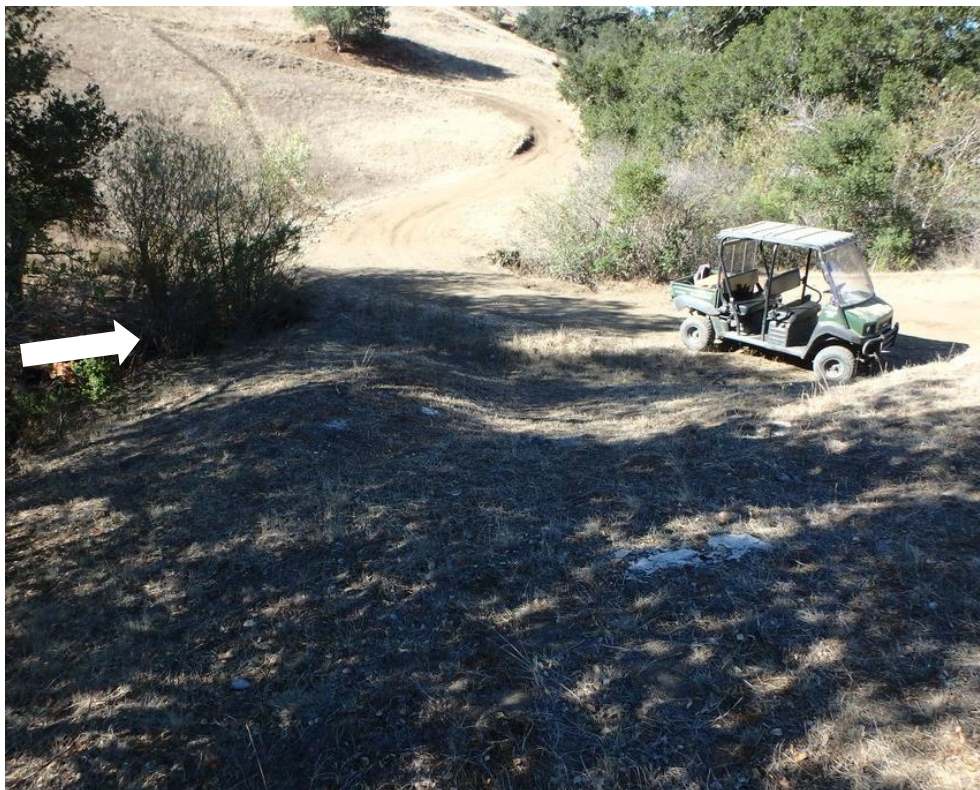
**Photo 48.** Site 211 (Peterson Ranch Rd.): View of Site 211 looking up the left road and obliquely at the stream crossing. The culvert inlet area is visible in the upper left frame (see arrow) and the culvert outlet area is visible in the upper right frame.

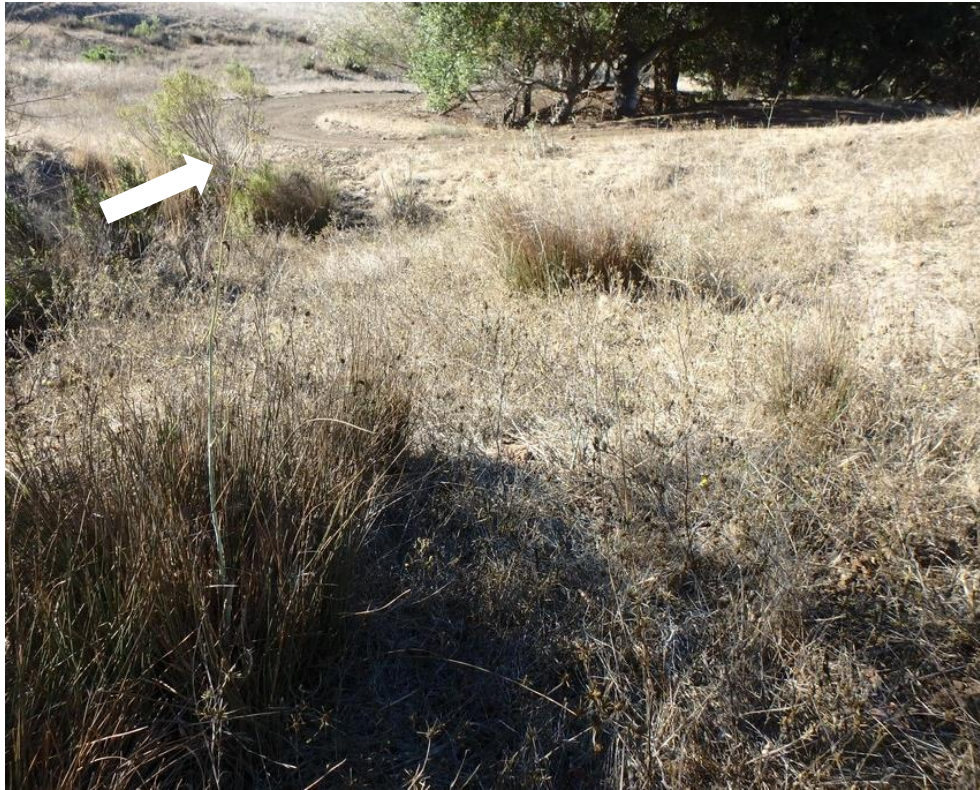
**Photo 49.** Site 212 (Peterson Ranch Rd.): View of Site 212 looking down/obliquely at the stream crossing. The road crossing is visible in the top frame (see arrow) as is the left road.

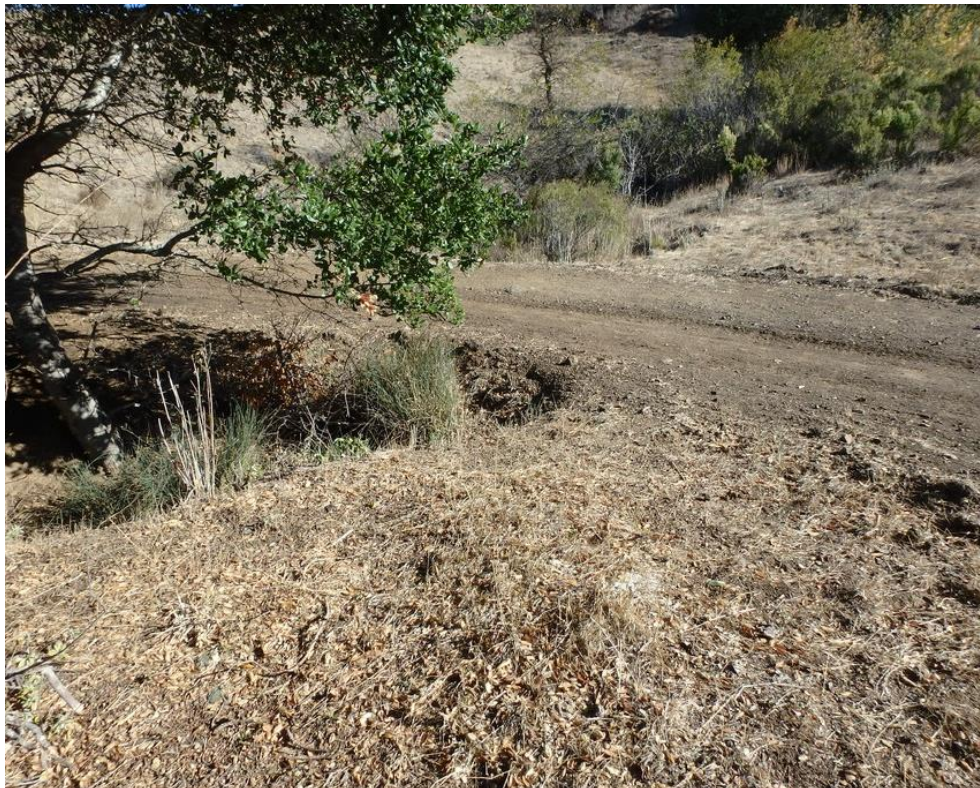
**Photo 50.** Site 212 (Peterson Ranch Rd.): View of Site 212 looking up/obliquely at the stream crossing. The road crossing is visible in the center of the frame. The upper stream channel is visible in the upper frame.

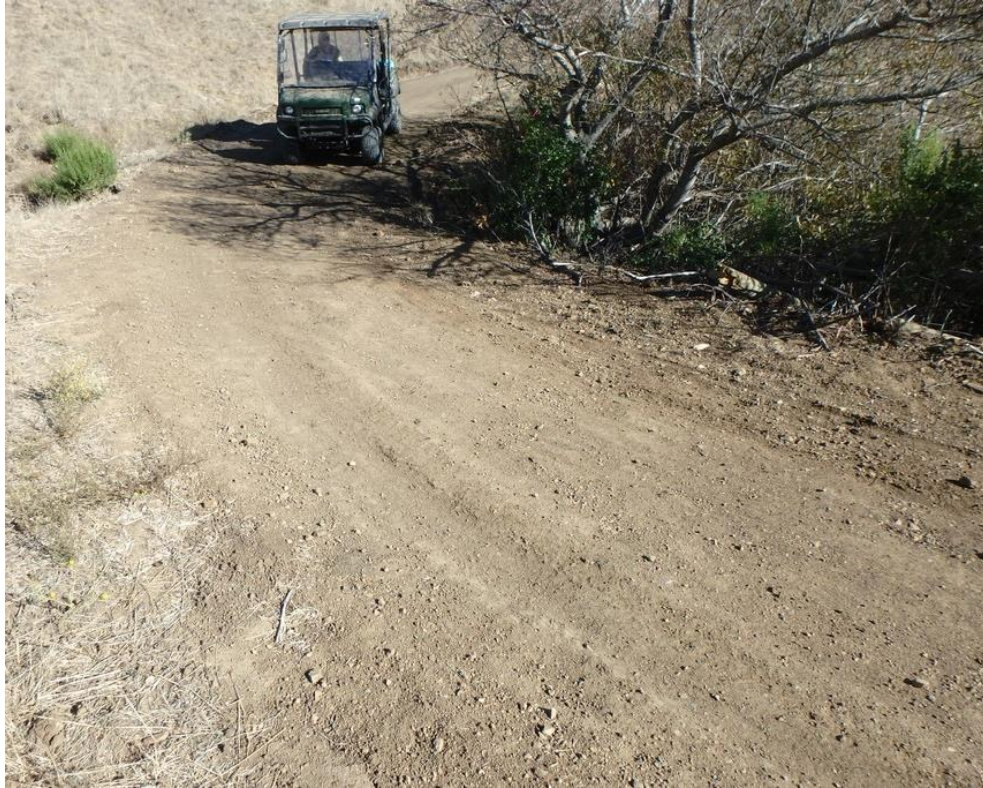
**Photo 51.** Site 213 (Peterson Ranch Rd.): View of Site 213 looking obliquely at the undersized stream crossing. The culvert outlet area is visible in the right frame located to the right of the ATV. The stream flows from left to right.

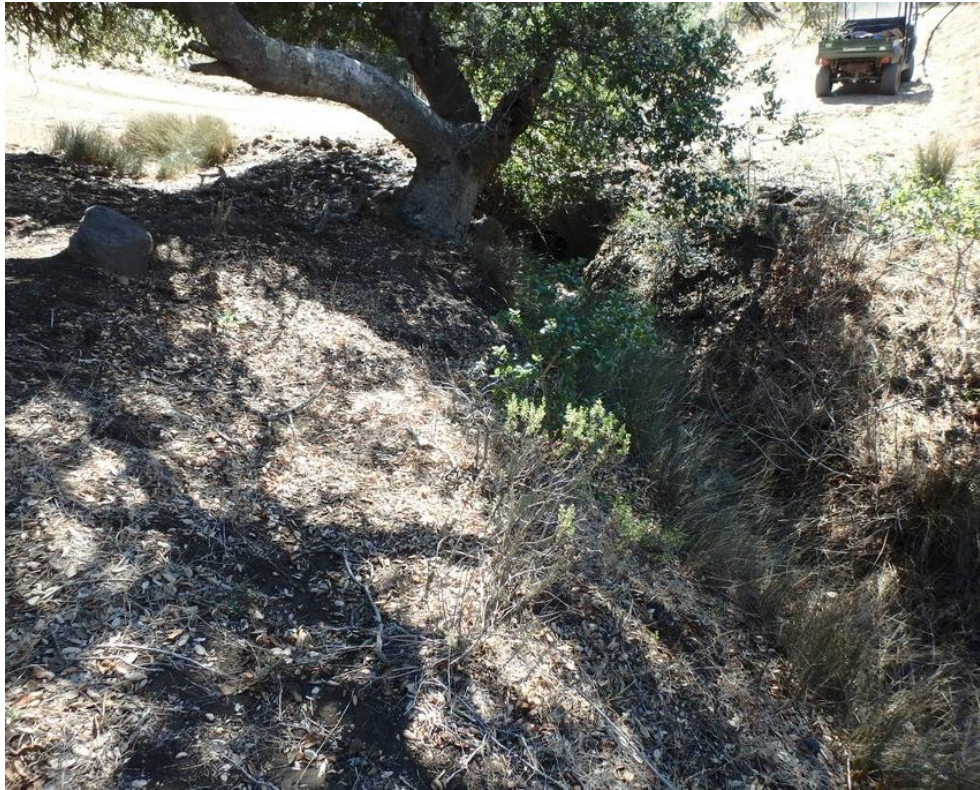
**Photo 53.** Site 214 (Peterson Ranch Rd.): View of Site 214 looking downstream. The undersized culvert inlet area is visible in the top center of the frame. The Right and left road approaches funnel fine sediment to the site each winter.

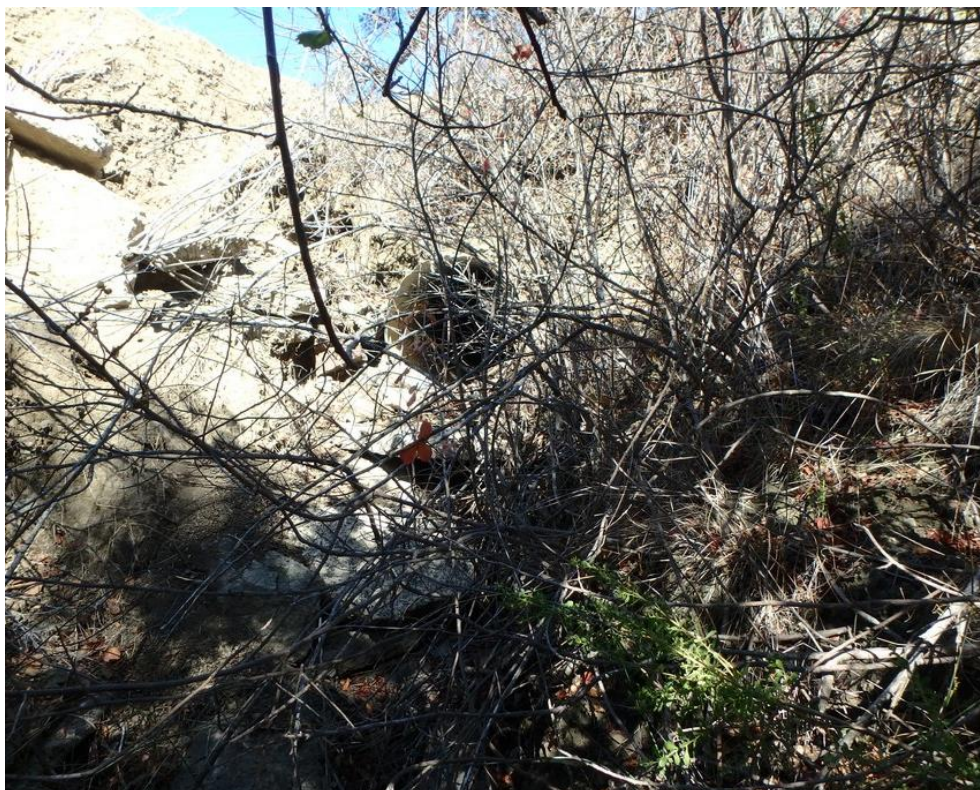
**Photo 54.** Site 214 (Peterson Ranch Rd.): View of Site 214 looking upstream. The culvert outlet is visible in the center of the frame.

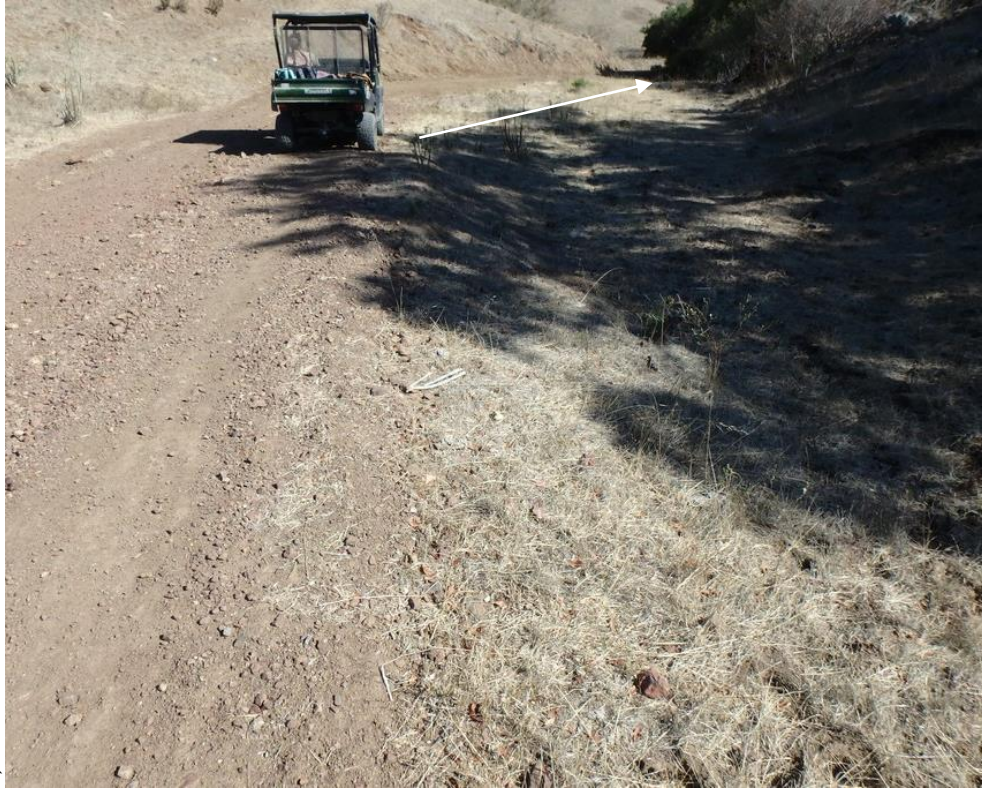
**Photo 55.** Site 215 (Peterson Ranch Rd.): View of Site 215 looking towards the discharge point and the headwaters area of a Class III stream (see arrow). Concentrated road and hillslope runoff exits the road at this location.

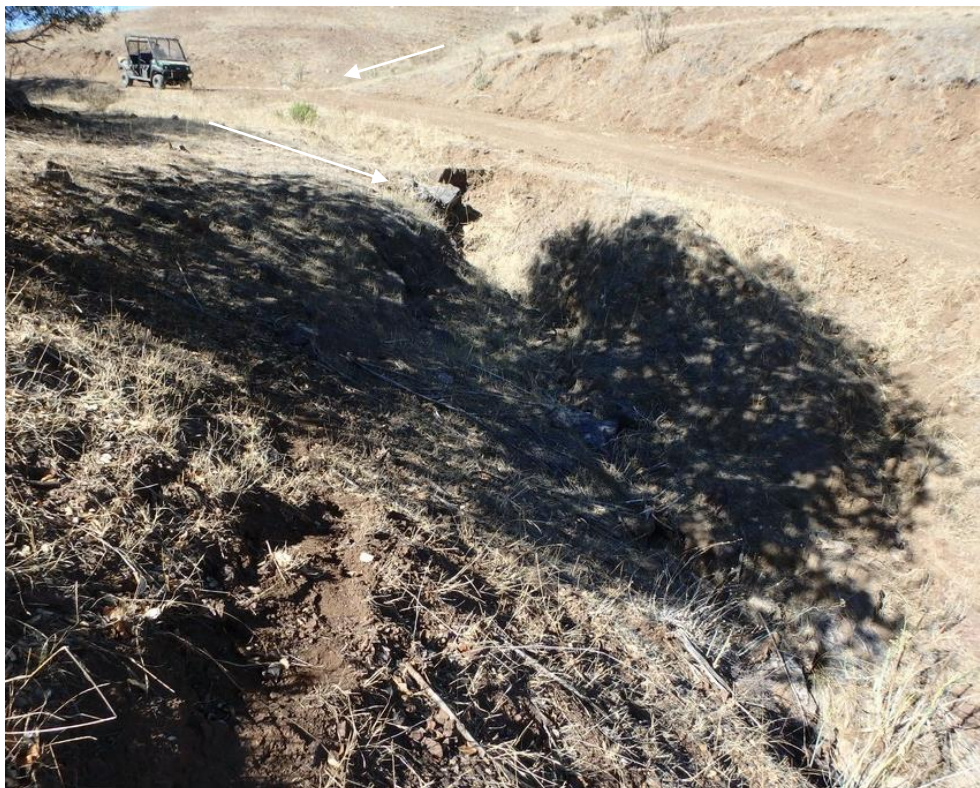
**Photo 56.** Site 215 (Peterson Ranch Rd.): View of Site 215 looking upslope at the road surface discharge point. The contributing swale is visible in the top of the frame (see arrow).

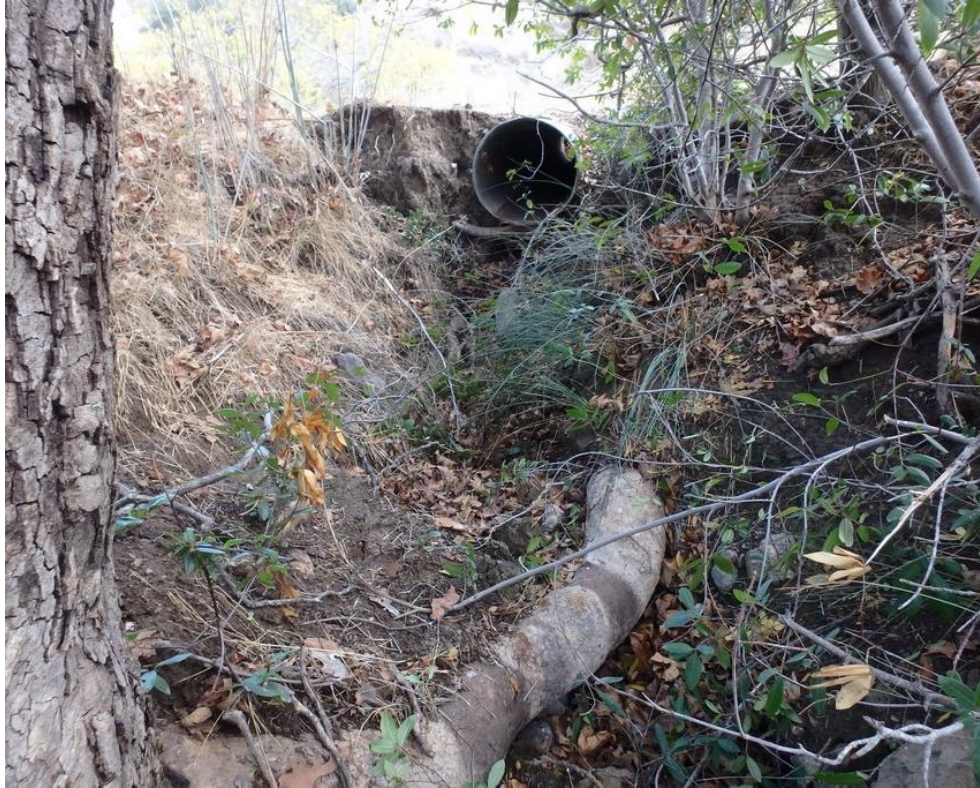
**Photo 57.** Site 216 (Peterson Ranch Rd.): View of Site 216 looking upstream at the culvert outlet. Erosion is visible on the outboard fillslope and at the base of the culvert due to culvert being installed high in the fill.

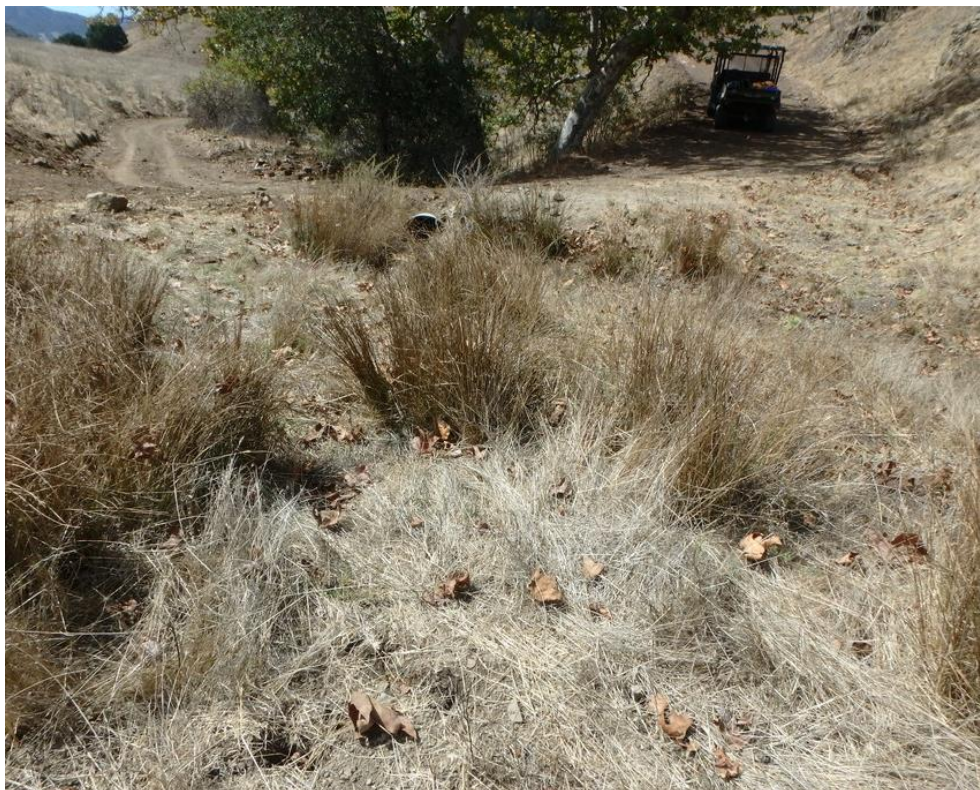
**Photo 58.** Site 216 (Peterson Ranch Rd.): View of Site 216 looking downstream at the culvert inlet area. The right road is funneling fine sediment directly to stream crossing each winter and the left road carries diverted stream when culvert plugs.

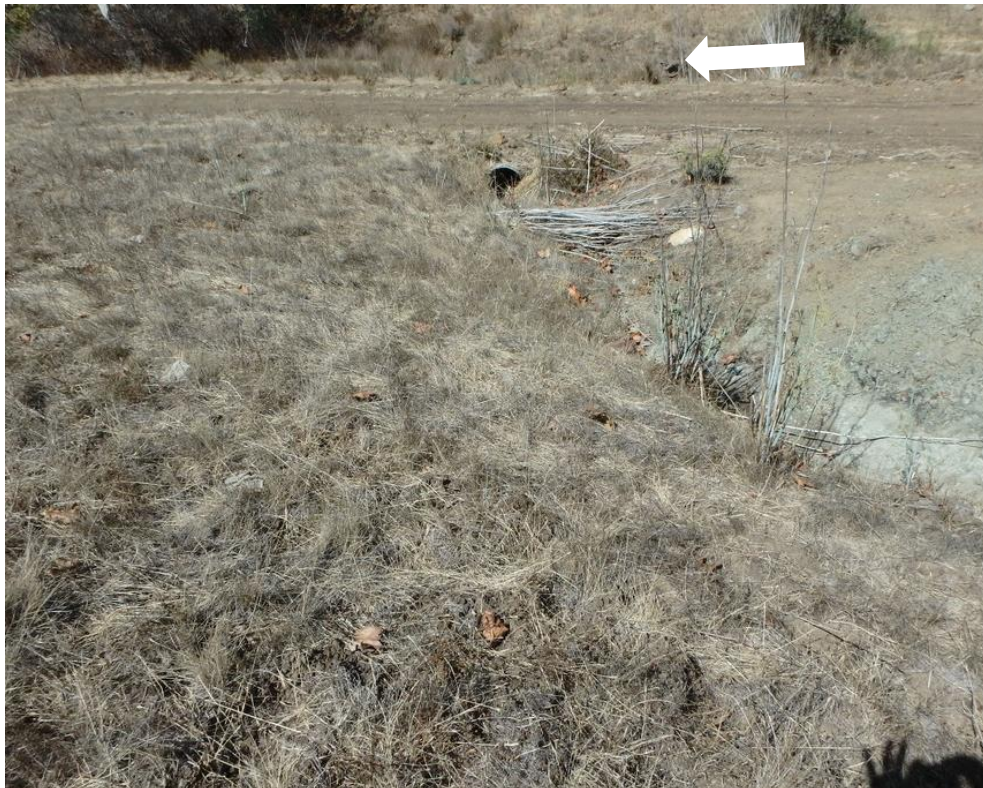
**Photo 60.** Site 217 (Peterson Ranch Rd.): View of Site 217 looking downstream at the culvert inlet. A secondary stream running parallel to the road crossing is visible in the uppermost portion of the frame as well (see arrow).

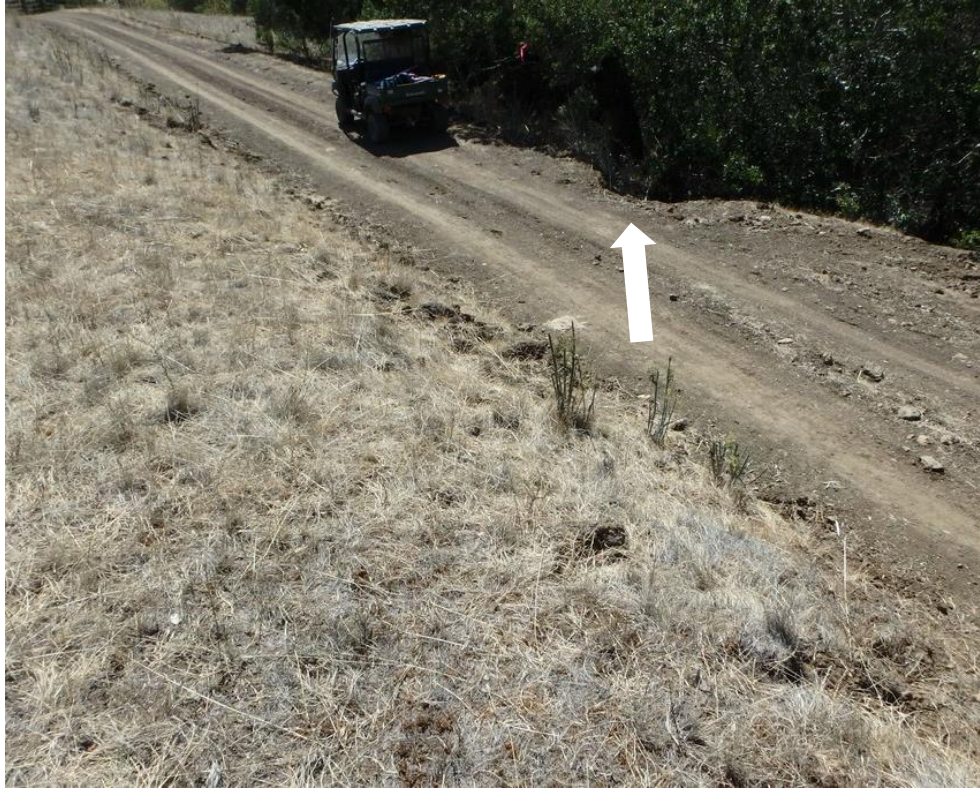
**Photo 61.** Site 217.1 (Peterson Ranch Rd.): View of Site 217.1 looking down towards the discharge point. The discharge point area is visible in the upper middle portion of the frame (see arrow).

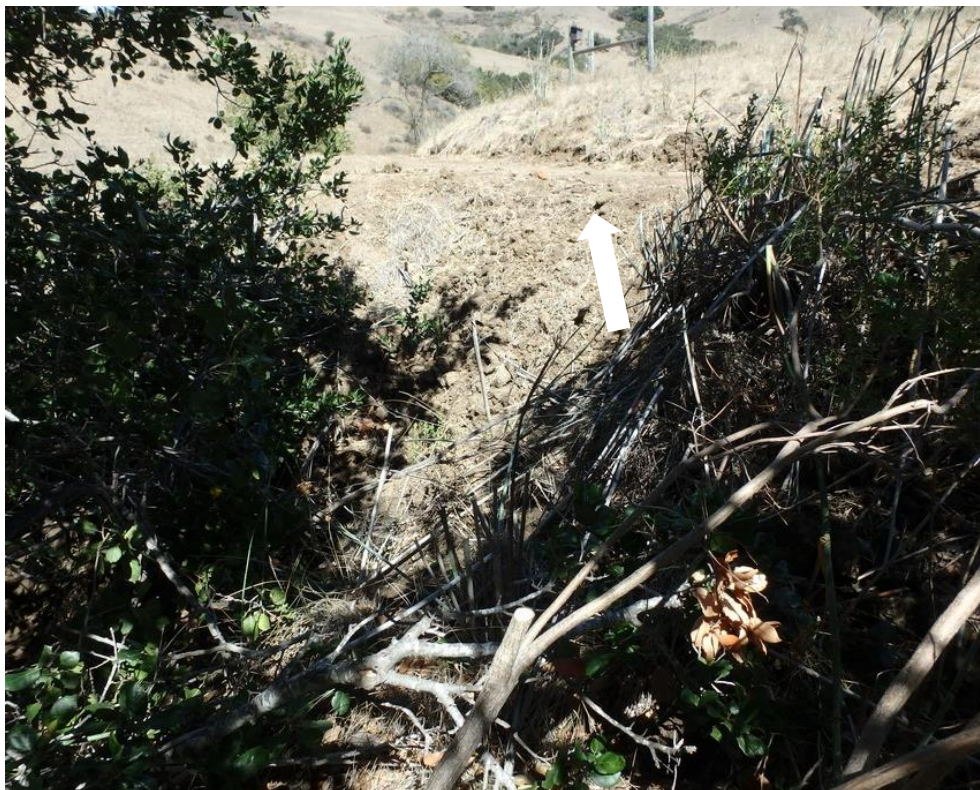
**Photo 62.** Site 217.1 (Peterson Ranch Rd.): View of Site 217.1 looking up at the discharge point (see arrow). The road discharge point is visible in the center of the frame and the road is visible in the center top portion of the frame.

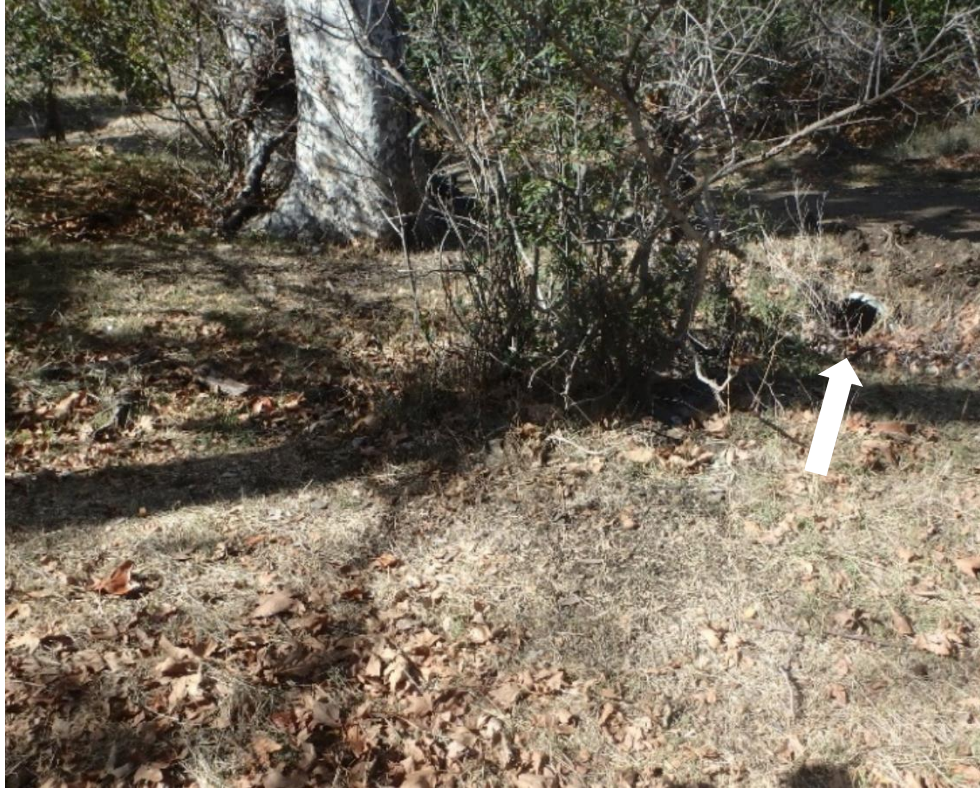
**Photo 69.** Site 221 (Peterson Ranch Rd.): View of Site 221 looking downstream towards the culvert inlet (see arrow). This undersized culvert is prone to plugging during wet weather events. This culvert discharges directly into Brizziolari Creek.

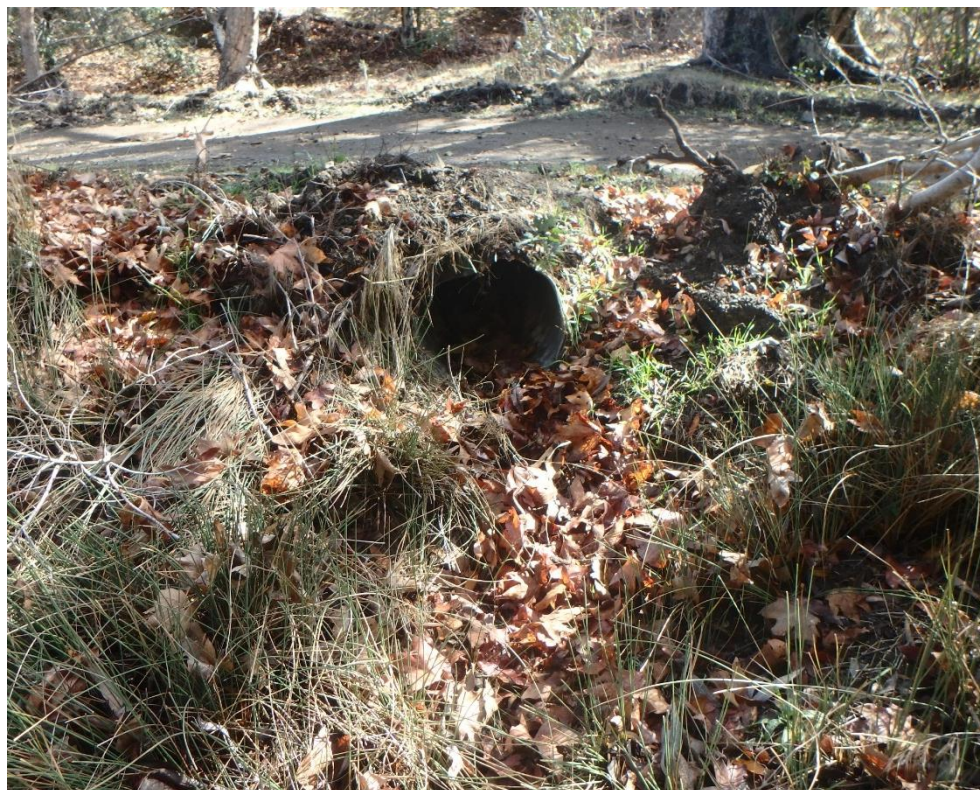
**Photo 70.** Site 221 (Peterson Ranch Rd.): View of Site 221 looking upstream at the culvert outlet area. This section of road runs adjacent to mainstem Brizziolari Creek and frequently becomes inundated during wet weather events.

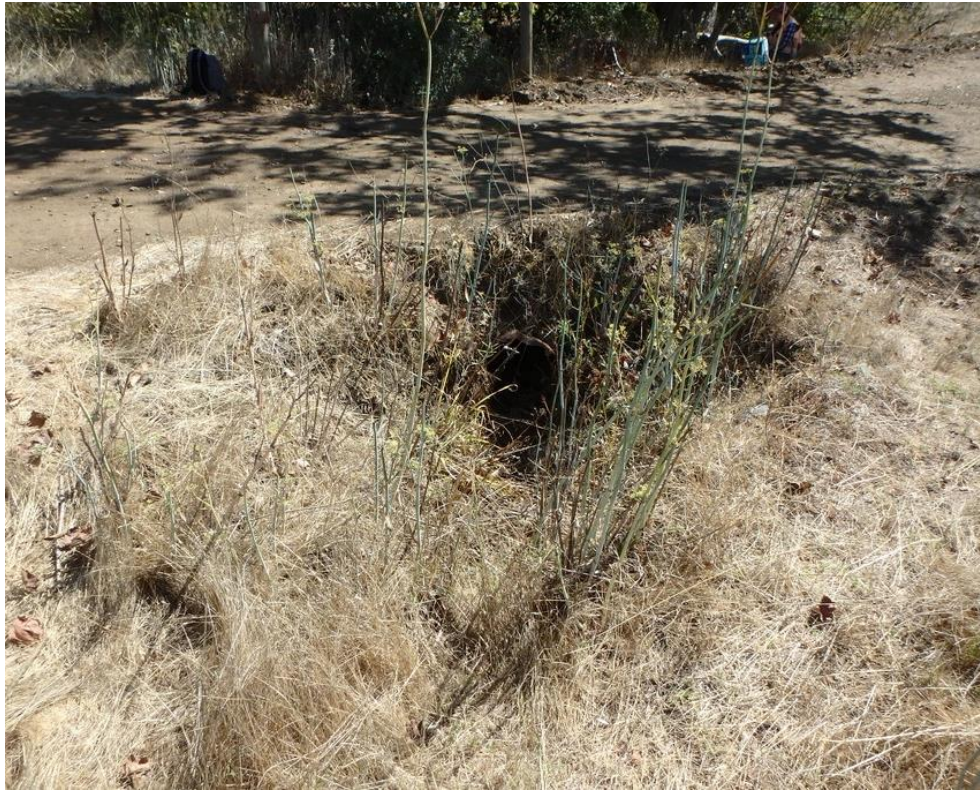
**Photo 75.** Site 224 (Peterson Ranch Rd.): View of Site 224 looking downstream at the culvert inlet. This culvert is undersized and visible in the center of the frame.

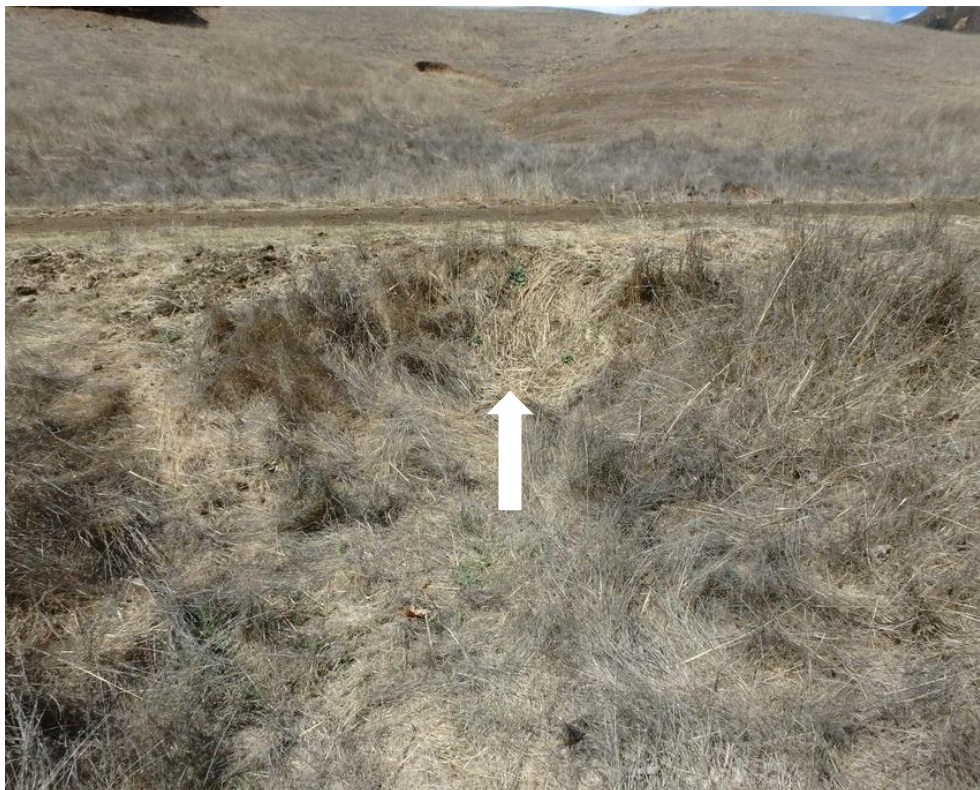
**Photo 84.** Site 227.1 (Peterson Ranch Rd.): View of Site 227.1 looking at the plugged ditch relief culvert outlet (see outlet). The road crossing is visible at the center of the frame and the swale leading to the culvert is present at the top of the frame.

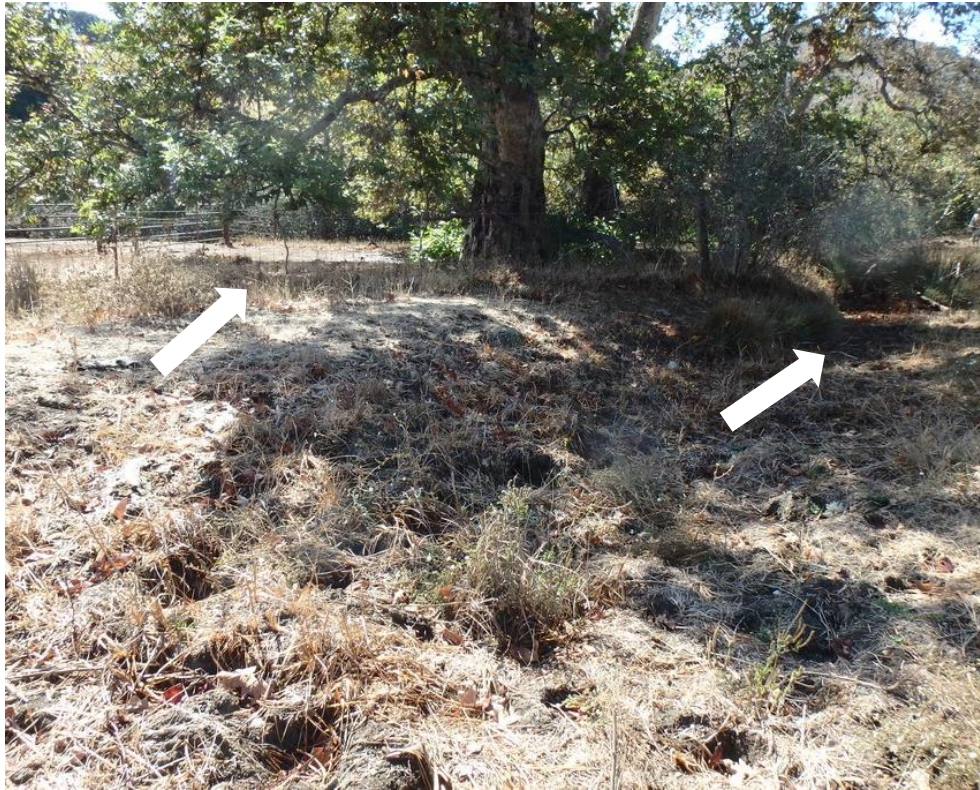
**Photo 85.** Site 228 (Peterson Ranch Rd.): View of Site 228 looking downstream towards mainstem Brizziolari Creek. The current alignment is visible on the right while the proposed stream channel restoration is in the left frame (see arrows).
