**Stenner Creek Erosion Control and  
Sediment Reduction Plan,  
California Polytechnic State University,  
San Luis Obispo County, California**

**PWA Report No. 231039902  
April 2023**

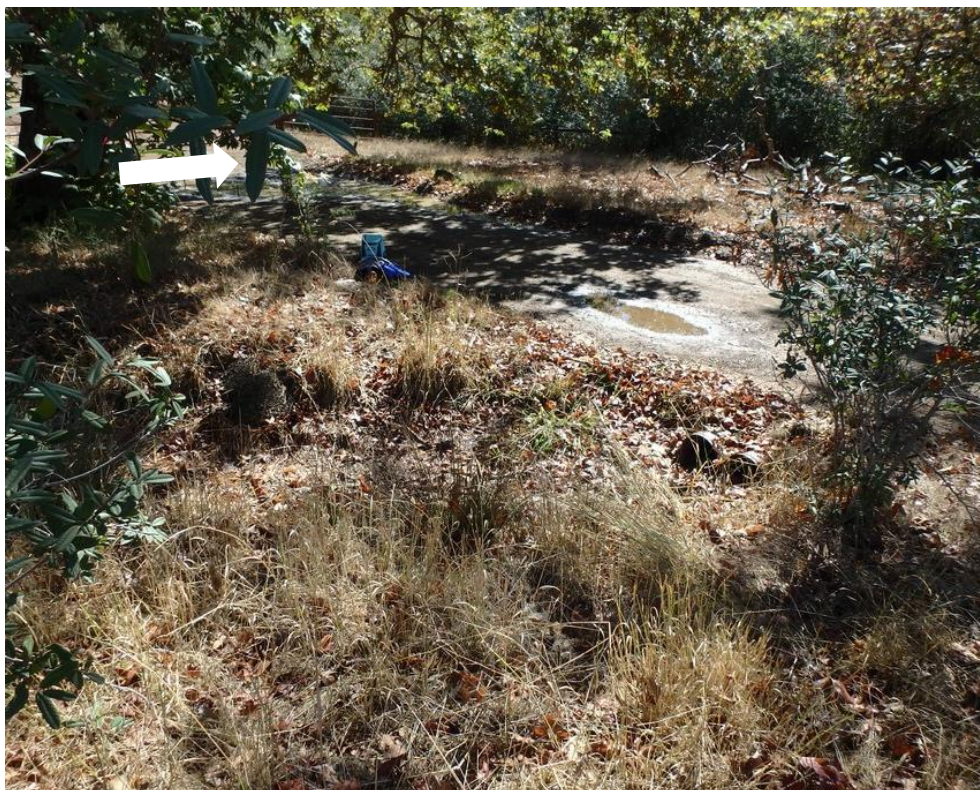
**Photo 86.** Site 228 (Peterson Ranch Rd.): View of Site 228 looking obliquely at the current stream channel. The double culvert inlet is visible in the lower right frame. The proposed stream channel is visible in the upper left frame (see arrow).

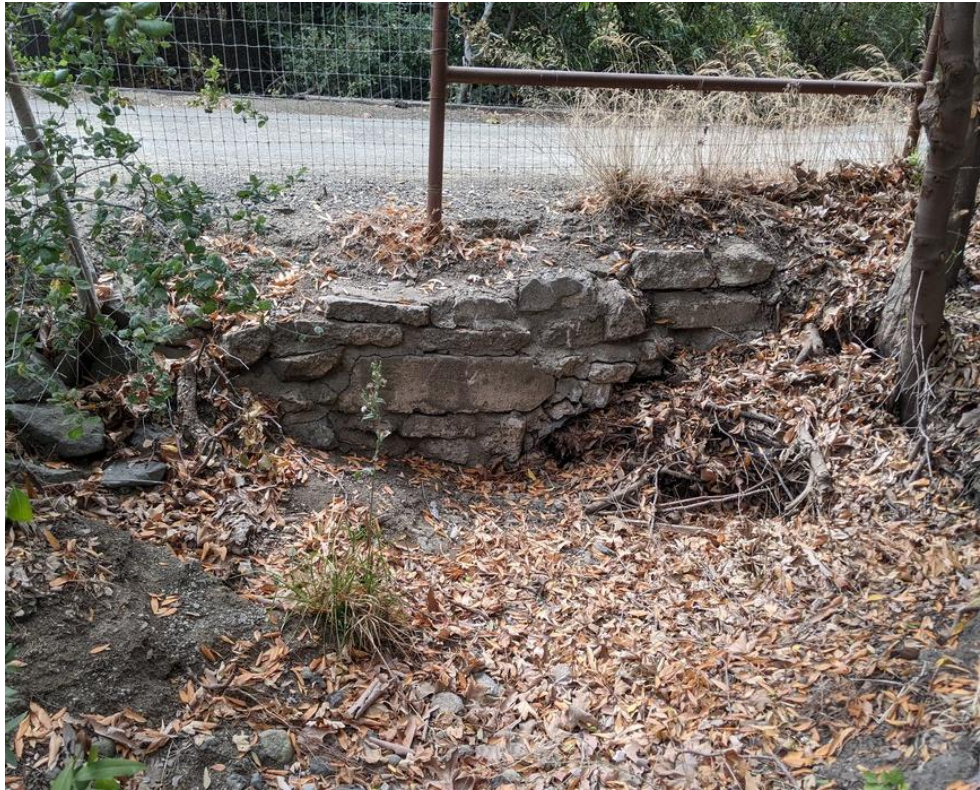
**Photo 87.** Site 229 (Peterson Ranch Rd.): View of Site 229 looking downstream towards the double culvert inlets that are plugged with detritus. The road crossing is visible at the top of the frame.

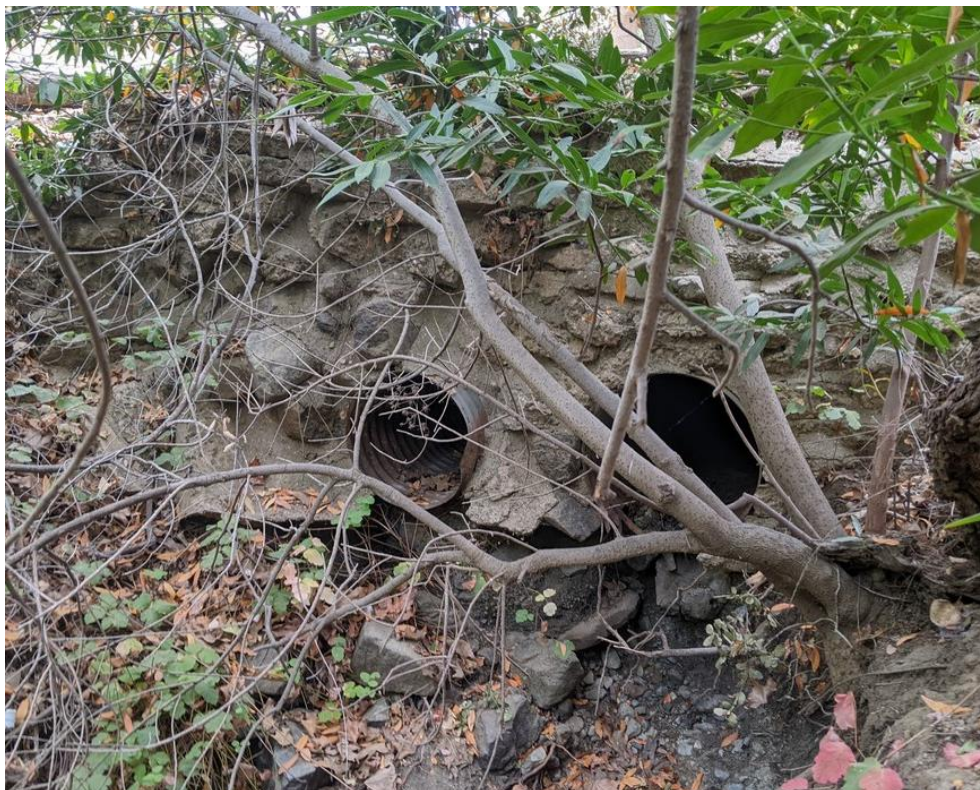
**Photo 88.** Site 229 (Peterson Ranch Rd.): View of Site 229 culvert outlet area looking upstream. The culverts are not plugged at the outlets but there is evident erosion at the base of the culverts from undercutting.

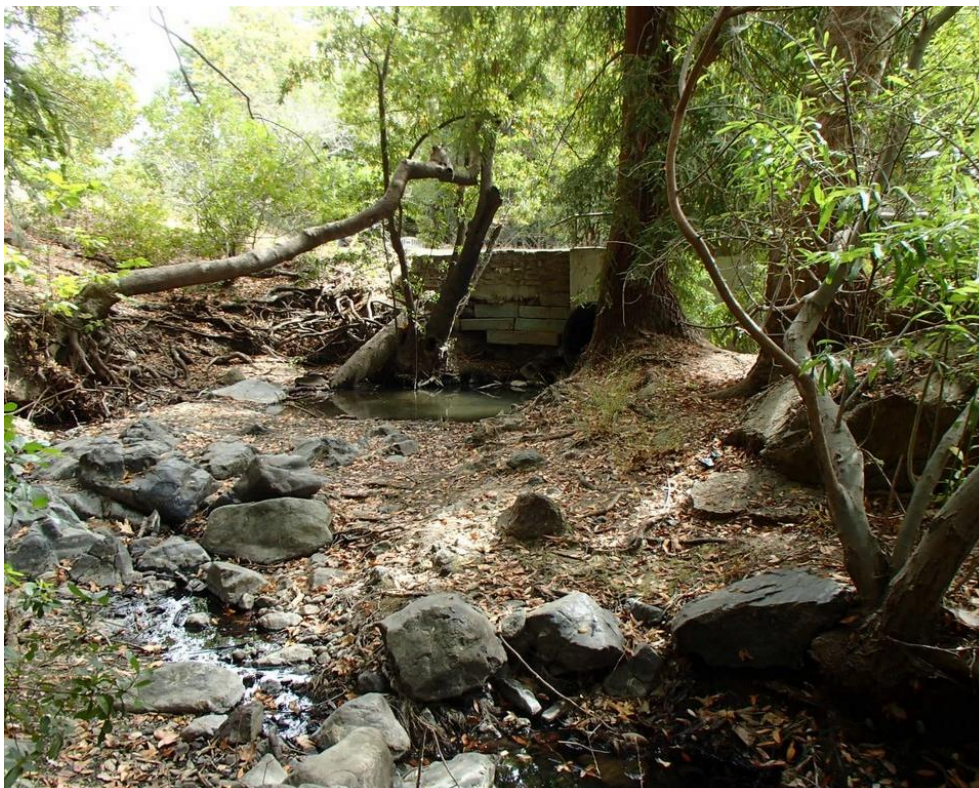
**Photo 92.** Site 230 (Poly Canyon Rd.): View of Site 230 culvert outlet, road crossing, and downstream channel of mainstem Brizziolari Creek.

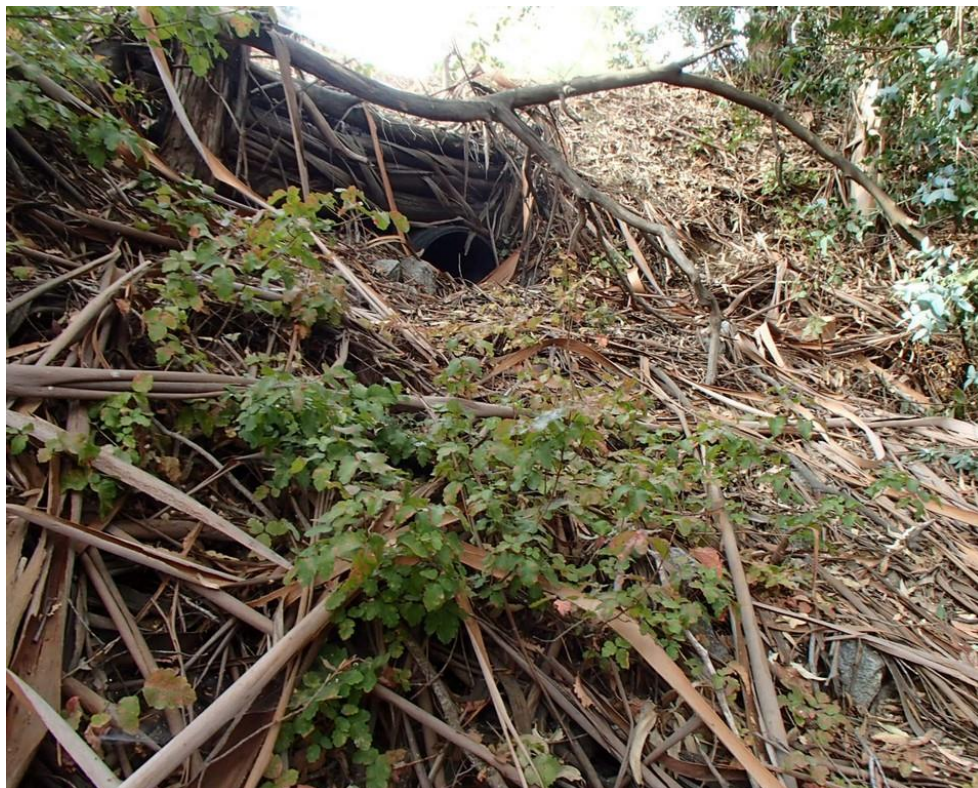
**Photo 94.** Site 232 (Poly Canyon Rd.): View of site 232 ditch relief culvert outlet area. Looking upslope, the culvert outlet is protruding from a crib wall built of eucalyptus branches at the top-center of the frame.

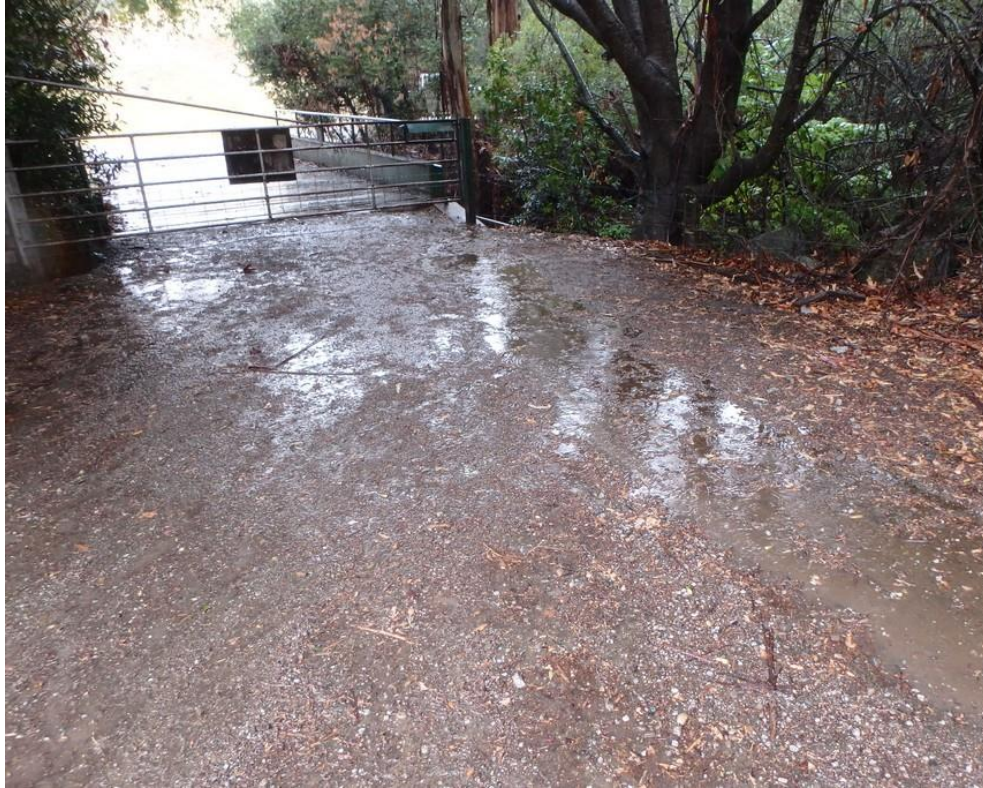
**Photo 99.** Site 235 (Stenner Creek Rd.): View of Site 235 looking obliquely at the stream crossing. This heavy-duty steel and concrete bridge spans mainstem Stenner Creek. Fifty feet of left road approach discharges to this location.

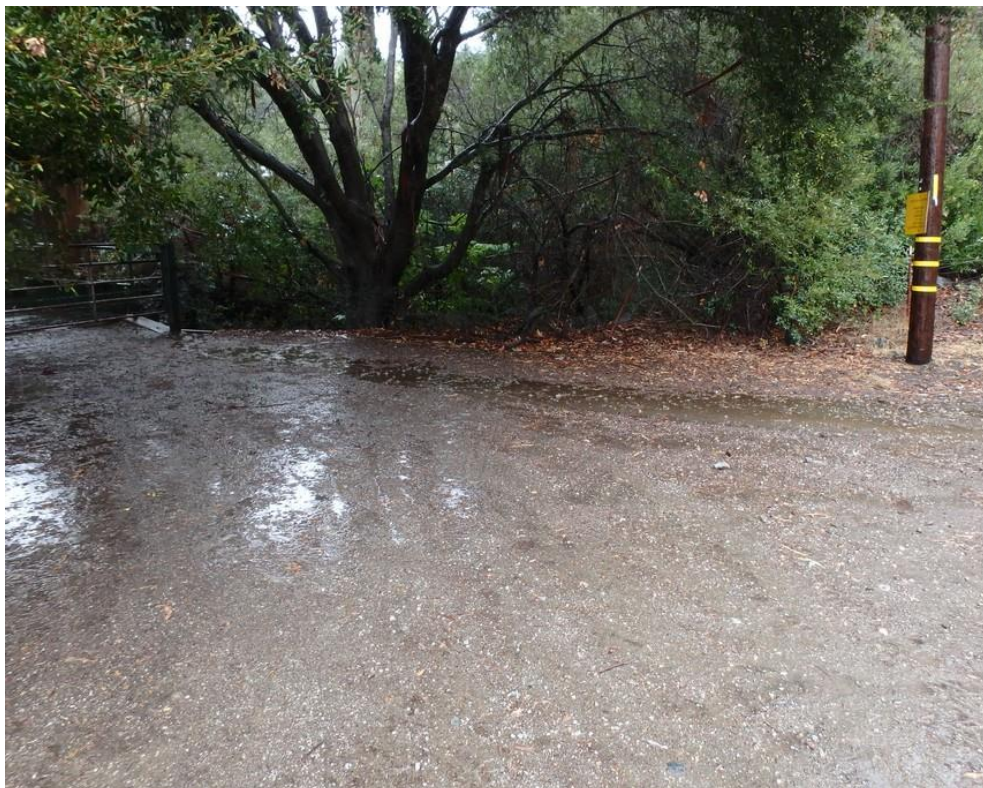
**Photo 100.** Site 235 (Stenner Creek Rd.): View of Site 235 looking upstream of mainstem Stenner Creek. The bridge is visible in the left frame.

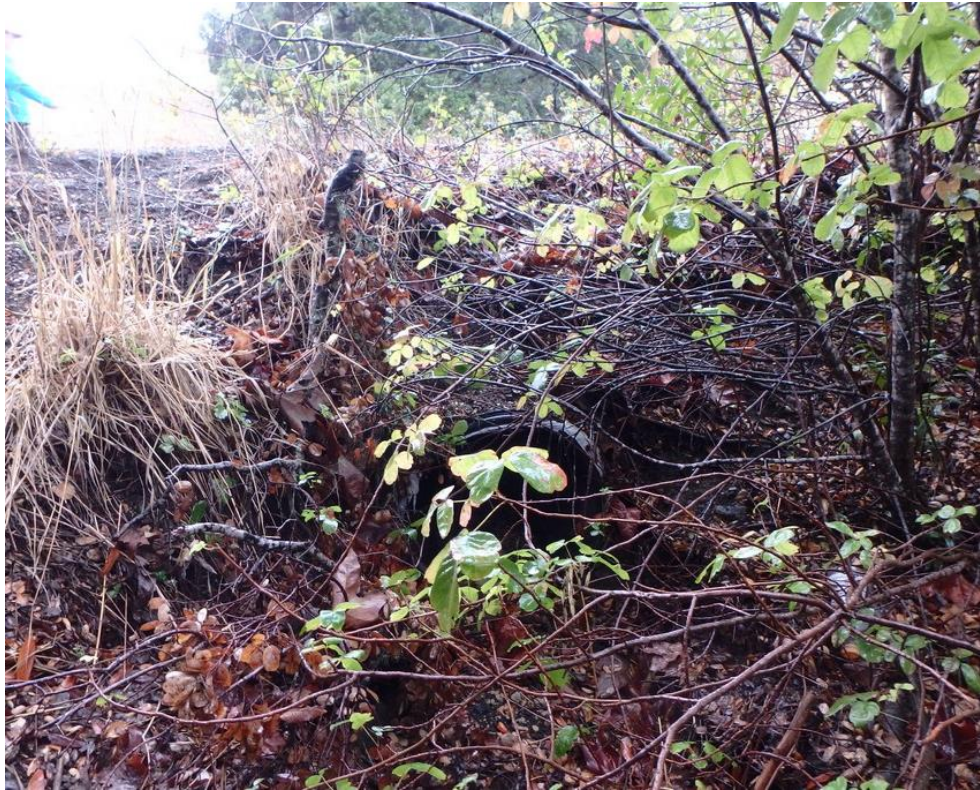
**Photo 101.** Site 236 (Stenner Creek Rd.): View of Site 236 looking upstream at culvert outlet. Road crossing visible in upper frame.

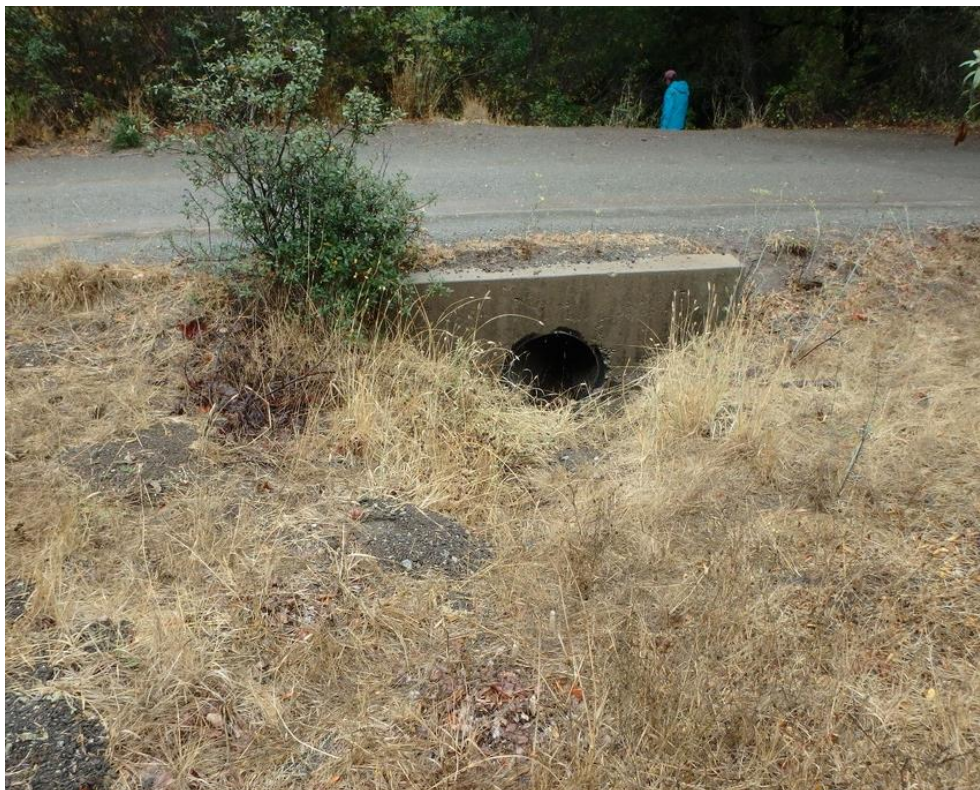
**Photo 102.** Site 236 (Stenner Creek Rd.): View of Site 236 looking downstream at the culvert inlet. Mainstem Stenner Creek is located in the upper frame.

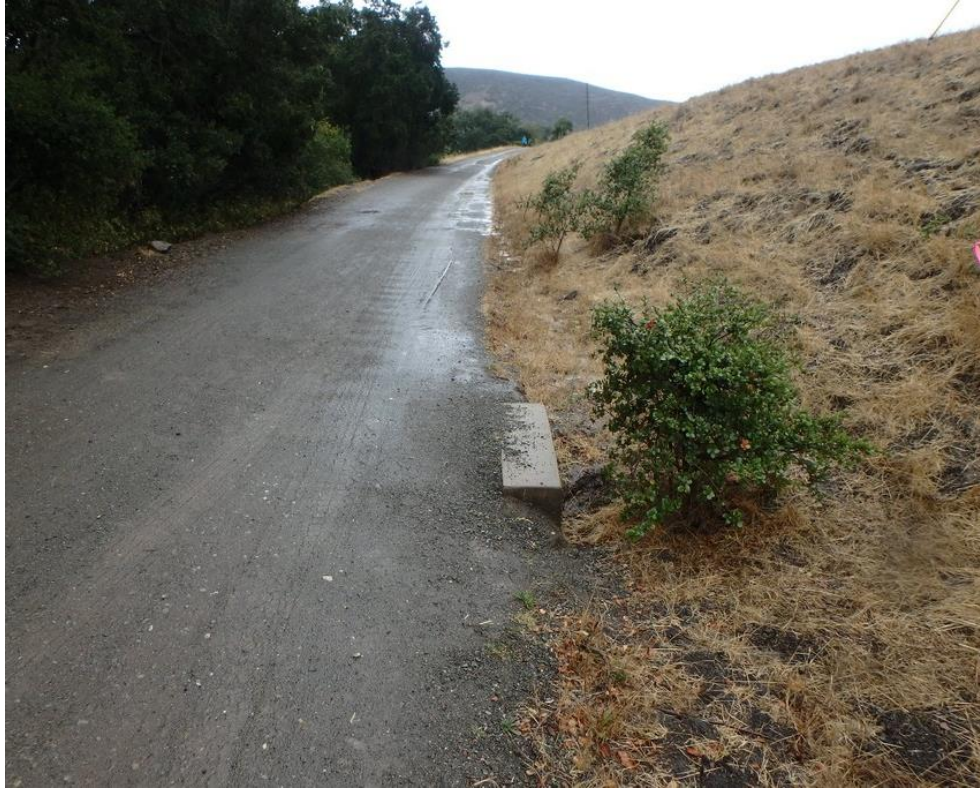
**Photo 103.** Site 237 (Stenner Creek Rd.): View of Site 237 looking down the right road. Muddy water is visibly ponding and draining into the inlet with concrete headwall in the center of the frame. Mainstem Stenner Creek is located to the left and runs parallel to the road.

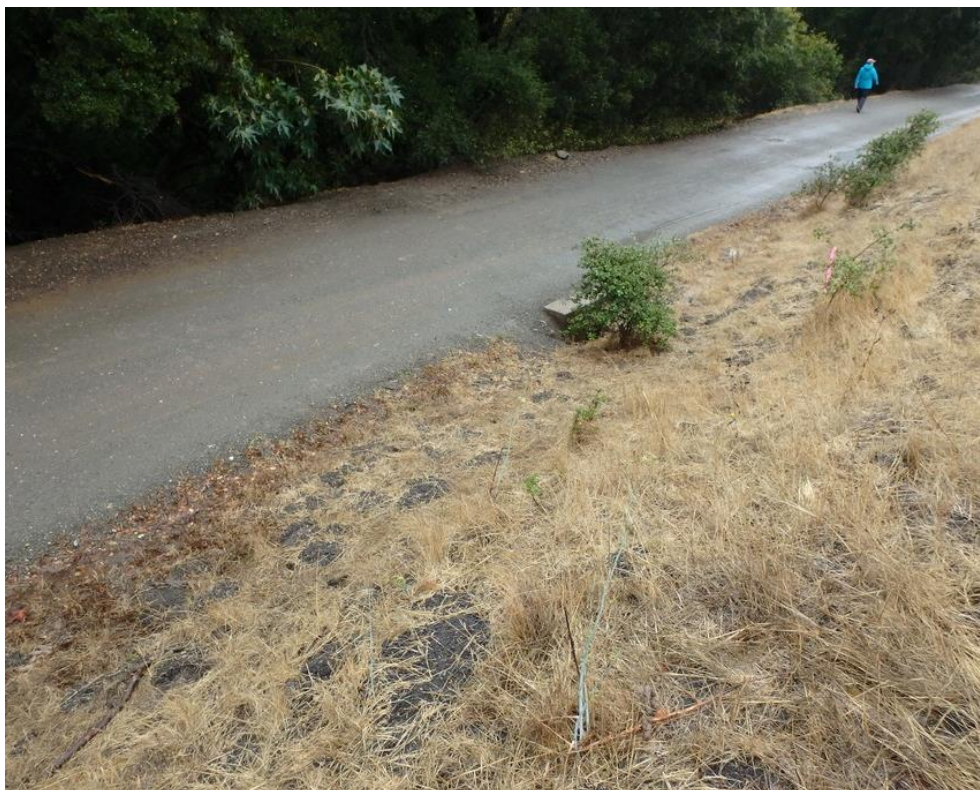
**Photo 104.** Site 237 (Stenner Creek Rd.): View of Site 237 looking obliquely at the culvert inlet with concrete headwall. The culvert discharges approximately 15' above mainstem Stenner Creek, which is in the upper frame.

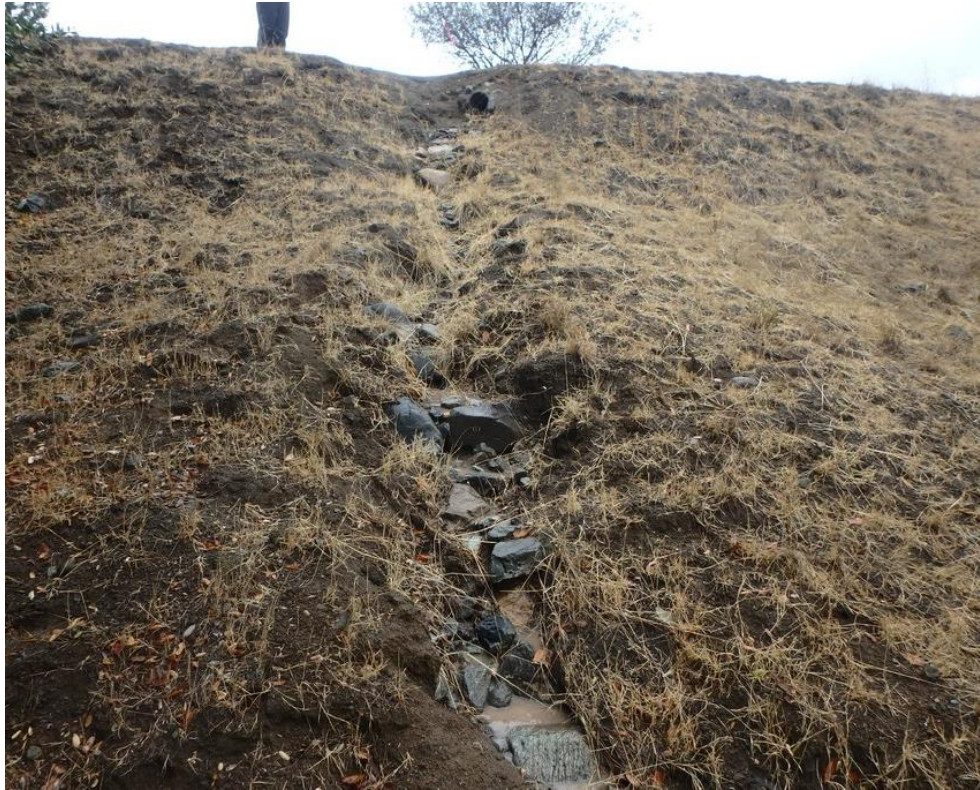
**Photo 105.** Site 238 (Stenner Creek Rd.): View of Site 238 gully erosion from concentrated road runoff from the ditch relief culvert outlet. Fine sediment and muddy water deliver to mainstem Stenner Creek at this location.

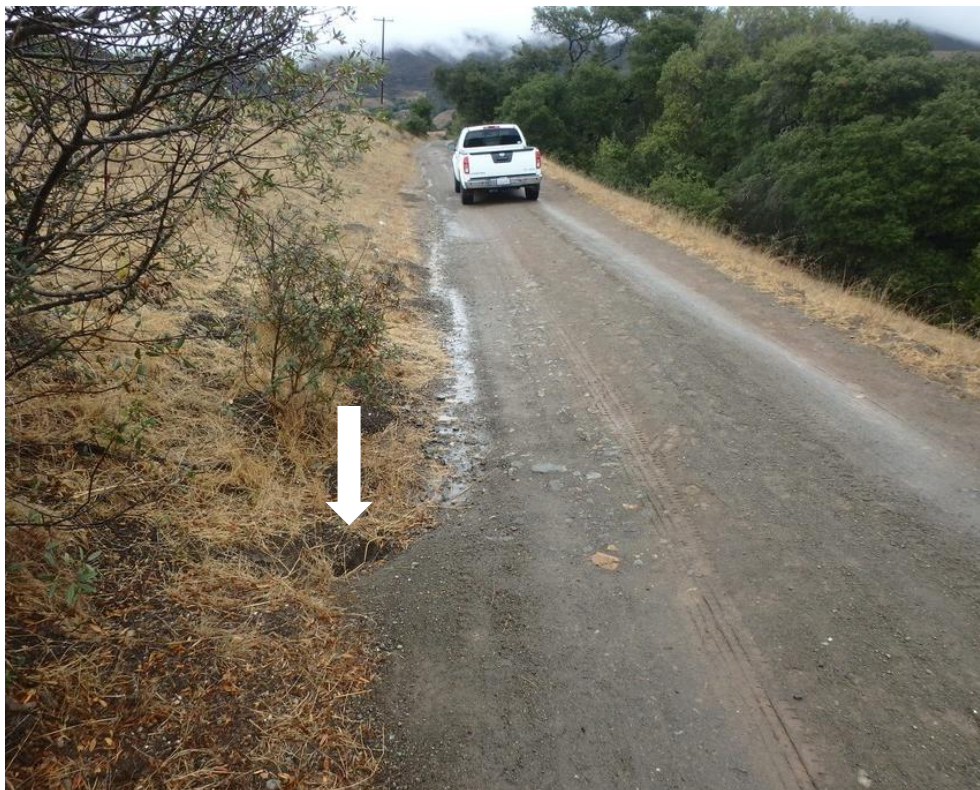
**Photo 106.** Site 238 (Stenner Creek Rd.): View of Site 238 looking at the ditch relief culvert inlet (see arrow). Muddy water is visibly running down the road and into the culvert. Mainstem Stenner Creek runs parallel to this road on the right side of the frame.

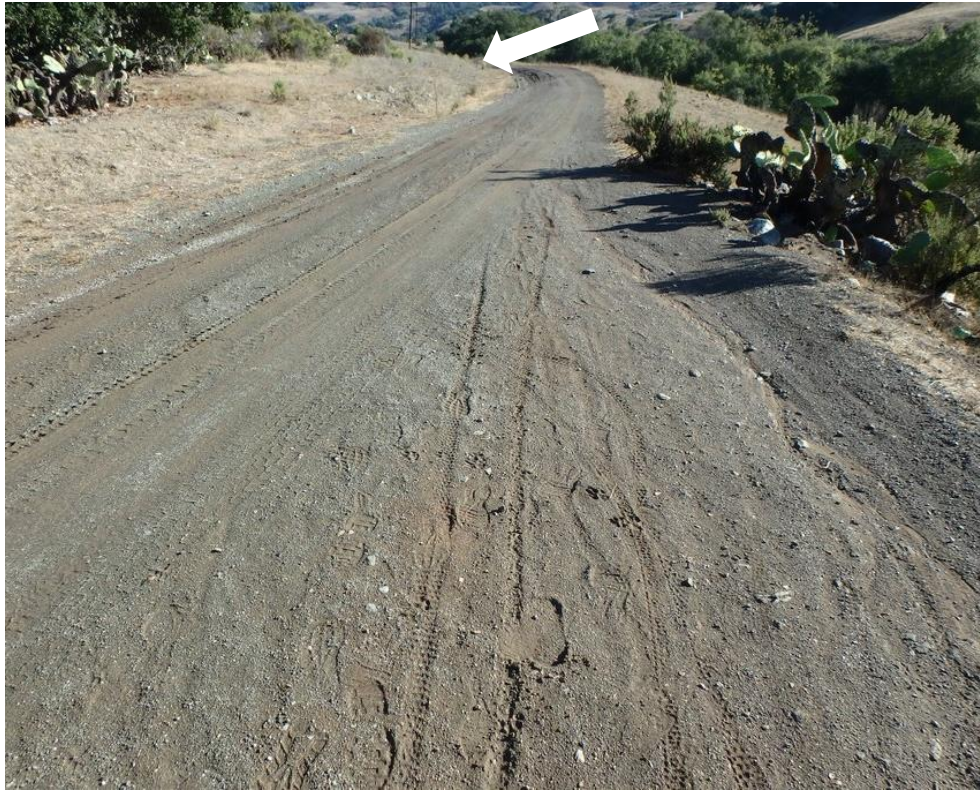
**Photo 107.** Site 238.1 (Stenner Creek Rd.): View of Site 238.1 looking towards Site 238 (see arrow). Evidence of poor road drainage is visible to the evidenced by presence of rilling from concentrated road runoff. Mainstem Stenner Creek runs parallel to this road on the right side of the frame.

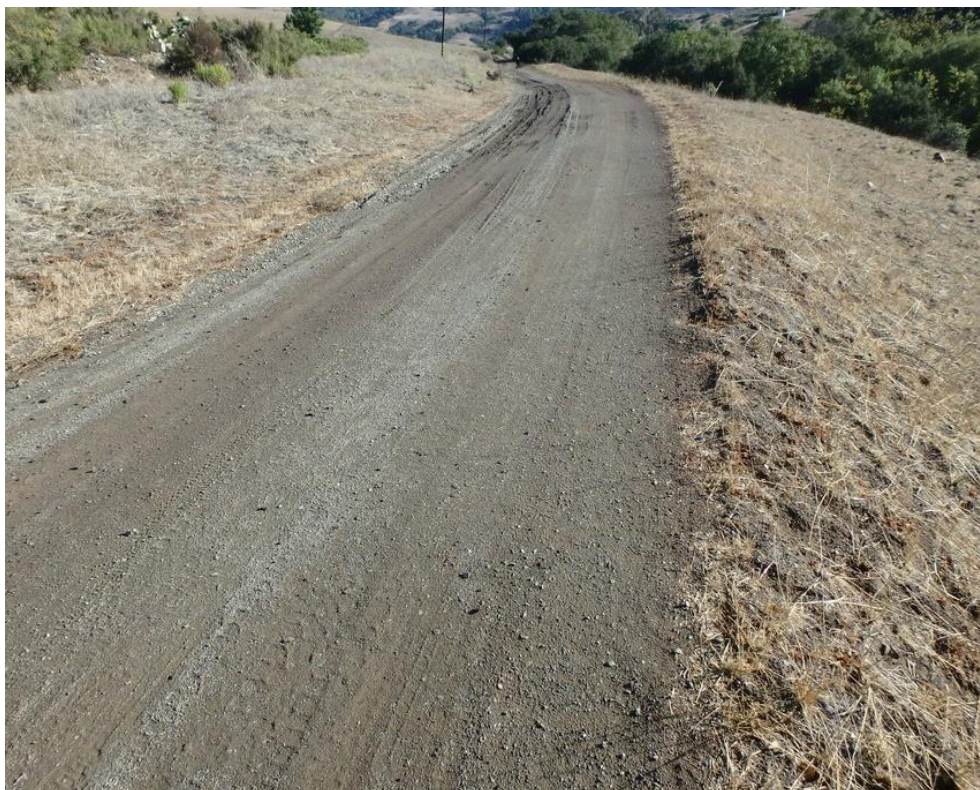
**Photo 108.** Site 238.1 (Stenner Creek Rd.): View of Site 238.1 road approach, looking up road. The insloped road concentrates road and hillslope runoff to a stream crossing located just outside of Cal Poly property.

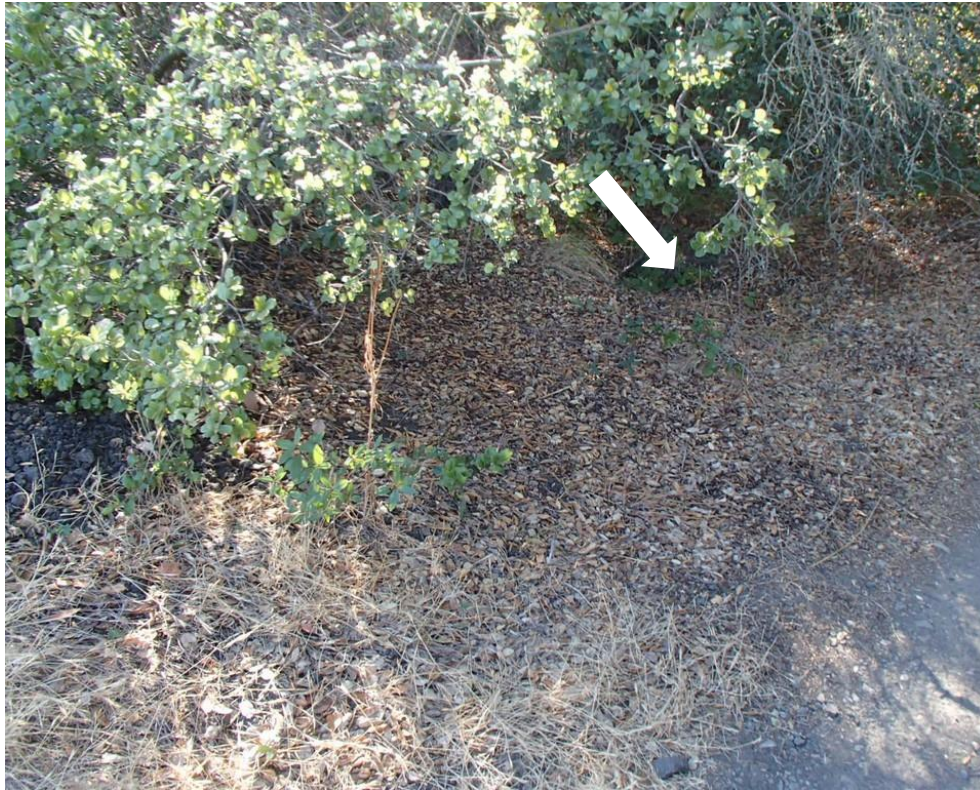
**Photo 109.** Site 410 (Yewks Trail): View of Site 410 looking obliquely at the stream crossing. The stream flows from right to left (see arrow).

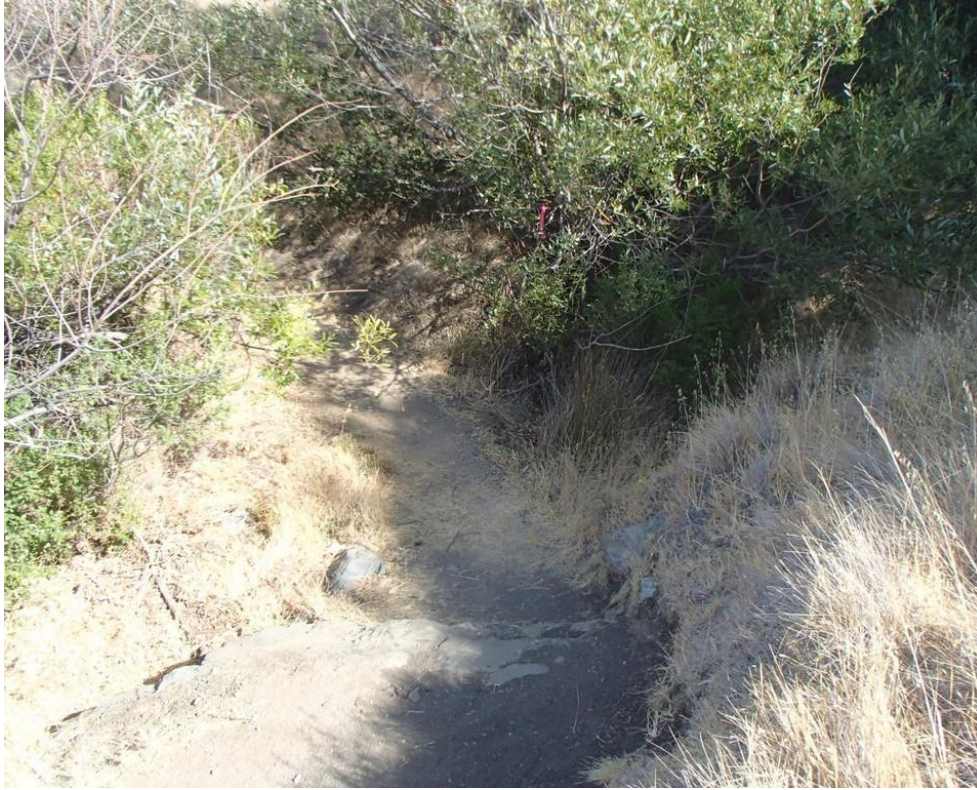
**Photo 111.** Site 411(Yewks Trail): View of Site 411 ford crossing. Looking obliquely at the stream crossing.

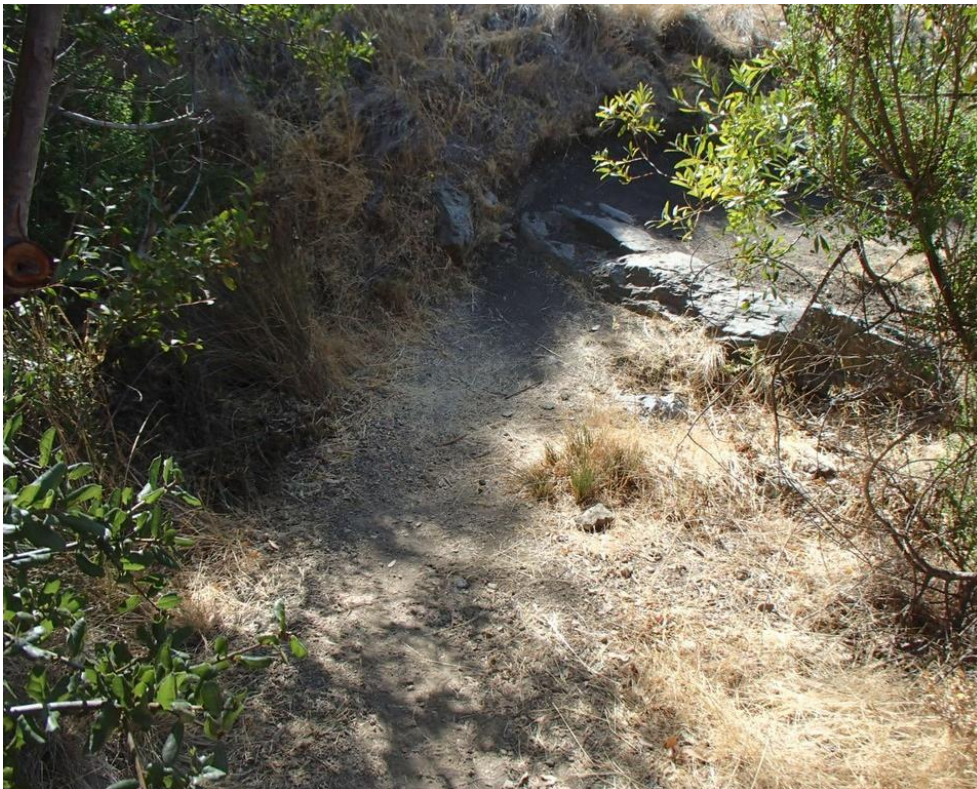
**Photo 112.** Site 411 (Yewks Trail): View of Site 411 ford crossing. This stream channel is low in gradient and grassed over. Both right and left trail approaches contribute to this site.

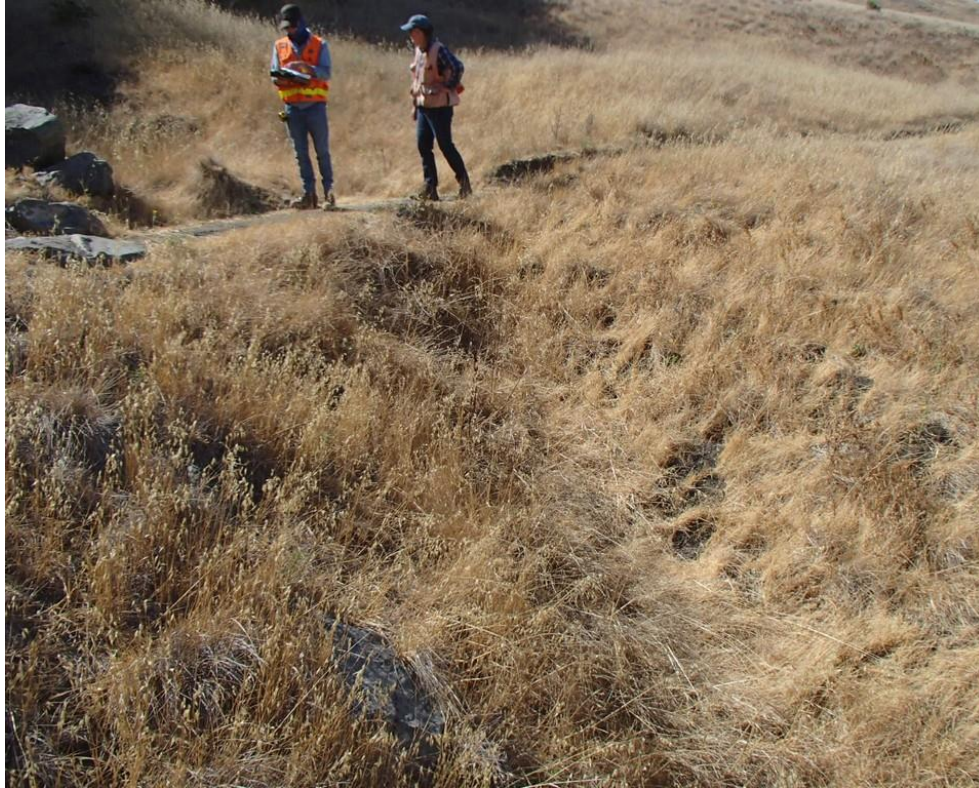
**Photo 113.** Site 412 (Yewks Trail): View of Site 412 looking upstream towards the stream crossing. The stream channel is grassed over, and the outboard fillslope is armored with riprap.

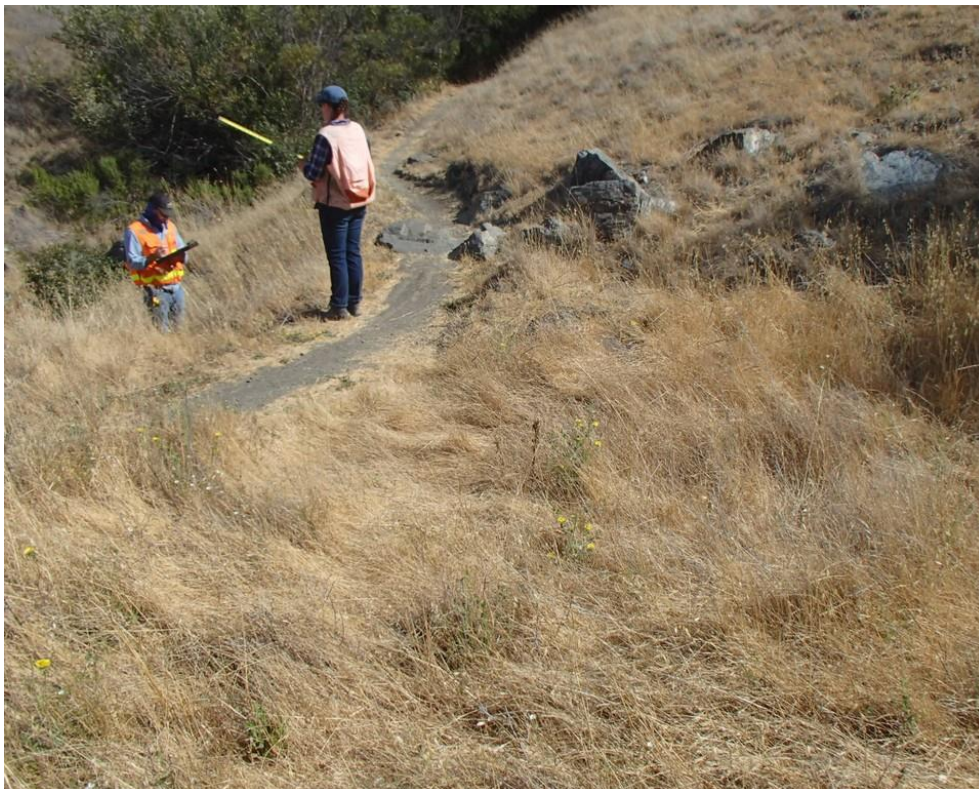
**Photo 114.** Site 412 (Yewks Trail): View of Site 412 looking obliquely at the stream crossing. The stream flows from right to left. The upper channel is armored with riprap.

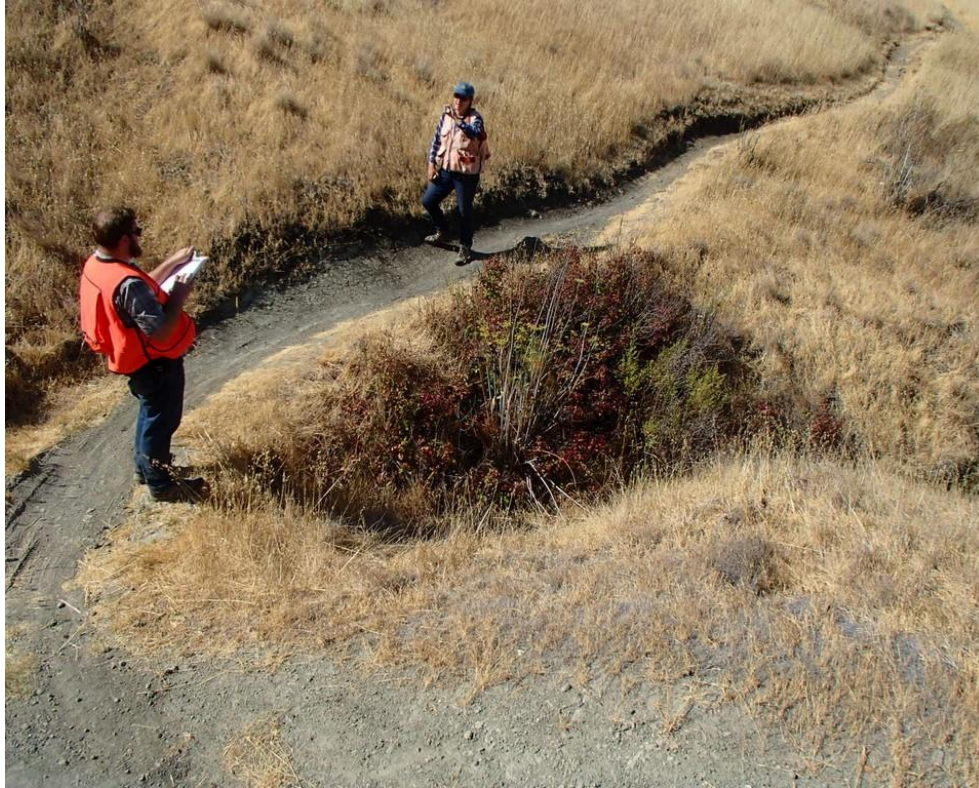
**Photo 115.** Site 413 (Yewks Trail): View of Site 413 stream crossing looking obliquely at the stream crossing. This stream crossing shows signs of wear from bicycle traffic.

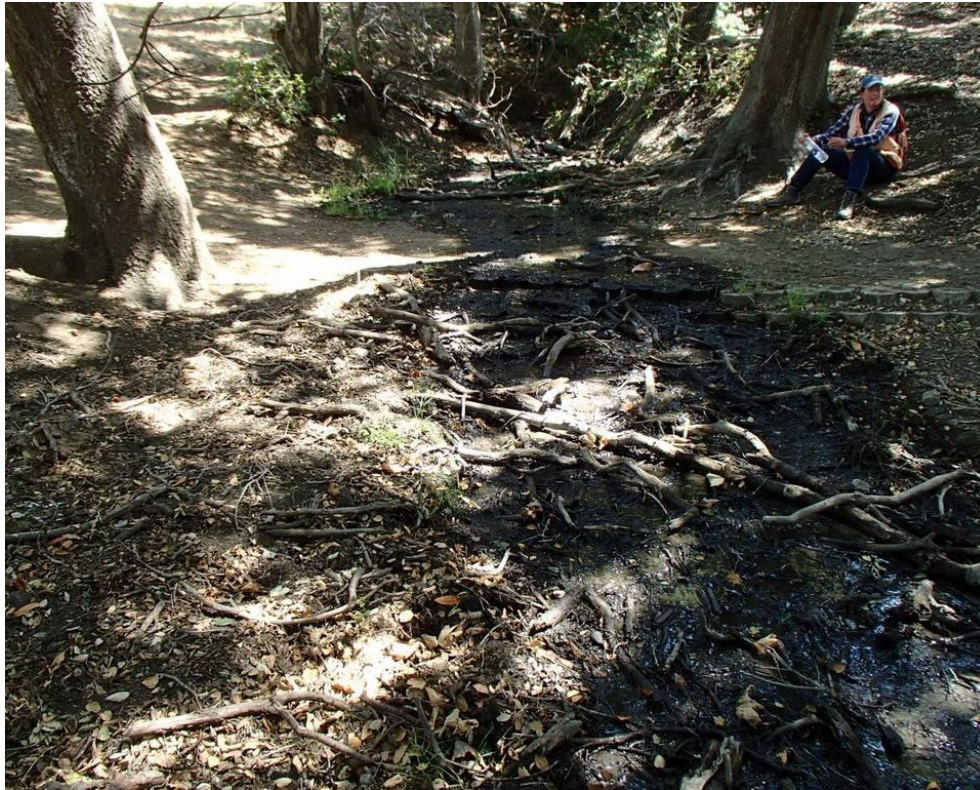
**Photo 117.** Site 414.1 (Yewks Trail): View of Site 414.1 ford crossing looking upstream. This Class III stream ford crossing has been reinforced with concrete blocks that are visible in the right of the frame.

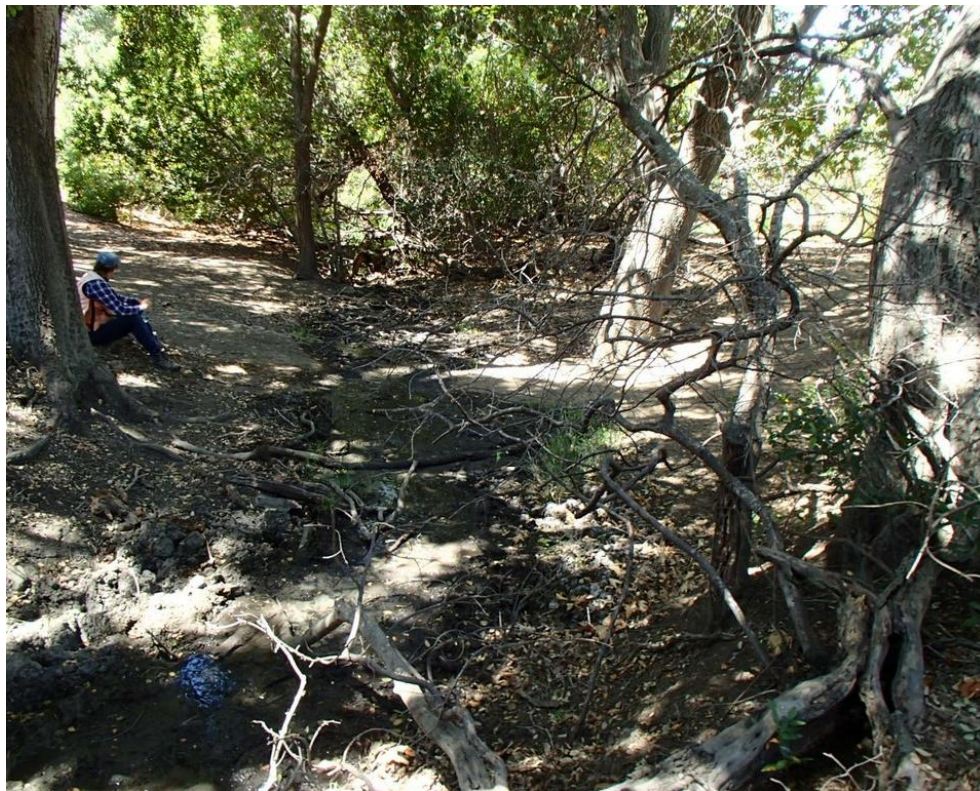
**Photo 118.** Site 414.1 (Yewks Trail): View of Site 414.1 ford crossing looking downstream. This Class III stream ford crossing has been reinforced with concrete blocks.

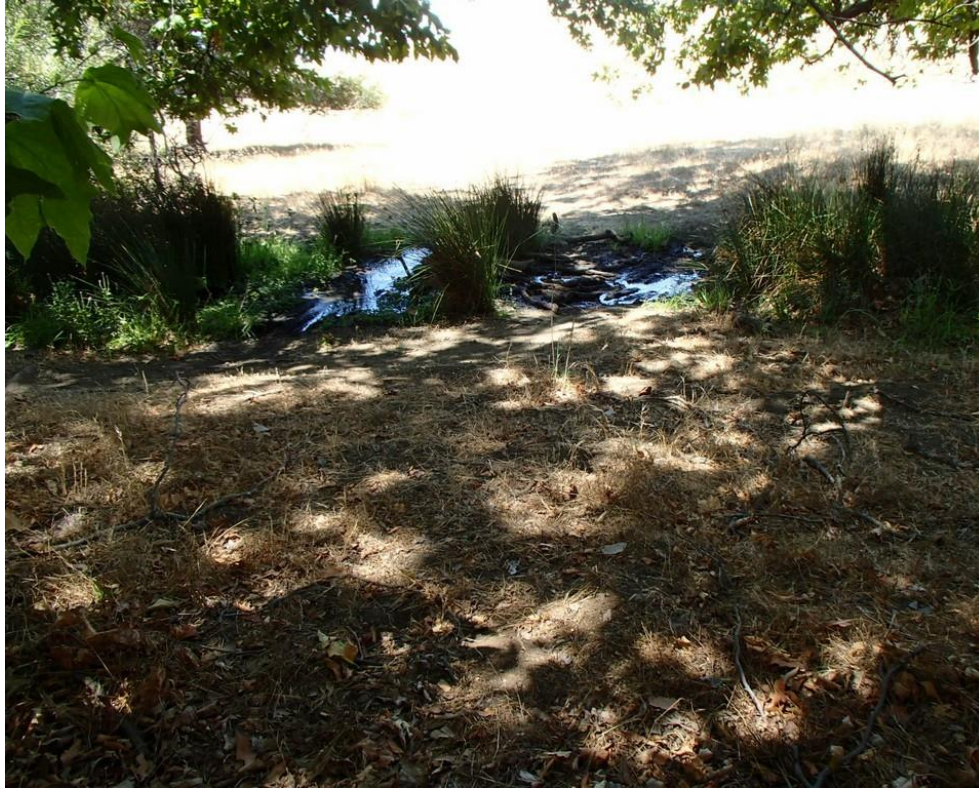
**Photo 119.** Site 414.2 (Yewks Trail): View of Site 414.2 ford crossing looking obliquely at the crossing. Bicyclists and hikers have been navigating this Class II stream by lying down sticks to get across.

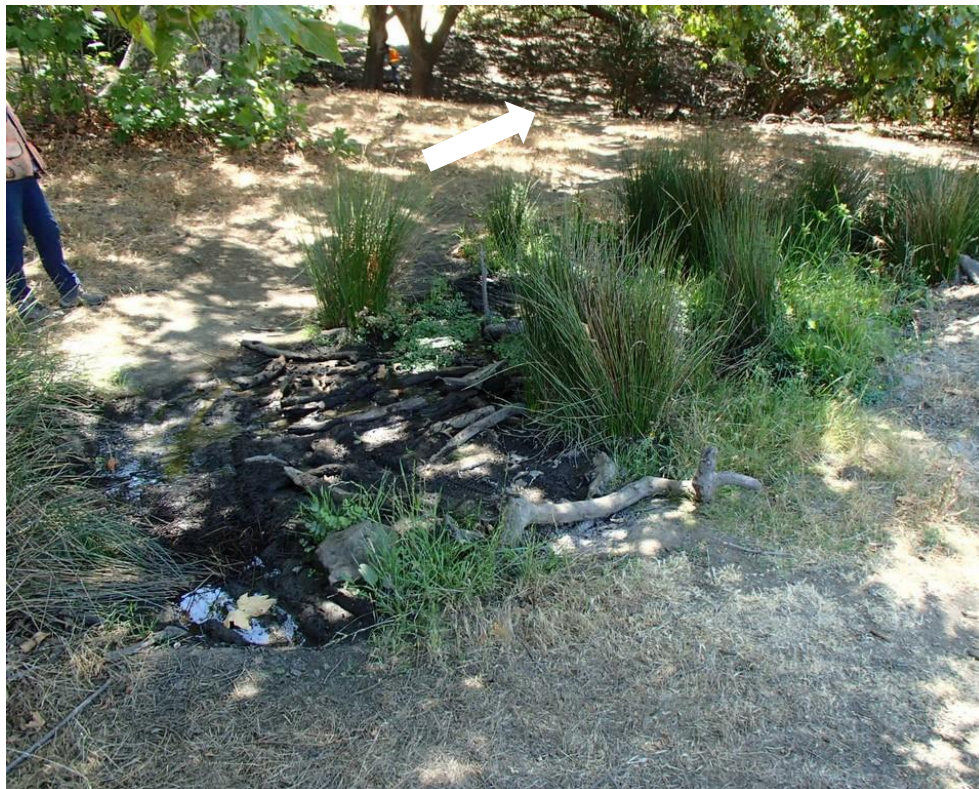
**Photo 120.** Site 414.2 (Yewks Trail): View of Site 414.2 ford crossing. Looking obliquely at the crossing the stream flows left to right. Site 414.1 is visible in the background (see arrow).

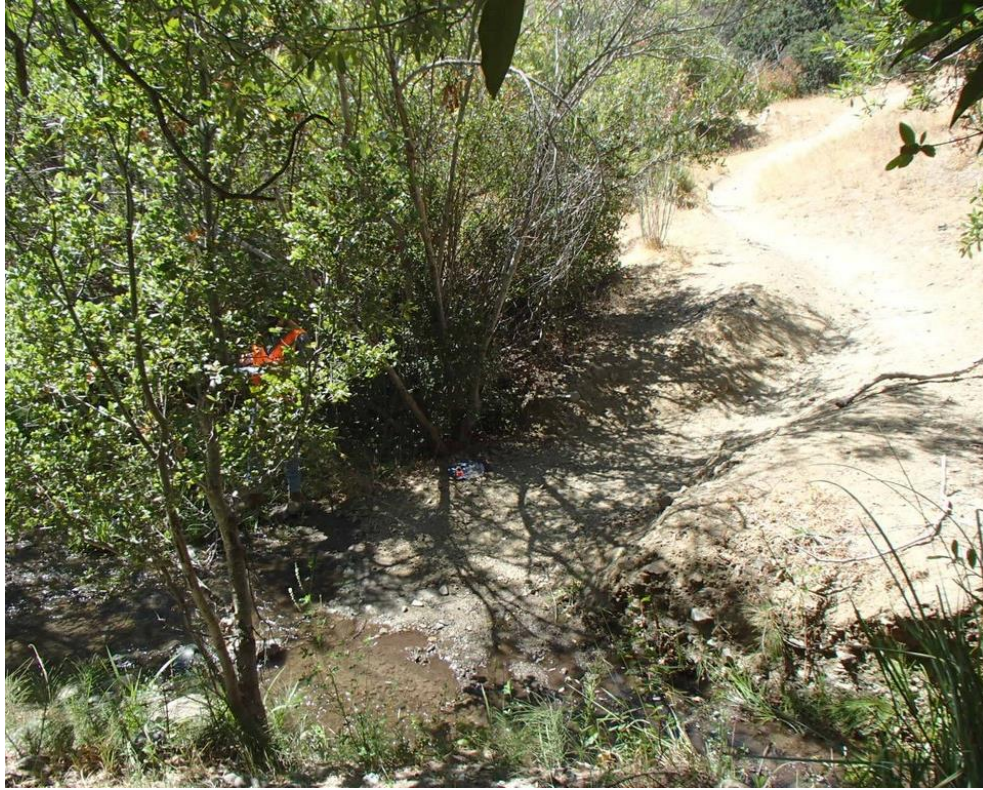
**Photo 121.** Site 415 (Elevator Trail): View of Site 415 ford crossing. Looking obliquely at the stream crossing the right road is visible in the upper right frame. 616' of right and 45' of left trail contribute to this site.

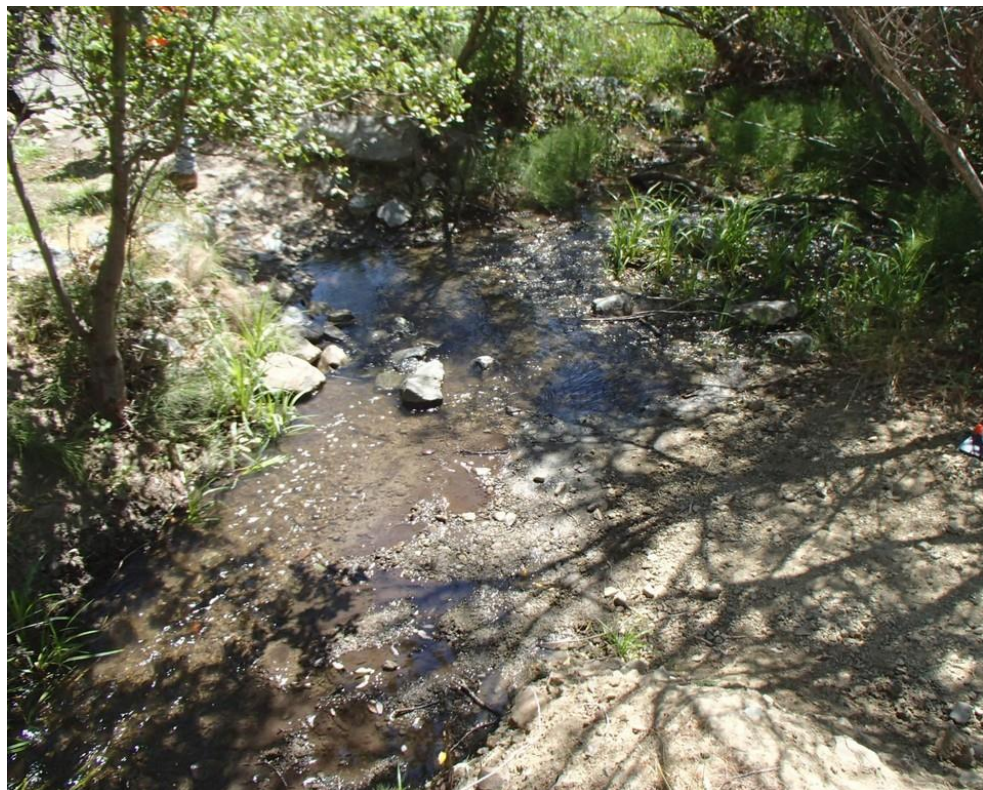
**Photo 122.** Site 415 (Elevator Trail): View of Site 415 ford crossing looking downstream.
