**Stenner Creek Erosion Control and  
Sediment Reduction Plan,  
California Polytechnic State University,  
San Luis Obispo County, California**

**PWA Report No. 231039902  
April 2023**

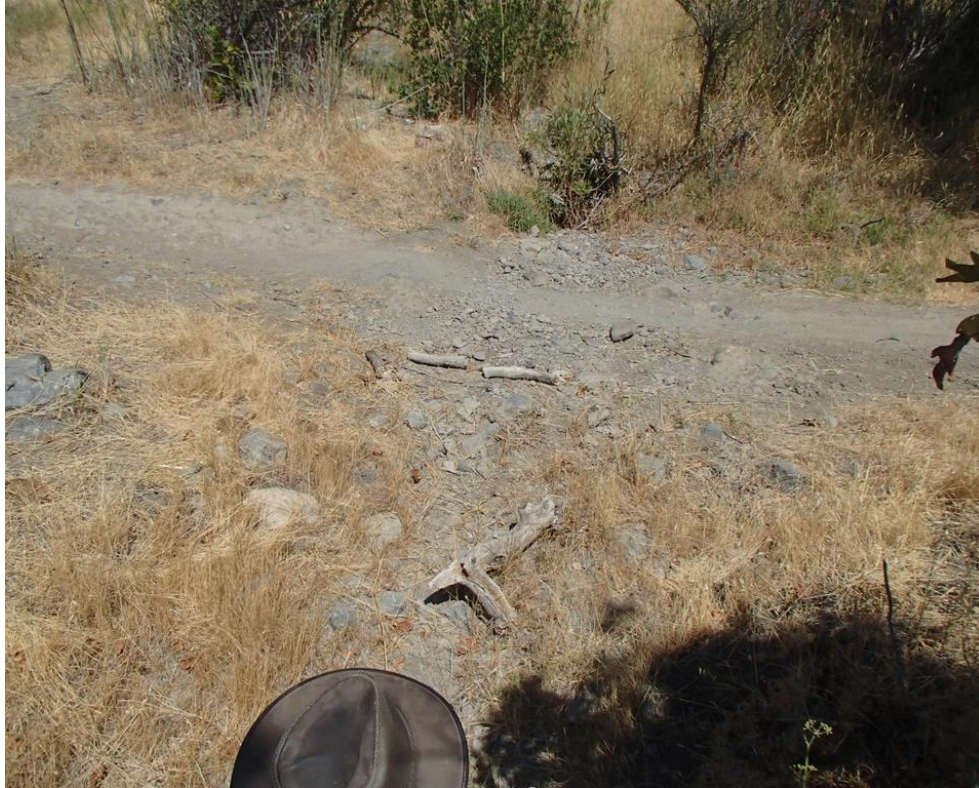
416	Elevator	L	Stream crossing	33	280	0	27	A 2' x 1' Class II flows across a small but heavily used mountain bike trail. There is no fill in the crossing and no eroding banks. The crossing is a perfect ford. The right approach is connected.	1. Install 3 rolling dips along the right trail.
417	Elevator	ML	Stream crossing	40	295	0	16	This is a well-designed ford crossing on a bike trail. Banks are pulled back and stable. There is no fill left in the crossing. Right approach shows wear from bike traffic and is getting rutted. Multiple trail alignments have been developed along the right approach with up to three parallel alignments.	1. Install 5 rolling dips to right.

**Photo 123.** Site 416 (Elevator Trail): View of Site 416 ford crossing looking downstream. The stream crossing is visible in the center of the frame.

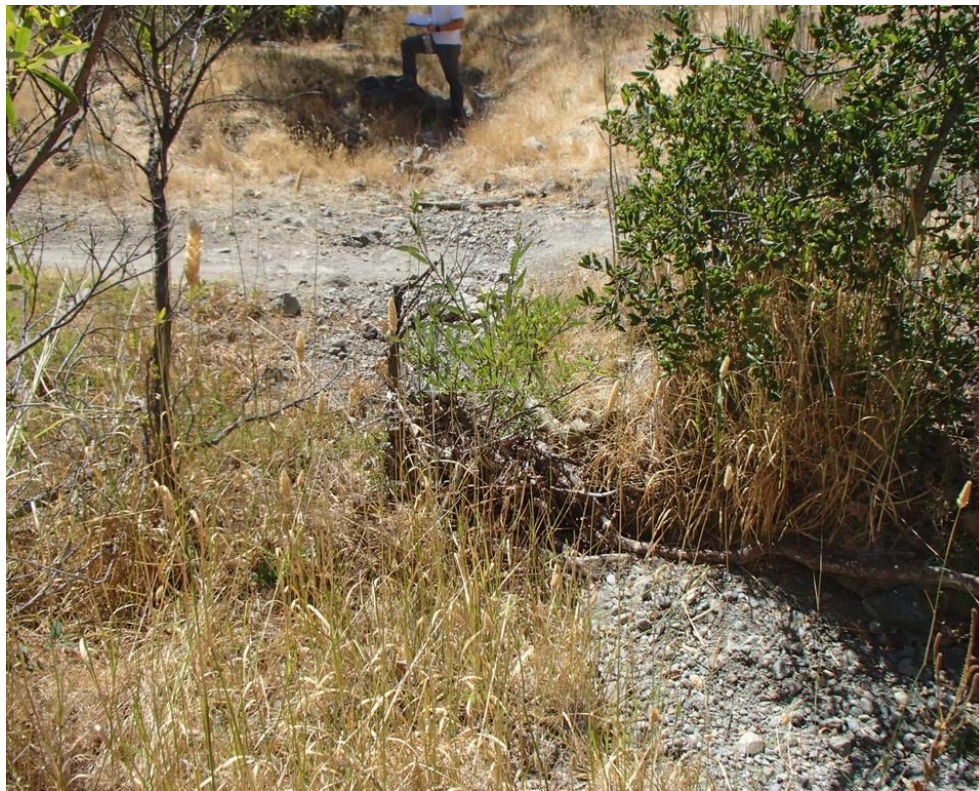
**Photo 124.** Site 416 (Elevator Trail): View of Site 416 ford crossing. Looking upstream the stream crossing is visible in the center of the frame. 210' of right and 15' of left trail contribute to this site.

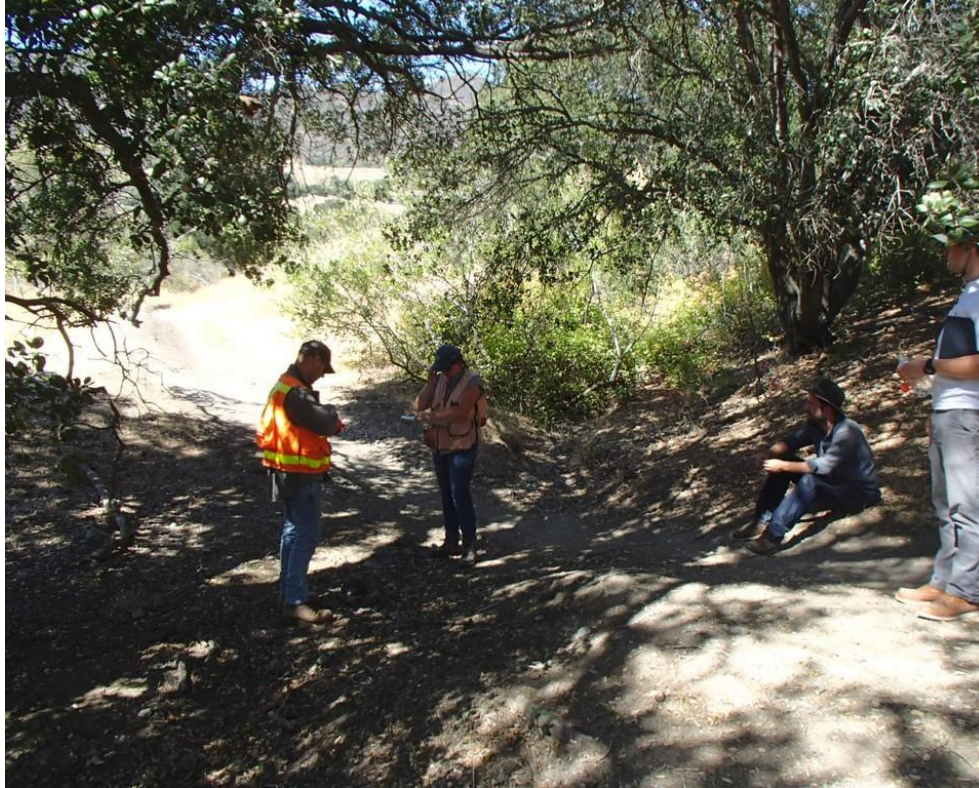
**Photo 125.** Site 417 (Elevator Trail): View of Site 417 ford crossing looking obliquely at the crossing. Multiple trail alignments have been developed along the right approach with up to 3 parallel alignments.

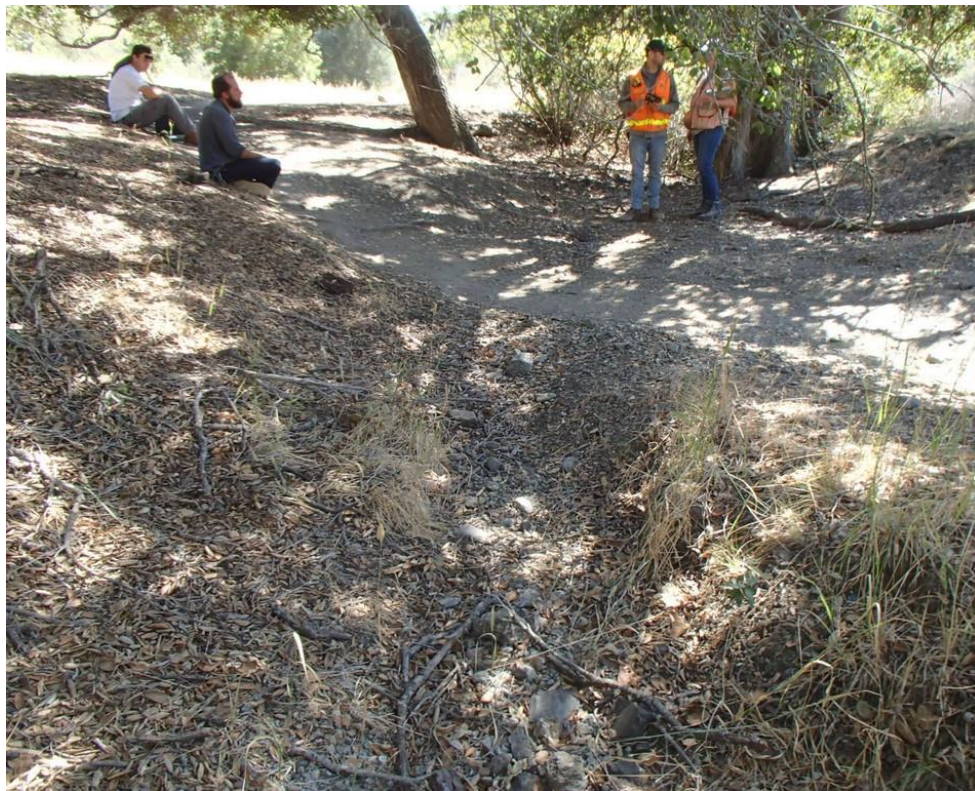
**Photo 126.** Site 417 (Elevator Trail): View of Site 417 ford crossing looking upstream. The stream crossing is visible in the center of the frame. 295' of right and 40' of left trail contribute to this site.
