# ATTACHMENT F

## Mitigation Project PC-05-01

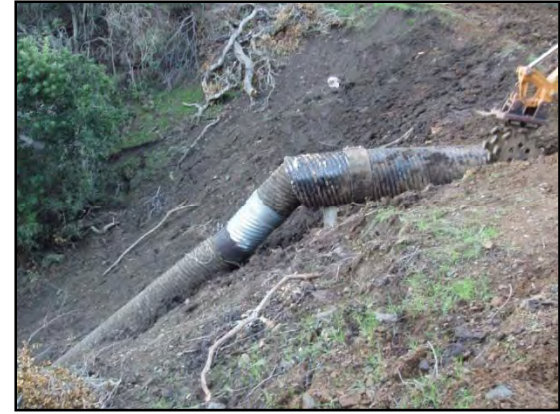
Figure 156. Extended downspout with new nipple.

**Project:** During a major storm event, a culvert failed on an access road which led to scouring and erosion of the road as well as making the road impassable.

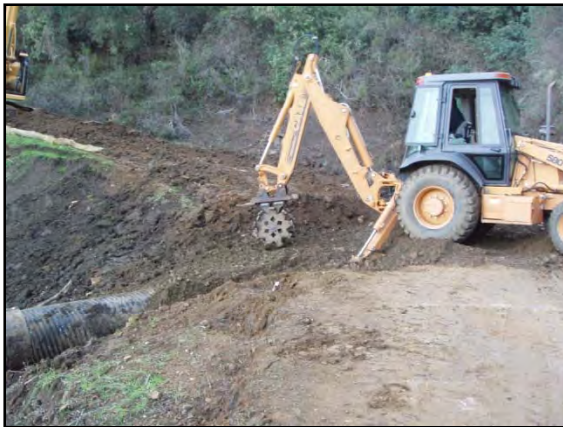
Figure 157. Compacting fill over new culvert

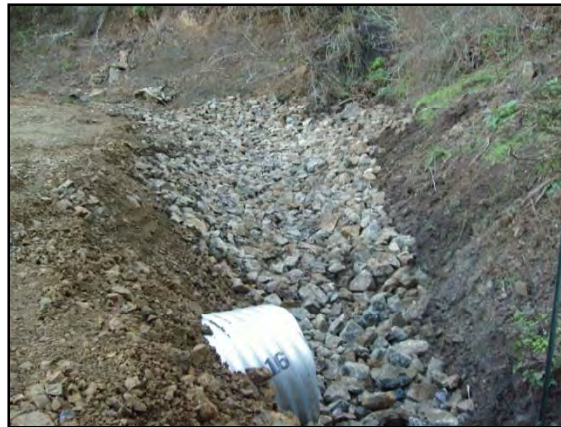
Figure 158. Improved entrance to new culvert.

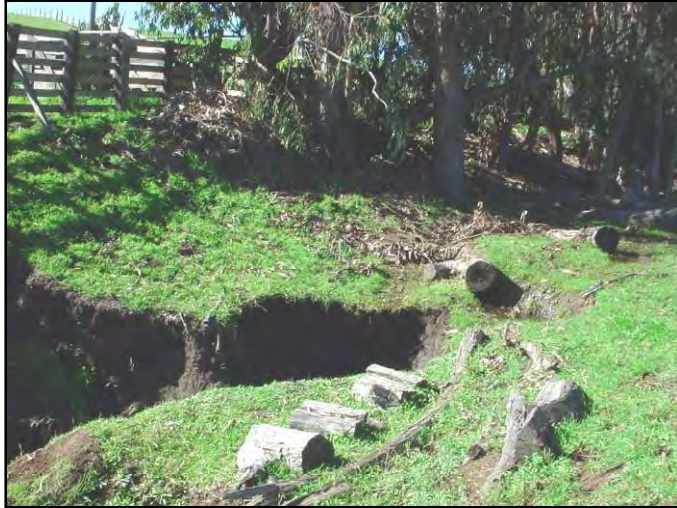
Figure 160. View of headcut, looking from left bank to right bank.

**Resource concern:** The head cut and a sloughing bank contribute to sediment loading into Warden Creek.

**Solution:** Install drop structure to eliminate head cut; backfill around drop structure; fill in head cut to support sloughing bank.

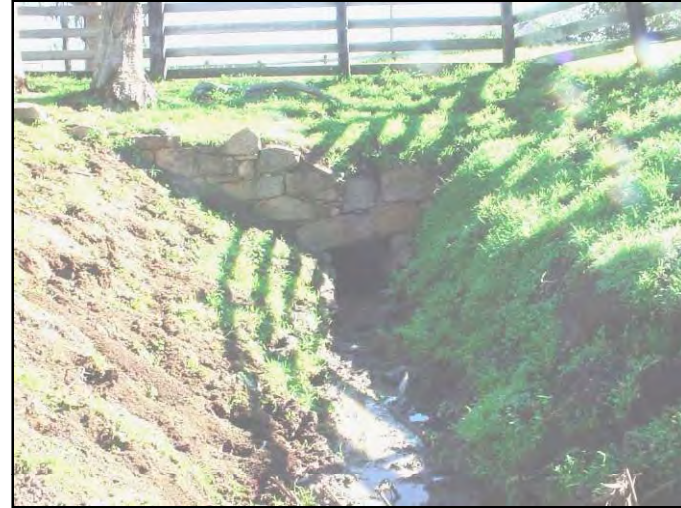
Figure 161. Looking downstream at entrance of existing rock culvert.

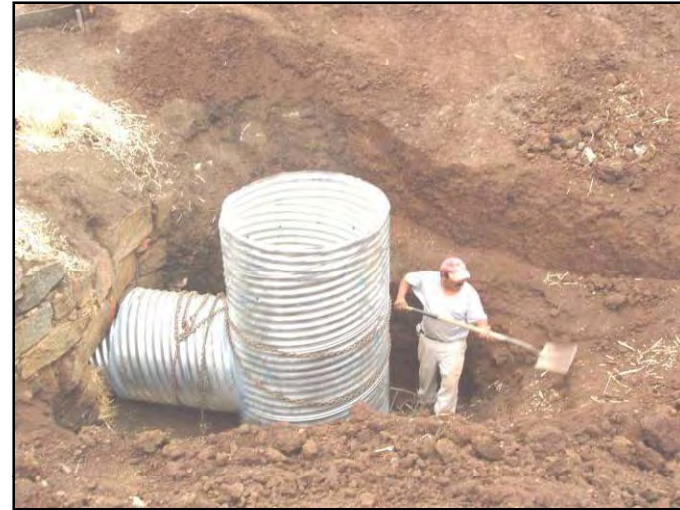
Figure 166. Placed drop structure.

**Construction:** A large drop structure was installed to channel flow under the historic stone bridge without erosion.

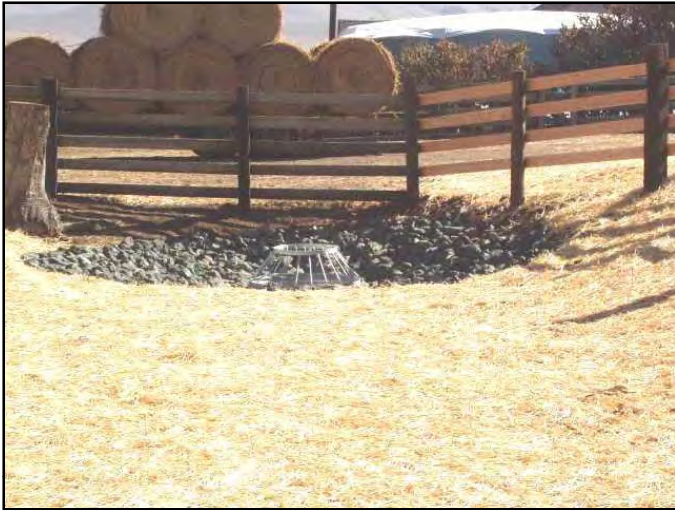
Figure 169. Installed drop structure and grate.

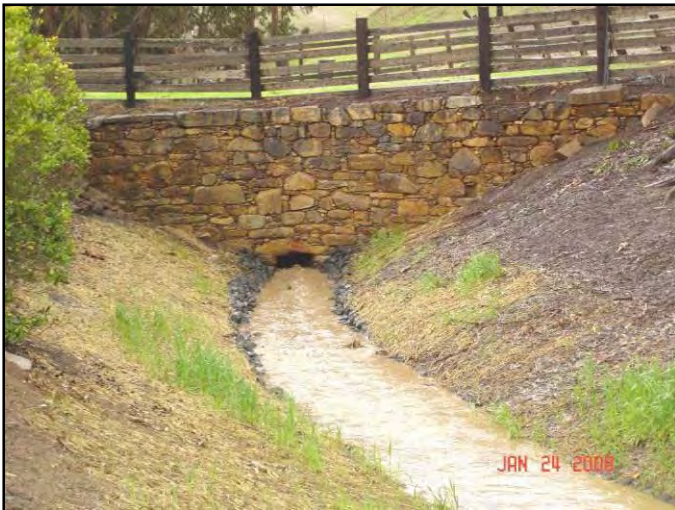
Figure 170. Looking upstream at outlet under stone bridge. Revegetated slopes are sprouting.

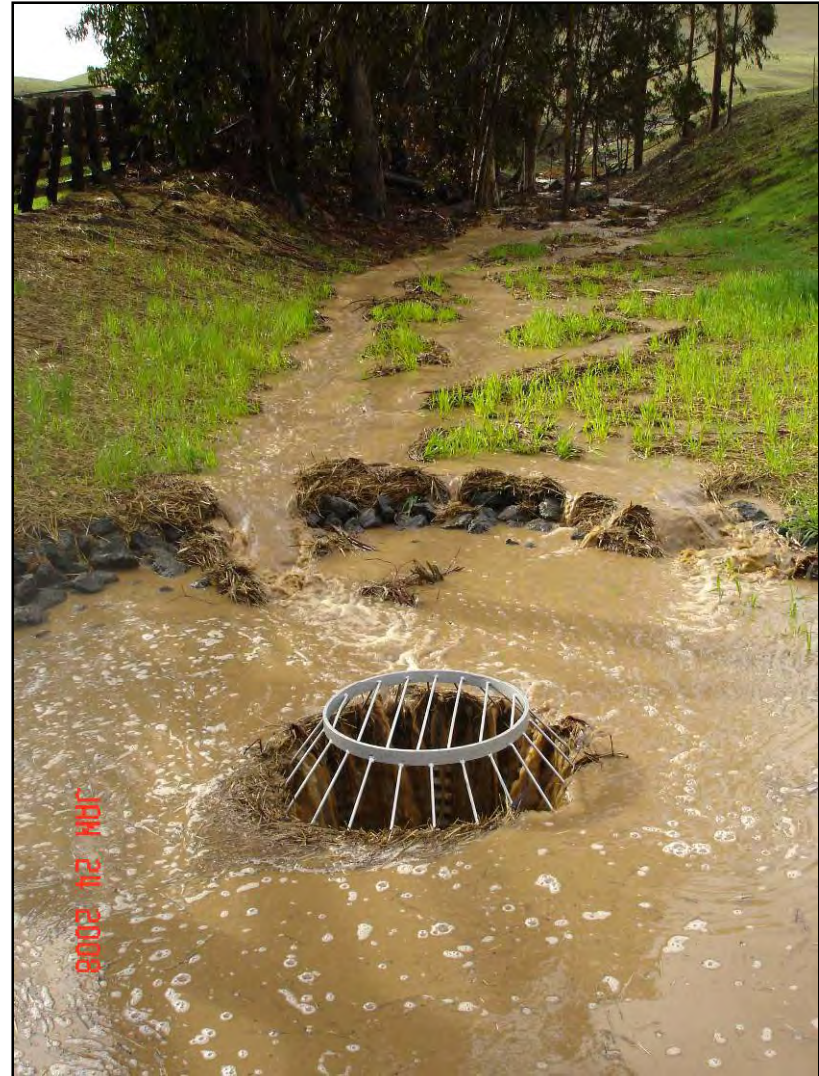
Figure 171. Looking upstream at drop structure and restored headcut during storm.

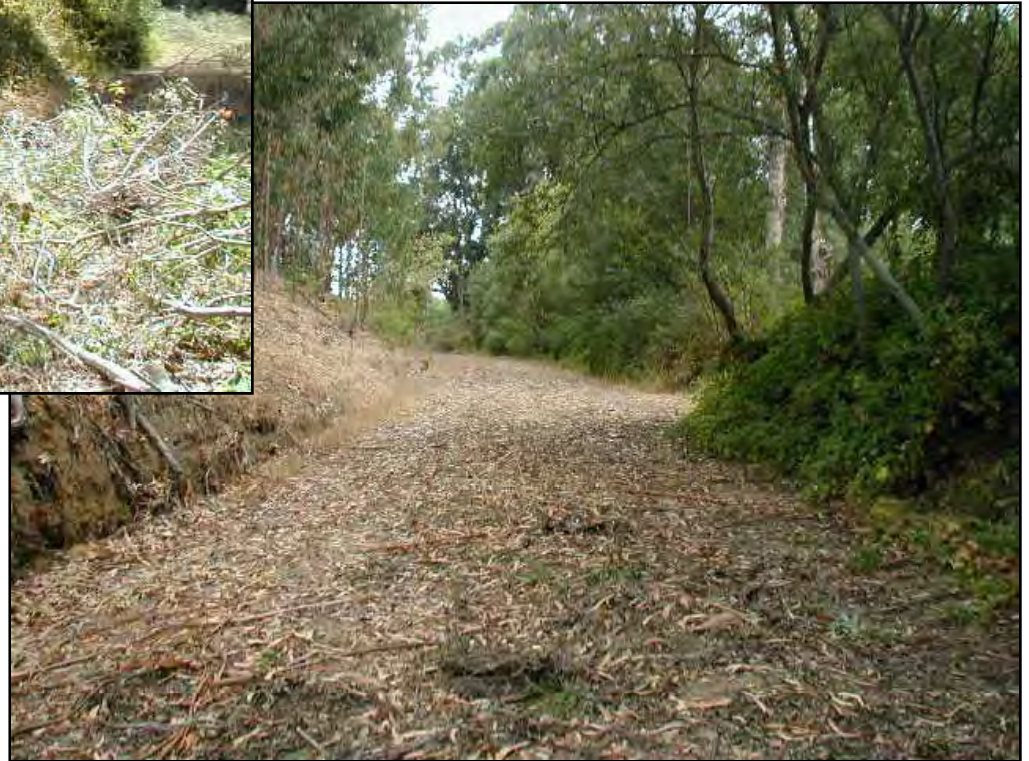
Figure 186. Channel ready for high flows of storm season

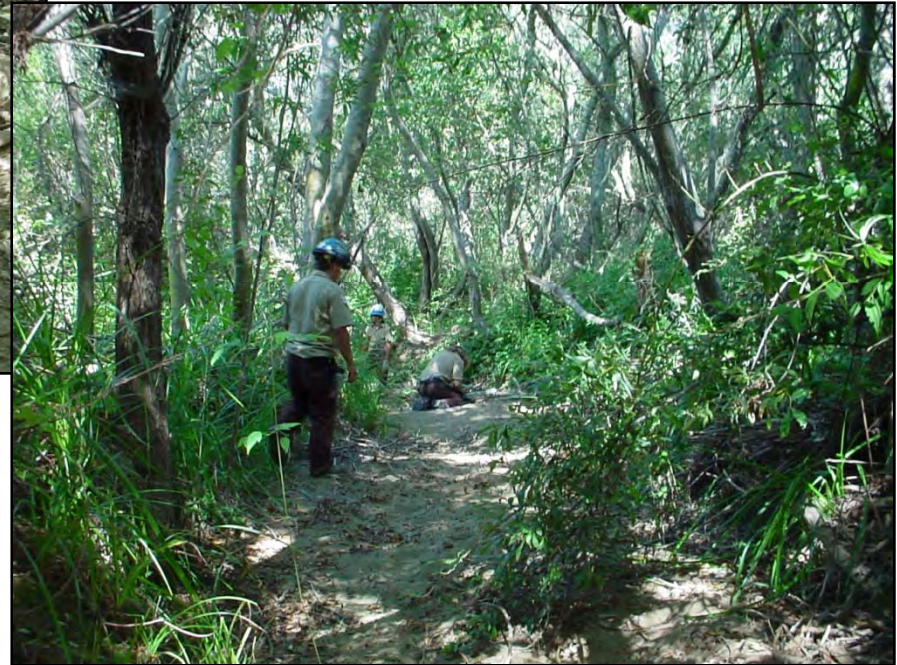
Figure 202. Channel cleared of debris jams and barriers.

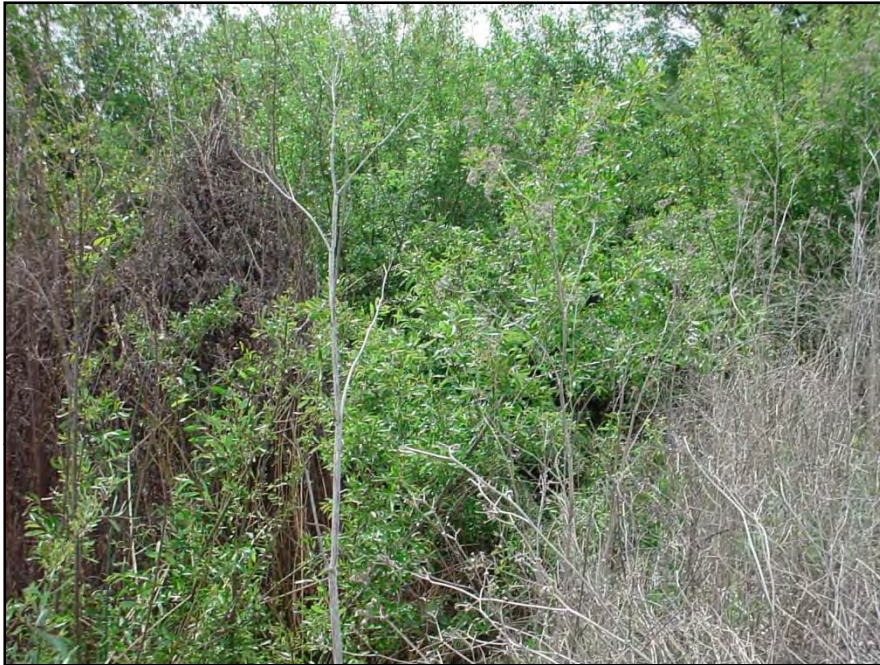
Figure 216. This reach included pruning willow in the center of the channel and pruning up larger willow for canopy on the banks.

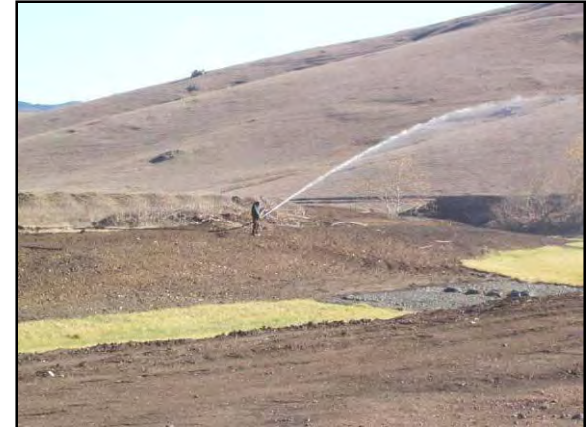
Figure 225. Cleaning rocks out of pipe.

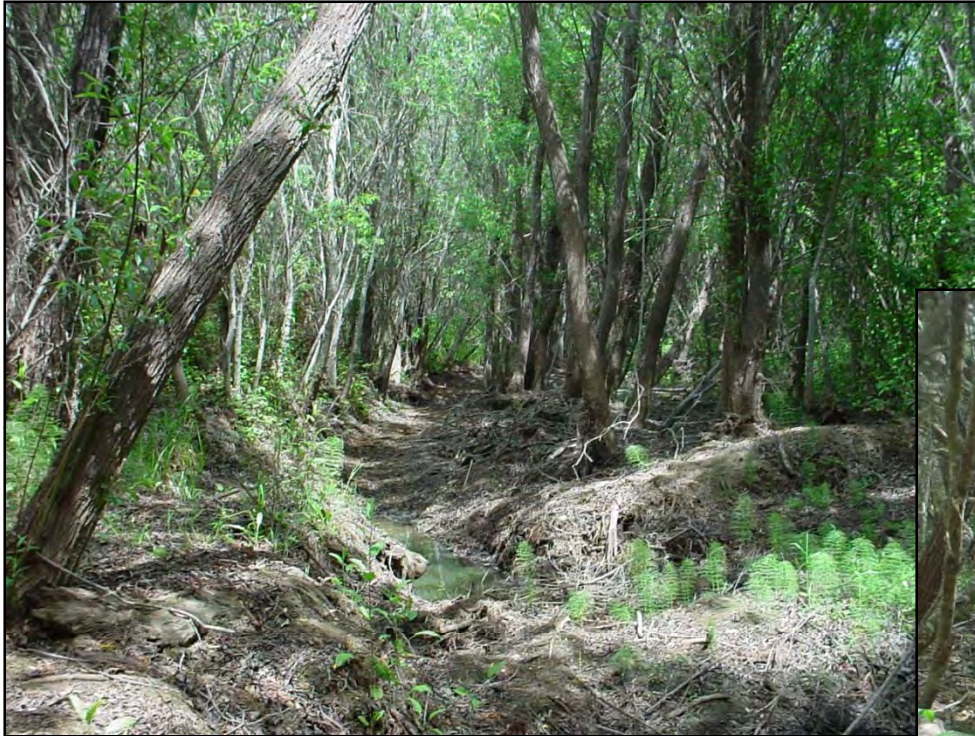
Figure 231. The channel looked remarkably clear this year due to a combination of light rain and reduced debris.

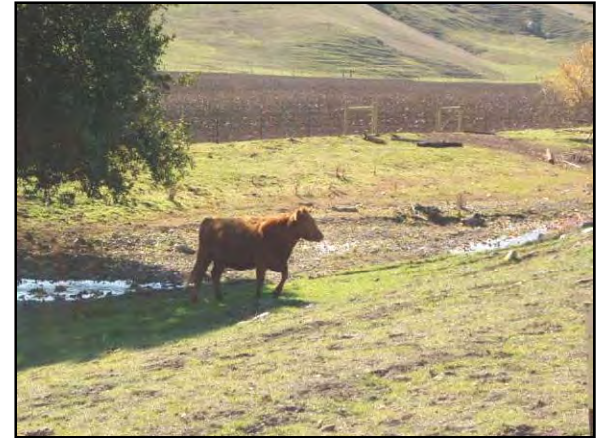
Figure 238. Coming out of the creek.

**Resource concern:** Impaired water quality and riparian vegetation due to cattle in creek; water quality parameters of concern include pathogens.

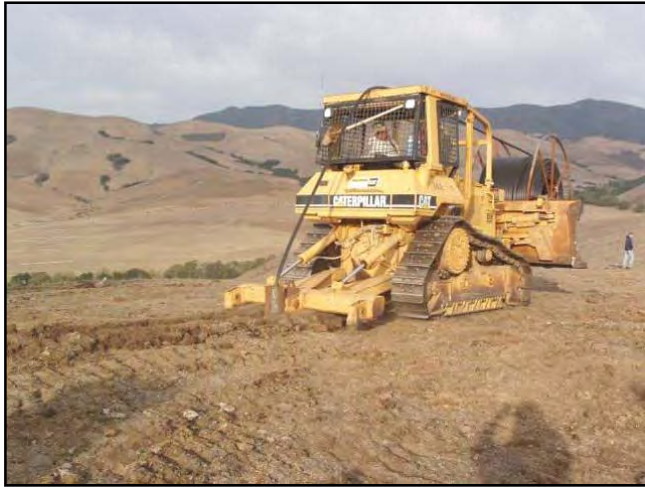
Figure 242. Cat and spool system used to rip in pipe.

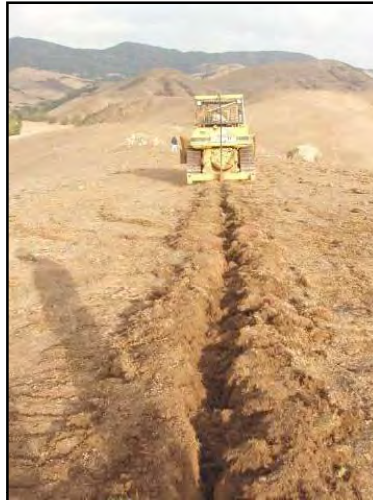
Figure 243. Ripping in pipe.

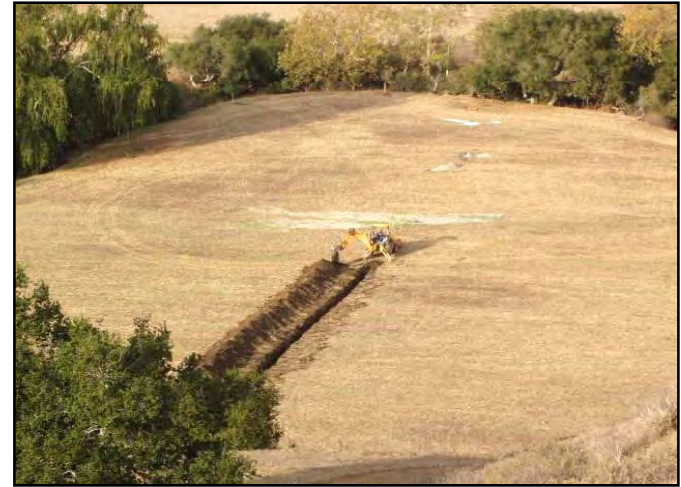
Figure 244. Backhoe used to install pipe in hayfield in order to get 48" depth.

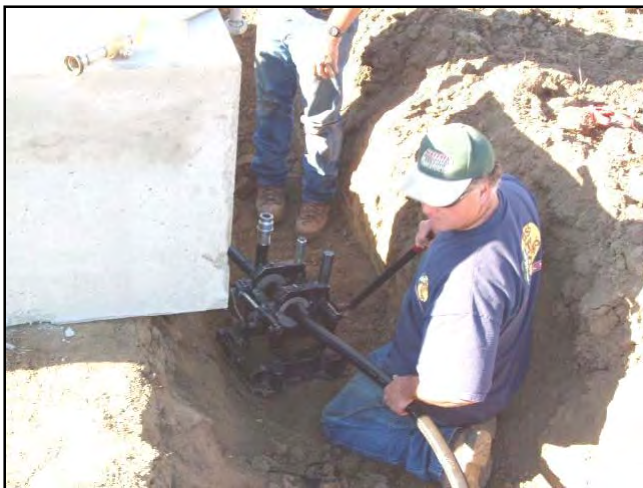
Figure 245. Installing tee to trough #30 with fusion welder.

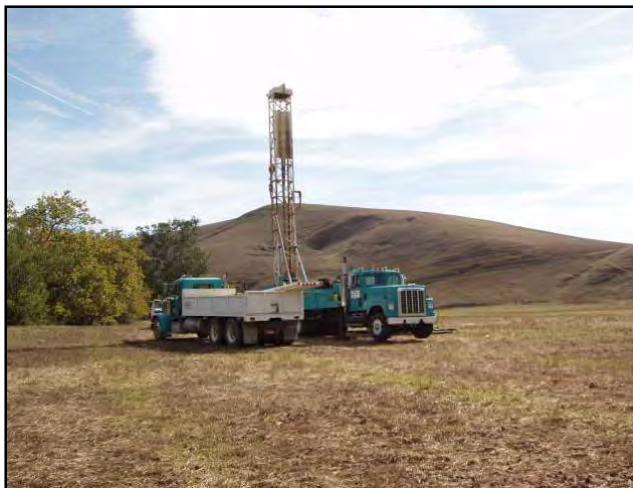
Figure 246. Site 1 well installation.

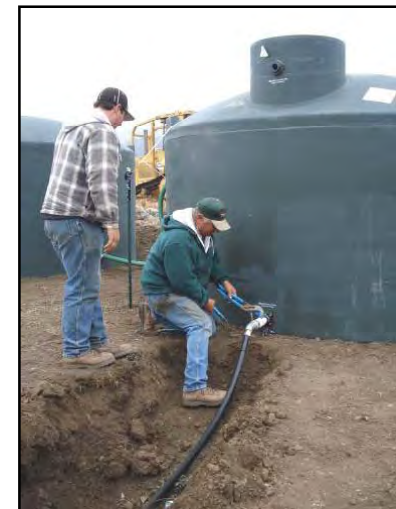
Figure 247. Tank install on south side of creek.

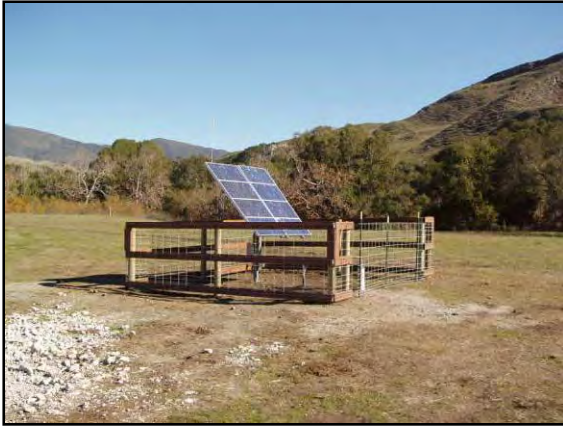
Figure 248. Solar panel and pump manifold at well site #2.

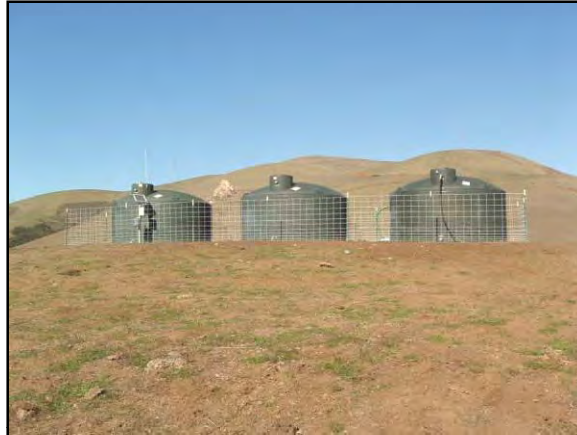
Figure 249. Three 4,500-gallon water tanks on north side of creek.

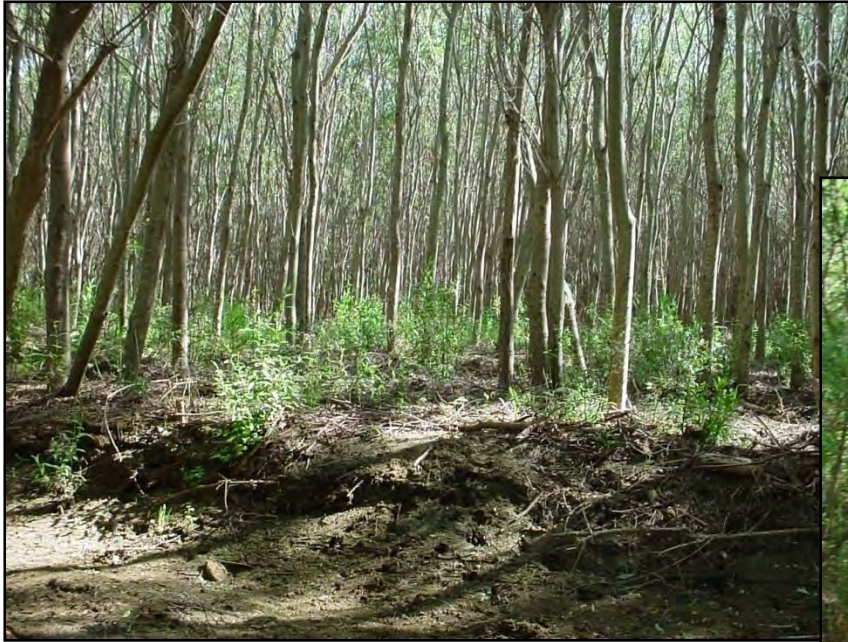
Figure 254. The riparian forest understory is really starting to come back and the once matchstick willow is growing larger and stronger.

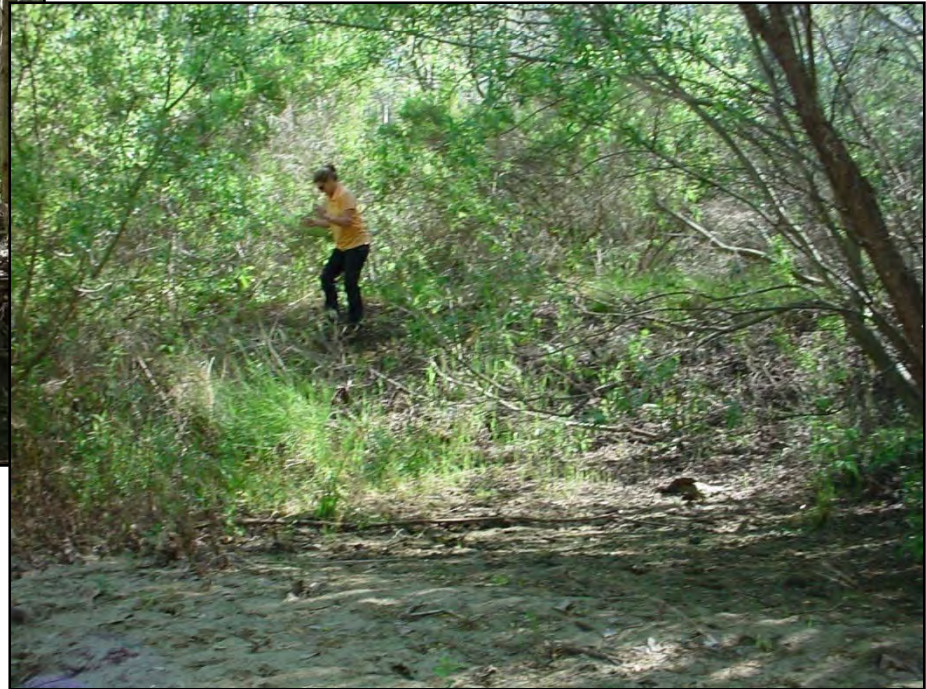
Figure 255. Margy Lindquist is standing on the levee. The levee is of no use any longer in this reach so we had the CCC crews punch two 4x6x6 foot holes in the levee and spread out the soil in the forest. We look forward to seeing the results from this effort in late spring.

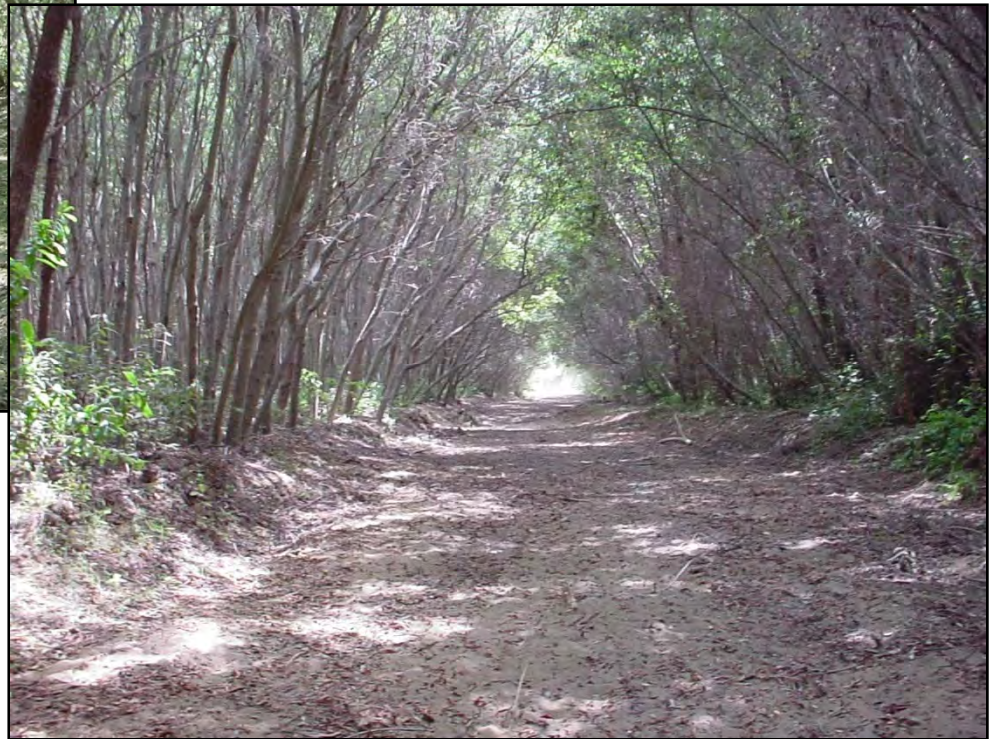
Figure 257. The CCC cleared the debris and canopy is maintained.
