Erosion Reduction and Sediment Capture Assessment

For Stenner and Brizzolara Creeks

EROSION REDUCTION AND SEDIMENT CAPTURE ASSESSMENT FOR STENNER AND BRIZZOLARA CREEKS

San Luis Obispo Coastal Resource Conservation District

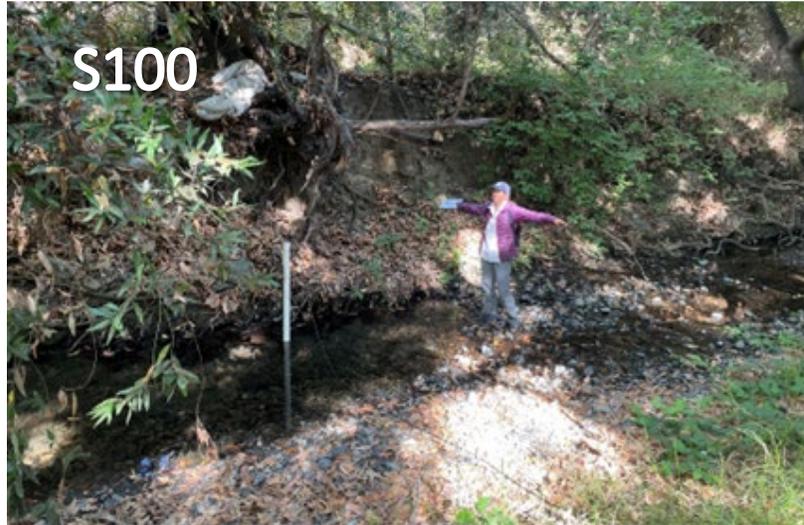
S100. Widening Channel (Stage 3/4) (Mainstem Stenner)

S100 is a reach of mainstem Stenner Creek that starts at the confluence with Brizzolara Creek and extends to the wetted crossing downstream of Highland Ave (~1,500 feet). This reach is within critical steelhead habitat (NMFS 2005) and contains perennial flow conditions across water year types (Bennett 2015; CLC 2020; CLC 2022). Although multiple waves of incision have impacted this reach, major vertical incision (Stage 2) is no longer predominant, rather, the

channel is widening, and deposition is beginning to occur (Stage 3/4). Downstream of Cal Poly land the reach becomes significantly confined by housing infrastructure. Because this channel reach is in later stages of evolution, it presents an opportunity to develop in-channel habitat features that also capture sediment and help manage future channel widening patterns. The sediment reduction and capture potential are estimated to be between 1,000 to 5,000 CY. The anticipated level of future engineering design and analysis effort is high and is likely to include hydraulic modeling (e.g., HEC-RAS). We recommend that this site is combined with adjacent sites (e.g., B50 and S105) when funding for design is sought. Repair and enhancement options include natural channel reconstruction that integrates habitat and sediment capture elements (e.g., log weirs). Concrete structures which act as local grade control structures and are partial fish passage barriers were observed on this reach. Addressing fish passage should also be integrated into future channel repair and restoration. The repair priority is high due to the sediment reduction and capture potential combined with the steelhead habitat enhancement potential.

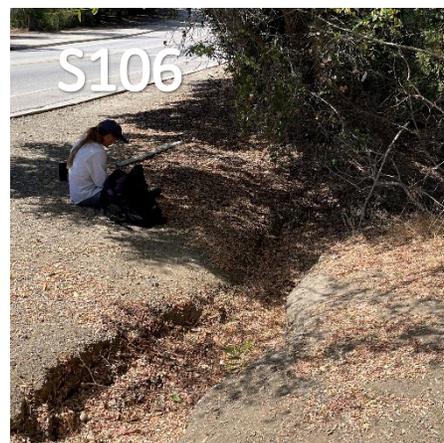
S106. Eroding ditch (Mainstem Stenner)

A small ditch drains an unpaved area next to Highland Drive, and transports sand and silt into Stenner Creek. Erosion associated with the ditch around some utility boxes positioned next to the road was also observed. In addition to the ditch shown in the adjacent photo, the channel has caused deeper gully-type erosion across the left bank (looking downstream) of Stenner Creek where it flows across the bank. Previous manually added woody debris to the gully portion of the ditch (not seen in photo) has slowed but not eliminated left bank erosion. The long-term sediment reduction potential is estimated at less than 100 CY. The overall repair priority is low, but the recommended repair is simple: loose rock check dams (Appendix B: Conceptual Detail B-1) in the ditch adjacent to the road and the addition of larger wood debris in the gully portion of the ditch as it flows across the left bank of Stenner Creek.

The anticipated future engineering design and analysis effort is lower, and all work could be conducted manually by California Conservation Corps (CCC) trained in restoration or equivalent with the supervision of a restoration engineer trained in manual restoration techniques. Recommend monitoring until the fix is implemented to track the degree of on-going erosion and monitoring after the fix to ensure hand-placed repairs are functioning as intended.

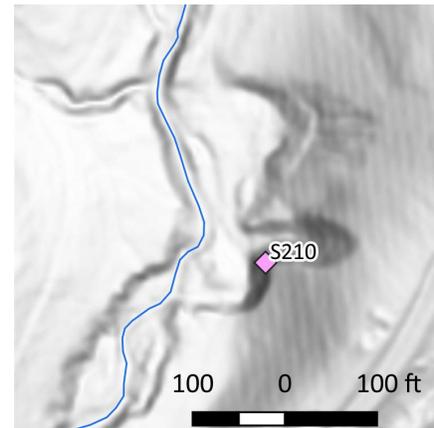
S210. Landslide (Mainstem Stenner)

A landslide is located on the left bank of Stenner Creek along a bike/walking trail that approaches the “Elevator Trail”. A significant slide occurred between 1972 and 2002. Further development of the feature occurred in the winter of 2023. The feature could produce an estimated 1000 to 5000 CY of sediment to Stenner Creek as slopes adjust to a form similar to the surrounding area. Stenner Creek jumps its banks in this location and episodically removes accumulated sediment at the base on the slide, which is deposited on a small inset floodplain. This reach is within critical steelhead habitat (NMFS 2005) and contains perennial flow conditions across water year types (Bennett 2015; CLC 2020; CLC 2022). The anticipated level of engineering design and analysis is high for this site. The repair for this site should consider whether to stabilize the slide and/or how to keep the creek from jumping its banks (channel is poorly defined in this reach) which removes sediment from the toe of the slide, thus reactivating the slide. If an in-channel repair is developed, habitat enhancing features should be integrated to the extent feasible as this perennial reach has a high habitat value. The repair priority is high. To learn more about this site to inform design, annual photo monitoring is recommended.

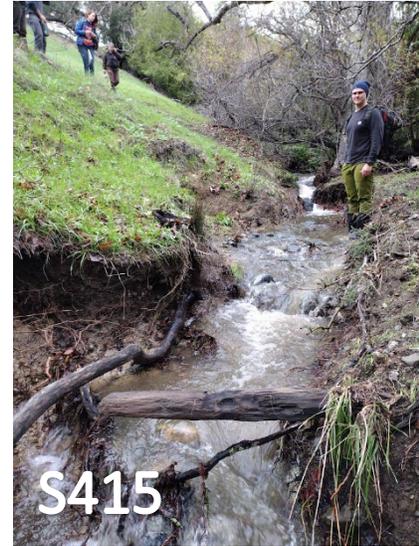
S415. Knickpoints (Tributary 4)

At the time of the first visit (11/2022) the site had a two-foot-high erodible knickpoint in the channel, with the downstream channel exhibiting recent erosion, exposed vertical alluvial banks and slumping. Upstream of the knickpoint, the channel had not eroded. Following the winter storms of 2023, the knickpoint traveled upstream, unraveling the stream channel, and evolving into a series of knickpoints (see photo). The sediment reduction potential from the bed and banks is estimated to be between 100 and 500 CY. When the repair occurs at S410, it is recommended to repair this site by adding boulders utilizing motorized wheelbarrows. Boulder stabilized knickpoints upstream and downstream form a basis of design. The anticipated engineering design and analysis is lower. All work could be conducted manually by California Conservation Corps (CCC) trained in restoration or equivalent with the supervision of a restoration engineer trained in manual restoration techniques. The anticipated priority is medium.

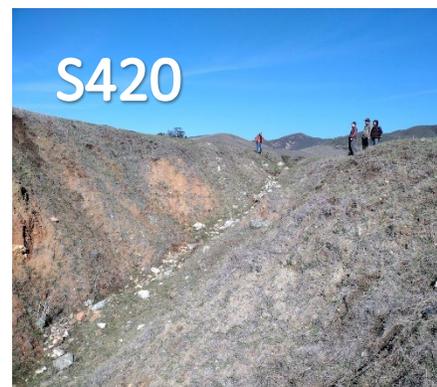
**S420. Gully (Mainstem Kirschner Creek)**

A gully has cut into the left bank of the mainstem of Kirschner Creek, about 200 feet upstream of the confluence of tributary 4 (Figure 5). The gully is 240 feet long and about 40 feet wide on average, with a slope of approximately 27 percent. Historical aerial images from 1937, 1972, and 2005 show that the feature has not expanded significantly over the last 80 years. Recent storms in the beginning of 2023 did not cause a large amount of new erosion in this gully despite being one of the top three wettest years in this watershed since

1870 (Cal Poly 2023), but dry ravel was observed on the sides of the gully in the preceding dry season. Although this feature is relatively stable, long-term monitoring is recommended. This gully is downslope from an area containing ephemeral slope wetlands maintained by groundwater seepage.

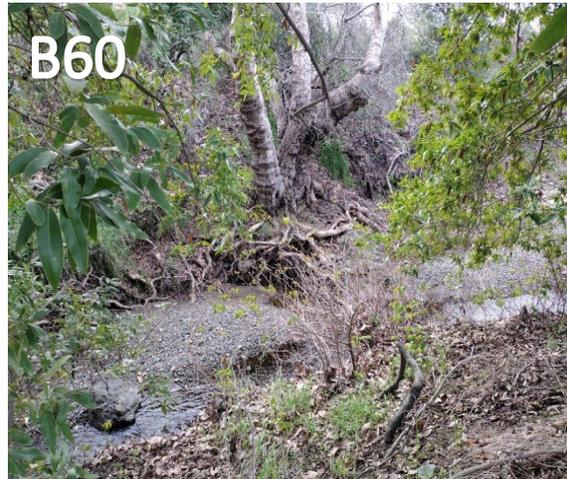
B60: Widening Channel (Stage 3) (Mainstem Brizzolara)

This site is a reach from the California Road Crossing (at the fish ladder) to a bedrock control approximately 350 feet upstream. This reach is within critical steelhead habitat (NMFS 2005) and is hypothesized to be ephemeral. Flow mapping by Creek Lands Conservation to determine dry season flow conditions is in progress. This reach is primarily widening (Stage 3) but the widening is constrained in some locations by existing infrastructure at the top of bank. The sediment reduction and capture potential are estimated at 500 to 1,000 CY. The anticipated level of future engineering design and analysis effort is high and is likely to include hydraulic modeling (e.g., HEC-RAS). The repair priority is medium.

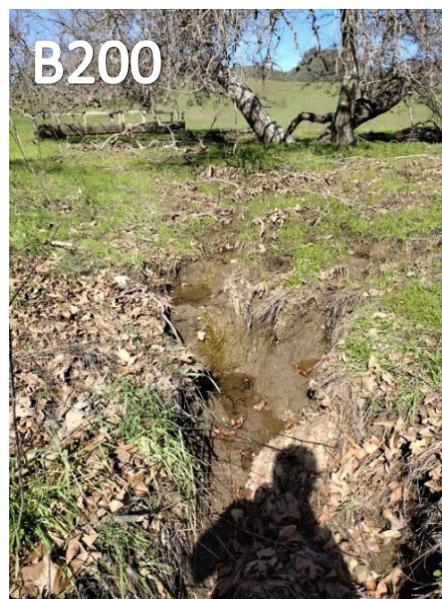
B200: Eroding Ephemeral Channel

This site includes an ephemeral channel with at least three headcuts including “multi-stair head-cut” threatening a road. This site has a modest sediment reduction potential from both bed and banks that is estimated to range from 100 to 500 CY. Loose rock or vegetated headcut repairs (Appendix B; Conceptual Details B-2 and B-3) and revegetation are recommended. Revegetation should be conducted with local native species, and our local CCC team can both develop simple planting plan including associated surface or erosion control treatments, propagate plants in their nursery if needed, install and surface treatment or revegetation repair. The anticipated engineering design and analysis is low, and all work could be conducted manually by California Conservation Corps (CCC) trained in restoration or equivalent. The anticipated repair priority is high.

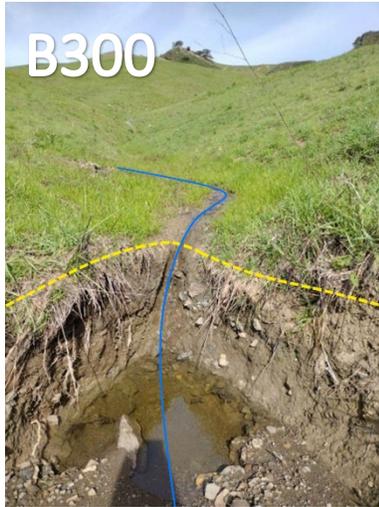
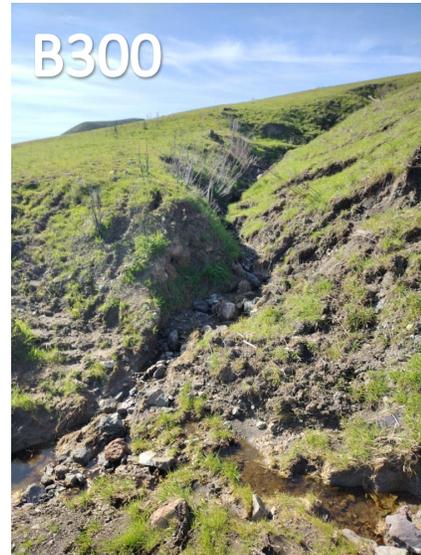
B300: Incising and Widening Ephemeral Channel

This site features approximately 1800 ft of eroding ephemeral channel with at least a dozen erodible knickpoints and slumping banks. The knickpoints range from 0.5 to 3 ft in height. This site has significant a sediment reduction potential from both bed and bed sediments that is estimated to range from 1,000 to 5,000 CY. A series of loose rock check dams (Appendix B; Conceptual Detail B-1), loose rock or vegetated headcut repairs (Appendix B; Conceptual Details B-2 and B-3), and revegetation are recommended. Revegetation should be

conducted with local native species, and our local CCC team can both develop simple planting plan including associated surface or erosion control treatments, propagate

plants in their nursery if needed, install and surface treatment or revegetation repair. The anticipated engineering design and analysis is low. All work could be conducted manually by California Conservation Corps (CCC) trained in restoration or equivalent with the supervision of a restoration engineer trained in manual restoration techniques. The anticipated repair priority is high. This site is selected as one of three high priority sites to advance to 65% engineering analysis and designs under this grant funding source.

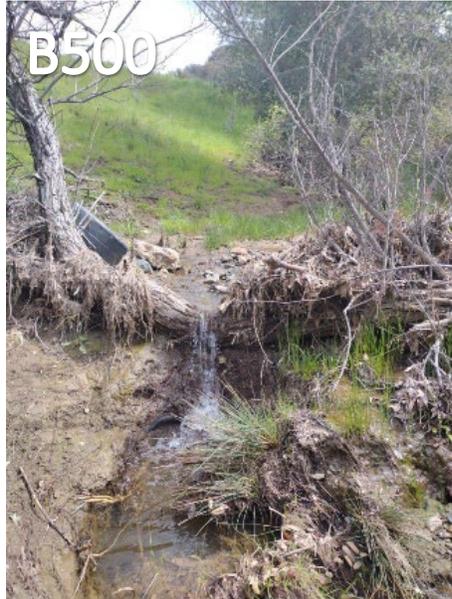
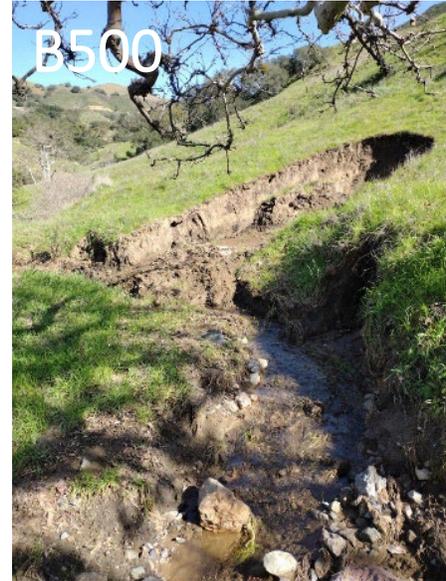
B500: Incising and Widening Ephemeral Channel (Stage 2/3)

This site is approximately 900 feet of ephemeral channel with multiple knickpoints, bank failures, and gullies. The first bank failure (left bank) (photo to the right) formed in response to channel incision and resultant groundwater seepage from the freshly exposed bank. Two more bank failures are located upstream on right bank and another left bank failure further upstream is triggering a shallow landslide. A significant early-stage gully on is also present further upstream on the left bank. This gully extends onto Miozzi property at the upslope extent. There are series of knickpoints both upstream and downstream of the road crossing. The knickpoints downstream of the road pose a risk to the road (see photo below). Repairs to the reach should tie into mainstem Brizzolara Creek immediately upstream and downstream of the ephemeral channel location.

While the mainstem is within critical steelhead habitat (NMFS 2005), it is likely ephemeral in all water year types and thus considered non-fish bearing. The sediment reduction and capture potential are estimated at between 1,000 and 5,000 CY. The anticipated level of future engineering design and analysis effort is high and could include in-channel check dams, headcut repairs, bank stabilization, beaver dam analogs (BDA's) and loose rock repairs among others. Along sections that have lost mature riparian vegetation, revegetation with local native species is recommended. Our local CCC team can both develop a simple planting plan including associated surface and erosion control treatments, propagate plants in their nursery if needed, and install plants. This site is selected as one of three high priority sites to advance to 65% engineering analysis and designs under this grant funding source. This site could benefit from a combination of heavy machinery work with hand work.

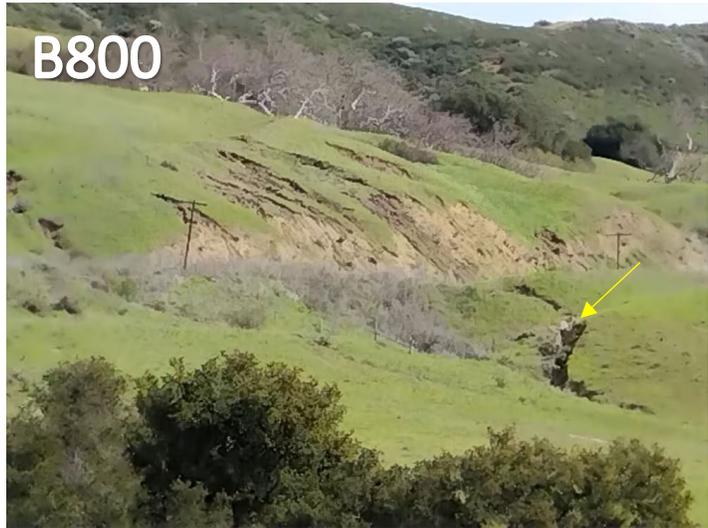
B800: Incising Ephemeral Channel (Stage 2)

This site includes portions of an incising ephemeral channel with knickpoints and slumps both downstream and upstream of the road crossing. Repairs to the reach may need to tie into mainstem Brizzolara Creek immediately upstream and downstream of the ephemeral channel location. The sediment reduction is estimated at between 1,000 and 5,000 CY. Some of the most highly eroding subreaches may be located on railroad right-of-way (see gully forming on railroad embankment in photo). The anticipated level of future engineering design and analysis effort is high and could include adding roughness elements to slow

erosion and capture sediment, check dams and headcut repairs, among others. Along sections that have lost mature riparian vegetation, revegetation with local native species is recommended. Our local CCC team can both develop a simple planting plan including associated surface and erosion control treatments, propagate plants in their nursery if needed, and install plants.
