Arroyo Grande Creek Watershed Management Plan Update

March 2009

Prepared for
The Department of Fish and Game
State of California

Prepared by
Central Coast Salmon Enhancement

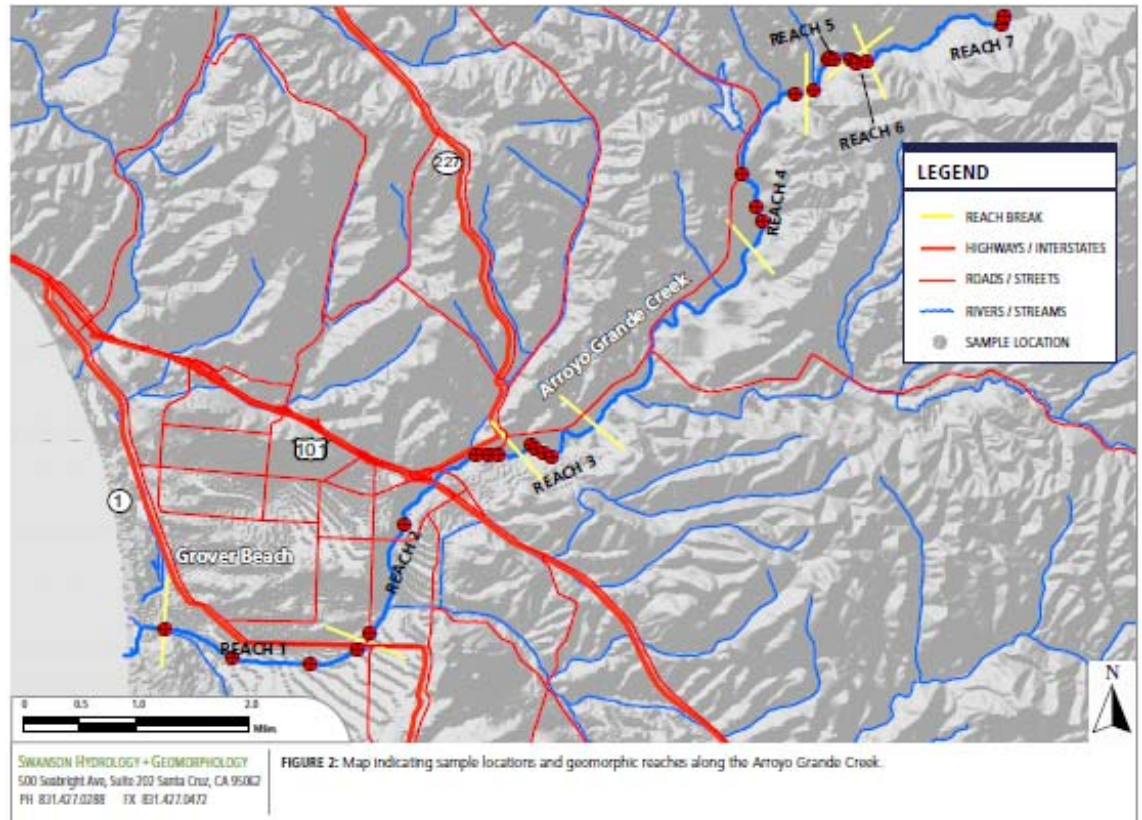
Figure 5. Sample Locations and Geomorphic Reaches

Source: Swanson Hydrology + Geomorphology, 2008

Steelhead were present in all 7 reaches but were found in relatively low numbers. Steelhead were most abundant in the upper portions of Reach 2, in Reach 3, and the lower portion of Reach 4. Steelhead length distribution in electrofishing surveys indicated the following size and age-class distributions: young-of-year or 0+ fish = 60-90 mm fork length; 1+ fish = 110-140 mm fork length; 2+ or older fish = >150 mm fork length. The length frequency distribution indicates that young-of-year fish may have grown larger than was anticipated (up to 90mm or 3.5 inches instead of 3 inches) and the age class designations used in the visual surveys may have resulted in counting some young-of-year fish as 1+. Correlations between electrofishing and visual survey results for steelhead were poor.

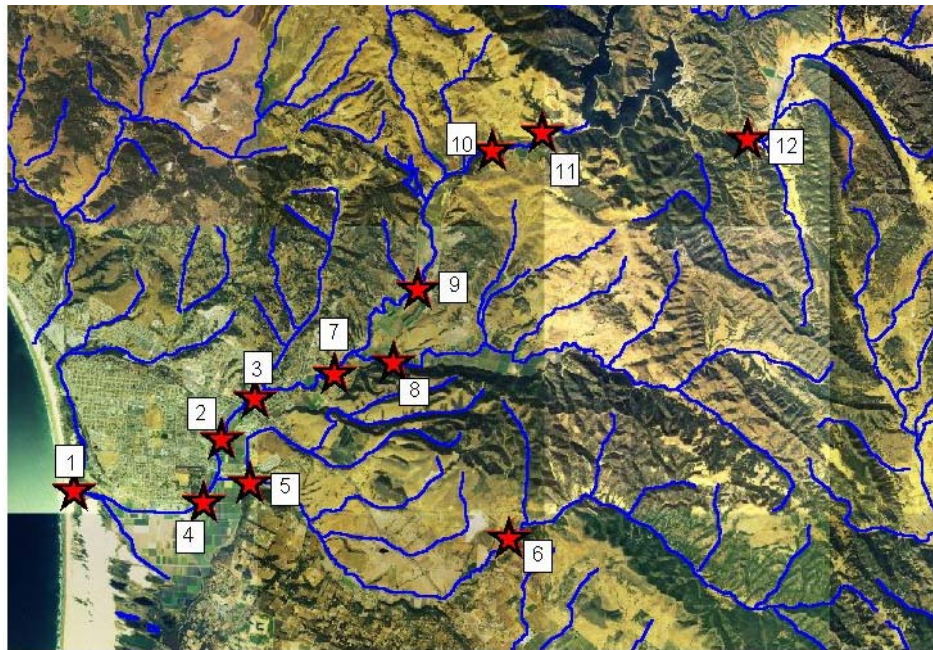
Figure 8. Water Quality Monitoring Sites

1. Estuary
2. Fred Gried Bridge
3. Kiwanis Park
4. Highway 1
5. Valley Road
6. Upper Los Berros
7. Strother Park
8. Tar Springs Creek
9. Cecchetti Road
10. Biddle Park
11. Upper Arroyo Grande Creek
12. Upper Lopez

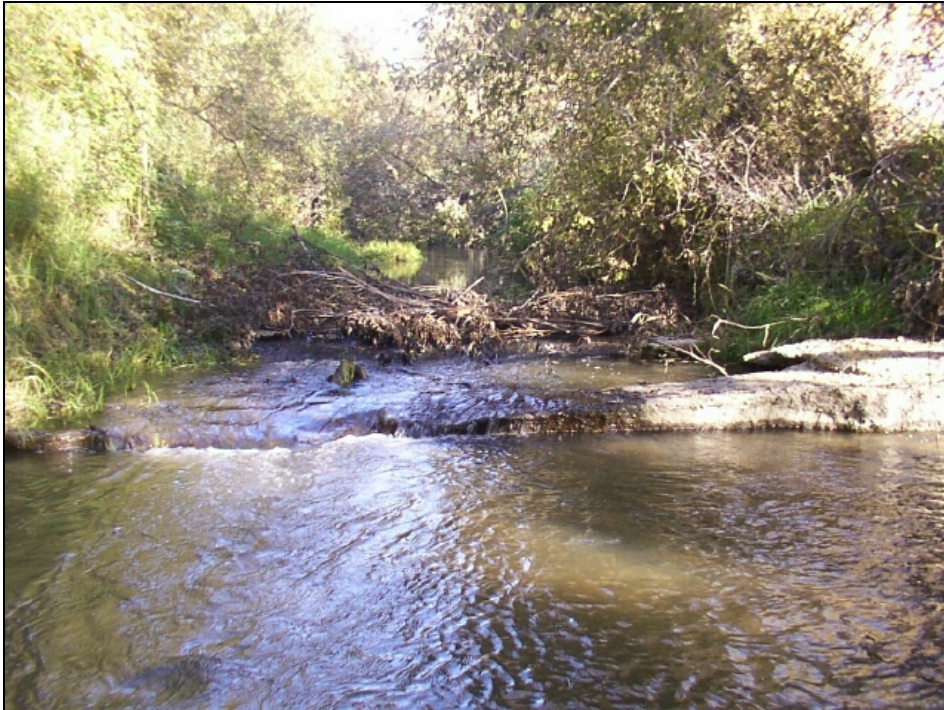
Figure 10. Fish Passage Barrier - Two Concrete Dams

This is identified in the Stream Inventory Report by the CCC. The dams seem to be nonfunctional as the creek flow has undermined the dams. A structure was identified in a 1972 Stream Survey from CDFG, which had the location at about ¼ mile downstream of the Fair Oaks Crossing. The CCC survey had placed the location of this structure at mile 2.88 from the confluence with the ocean and just over ½ mile downstream of the Fair Oaks Crossing.

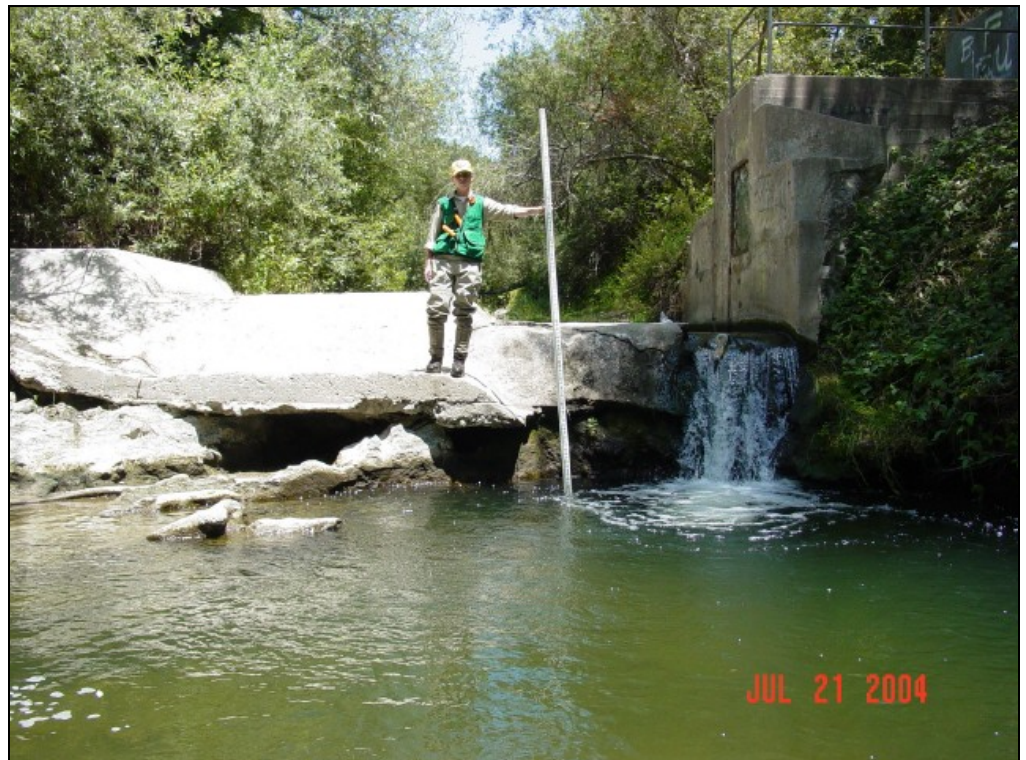
Figure 11. Fish Passage Barrier – Stream Gauge

This is identified in numerous reports as probably the most significant barrier downstream of Lopez Dam in the watershed. It is identified in the California Fish Passage Assessment Database as I.D.# 8409. During the CCC stream survey, the structure was measured to be 34.2' wide x 17.5' thick x 4.7' high. It is located at stream mile 4.98 from the confluence with the ocean. There is a low-flow notch in the structure but it may add to the intensity of the barriers by not only being a height barrier but also a velocity barrier. This structure poses a complete barrier for juvenile steelhead as they have been seen jumping at the base of the structure. Adults should be able to pass the structure during migration periods, when there is more water coming over the spillway and back-flooding of the pool downstream of the gauge. The pool below the gage is over 5 feet deep and will aid in the migratory effort to pass the gauge. The County of San Luis Obispo had identified this site in the HCP as a mitigation project and subsequently removed it to allow Central Coast Salmon Enhancement to address the barrier prior to the finalization of the HCP. As of February 2009, project design to modify the structure to improve passage is 70% complete.

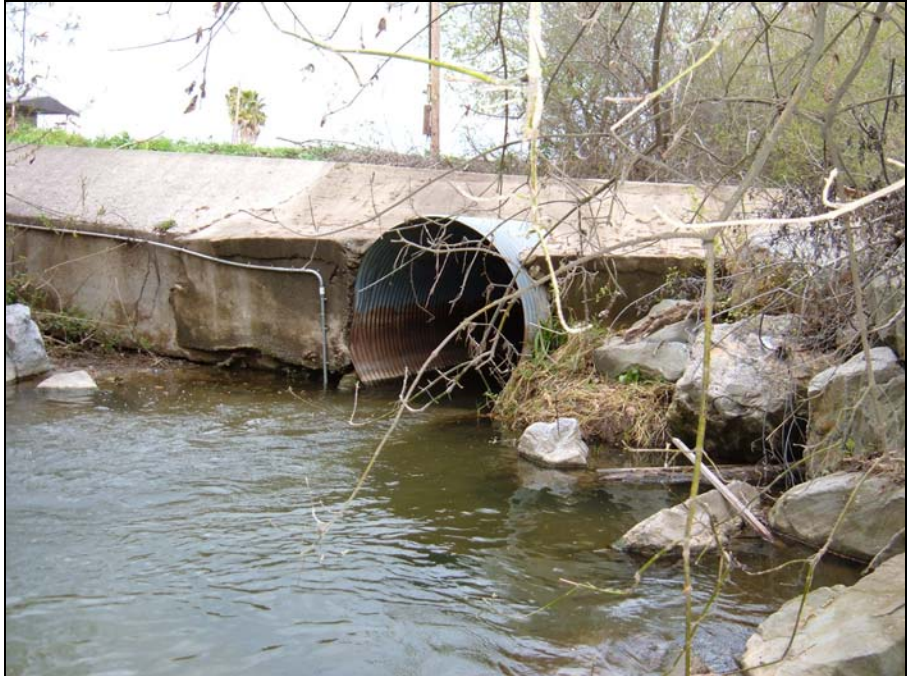
Figure 12. Fish Passage Barrier – Cecchetti Road Culvert

This crossing is identified in numerous reports. It is identified in the California Fish Passage Assessment Database as I.D.# 142. The structure was designed as an Arizona type crossing with a 5-foot Corrugated Metal Pipe (CMP) culvert. It is designed to overtop the crossing during high flows and has swept cars into the creek. This structure might pose a velocity barrier during heightened flows and passage might be an issue on the upstream side where sediment has been deposited. A thin steep channel is cut as the creek approaches the culvert. This structure has been identified in the HCP as a project that could be addressed with funding from the conservation account, but modifications are not specified.

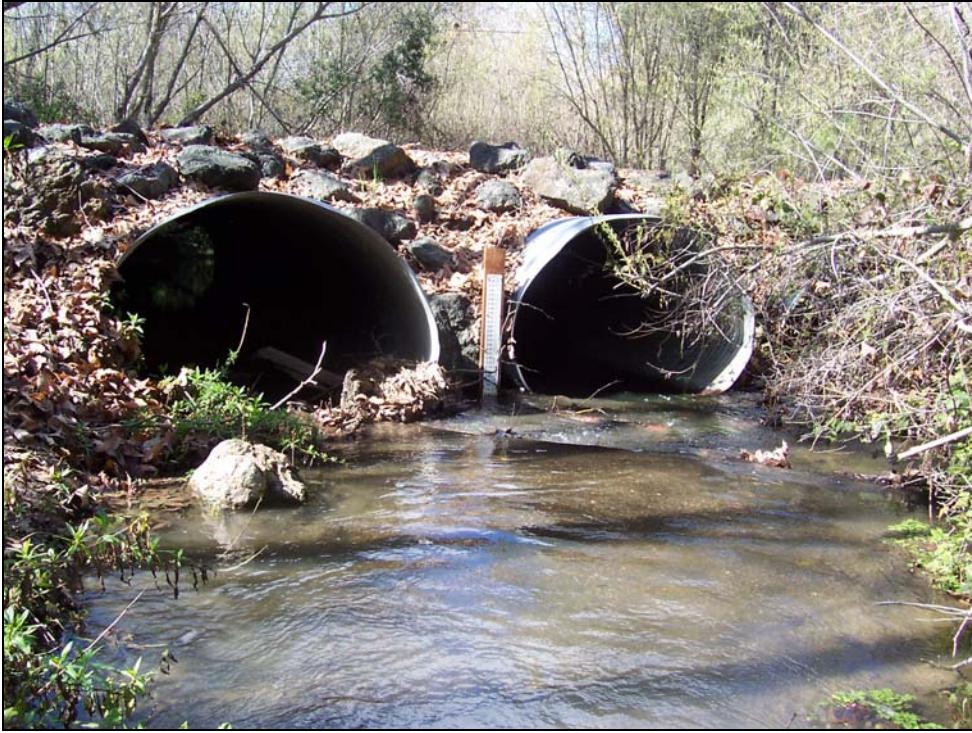
Figure 13. Fish Passage Barrier – Four Culverts at Biddle Park

In the early 1990’s, five 4-foot culverts were installed at stream mile 10.9 by the County Department of General Services after El Nino-generated flows plugged the existing culverts with debris, and washed out the road. The culverts were staggered in placement to prevent debris accumulation and allow the creek to meander over time. The culverts seemed to be sized appropriately for water flows, but their ability to pass fish is unknown.

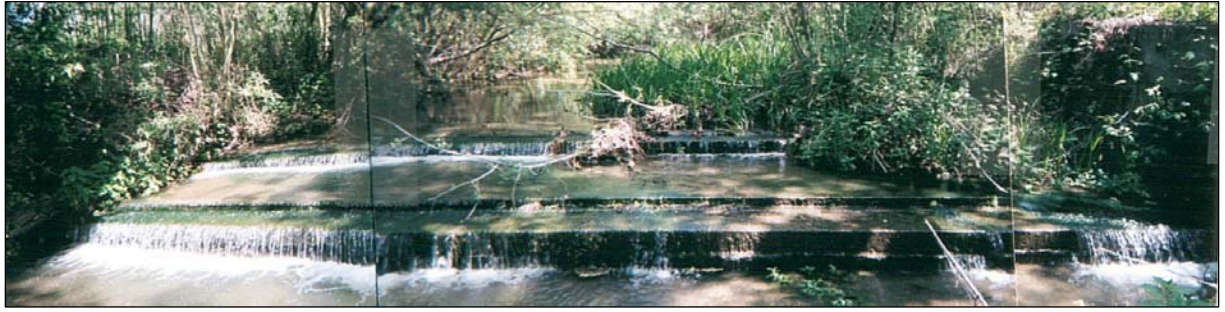
Figure 14. Fish Passage Barrier – Abandoned Dam Footings

Identified in numerous reports and also identified in the California Fish Passage Assessment Database as I.D.# 141 and located at stream mile 11.22 from the confluence with the ocean. This structure appears to be an old flash-board dam footing. Wood slats could be placed spanning the channel to impound water for irrigation or municipal use. The structure has not been used in many years and is one structure with three steps. The flow over the structure is sheet in form and does not allow for a plunge or scour pool to form. The structure is 48' wide x 10' thick x 2.2' high with two tiers. The middle section is filled with gravel and this structure is a very important grade control structure now. Modification rather than removal might be the best option to aid in fish passage for both adults and juveniles. As of November 2008, Central Coast Salmon Enhancement, the landowner and the CCC are in the process of modifying this barrier.

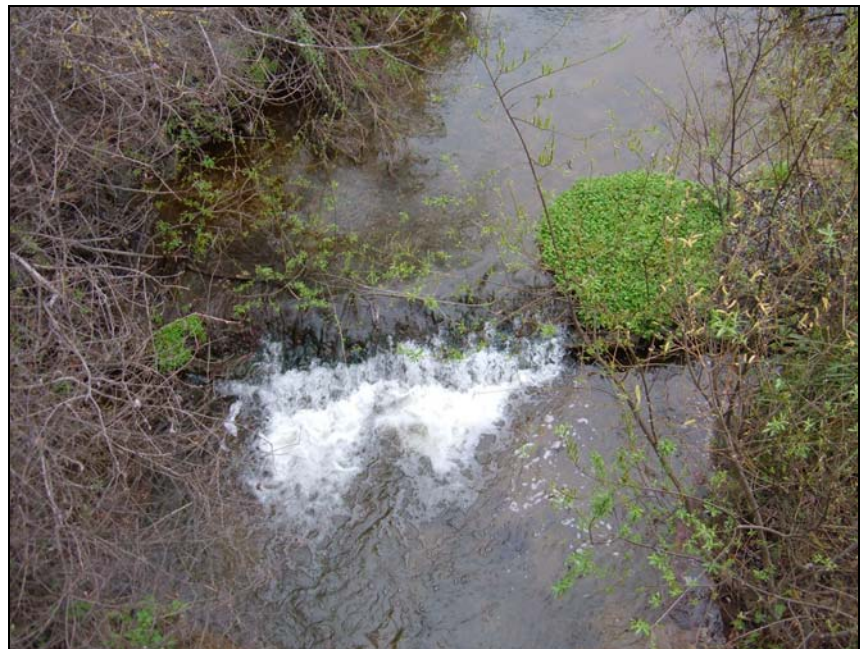
Figure 15. Fish Passage Barrier – Concrete Grade Control Weir

Identified by CCSE staff, this structure is located at a water-monitoring site and is located at stream mile 13.29, the Rodriguez Road crossing. It may be a partial barrier to juvenile fish but there is good flow since it is in proximity to Lopez Dam. There is a deep plunge pool, so with good acceleration, passage could be achieved. There is some sheet flow across the structure but it is semi-concentrated over half the structure. The structure is 20' wide x 5' thick x 2' high.

Removal for uninterrupted passage is not an option as it is the primary water supply line from Lopez Dam. Notching the weir or concentrating more of the flow could be a viable solution, but coordination with the County will be required to ensure the line is not damaged.

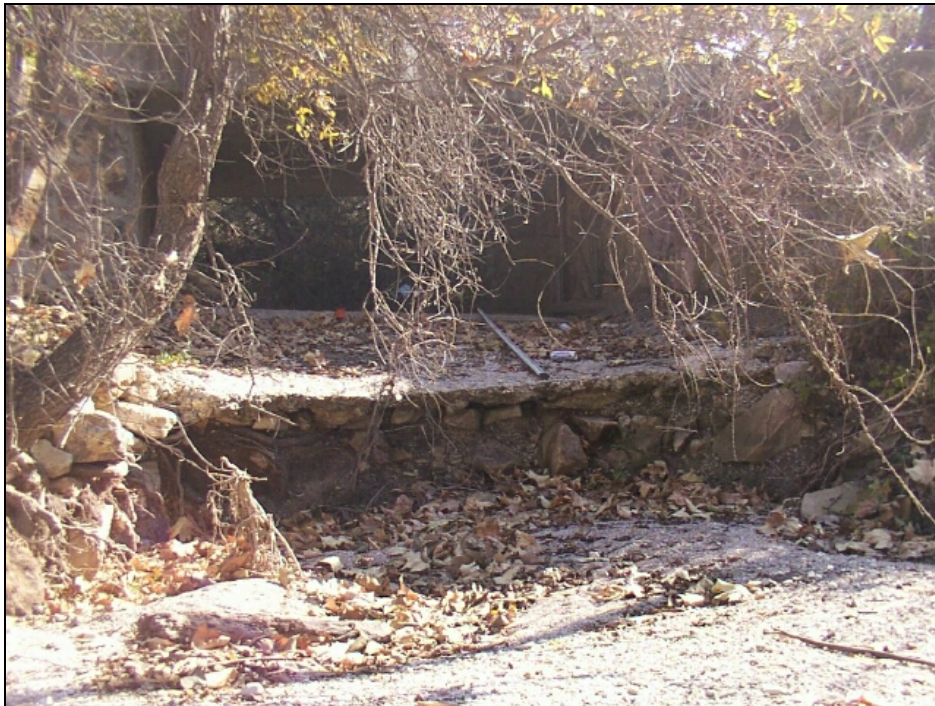
Figure 16. Fish Passage Barrier – Los Berros Creek Gauge

Los Berros Creek Road Crossing/Gauging Station – The first road crossing, 5.6 miles upstream of the confluence with Arroyo Grande Creek, is a gage station for United States Geologic Survey (USGS). The crossing is a box culvert with a 15-foot concrete lip that has become a grade control structure. The channel downstream has down cut significantly to form a barrier to fish passage. There is sheet flow through the culvert and across the concrete lip into the pool.

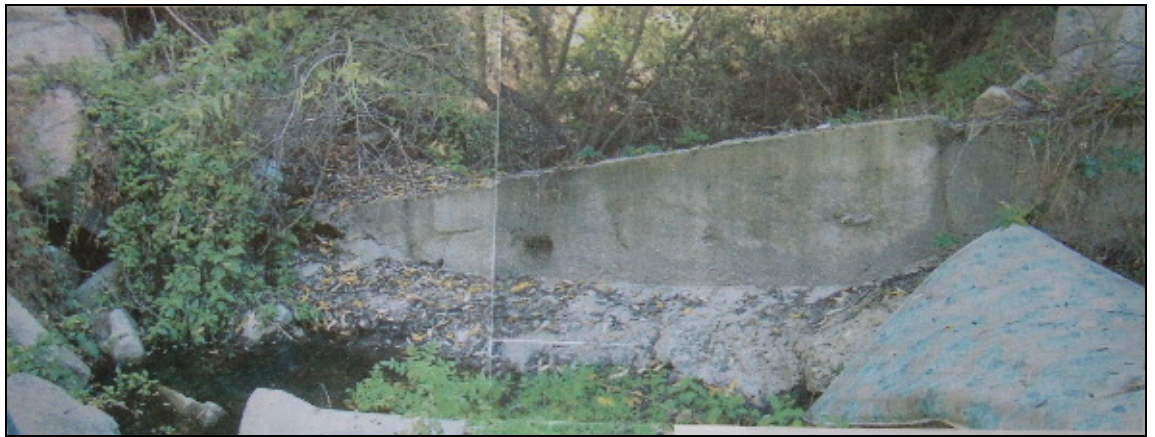
Figure 17. Fish Passage Barrier – Tar Springs Creek Concrete Weir

Low Flow Concrete Structure at Branch Mill Rd - There is an apparent low-flow concrete weir structure under the Branch Mill Road Bridge as it crosses Tar Springs Creek, 0.5 miles from the confluence that has been undermined by the active creek and most likely presents a full barrier to both adults and juvenile migrating steelhead. The weir is 20' wide x 2' thick x 3' high where the creek has undermined it. There is a 6-foot span from where the creek goes under one side and comes out the other as the downstream footing has been uncovered as the channel has eroded away below the weir. The pool below is up to 3' deep but strewn with boulders so a clear jump is not possible. The structure may have been installed as a grade control structure as there has been active down cutting in the channel and the footings of the bridge are becoming exposed.

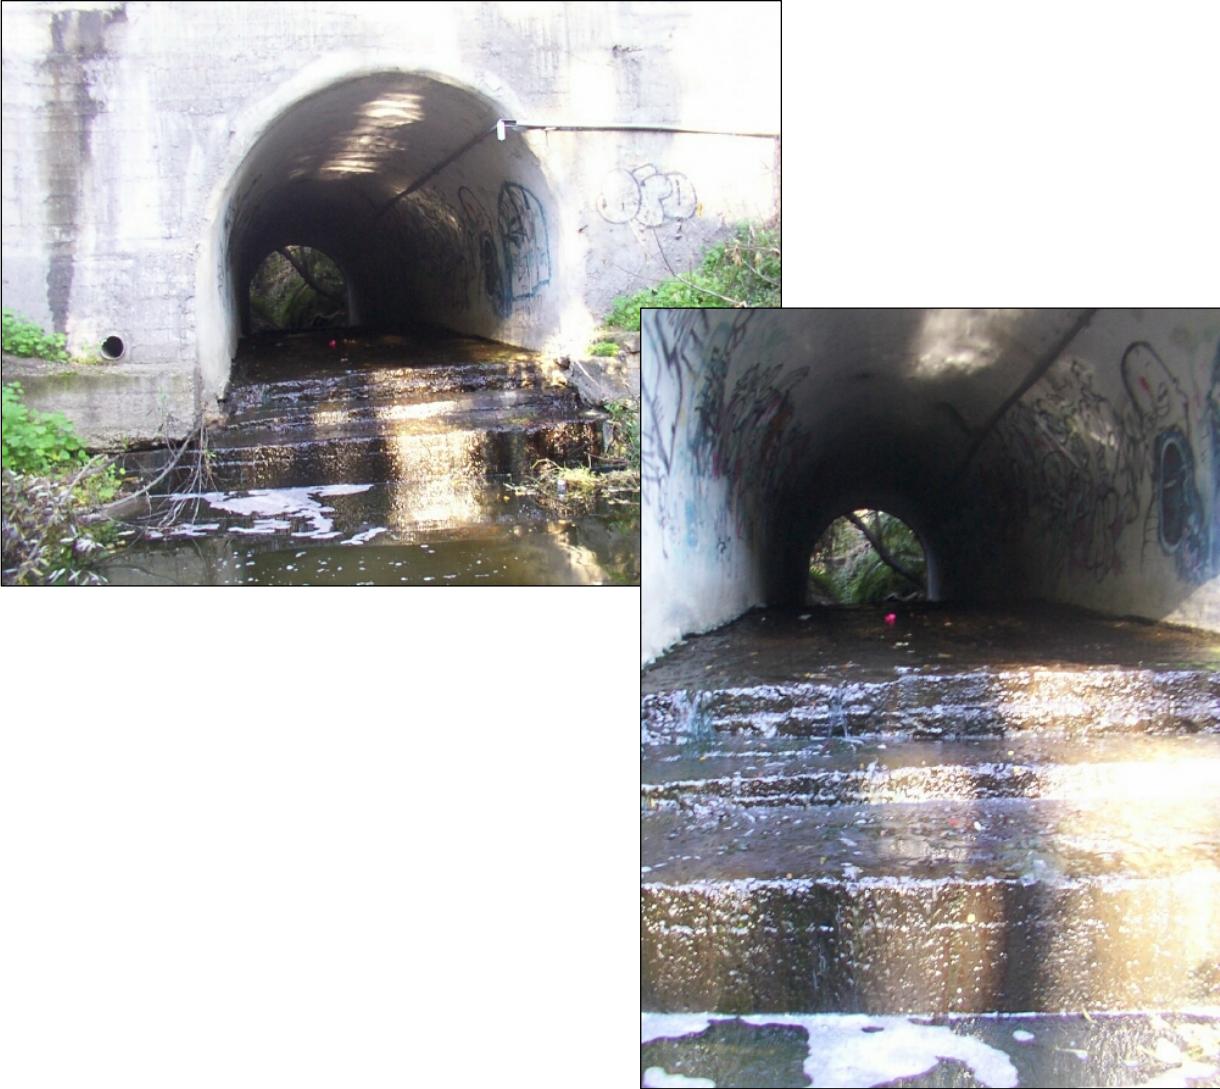
Figure 18. Fish Passage Barrier – Tally Ho Culvert

Branch St Road Crossing –The lower reach of the Corbett Creek Watershed is also known locally as Talley Ho Creek. Talley Ho Creek goes under Branch Street through an arch topped box culvert. The culvert is 6' wide x 90' long x 8' high. There are three steps entering the culvert and once inside, there is over 80 feet of flat concrete that fish must traverse to cross the barrier. The pool below the culvert is 2 feet deep.

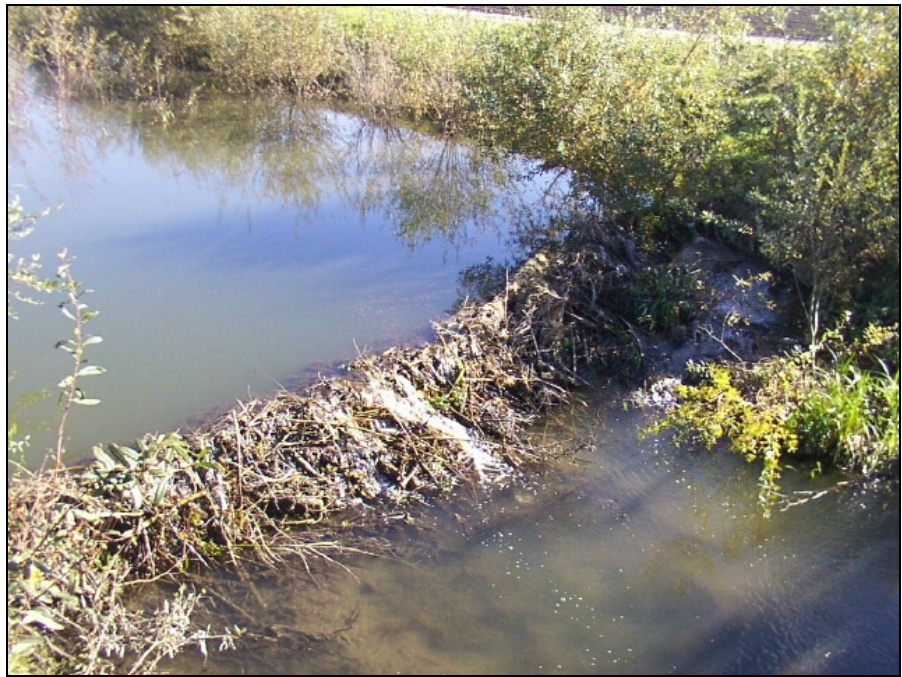
Figure 19. Beaver Dam

Beaver have become established in Arroyo Grande Creek and have been documented since 1970. Local landowners have indicated their presence as far back as the 1940's (George Cecchetti, personal communication). Beaver dams create pools for fish, but their overall impacts may be more negative than positive. When there are limited surface flows, beaver dams impound water, allowing for percolation and ground water recharge, but reducing surface flow to the ocean. Beaver dams also present migratory problems for both adult and juvenile salmonids. Although it has been shown that dams aid in the rearing of Coho salmon, beaver as a non-native species have not historically played an evolutionary role for winter run steelhead. This could be a serious detriment to both adult and juvenile to safely pass the dams. There is typically a small overflow or water sheeting over the top of the dam that can confuse the returning adults as to where to pass over the dam. Juveniles out-migrating to the ocean can get caught or impaled on the exposed branches, as there is no dedicated flow over the dam and out of the pond. As the adults return, there is usually not an adequately deep plunge pool below the dam to clear it from lack of concentrated flow over the dam as the beavers are constantly patching overflow sections. If the dams are not too overgrown it is likely they will be blown out during winter storms.

As the beavers are historically exotic species and potentially harming the native steelhead population, CDFG has done some preliminary investigation into the beaver issue.

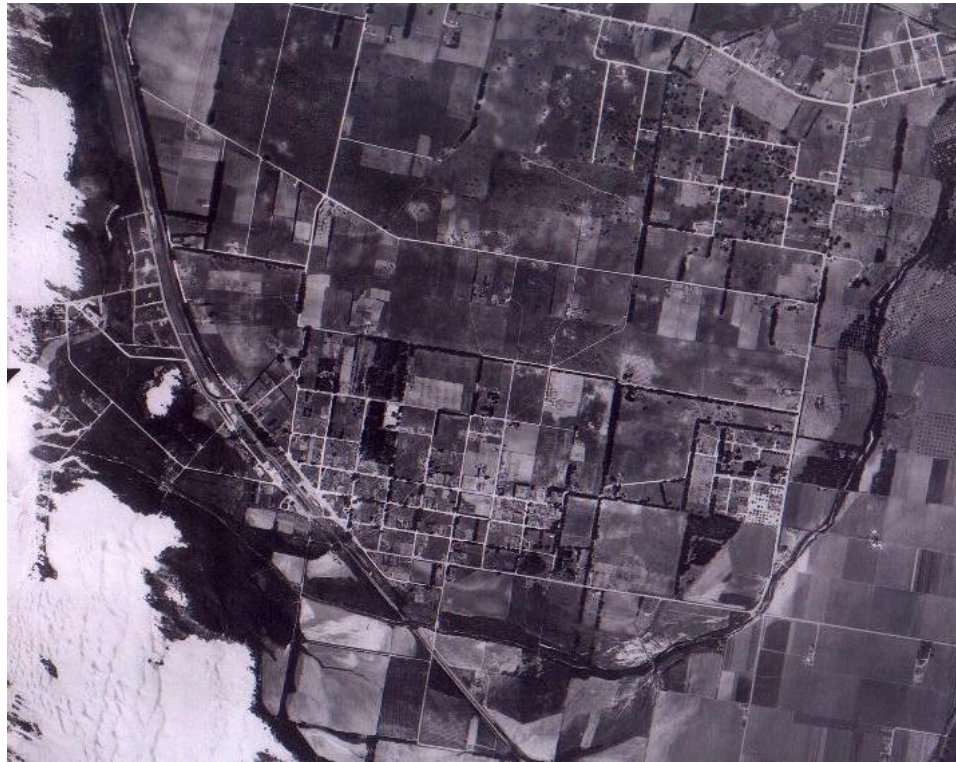
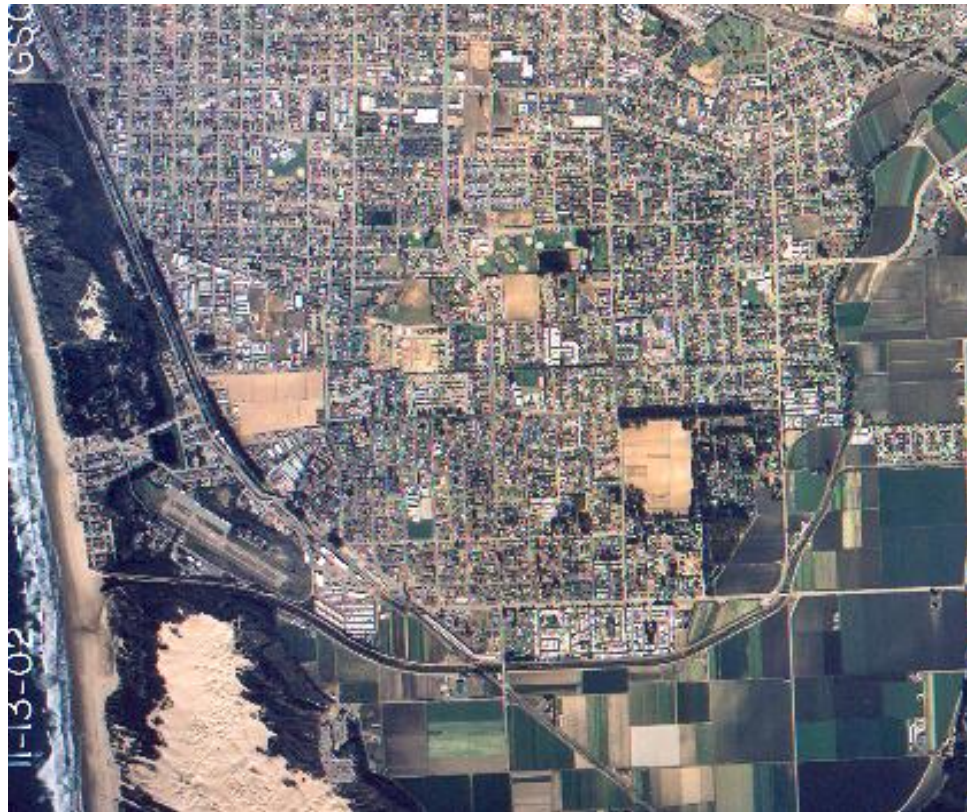
Figure 20. Historic Location of Flood Channel

Aerial photographs comparing the course of the creek in 1939 and 2002 reveal that its position prior to, and after, the construction of the flood control channel is very much the same, the difference being that the Los Berros tributary was diverted from its original course below the Nipomo Mesa to its current channelized flow beginning downstream of Century Road and joining Arroyo Grande Creek at the upstream end point of the flood control channel.

Designed and built in the late 1950's to protect adjoining farms and residences from flooding, the flood control channel originally consisted of a channelized streambed and a set of levees along approximately the last three miles of the creek, essentially shortening and straightening the creek. Due to changes in environmental regulations and the economics of channel maintenance (discussed below), the flood channel has not been maintained to its original design since mid-1990. It has consequently become filled with sediment, and perhaps as little as 15% of its original capacity remains. About 52,000 cubic yards of sediment have been removed since 1988. A more complete history of the flood control channel is explored in the Story of Arroyo Grande Creek (Brown, 2002) and Arroyo Grande Creek, Disaster Waiting to Happen (Honeycutt, 2004).
