ATTACHMENT F

Los Osos Creek Vegetation Management and Debris Removal PC-01-01

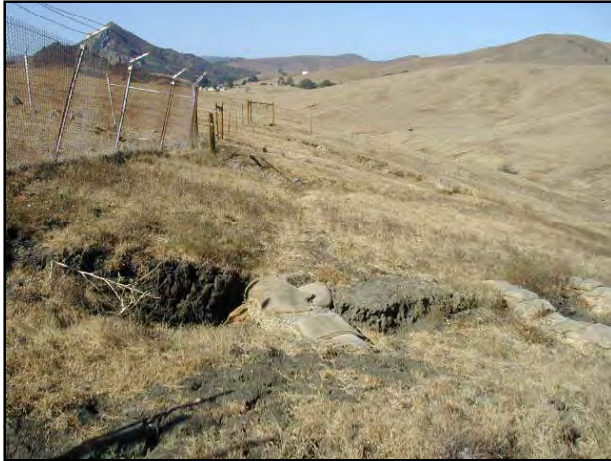
Figure 23. Top of gulley

Project: The RCD provided the materials to repair approximately 1,500 feet of steep to moderate gulley erosion caused by stormwater runoff from a 0.7 acre roof of a water storage reservoir.

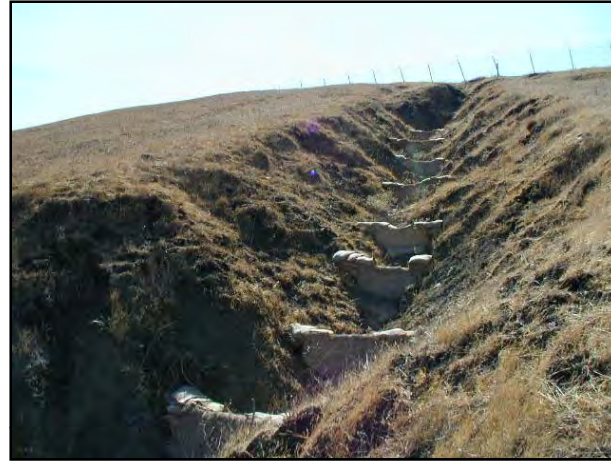
Figure 24. Looking upstream at check dams

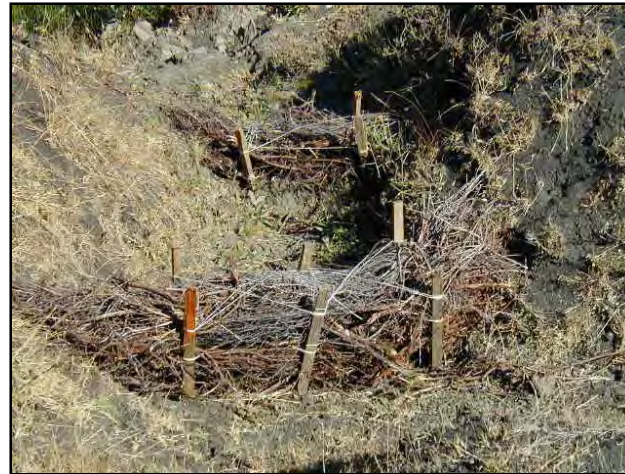
Figure 26. Brush check dam

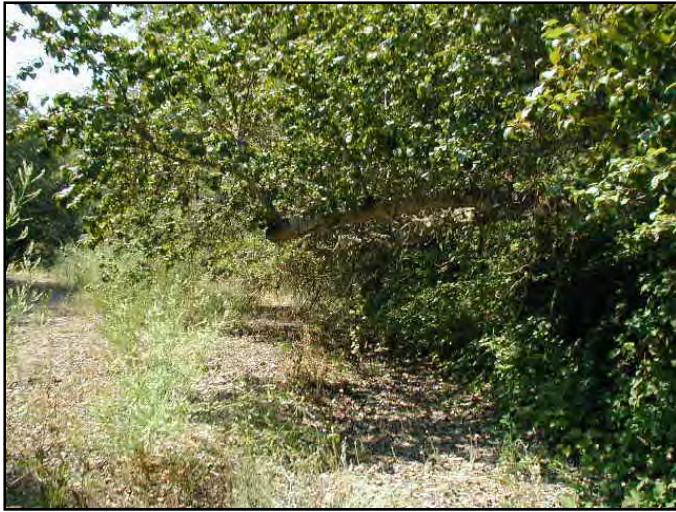
Fig 31. Before vegetation management

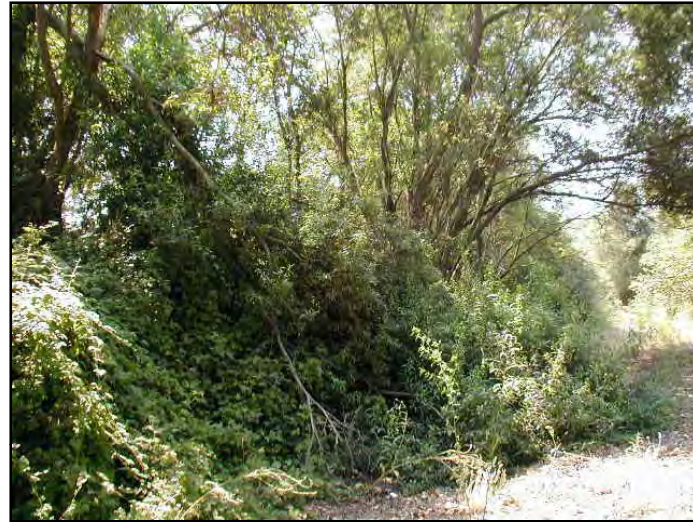
Fig 32. Before vegetation management

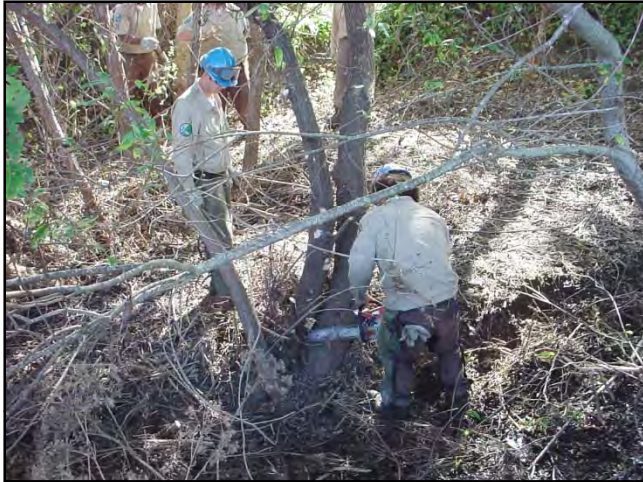
Figure 42. Tree pruning in Warden Creek.

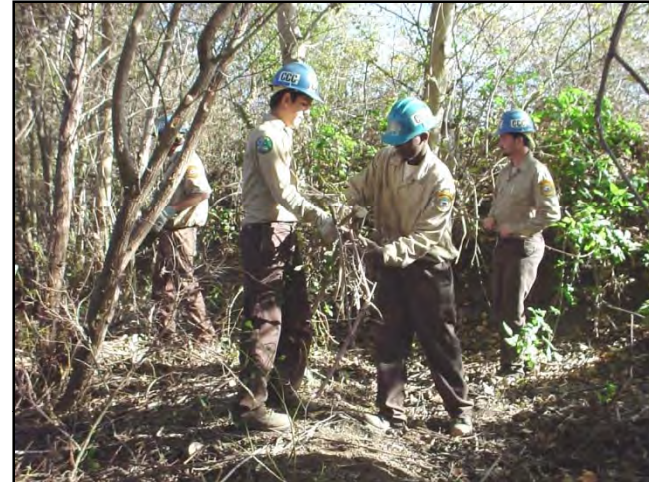
Figure 43. Taking the pruned vegetation to chipper.

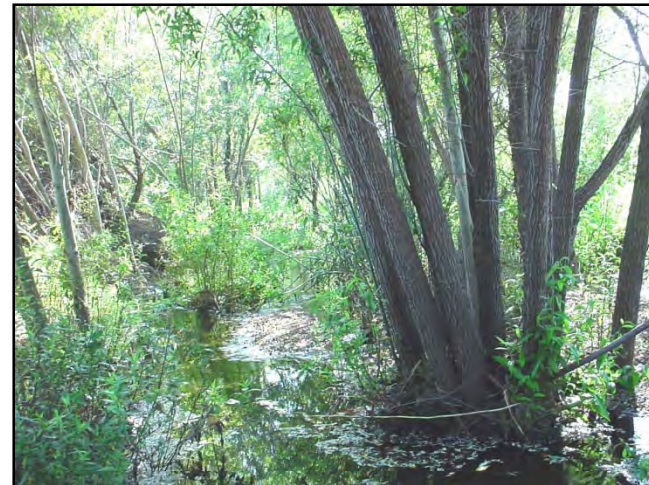
Figure 45. Channel 8 months later, note canopy maintained.

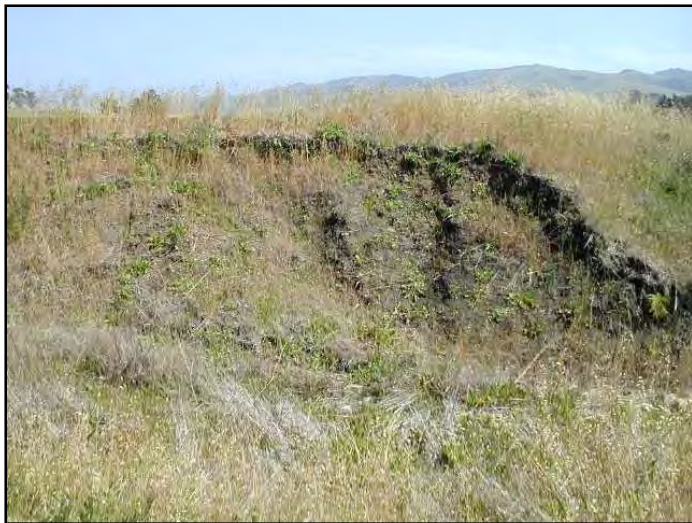
Figure 48. Sloughing bank.

Resource concern: The head cut at the culvert and sloughing bank contribute to sediment loading into this tributary to Warden Creek.

Solution: Installed coir logs to stabilize bank.

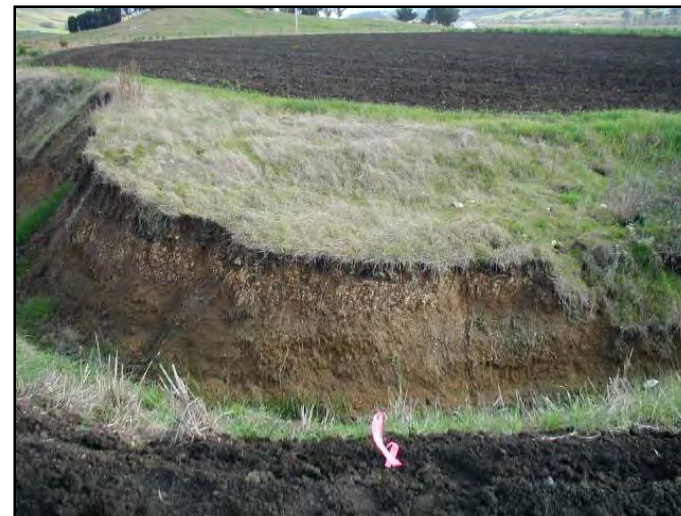
Figure 49. Eroding banks.

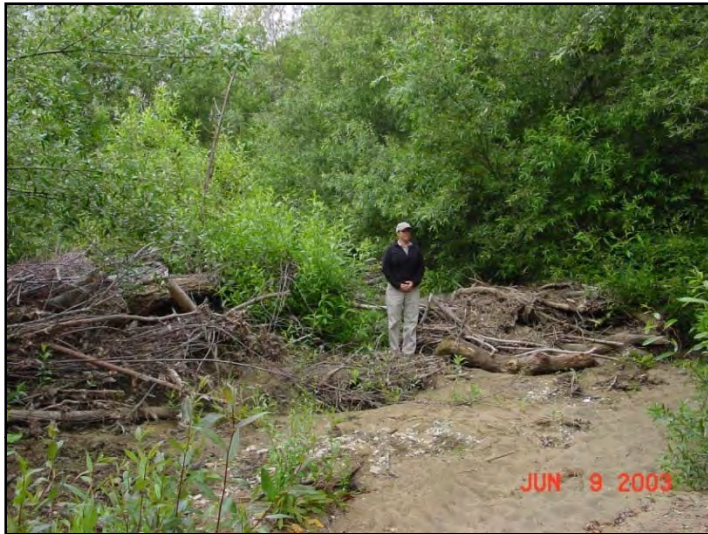
Figure 56. Meredith Hardy, CCC & Los Osos Creek debris jam

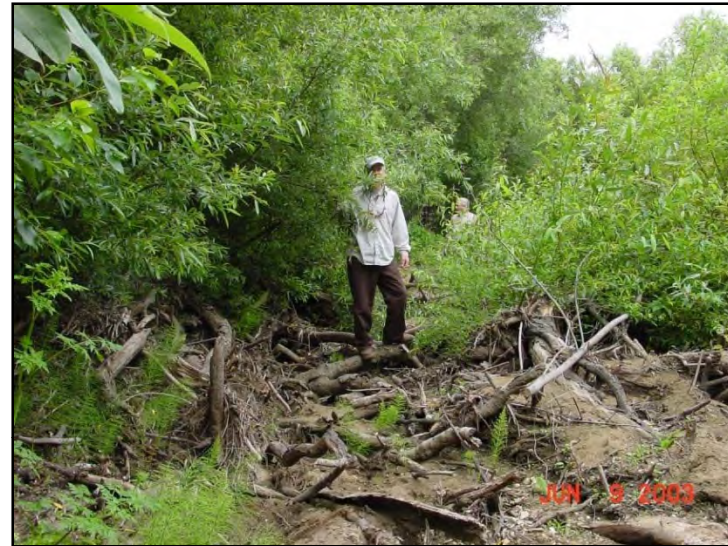
Figure 57. Phillip LaFollette, CCC & Los Osos Creek debris jam

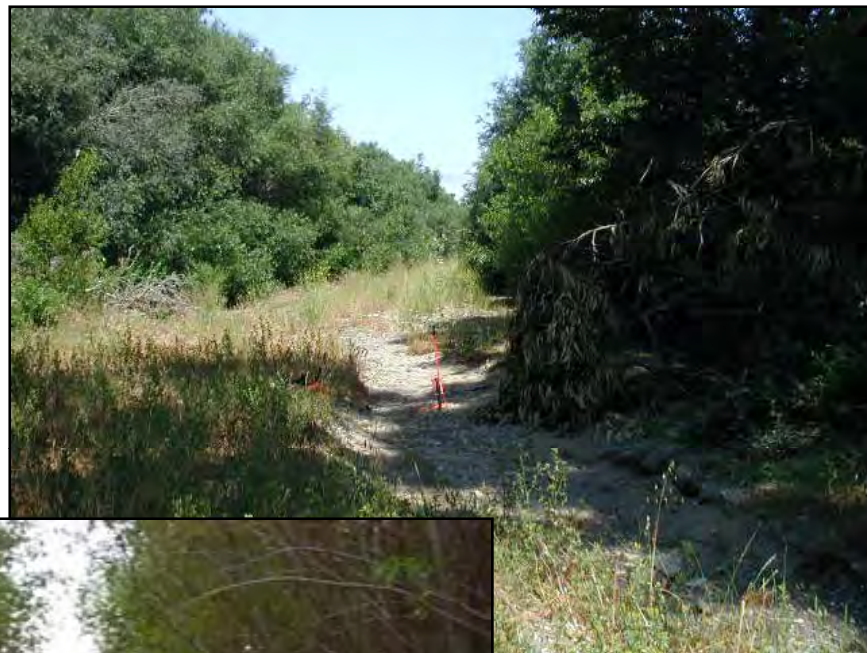
Figure 65. Photo above shows this reach of Los Osos Creek before project.

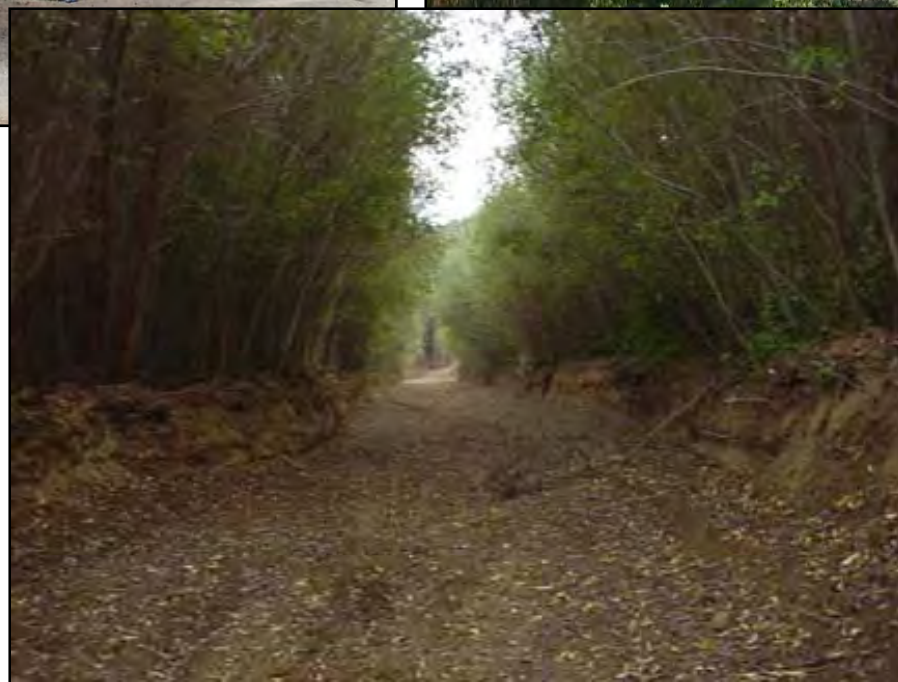
Figure 66. Photo to the left shows the reach after the project.

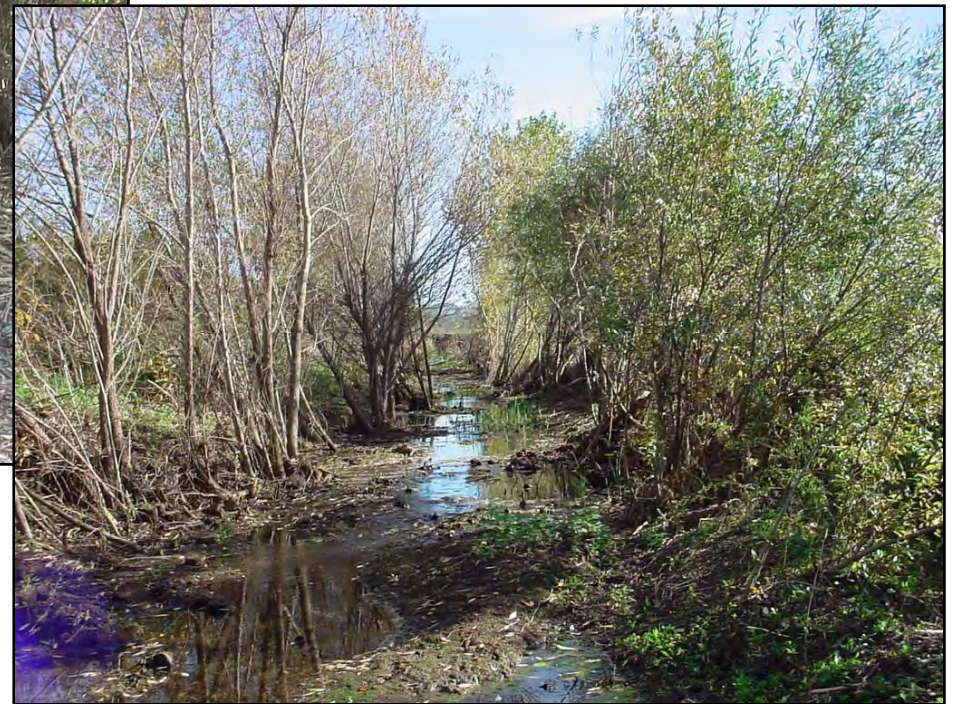
Figure 83. Reach after pruning and winter storms.

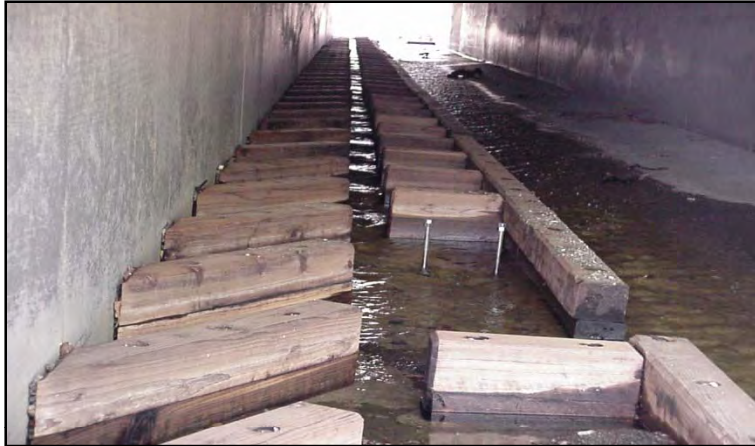
Figure 86. Dysfunctional baffles.

Project: The RCD designed a modification to the existing Pennington Creek fish ladder to improve fish passage and reduce maintenance.

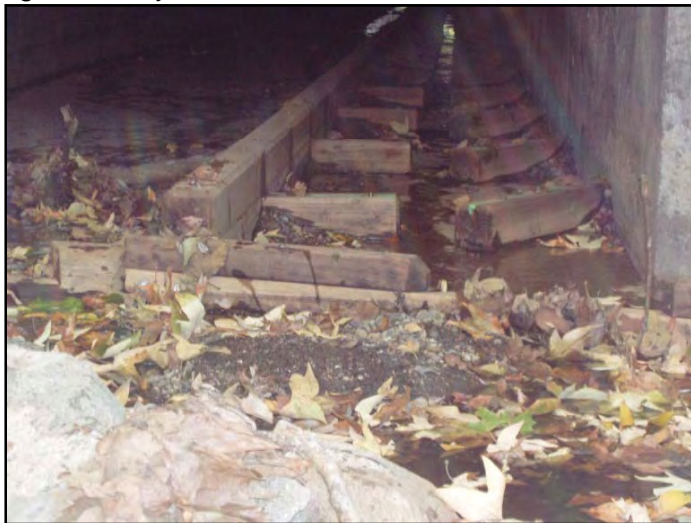
Figure 87. Modified baffles, note they are half as tall as before.

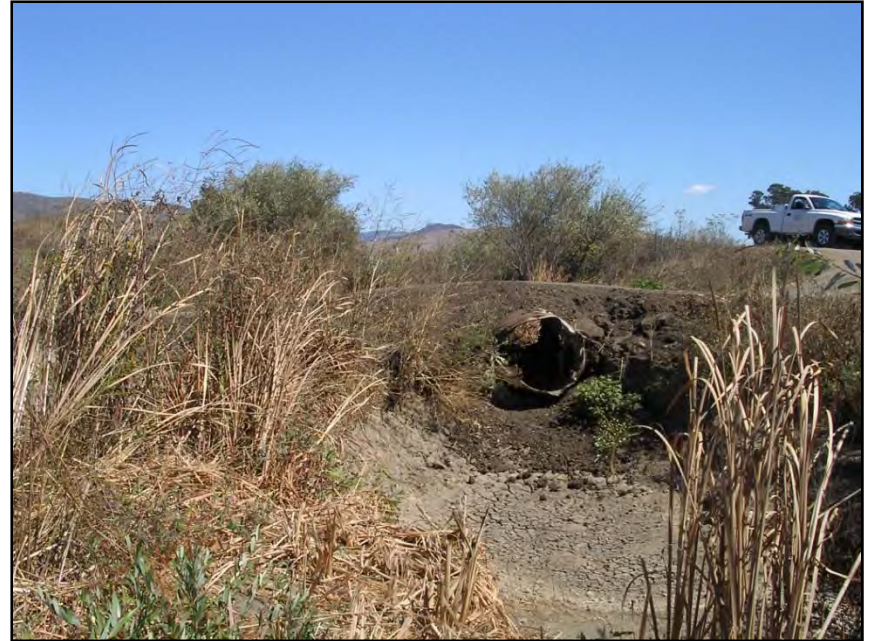
Figure 90. Looking upstream at Warden Creek crossing design.

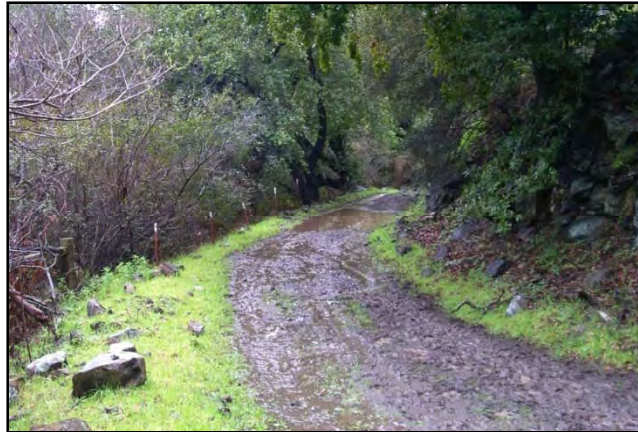
Figure 104. View of another seep.

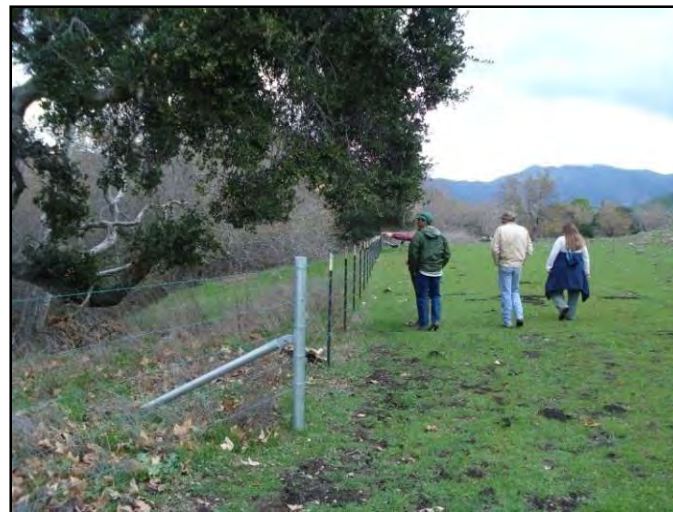
Figure 124. Riparian fencing protecting San Bernardo Creek (Feb. 2009)

Post-implementation photos: A site visit conducted February 6, 2009 found the riparian fencing and off-creek watering system in excellent condition.

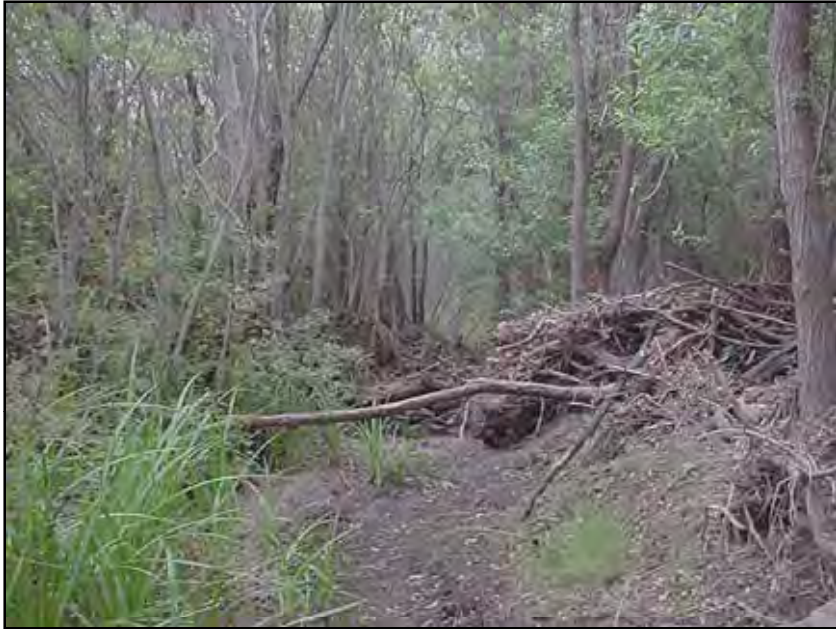
Figure 129. Debris jams cleared for fish passage and erosion reduction

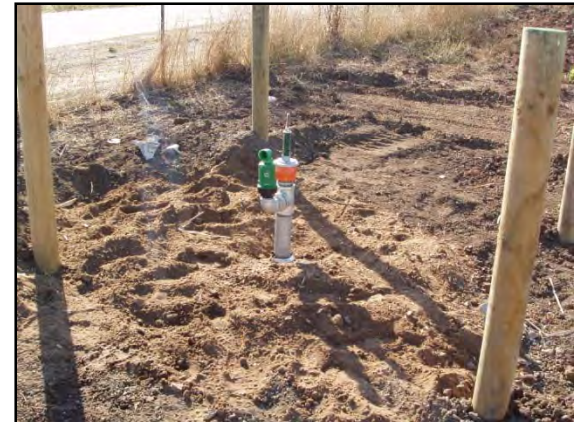
Figure 139. New combination air vent/Air release valve and a pressure relief valve.

Project: Replaced 1,200 feet of leaky 6" pipe with a new 8" line.

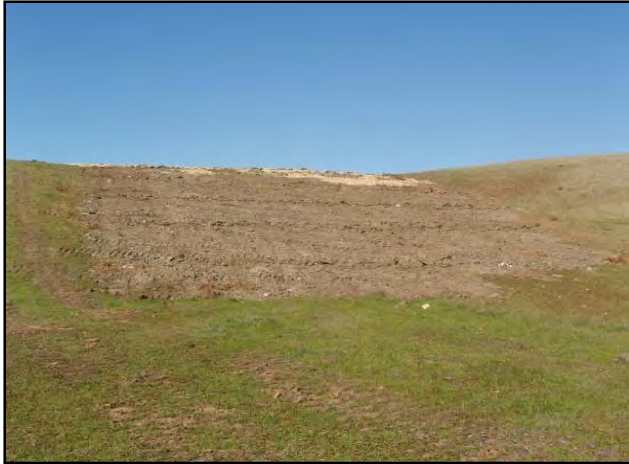
Figure 140. Compacted fill.

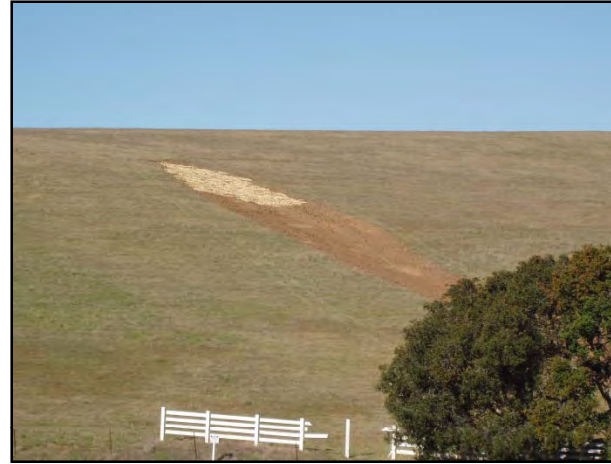
Figure 141. Implemented recommendations.
