# ATTACHMENT F

## Mitigation Project PC-05-01

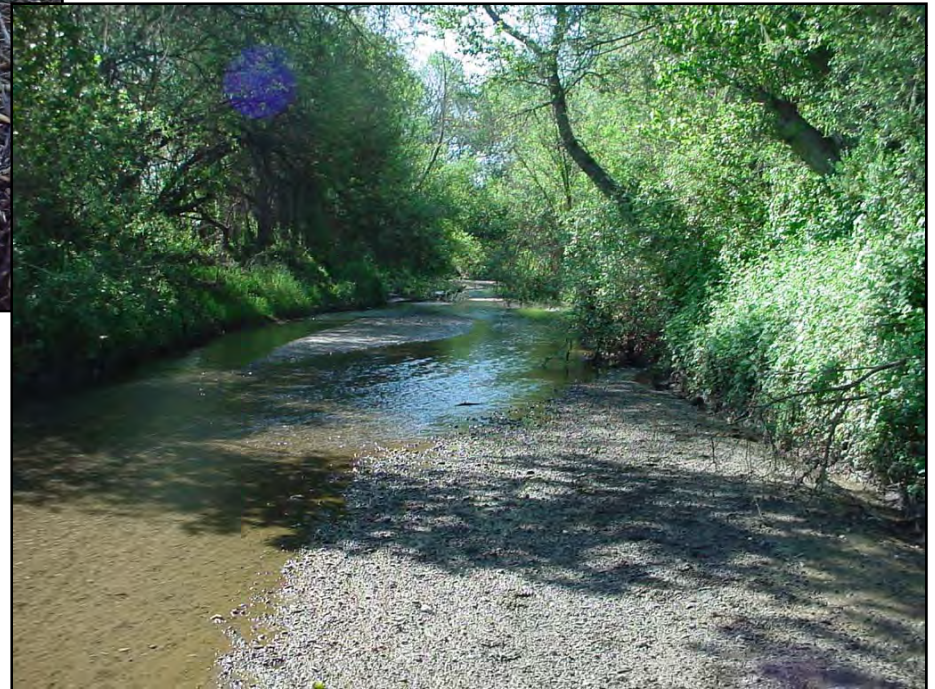
Figure 147. Good canopy, clear of debris and reduction in erosion.

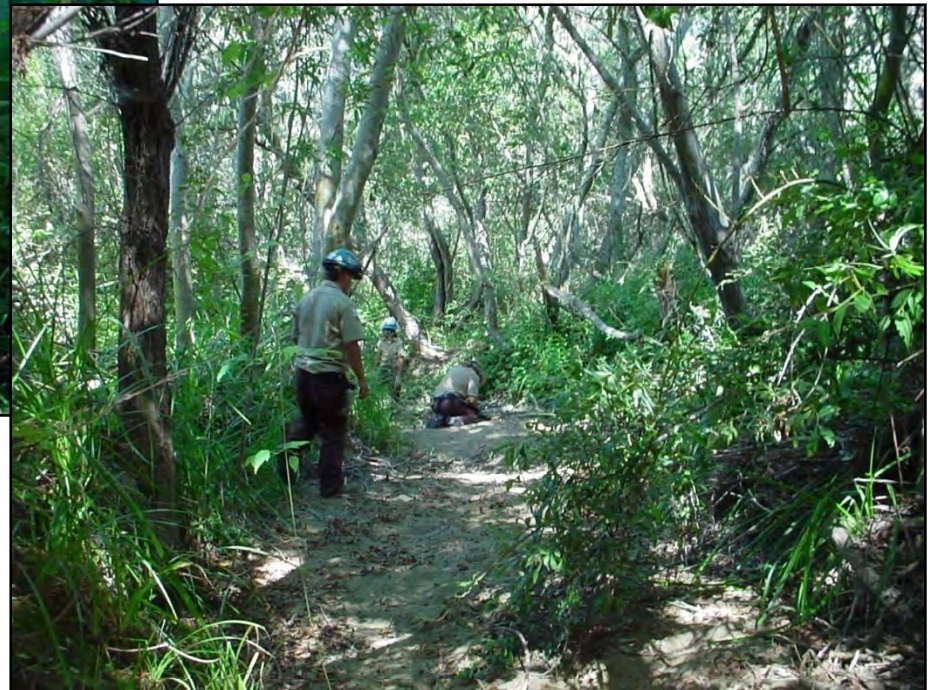
Figure 153. Pruned to encourage canopy and fish passage.

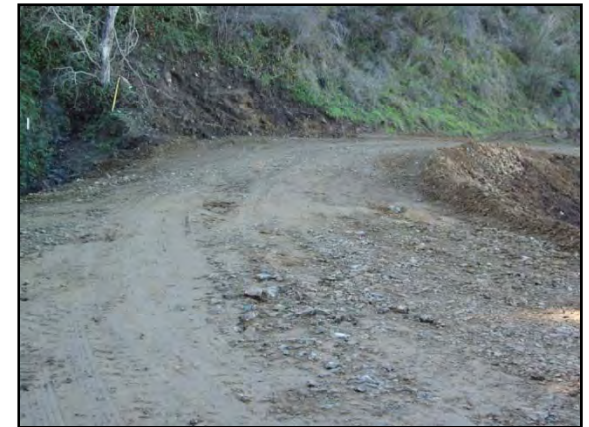
Figure 159. Completed road.

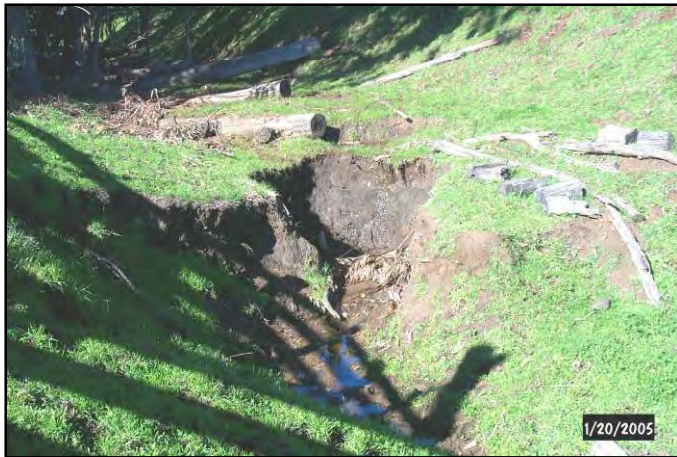
Figure 162. Another view of head cut.

**Resource concern:** The head cut and a sloughing bank contribute to sediment loading into Warden Creek.

**Solution:** Install drop structure to eliminate head cut; backfill around drop structure; fill in head cut to support sloughing bank.

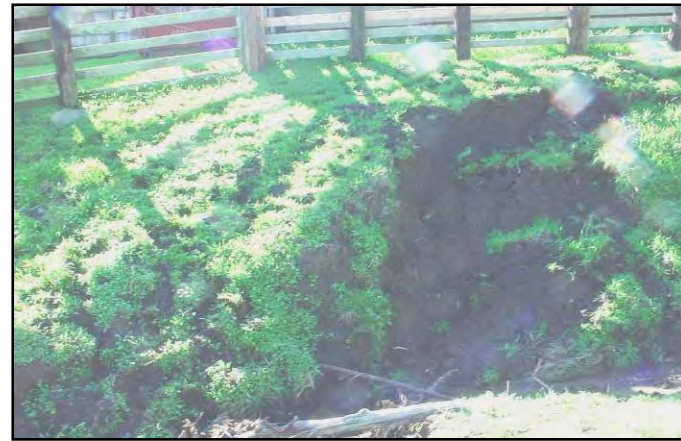
Figure 163. Sloughing bank.

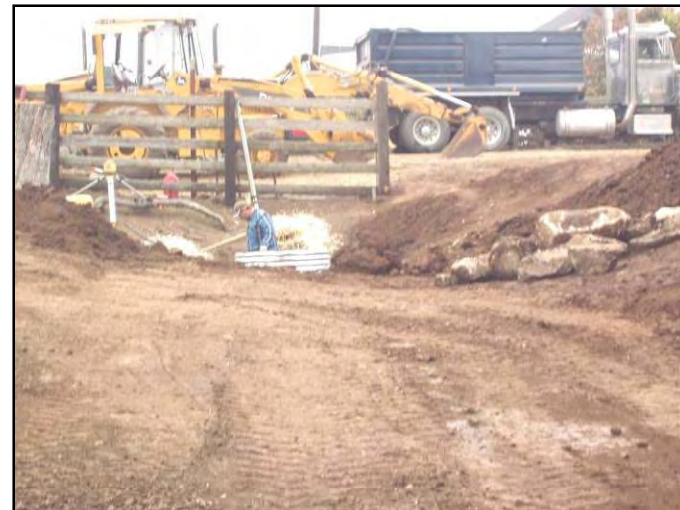
Figure 168. Headcut backfilled.

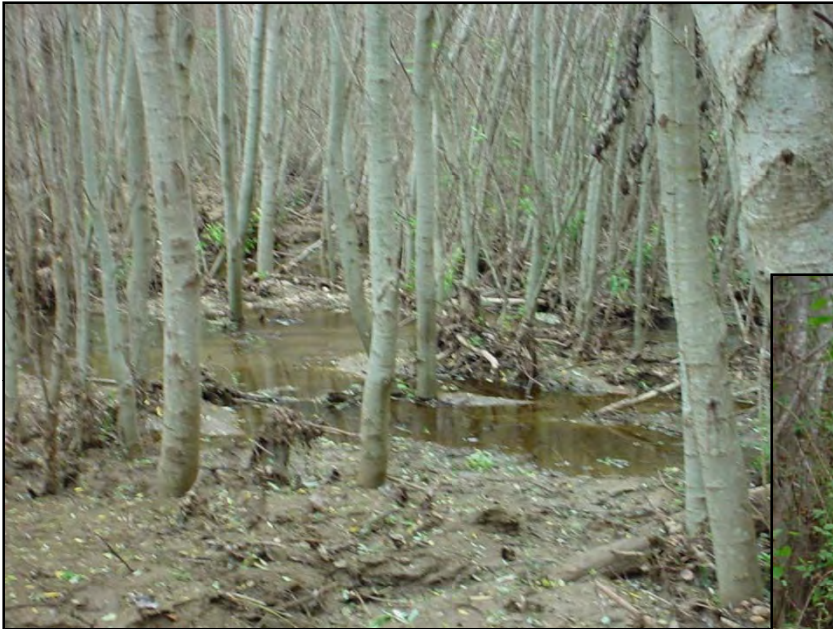
Figure 199. Riparian forest before thinning.

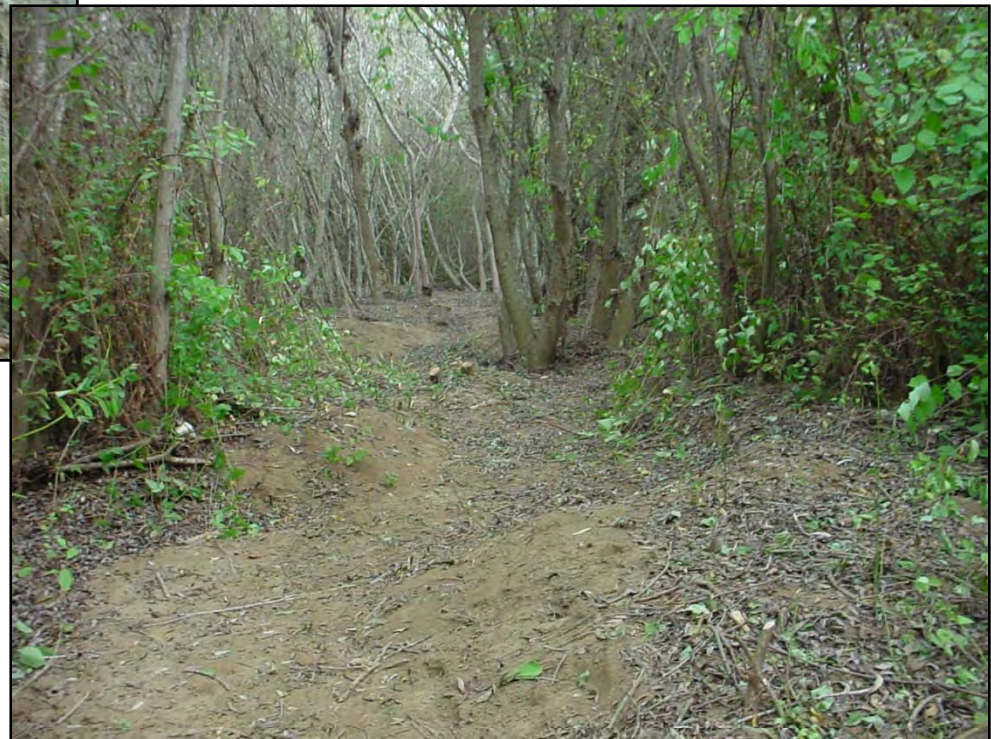
Figure 200. Riparian forest thinned to improve diversity.

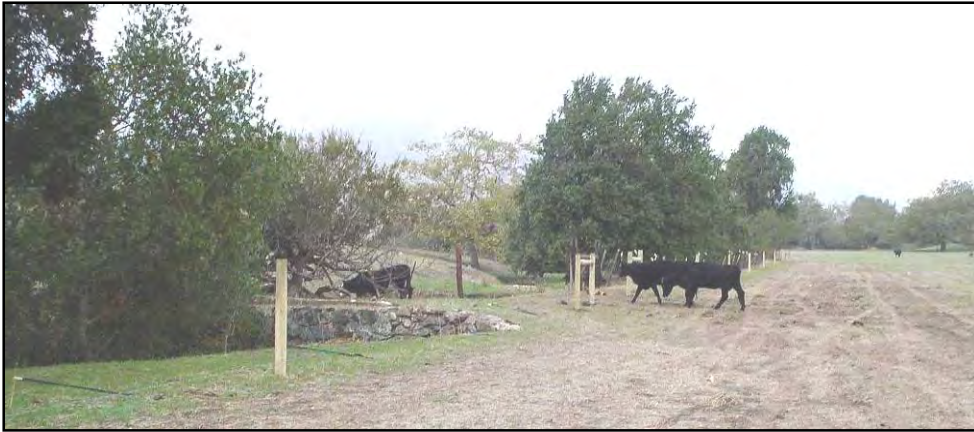
Figure 237. Cattle heading toward creek.

**Resource concern:** Impaired water quality and riparian vegetation due to cattle in creek; water quality parameters of concern include pathogens.

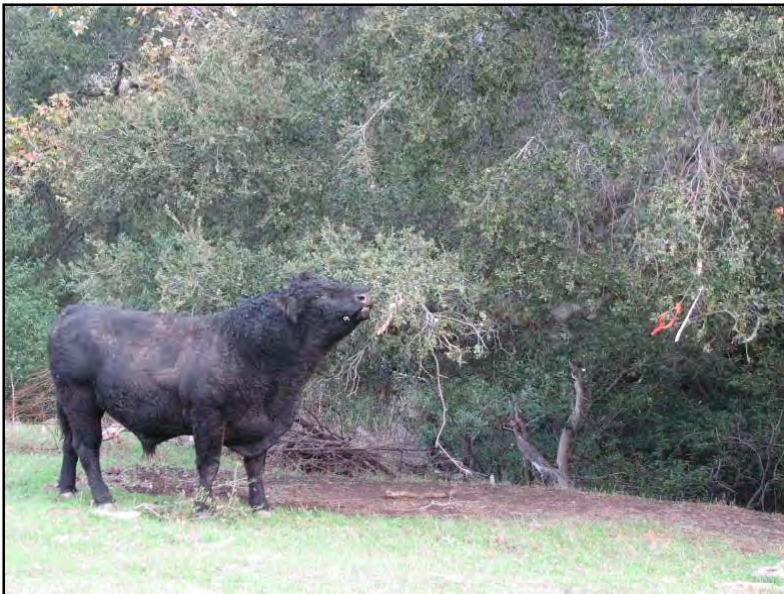
Figure 239. Bull browsing tree in riparian area.

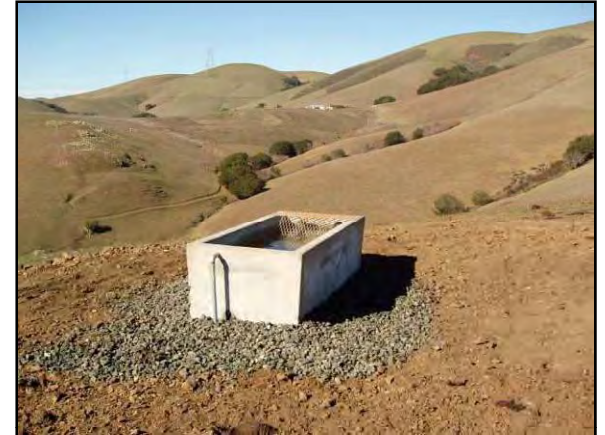
Figure 250. Water trough #10.

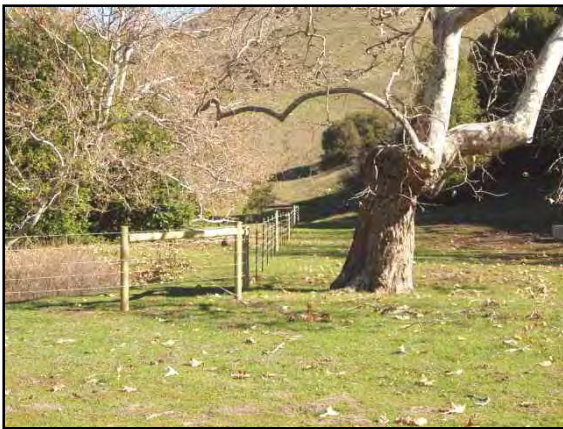
Figure 251. Riparian fencing

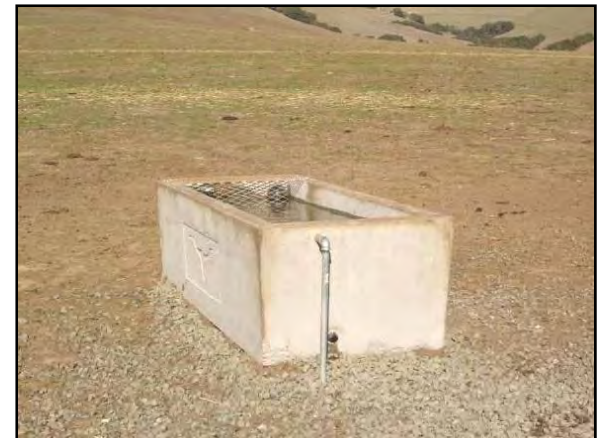
Figure 253. Water trough #60.
